Final report BBW 99.0579, June 2003

# **MTBF - PVm**

## Mean Time Before Failure of Photovoltaic modules

Antonella Realini  
SUPSI, DACD, LEEE-TISO  
6952 Canobbio

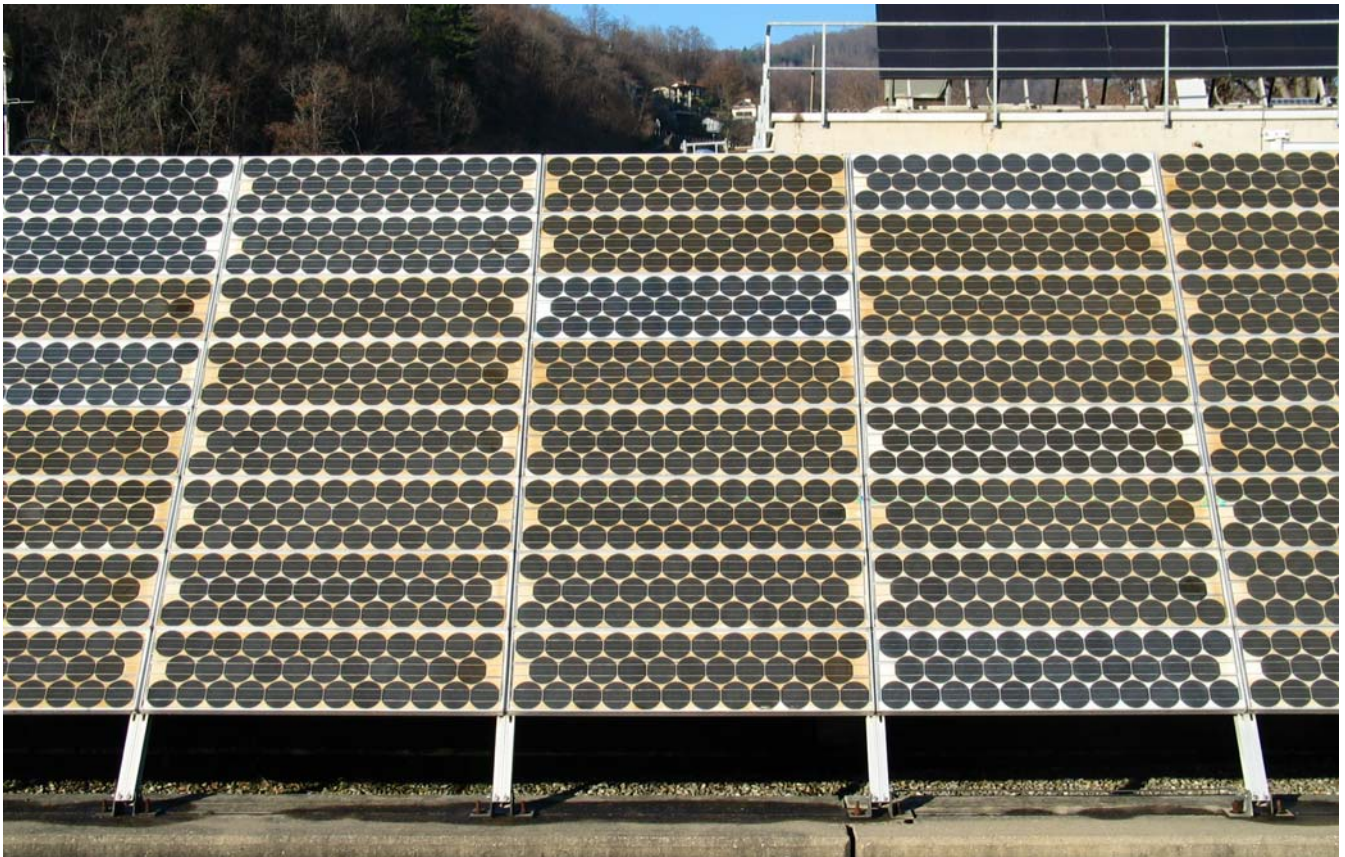
The most evident visual defect is the yellowing of the encapsulant. A 1985 TISO publication reports the presence of this type of colour change on 50% of the modules and pointed out to its rapidly increasing during the last 12 months [7]. In 2003, it affected with different intensities the **98%** of the plant. The reason why some modules have remained completely white (Figure 15) could be due to the use of a different encapsulant (Chapter 7), but it is not certain, as both PVB and EVA could be affected by yellowing when exposed to UV light. Furthermore, from the gas chromatography analysis of white and yellow samples removed from two broken modules results the same compound (PVB).

**Figure 15:** white and yellow modules in one field of TISO 10 kW plant (September 2002).

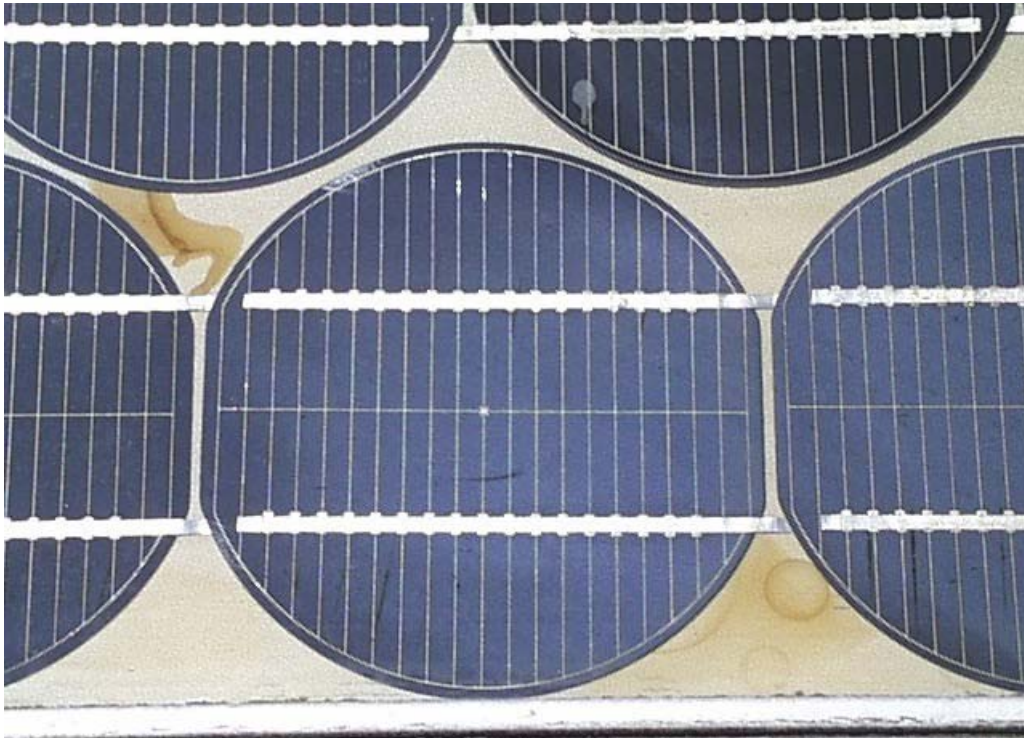
Other type of colour changes has been detected, such as browning of the internal Tedlar foil (Figure 18 and Figure 19), and the presence of red areas in correspondence of interconnection ribbons.

**Figure 18:** module presenting two different brown areas on internal Tedlar foil.

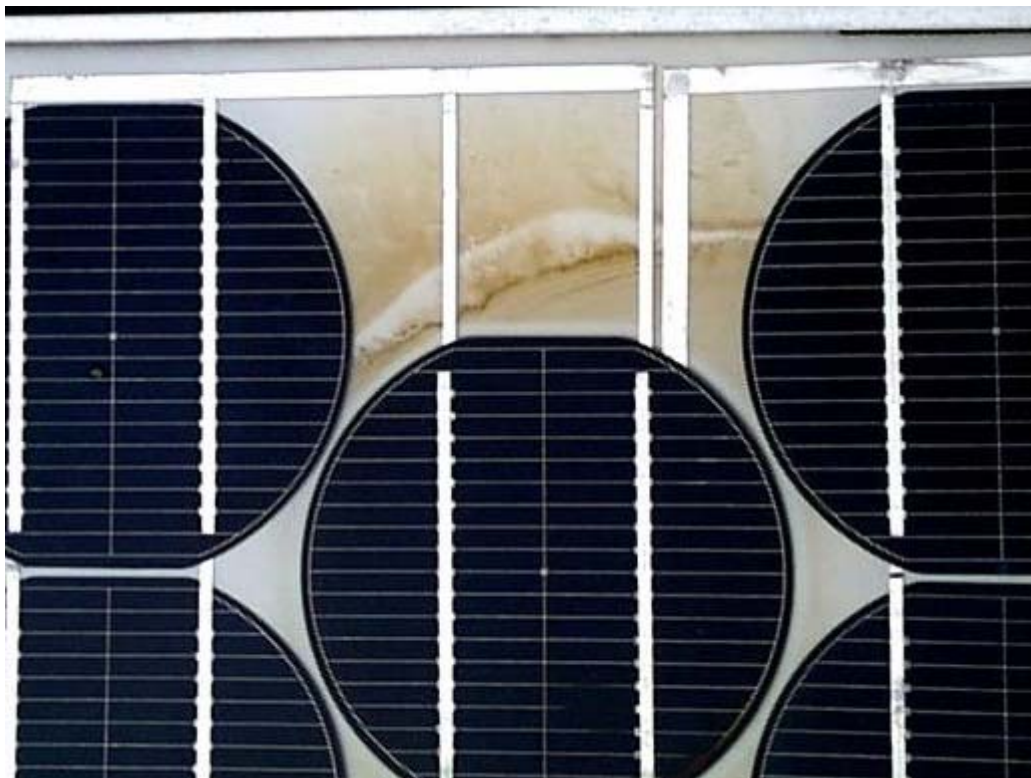
**Figure 19:** white module with one brown area on internal Tedlar foil.

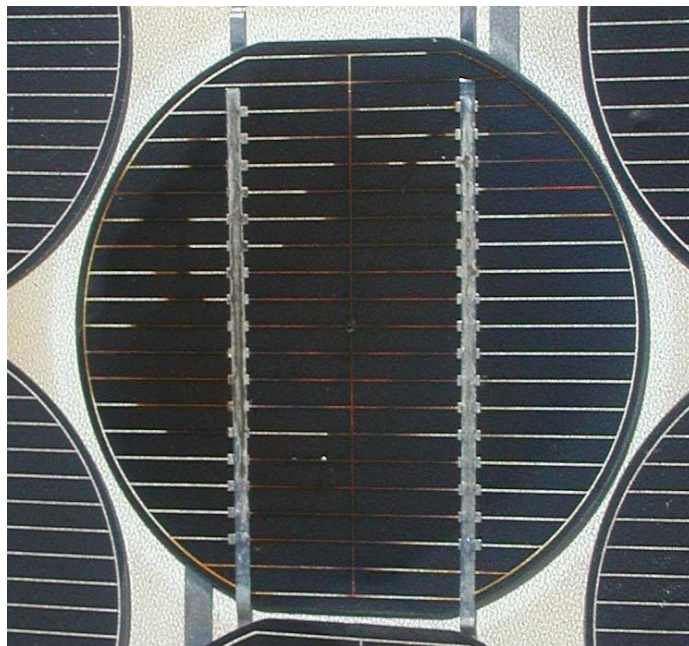
The browning of cells electrical grid was already detected in 1983 [8]; in particular, this phenomenon was associated with the cells sited in front of the junction box (Figure 20). A project final report dated 1984 [9] referred to a document, edited by Arco Solar, in which the browning of electrical grid, previously detected in other plants, was attributed to a PVB encapsulant oxidation accompanied with a catalytic reaction with decomposition products of poly-vinyl-alcohol (PVA). The manufacturer affirmed that this reaction did not involve the silver grid contacts; hence the cell electrical characteristics were not modified. No significant effects were mentioned in regard to PVB optical transmittances.

**Figure 20:** grid-lines oxidation on the cell corresponding to junction box.

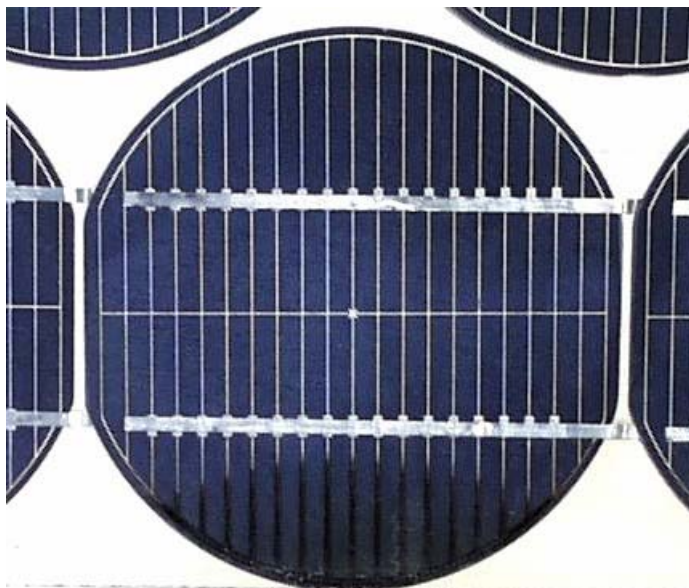
In 2003, oxidation, detected on **93%** of the plant modules, also affected the cells close to the edges of the modules (Figure 21). It could be attributed to moisture permeation through the module edges.

**Figure 21:** grid oxidation on cell close to module edge.

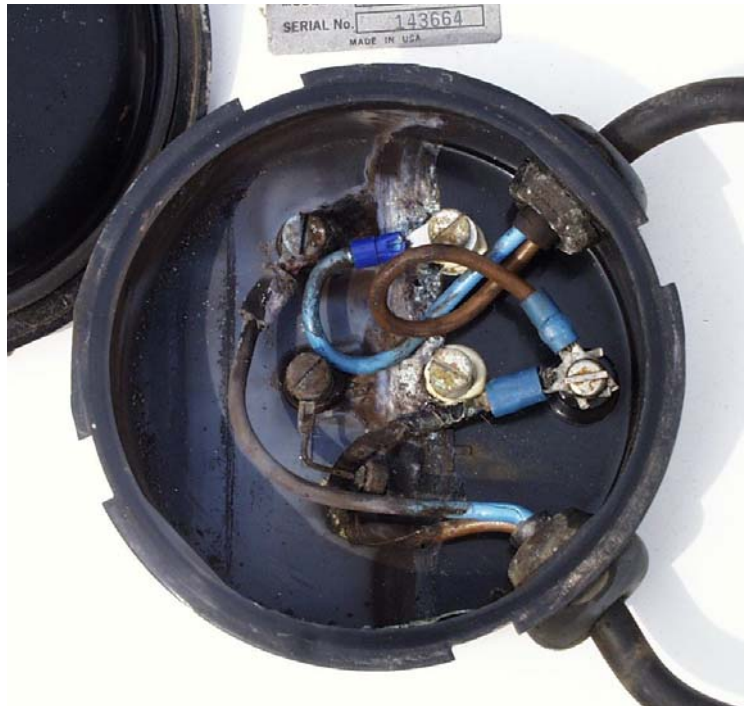
The oxidation of terminals has been detected on **45%** of the plant modules. It is probably caused by the bad sealing of the junction box on the tedlar backsheet which, in turn, leads to loss in insulation resistance (Figure 22). Terminals oxidation results in higher electrical resistance, and could provoke detachment when wiring (Figure 23).

**Figure 22:** terminal oxidation (worst detected one).

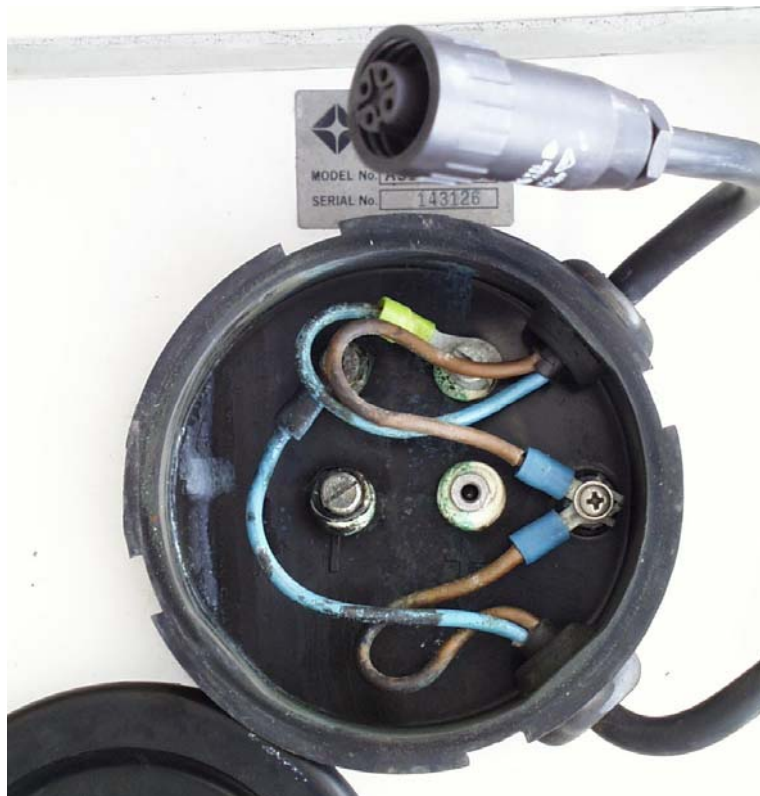
**Figure 23:** oxidation inside junction-box and detachment of one terminal.

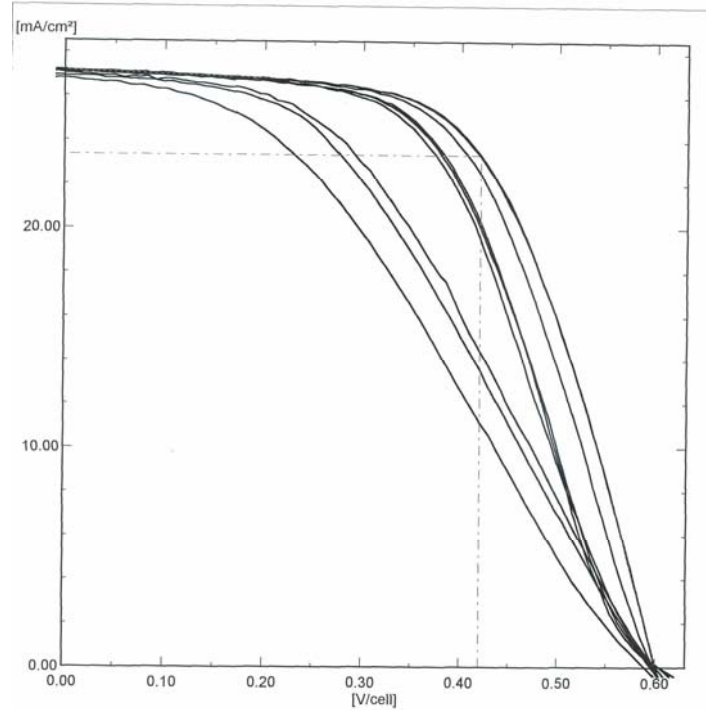
Partially detached terminals could affect module efficiency (hence, the overall plant production). For example, several consecutive indoor performance measurements (one flash about every minute) were executed on one module with a terminal partially detached. During the test no changes, such as settings and connections, have been applied. Results (Figure 24) always gave different electrical characteristics (fluctuating maximum power values).

**Figure 24:** results of a series of I-V measurements on module with one partially detached terminal.

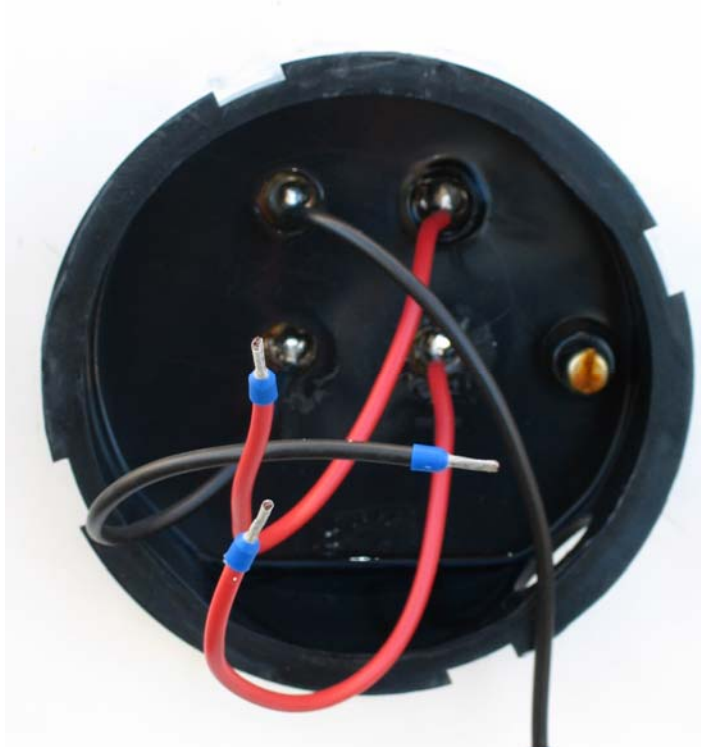
**Figure 25:** module with detached terminals repaired with soldered cables.

Having no spare modules, detached terminals have been replaced with simple soldered cables (Figure 25).

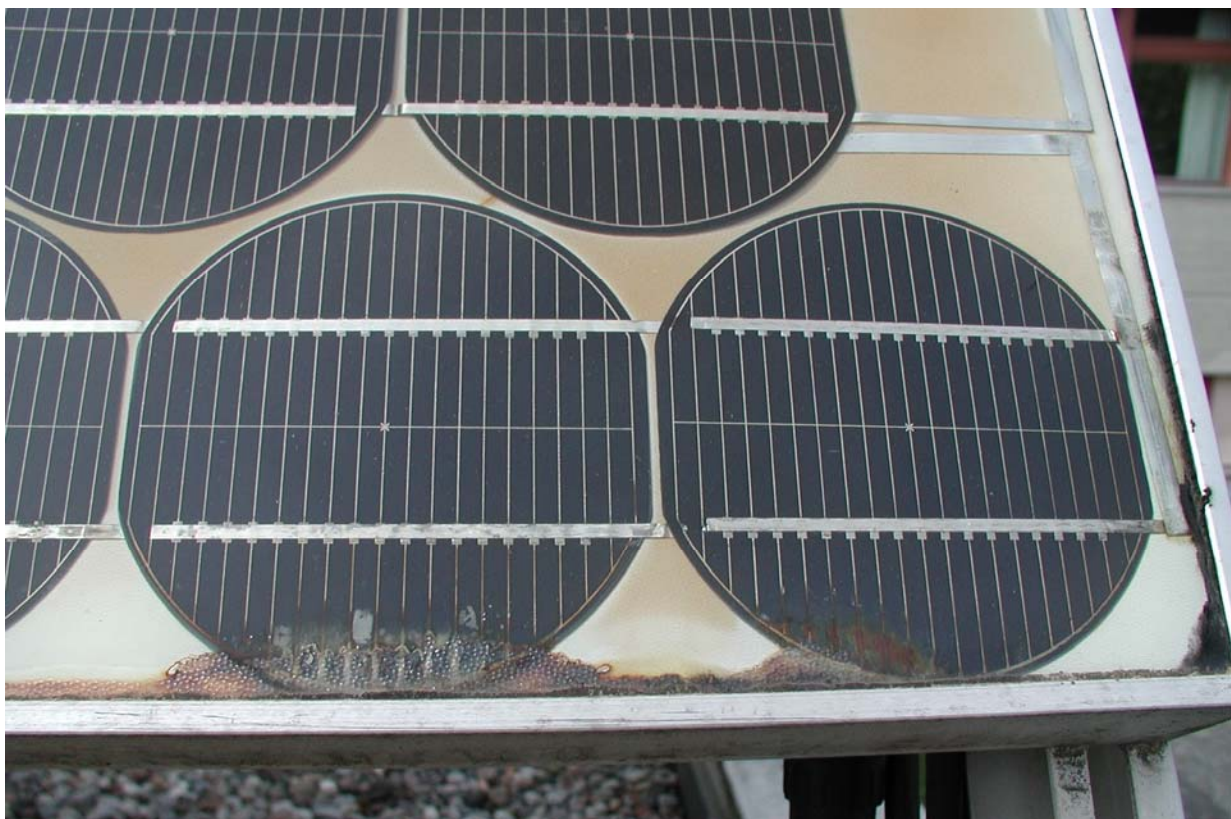
Even if in 69 modules (27% of the plant) delamination represents a **major defect**, as it forms a continuous path between frame and circuit (as defined by IEC 61215), no insulation failures were detected for these modules both in wet and dry conditions (Figure 26).

**Figure 26:** heavy delaminated module subjected to insulation test. No insulation failures detected.

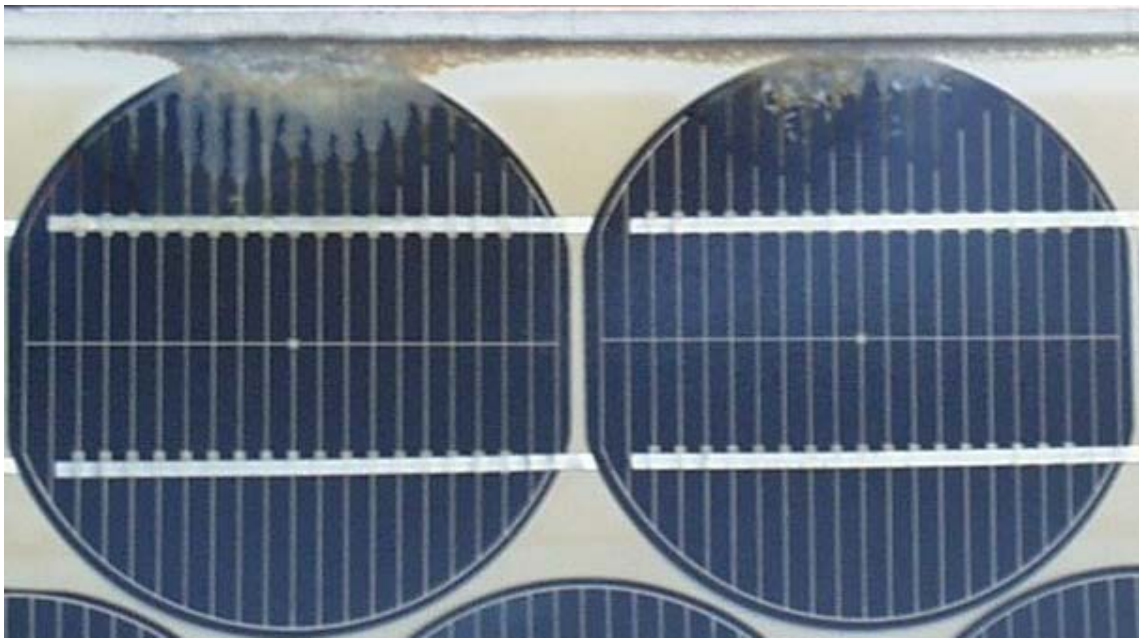
This measurements, executed in 2001, evidenced that the presence of partially delaminated cells does not necessarily significantly affect the overall module efficiency; in this case the module showed no measurable degradation in power, having a maximum of 33 W (mean modules maximum power), similar to other non-delaminated panels.

Figure 27: cell 5 (on the left) and cell 6 (on the right) differently affected by delamination in 2001.

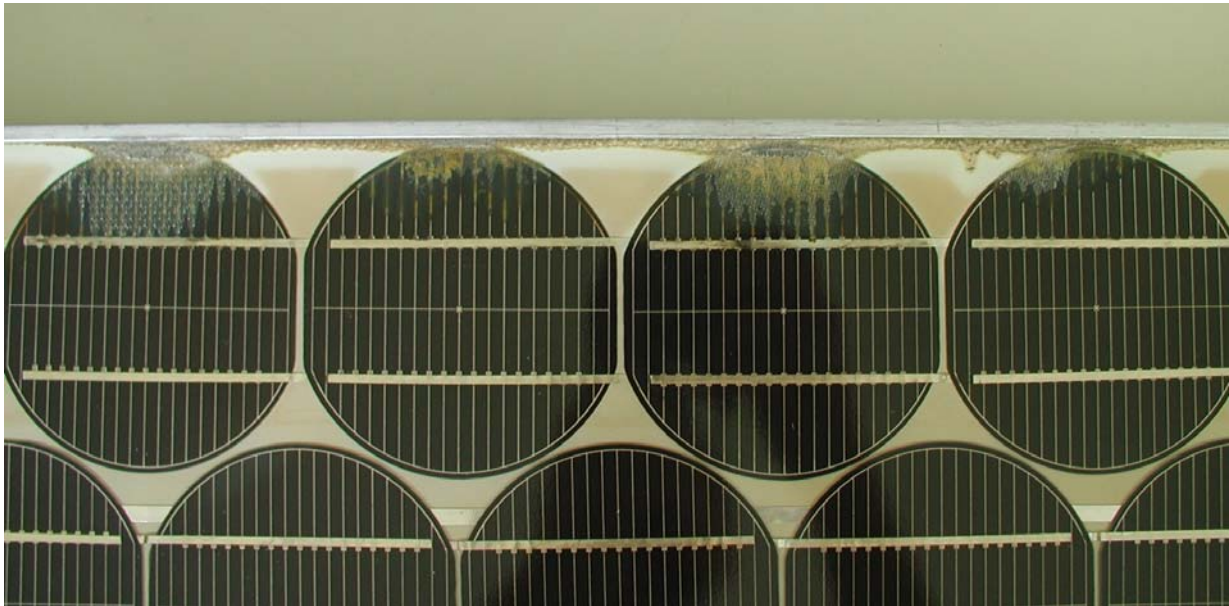
During two years, this module has been kept under control to follow the progressive electric degradation related to the cells deterioration. Table 3 shows the differences of the electrical parameters of four differently delaminated cells (Figure 29), detected from 2001 to 2003.

**Figure 29:** from left to right – cells 5, 6 (same as in Figure 27), 7 and 8. Different degrees of delamination detected in 2003.

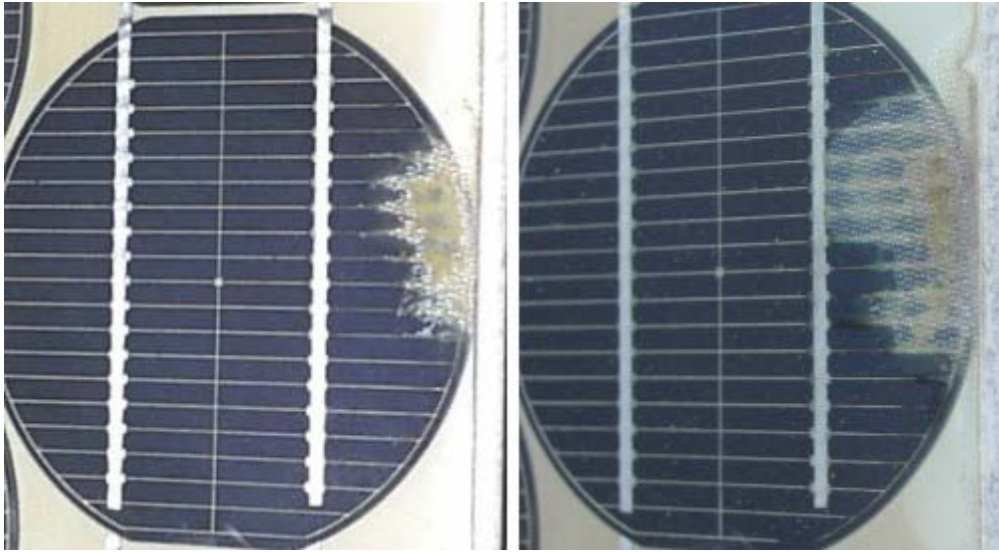
Another example of the effects of cell delamination increase on module electrical characteristics is shown in Figure 30 and Table 5.

**Figure 30:** delamination evolution on cell surface from 2001 (left) to 2003 (right).

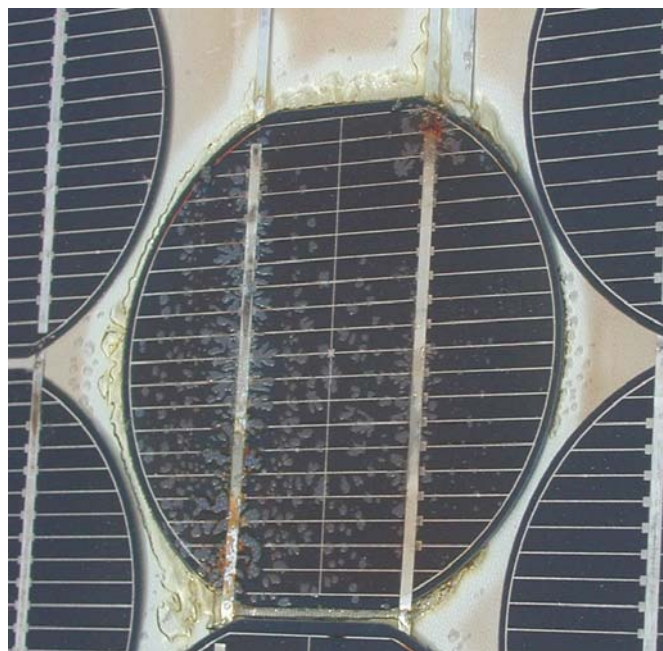
Particular attention has to be paid to modules where delamination affects the area of hot-spotted cells (chapter 9). In 20 years, 3 modules (1.2% of 252) presented such a defect: 1 of them was replaced in 1997, while 2 are still working and have a maximum power respectively of 26.4W and 28.2W (**Figure 31**) (-20.2% and -14.8% with respect to the actual mean module power).

**Figure 31:** delamination on one hot-spotted cell.

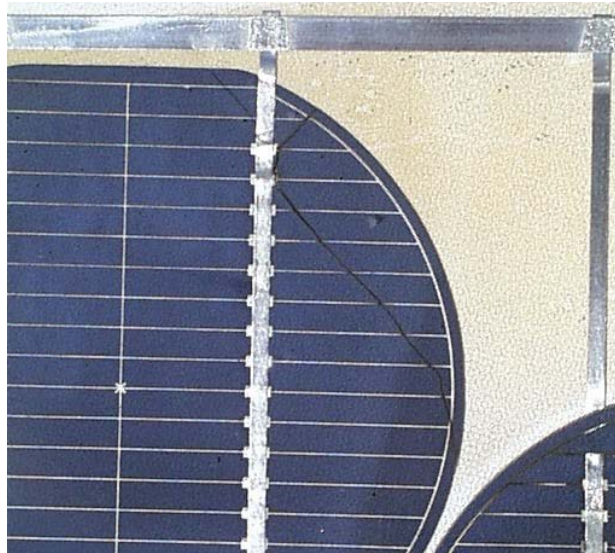
From performance measurements executed on each module emerged that detected cracked cells do not significantly affect modules efficiency; even though their presence is sometimes verifiable by the analysis of the I-V curve shape (Figure 33). In 2003, the percentage of modules with cracked cells increased to **22%**; with new breakages corresponding to hot-spotted cells (Figure 32 and Figure 33).

**Figure 32:** cracked cell which presence is visible in the module I-V curve (**Figure 33**).

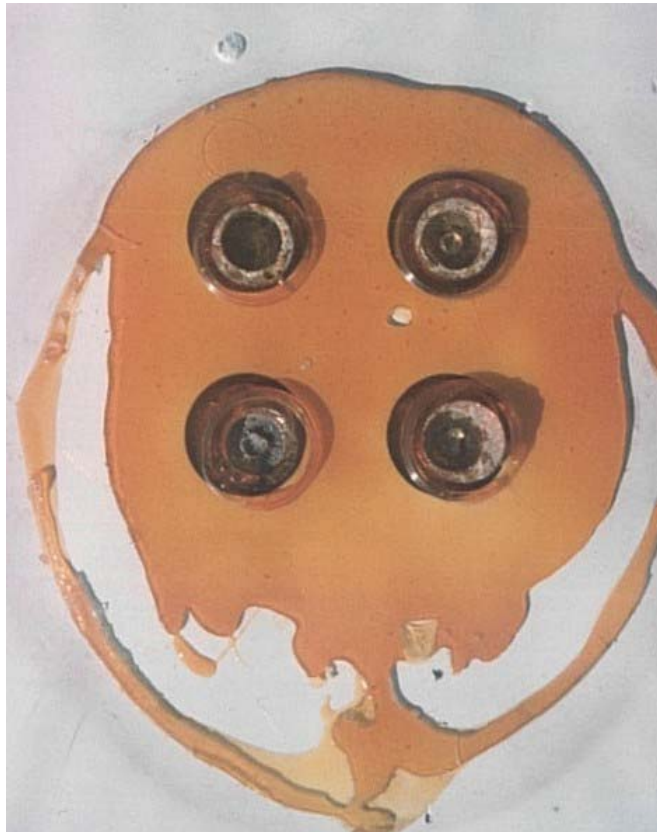
**Figure 34:** box and terminals detachment caused by bad seal (so bad insulation) of the junction box.

Bad sealed junction boxes have been fixed with silicone and detached terminals replaced with cables (8.2.2, Figure 25).

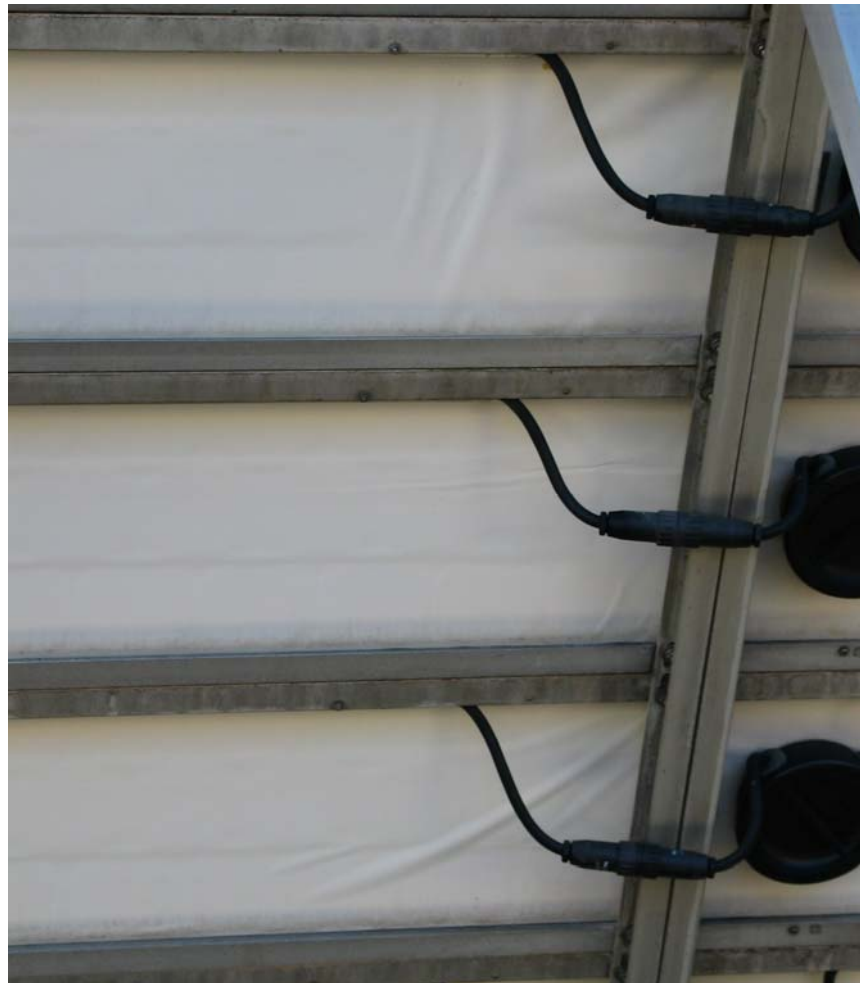
Regarding ASI 16-2300 the tedlar detachment from the metal layer was detected in the bottom part of two modules (Figure 35) in October 2002. Since then, this phenomena has been rapidly increased (about 4 modules/month); in march 2003, 24 modules (9.5% of the overall plant) presented such a defect; at present they are 50 (**20%** of the overall plant).

**Figure 35:** wrinkles caused by the detachment of Tedlar backsheet from the metal foil.

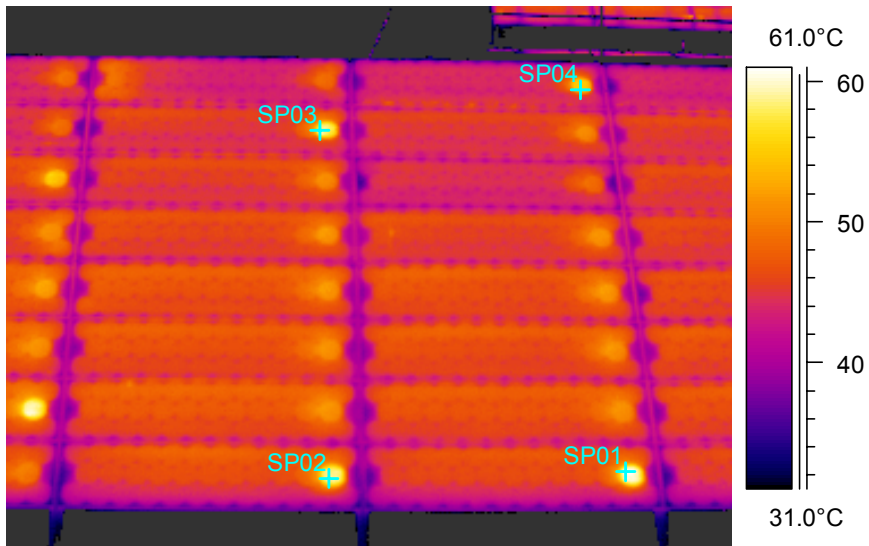
In 1985, hot-spots were not detected yet [11]. In 1996, 48 affected cells were noted and 56 in 1999 (+3.2%). In 2003, infra-red analysis of the plant detected the presence of hot-spots on 67 modules (26% of 252; +4.4% with respect to 1999); they are generally found on the cell in front of the junction box (Figure 36), which shows an overheating of about  $10^{\circ}\text{C}$  with respect to the rest of the module surface.

**Figure 36:** IR image showing higher temperatures always localized in correspondence of the junction box location. Four cells with hot-spot are also indicated (SP0x with  $\Delta T_{\text{cell\_module}} > 10^{\circ}\text{C}$ ).

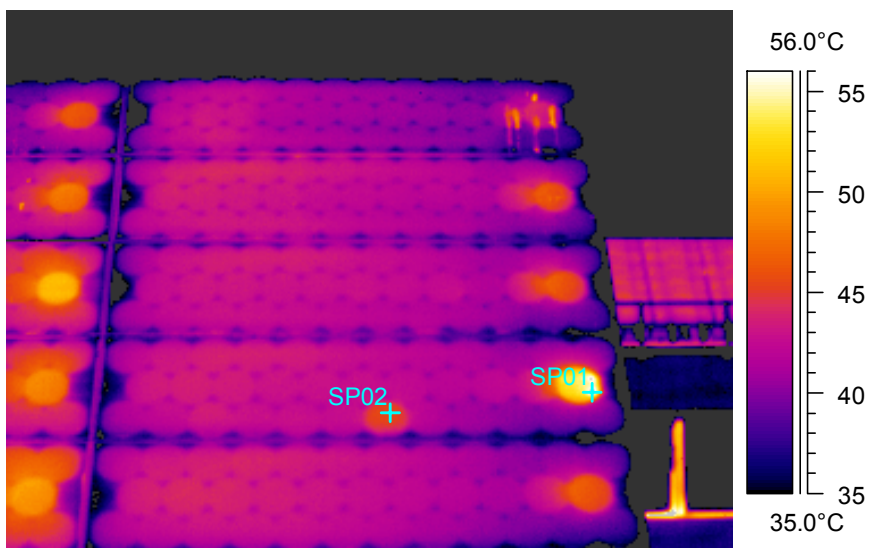
Cells partially affected by delamination also present higher temperature (Figure 37). The increase of delamination on the overall cell area could lead to hot-spot formation.

**Figure 37:** IR image showing one cell with hot-spot (SP01) and one area with higher temperature (SP02) corresponding to a partially delaminated cell.

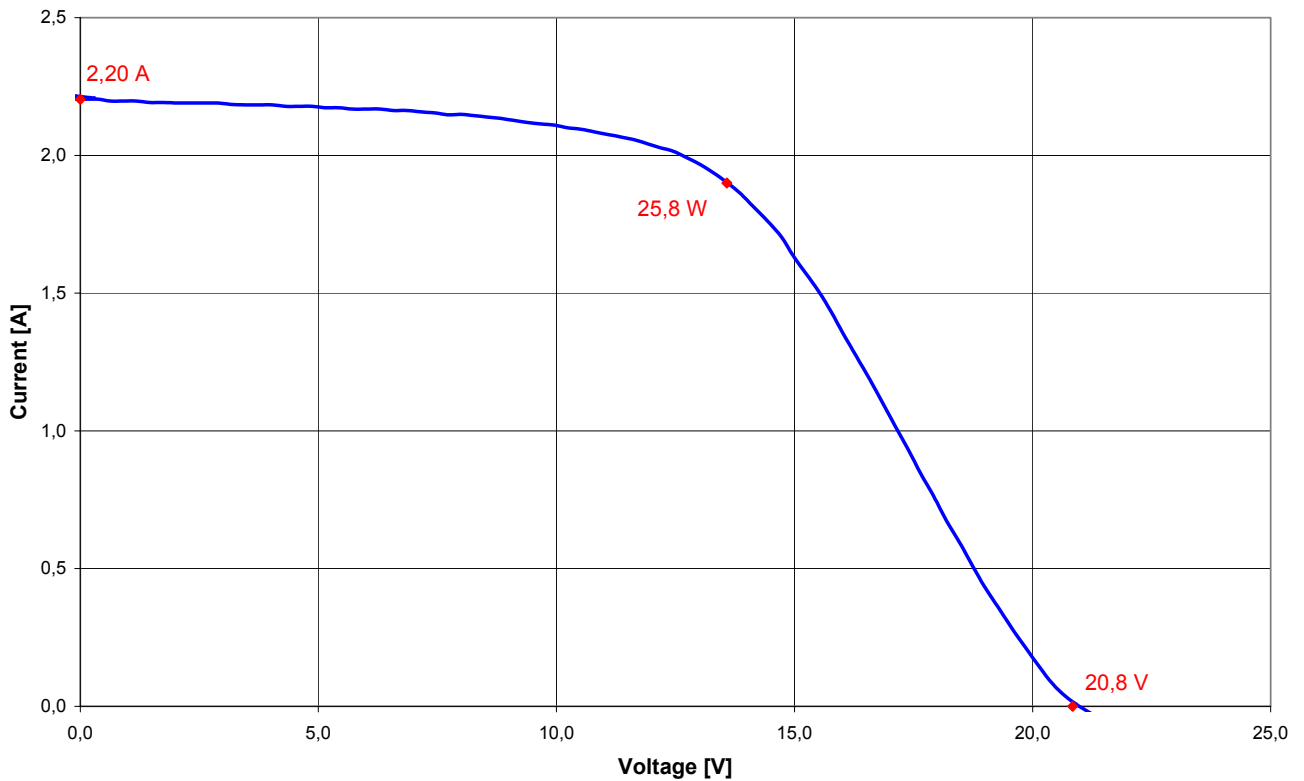
This gradual increase of number of hot-spots has to be monitored closely, as modules with hot-spots show the highest power degradation; the worst affected module of the plant (Figure 38), whose maximum power is equal to 25.8 W (-22.0% with respect to the actual mean module power), has a hot-spot.

**Figure 38:** I-V characteristic of the most degraded module of the plant, which has a hot-spot.

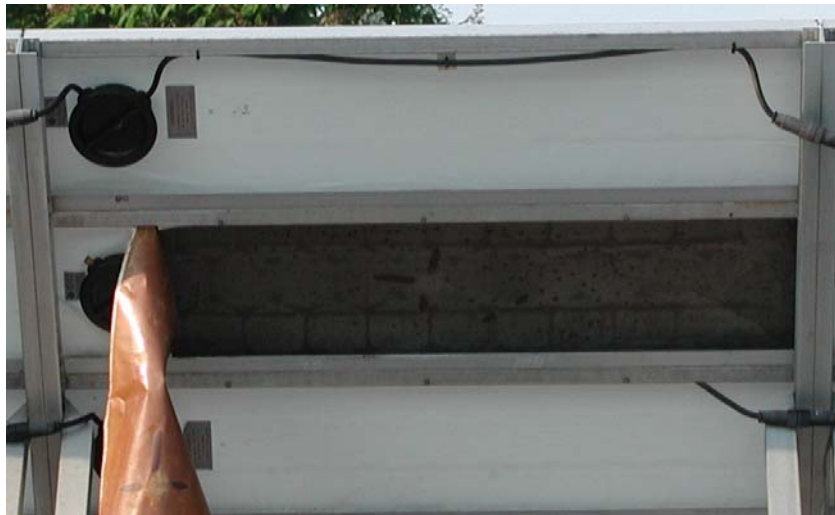
**Figure 43:** Tedlar detachment in modules subjected to 4000h DAH. After the test the module was installed in the plant, and complete detachment occurred after one year of further exposure.

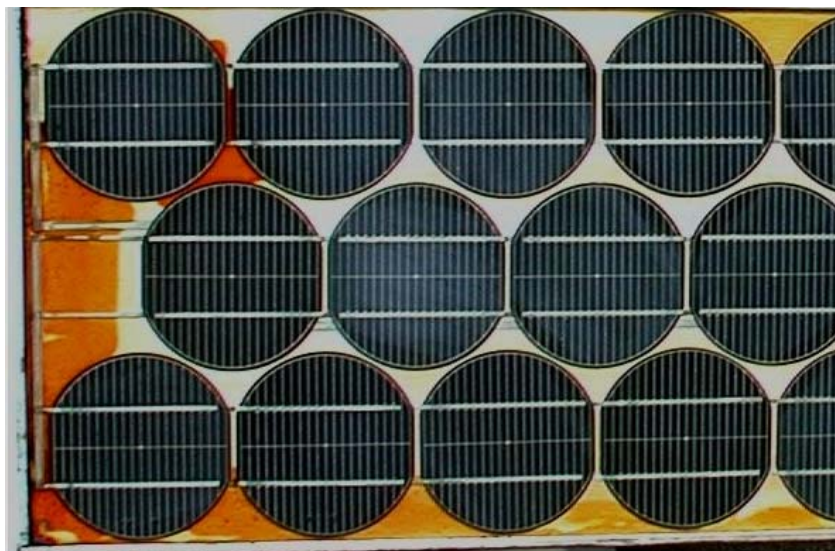
**Figure 44:** dark yellowing of background in module subjected to DAH.

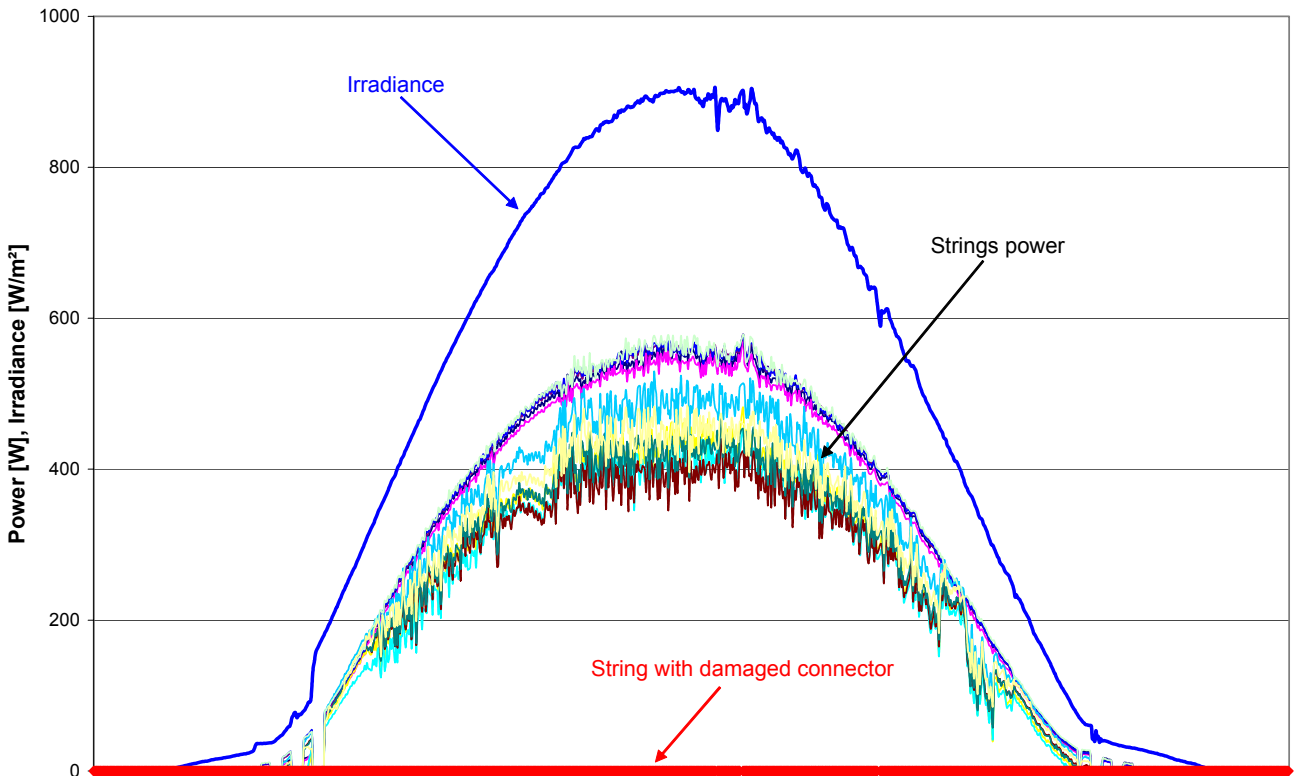
**Figure 48:** string fault detected by the analysis of the daily individual string's power production.

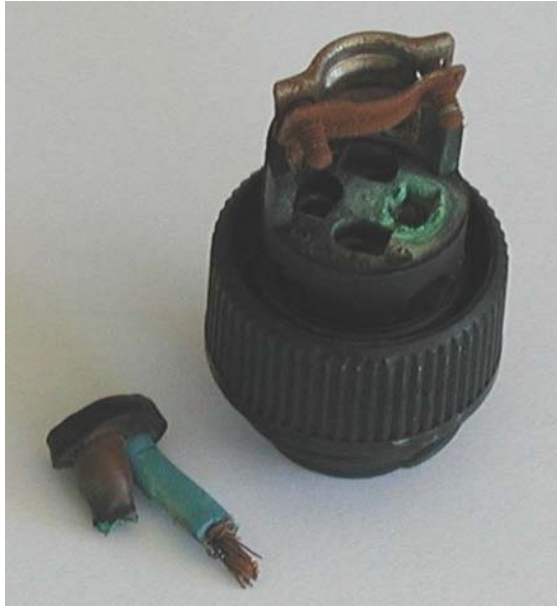
**Figure 49:** burned cable and damaged connector which caused string fault.
