Site Accessibility Evaluation

Bear Creek Regional Park

Accessibility Evaluation

***Inspection Date: 07/08/2019
Inspector: David Mejia***

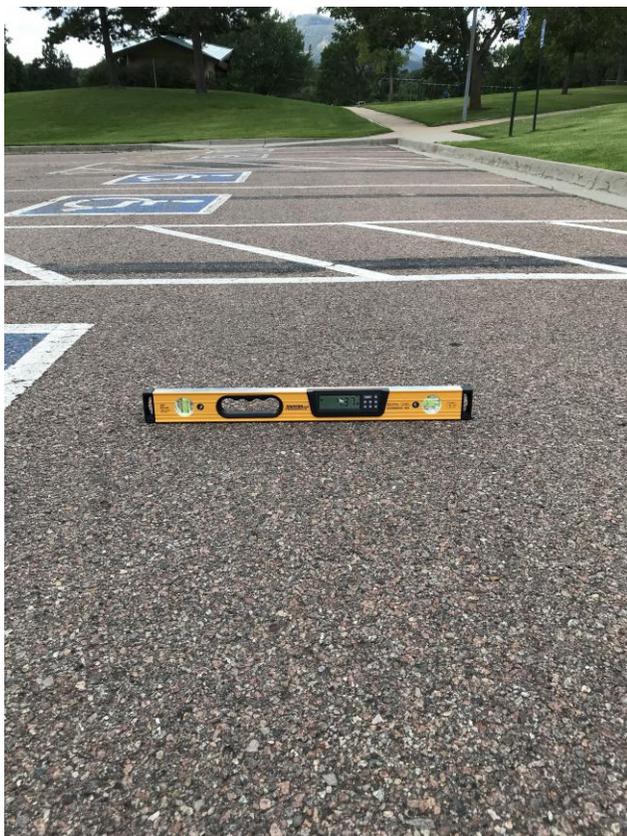
Finding #1 Continued

The running slope (long dimension) of the accessible parking stall exceeds 2%.

Running slope at
4.37%

The running slope for the 5 accessible parking stalls exceeds the 2% maximum. Re-pavement and re-striping will be required to meet compliance.

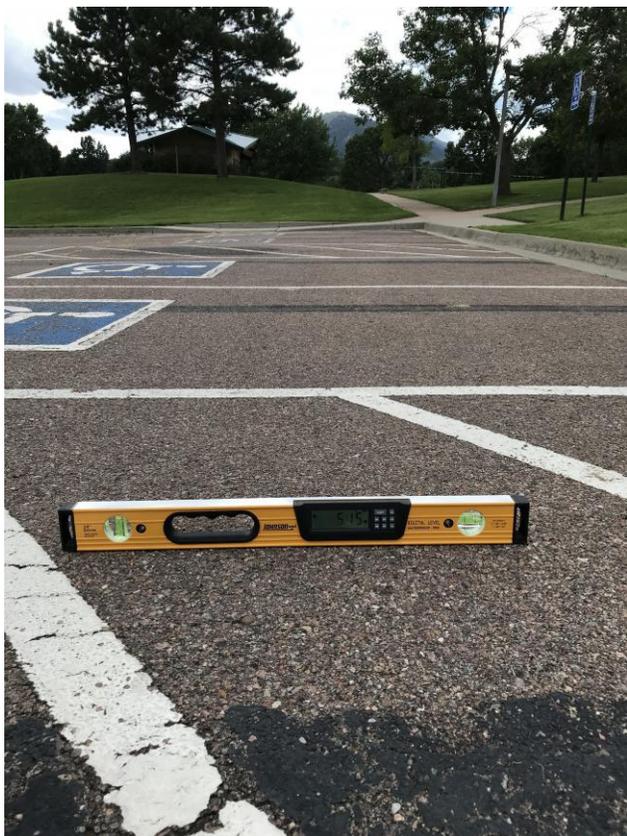
Finding #2 Continued

The running slope of the access aisle (long dimension) exceeds 2%.

Running slope at 5.5 %

The running slope for all access aisles exceeds the 2% maximum. Re-pavement and re-stripping will be required to meet compliance.

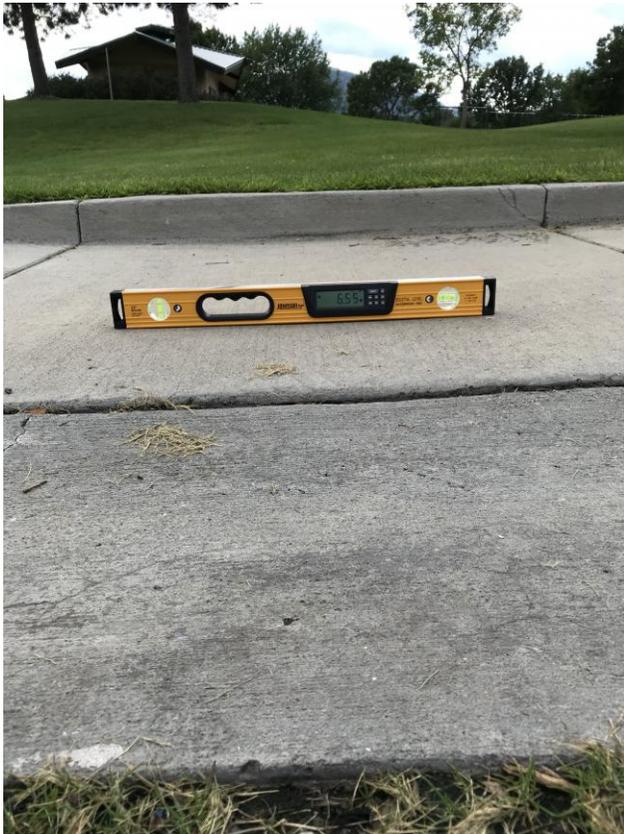
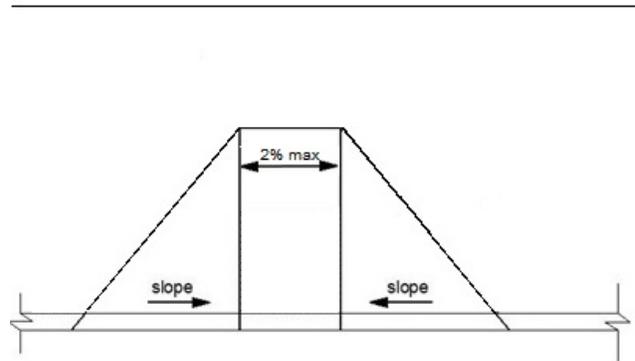
Finding #3 Continued

The curb ramp on the accessible route contains cross slopes greater than 2%.

Bottom landing cross slope at 6.55%

Replace with new parallel curb ramp meeting the 2% cross and running slope at the bottom landing and not to exceed 8.33% on the side ramps.

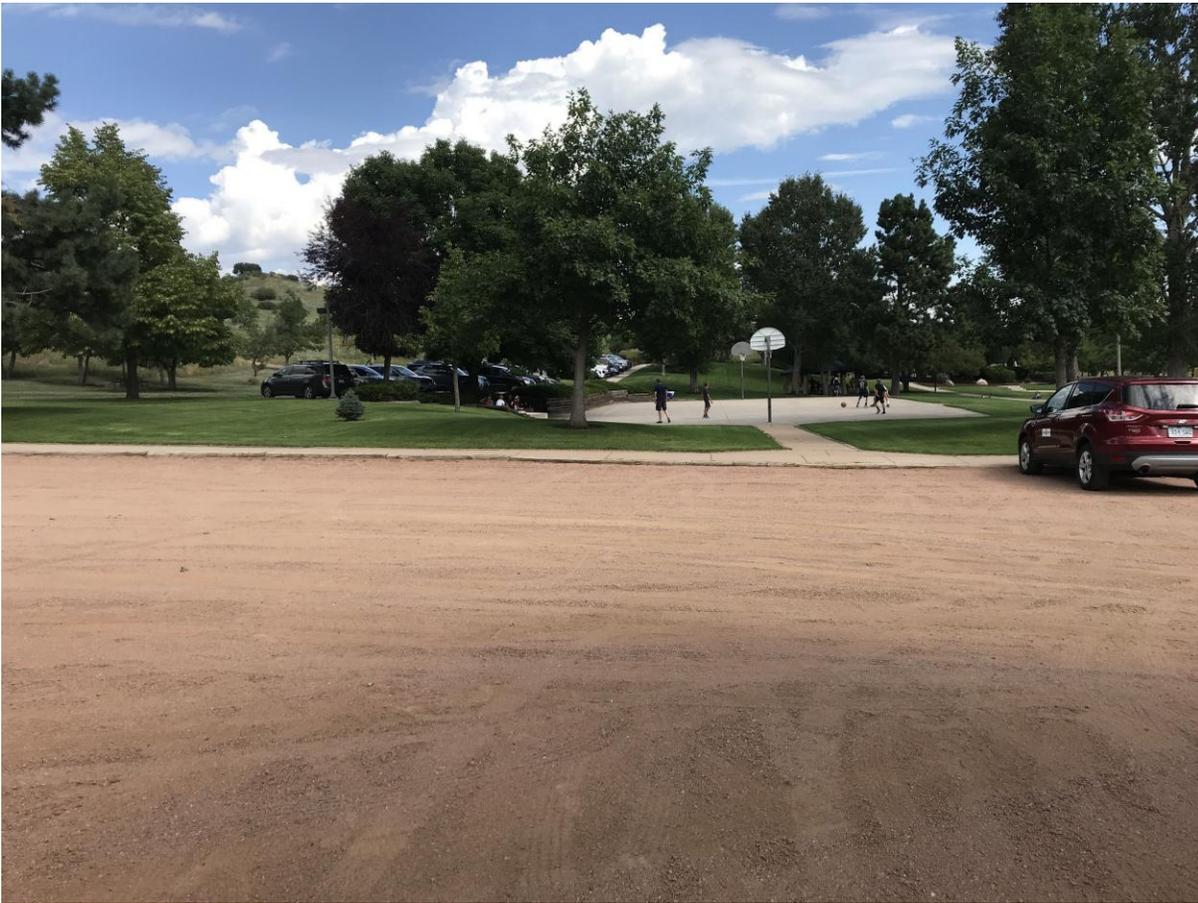
Finding #4 Continued

The surfaces of the accessible parking spaces and access aisles are not firm, stable, and slip resistant.

Surface not stable,
firm, and slip resistant

Pave parking lot with a firm, stable and slip resistant surface such as asphalt or concrete to include the required access aisles. Parking lot measured as if it were to be paved 100%. 102 parking stalls were determined based on 8 feet wide per parking stall. 5 accessible parking stalls are required with access aisles with one of those parking stalls being van accessible. Highly recommend providing more accessible parking stalls due to the west side parking lot undulated and hilly terrain.

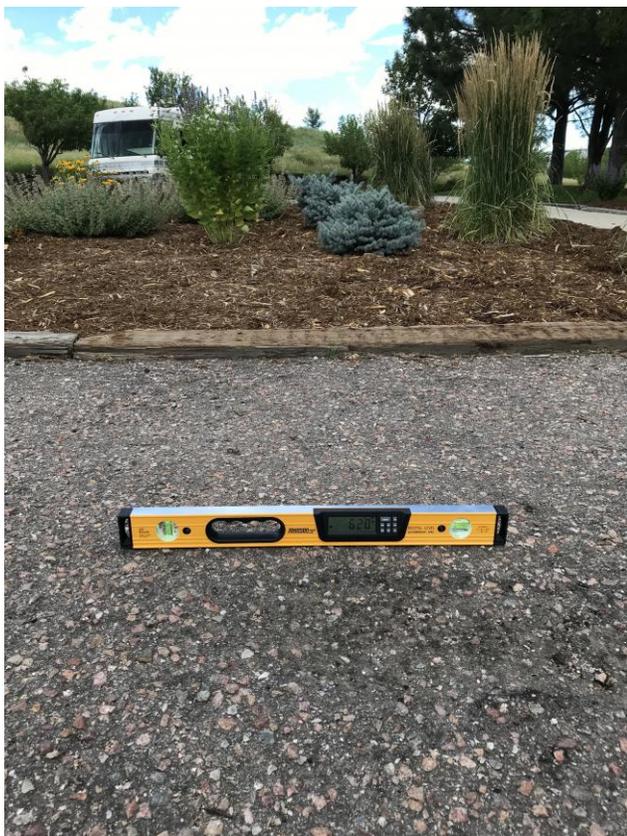
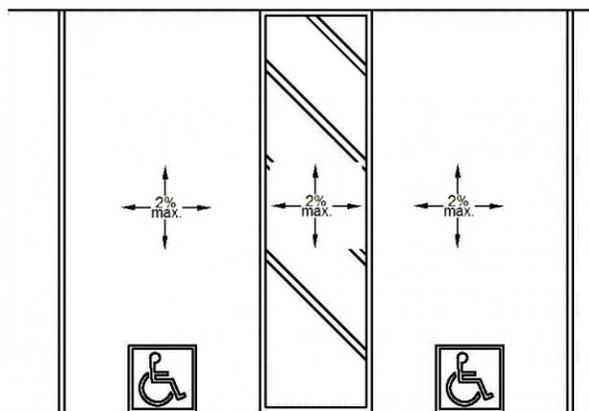
Finding #5 Continued

The cross slopes (narrow dimension) and/or running slopes (long dimension) of the accessible stall exceeds 2%.

6.20% running slope /
2.44% cross slope

May not be able to provide 100% compliant accessible parking stalls and access aisles on Creek Crossing Street on the west side of the park due to elevation and hilly terrain. Recommend providing more accessible parking stalls and accessible aisles on the south and north parking lots. Also, identified accessible parking stalls and access isles on Creek Crossing Street should be located on the flattest possible section if possible.

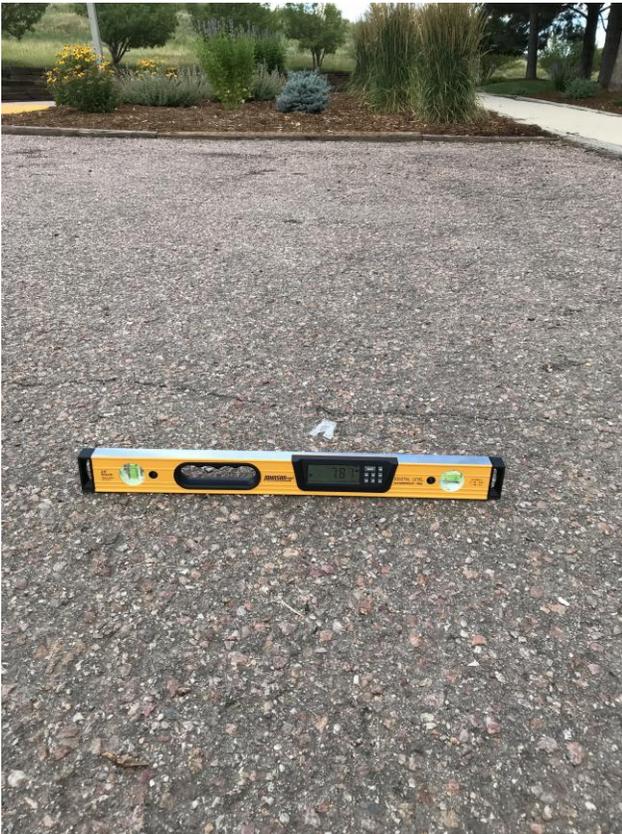
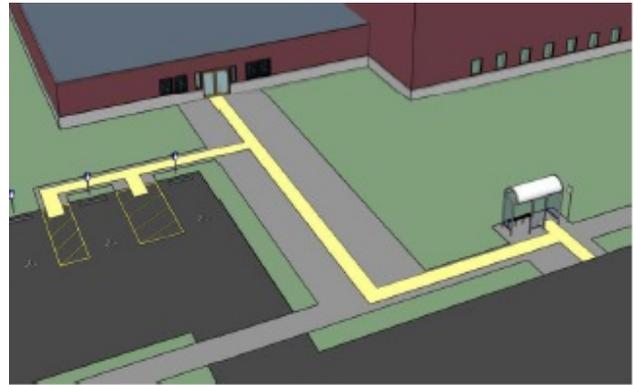
Finding #6 Continued

The accessible parking is not located on the shortest accessible route to the parking facility entrance.

Accessible parking
stalls missing access
isle

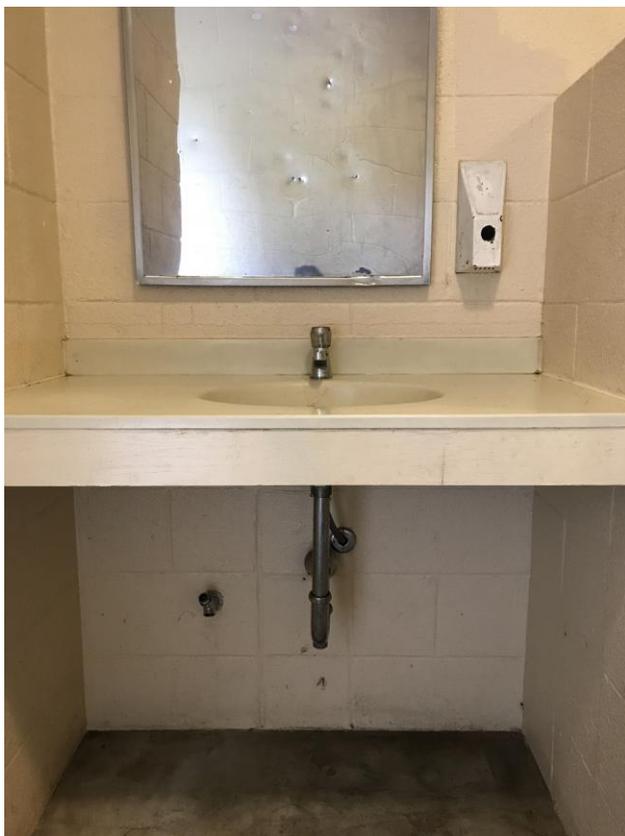
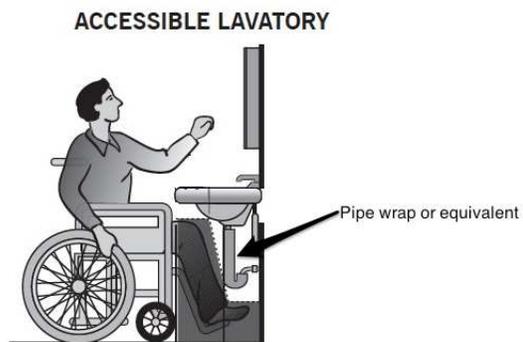
Finding #7 Continued

The water and drain pipes under the lavatory are not adequately insulated.

Drain pipes not insulated

Insulate drain pipes underneath lavatory.

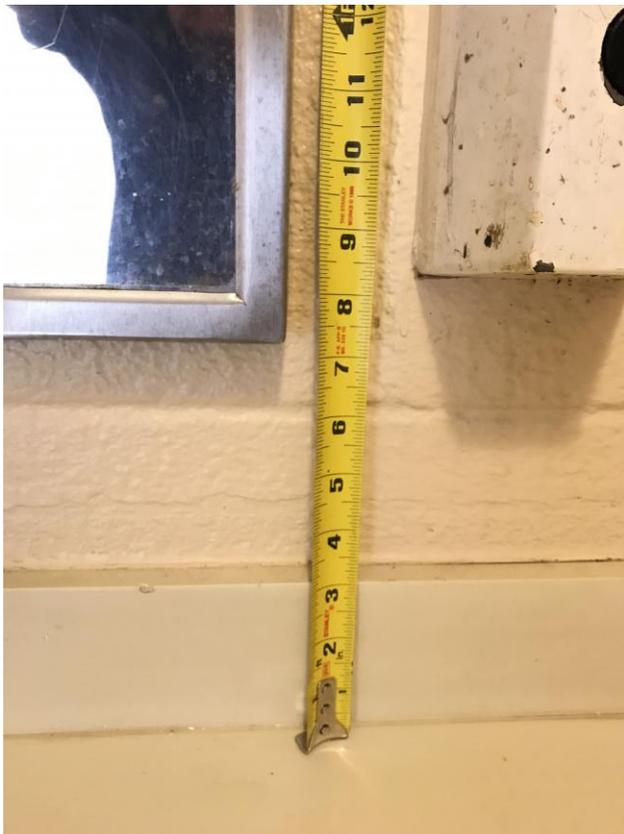
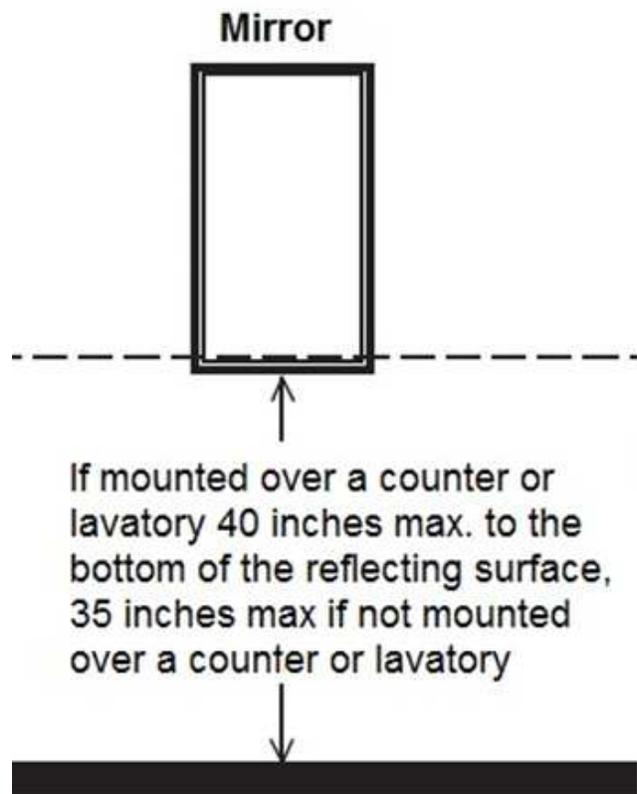
Finding #8 Continued

The mirror is mounted too high.

41.5 inches above
finished floor

Lower mirror to a maximum of 40 inches above finished floor measured to the bottom edge of the reflective surface. Recommend lowering mirror 2 inches.

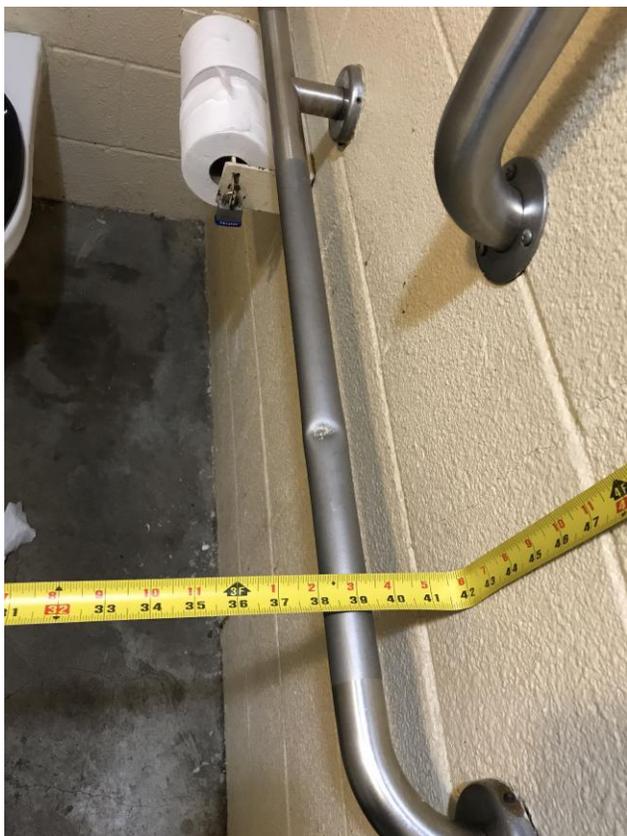
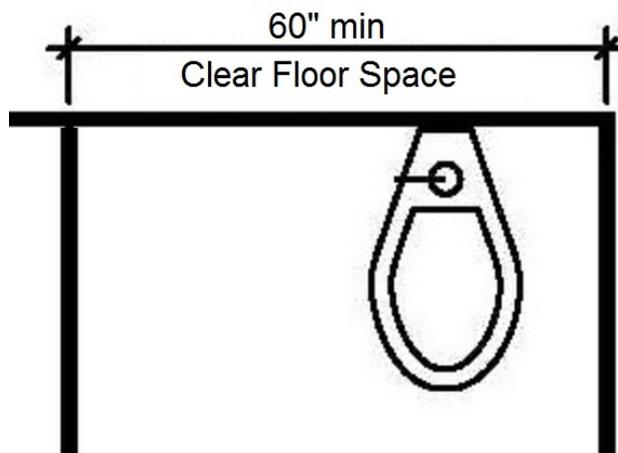
Finding #9 Continued

The toilet compartment is not wide enough.

41.5 inches in width

Providing the minimum required width clearance to the restroom is technically infeasible at this time because existing structural conditions would require removing or altering a load-bearing member that is an essential part of the structural frame; or because other existing physical or site constraints prohibit modification or addition of elements, spaces, or features that are in full and strict compliance with the minimum requirements. Best practice measures are recommended to ensure restroom is accessible to the maximum extent possible. Major remodel/reconstruction will be required to meet current ADA standards.

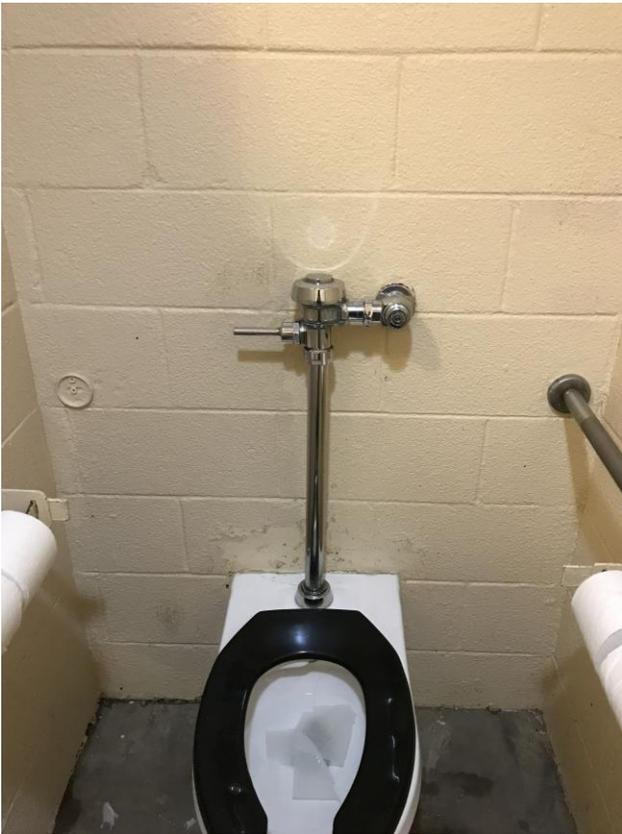
Finding #10 Continued

The rear grab bar is missing.

Missing rear grab bar

Install rear grab bar at 36 inches maximum above finished floor measured to the top of the gripping surface. Please see finding details for compliant measurements. Rear grab bar may not meet compliance clearances or length due to structural limitations.

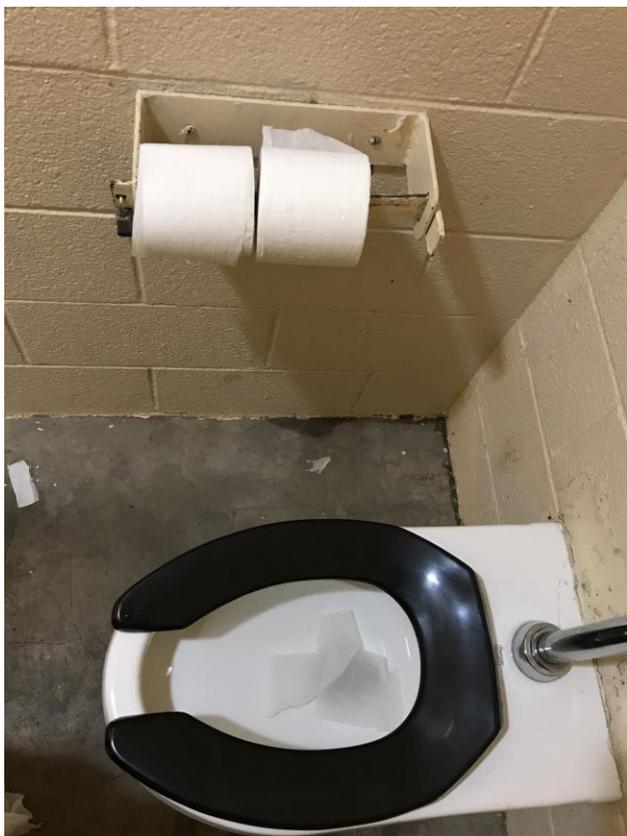
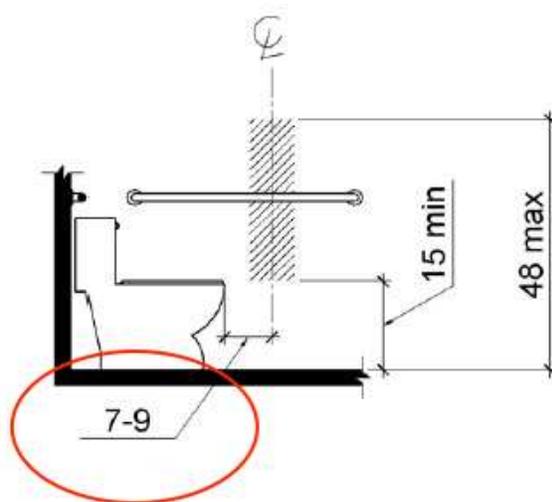
Finding #11 Continued

The toilet paper is not installed within the compliant range in front of the toilet.

17 inches from rear wall

Re-position toilet paper dispenser to be within 7 inches minimum to 9 inches maximum in front of the toilet measured to the centerline of the dispenser.

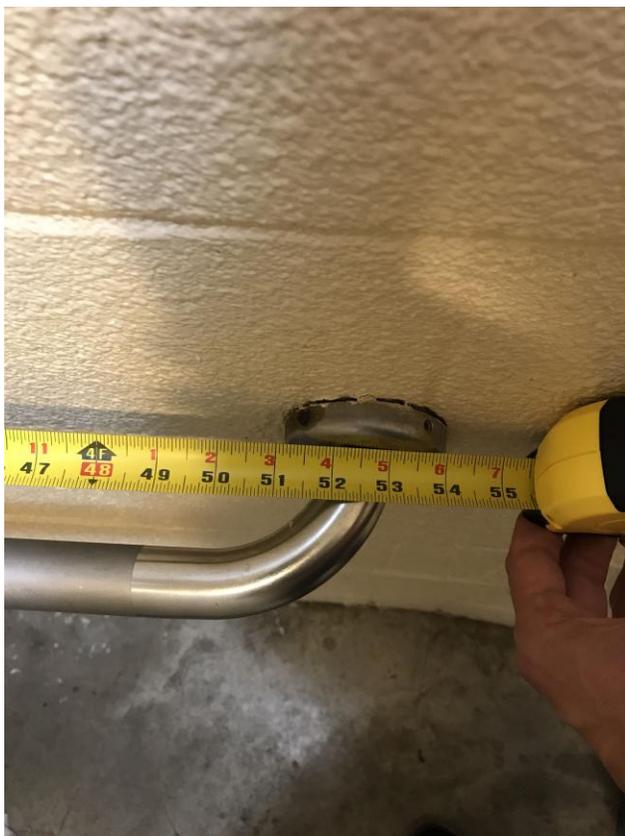
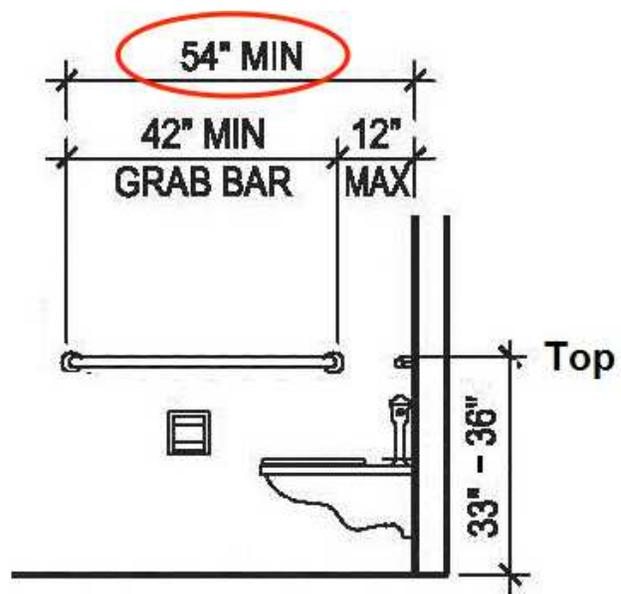
Finding #12 Continued

The side grab bar does not extend far enough from the rear wall.

52.5 inches from rear wall

Adjust side grab bar not to exceed 12 inches from rear wall. The side grab bar must be 42 inches minimum in length and extend at least 54 inches minimum beyond the rear wall.

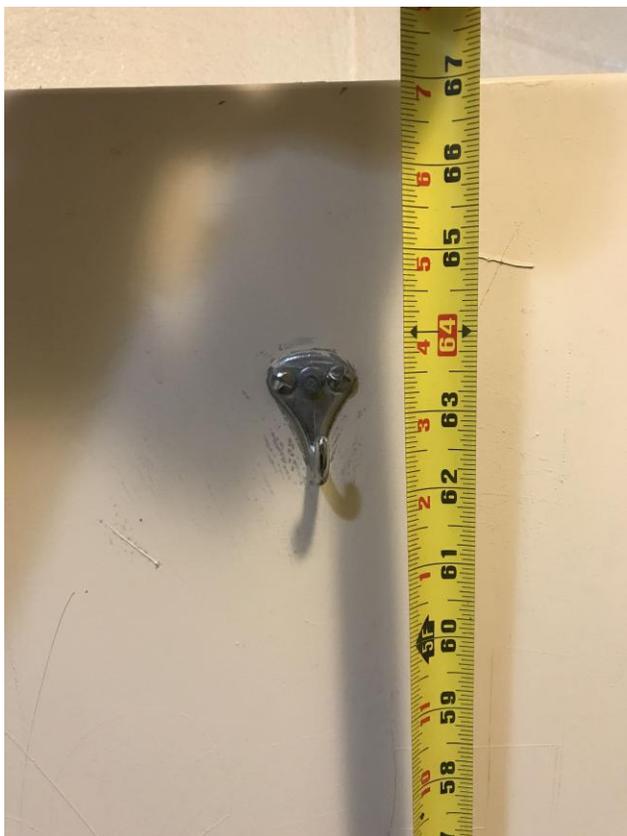
Finding #13 Continued

The coat hook is installed greater than 48 inches above the finished floor.

62.5 inches above
finished floor

Lower coat hook 14 inches minimum or install another coat hook not to exceed a maximum height of 48 inches above finished floor.

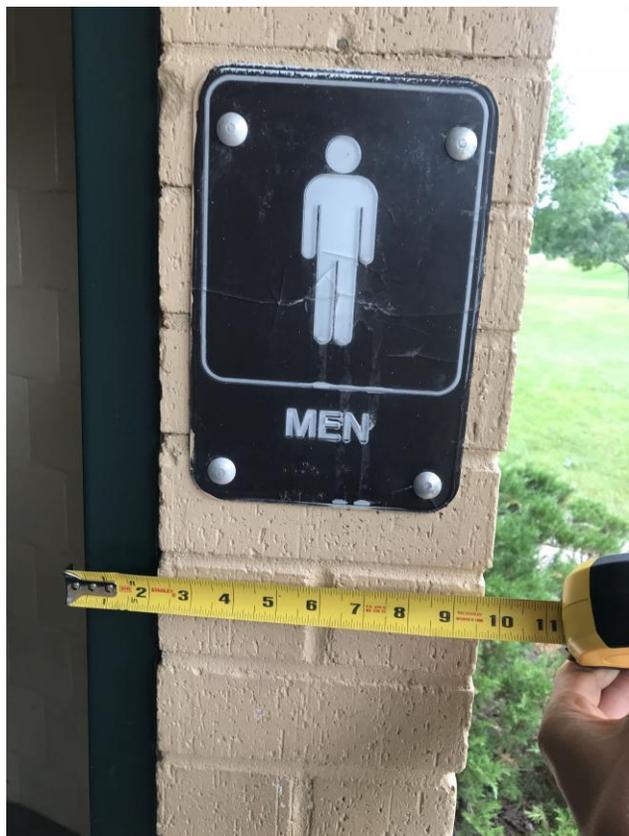
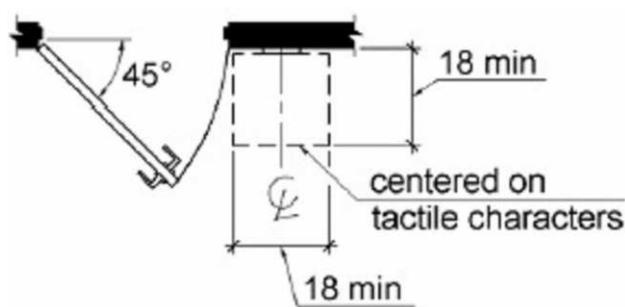
Finding #14 Continued

Clear floor space is not provide at the tactile door sign.

6 inches from latch side

Move to adjacent wall due to no wall space or can be placed directly on the door if door opens inward.

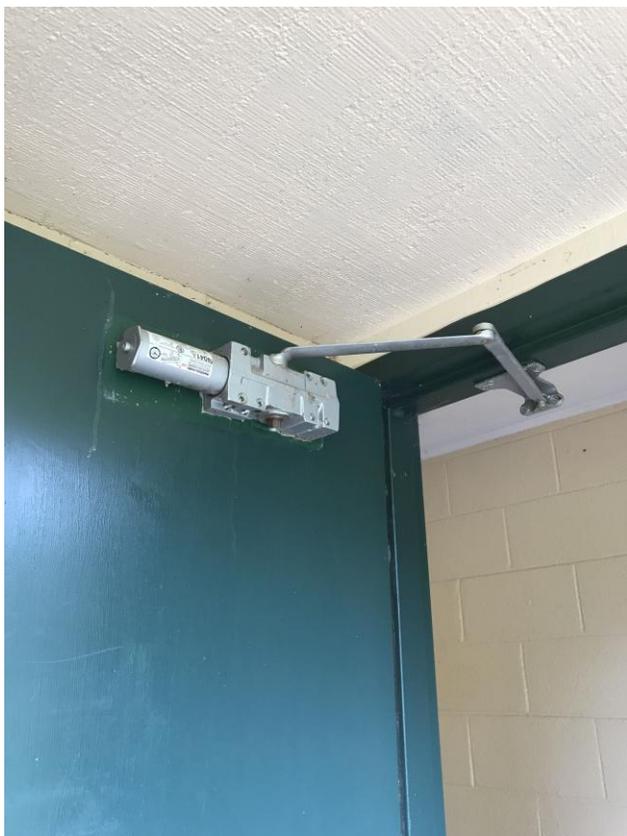
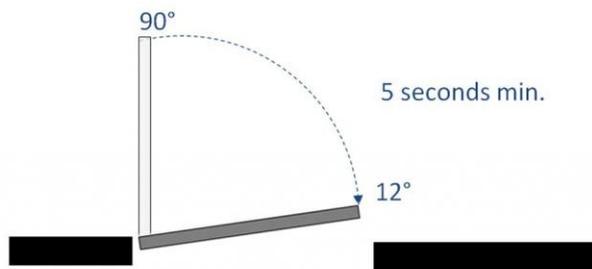
Finding #15 Continued

The door is equipped with a door closer and returns to a closed position too quickly.

3 seconds to closed position

Adjust door closer to allow a minimum of 5 seconds to move from the open position at 90 degrees to 12 degrees from the latch/locking mechanism.

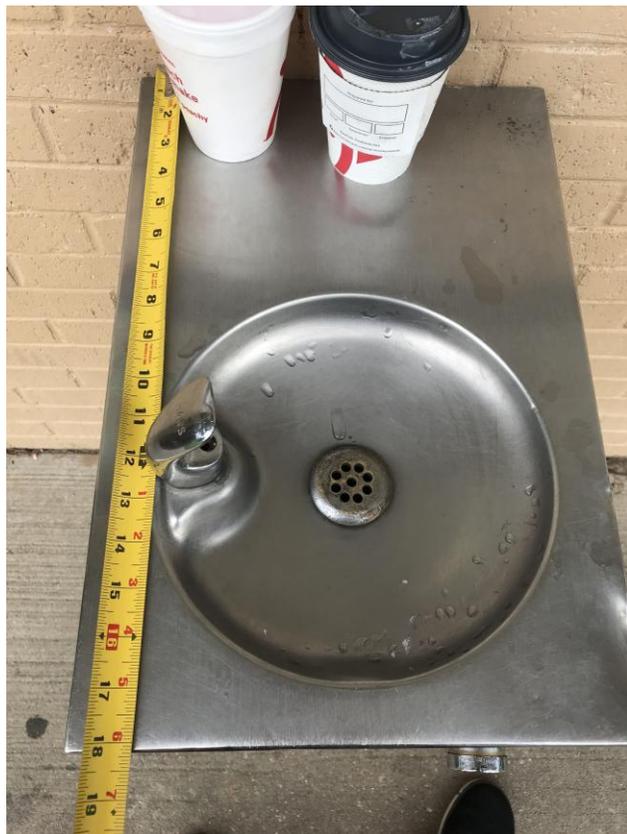
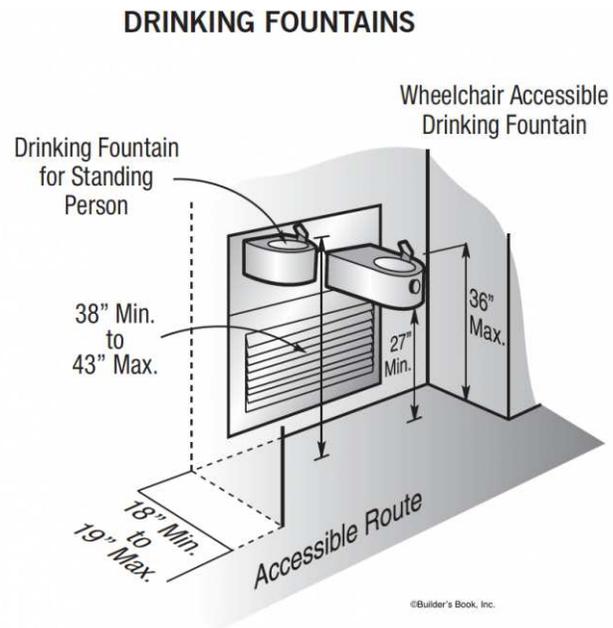
The drinking fountain is not accessible.

12 inches from rear wall

Replace existing drinking fountain due to multiple violations. Drinking fountains shall be positioned for a forward approach and a required clear floor space of 30" x 48" centered on the unit.

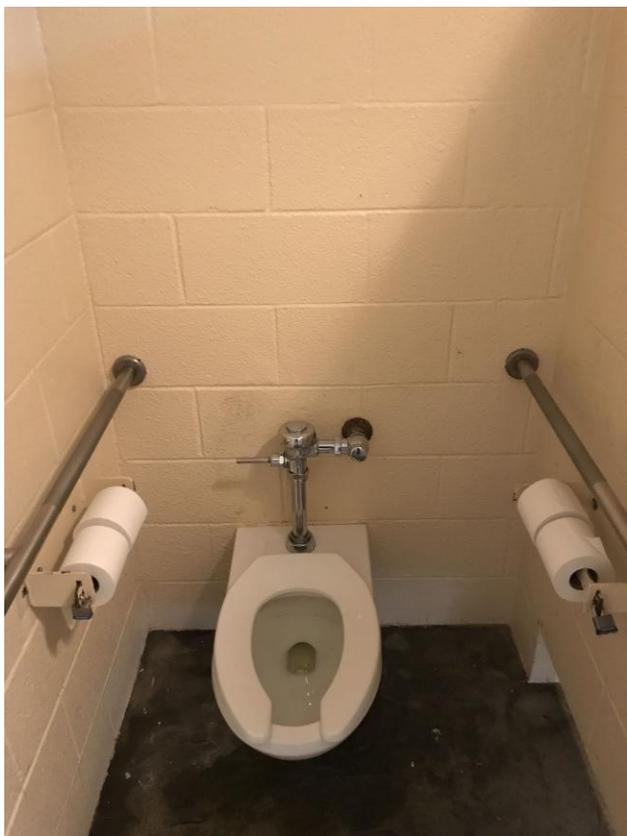
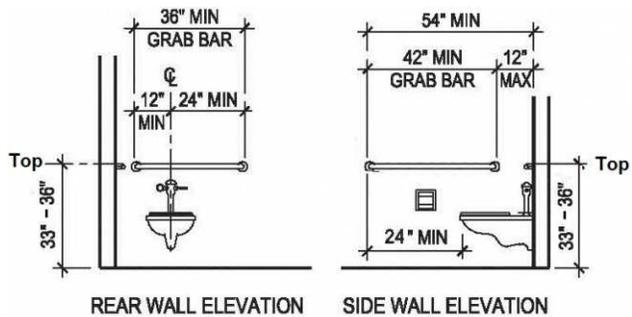
Finding #21 Continued

The rear grab bar is missing.

Rear grab bar missing
