Site Accessibility Evaluation

Americans with Disabilities Act Title II (Public Services: State and Local Government)

DOT Operations Center

**3275 Akers Dr
Colorado Springs, CO
80922**

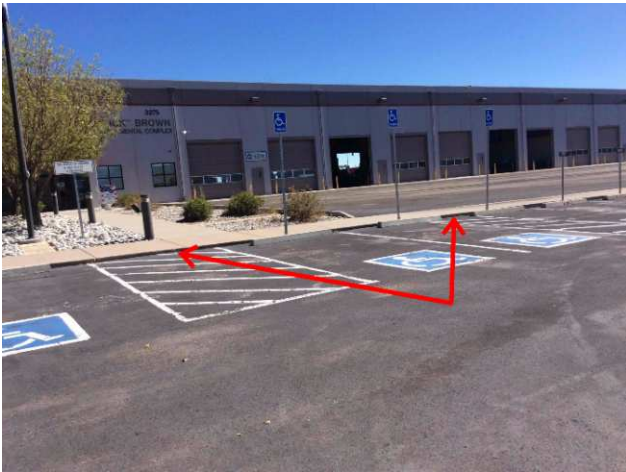
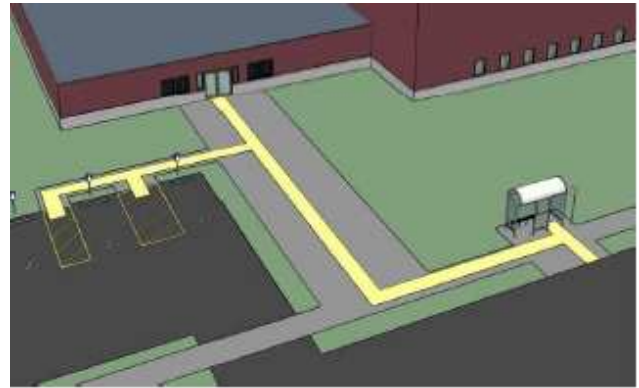
Finding 19554 Main Photo

The accessible parking is not located on an accessible route of travel to the accessible building entrance.

2010 ADAS Section: 208.3.1

Pedestrian ramp does not align w/aisle

Submit w/o for correction. Area needs to be re-striped and access aisle to sidewalk path of travel needs to align w/accessible ramp.

Corrective Action: Parking area was repaved to meet seamless transition from access aisle to access route. Corrected 18 Oct 2016.

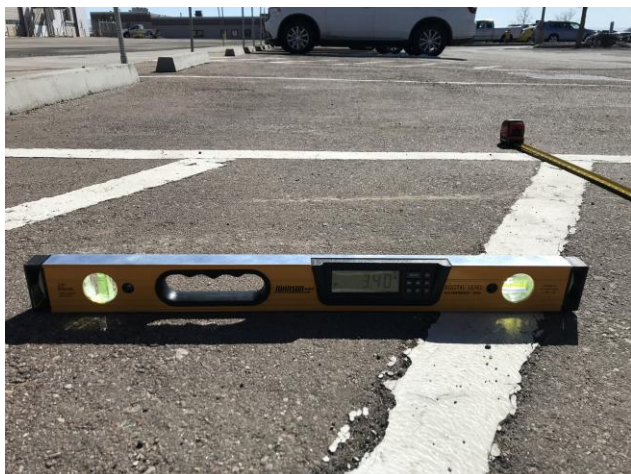
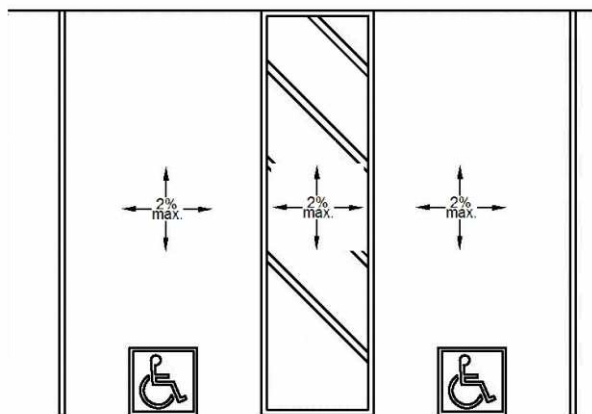
Finding 299216 Main Photo

The running slope of the access aisle (long dimension) exceeds 2%.

2010 ADAS Section: 502.4

Running slope ranges
from 1% and 9.5%

Re-pave access aisle and ensure a 2% maximum cross and running slope for the full length and width of the access aisle.

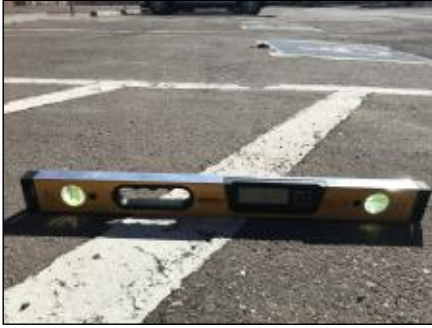
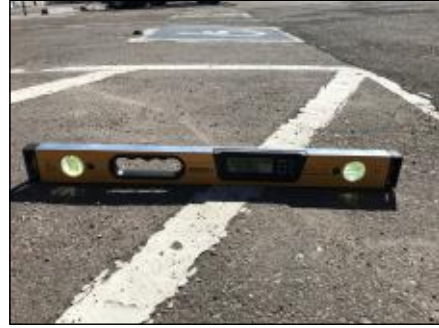
Finding 299216 Additional Photo

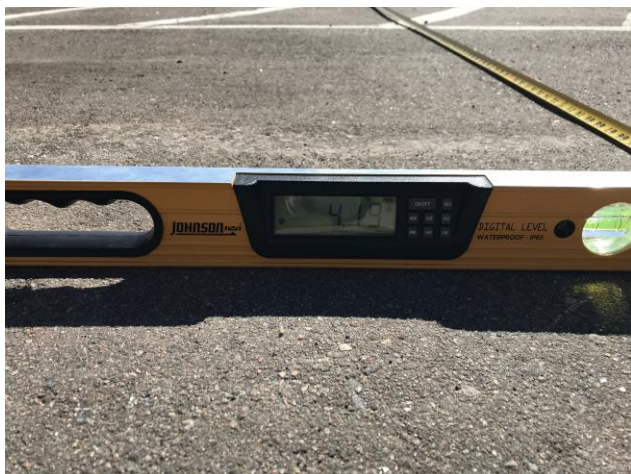
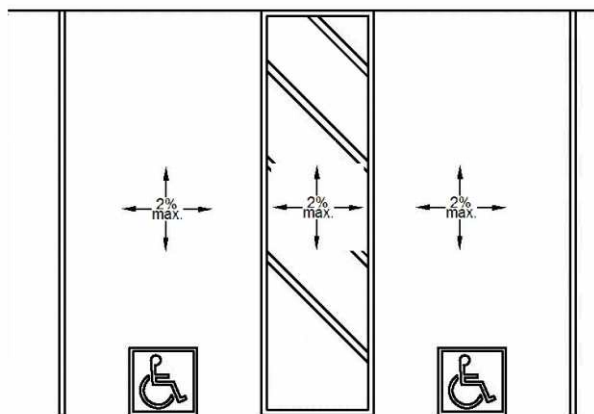
Finding 299217 Main Photo

The running slope (long dimension) of the accessible parking stall exceeds 2%.

2010 ADAS Section: 502.4

Running slope ranges
from 1% up to 9.5%

Re-pave designated ADA parking stalls and ensure a 2% maximum cross and running slope for the full length and width of the parking stalls.

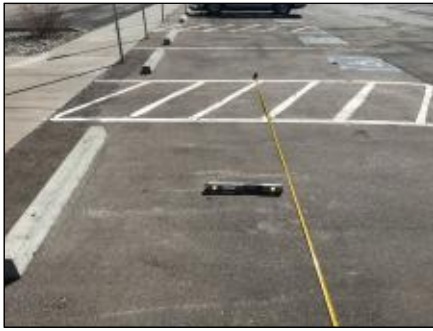
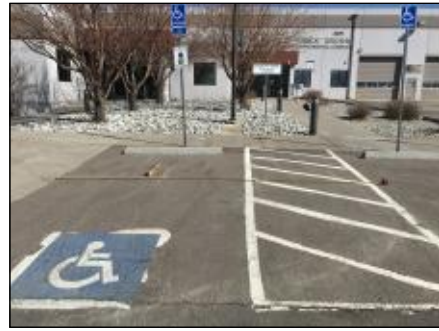
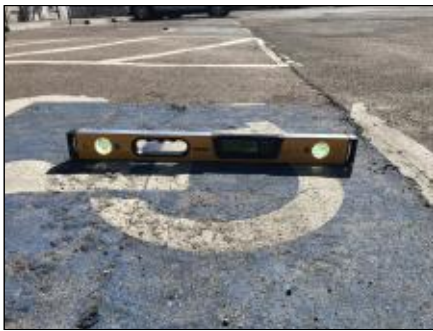
Finding 299217 Additional Photo

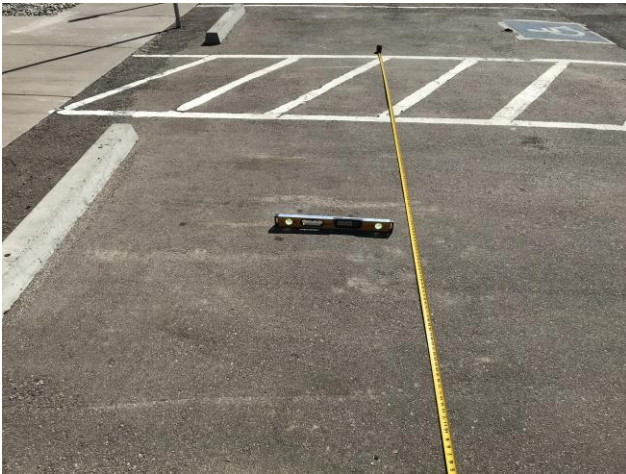
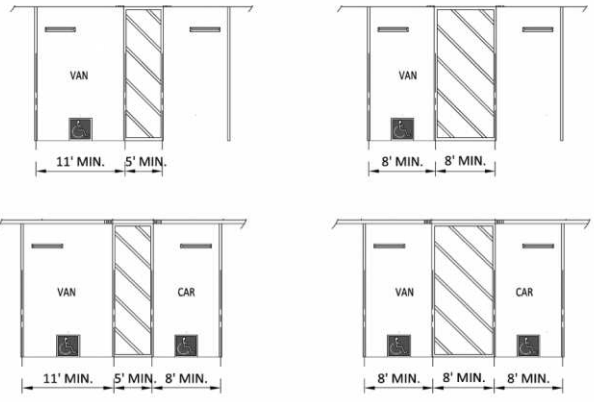
Finding 299218 Main Photo

The accessible parking stall is not wide enough.

2010 ADAS Section: 502.2

Van parking stall
measures 9.8 feet in
width

Re-stripe ADA parking stall/s and access aisle/s. ADA parking stalls shall measure 8 ft minimum in width measured to the centerline of the paint stripes. Access aisles shall measure 5 ft minimum in width measured to the centerline of the paint stripes. Ensure ADA van parking stall/s are 8 feet wide minimum with an access aisle of 8 feet wide minimum or 11 feet wide minimum with an access aisle of 5 feet wide minimum measured to the centerline of the paint stripes.

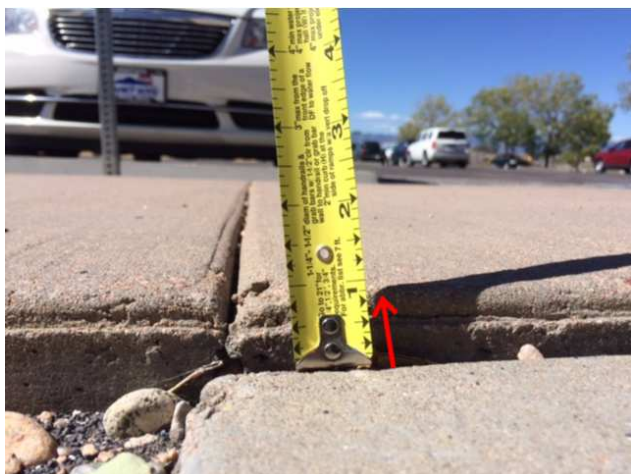
Finding 19562 Main Photo

The walkway contains abrupt vertical edges and/or variations over a 1/4 inch.

2010 ADAS Section: 303.3, 303.2

3/4 of an inches upheaval.

Submit a work order to have sidewalk area shaved.

Corrective Action:

CORRECTED

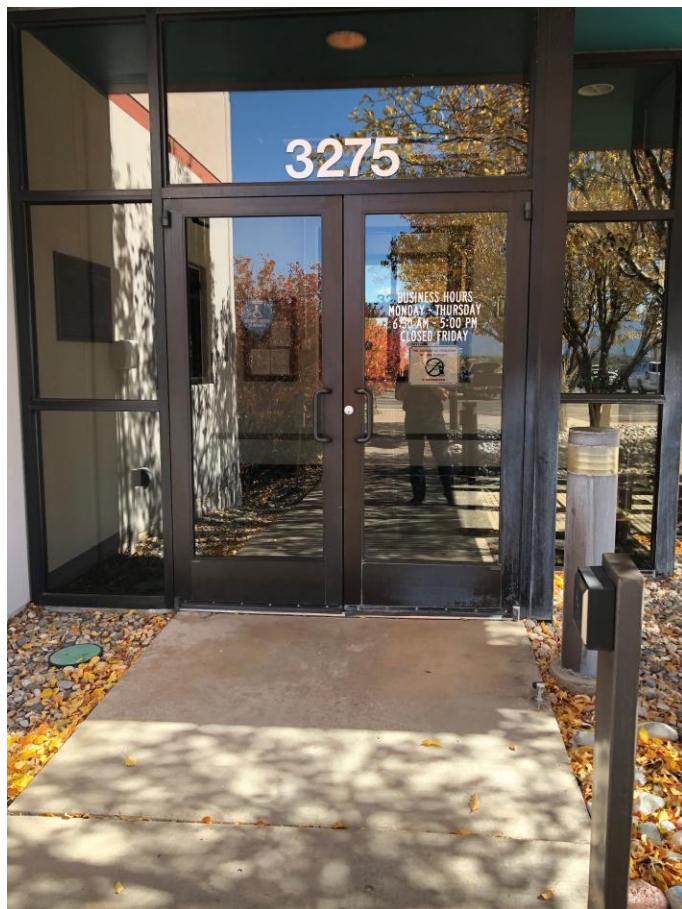
Front door ADA push plate not working

Front door ADA push plate malfunctioning / inoperable.

Inspect and replace batteries on All ADA push plates.

9/14/2020 W.O.# 498255 for the replacement of switch post.

Corrective Action: Work order # 403142 submitted for correction. Work order completed on 9/7/17.

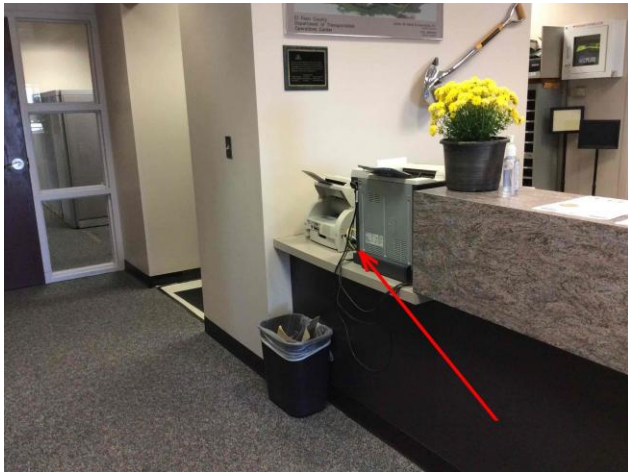
Finding 19555 Main Photo

Counter not accessible due to fax/printer.

2010 ADAS Section: 904.4.2, 904.4.1

Not accessible due to fax/printer on accessible counter area

Relocate fax/printer in order to clear counter for service.

Corrective Action: Relocated to provide clear counter area on 18 Jan 2017.

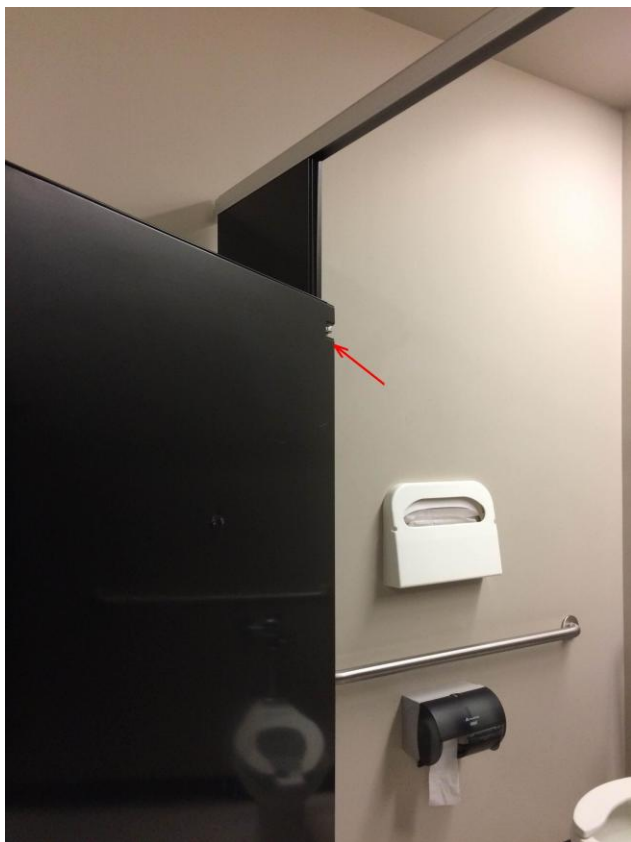
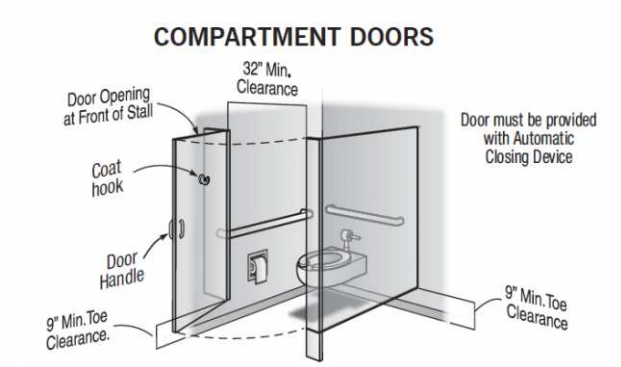
Finding 27939 Main Photo

The compartment door is not self closing.

2010 ADAS Section: 604.8.1.2

Compartment door not self closing

Adjust or install automatic closing hinges.

Corrective Action: W/O 381195 submitted.

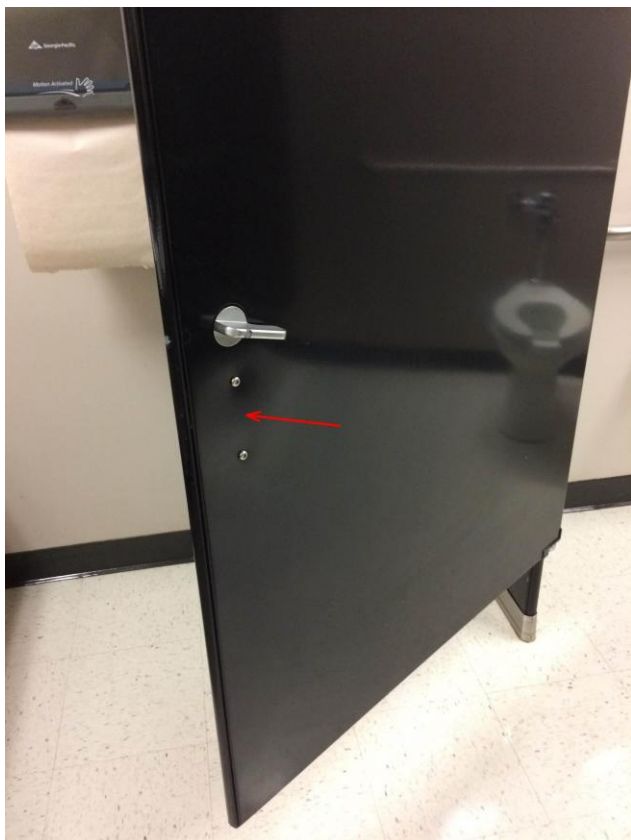
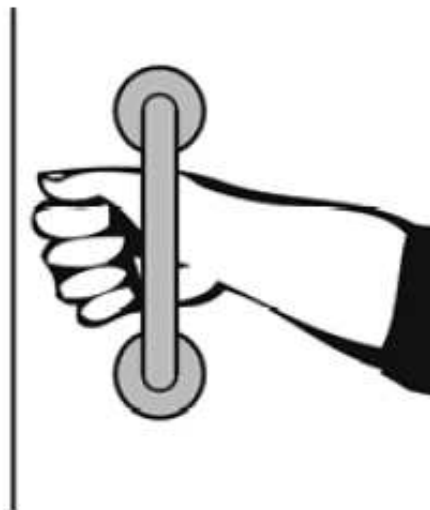
Finding 27940 Main Photo

The water closet compartment door is missing a loop handle on the inside.

2010 ADAS Section: 604.8.1.2

Missing inside loop handle on compartment door

Install loop or U-shaped handle on inside of compartment door.

Corrective Action: W/O 381194 submitted. Installed loop handles on inside/outside of stall door-completed 3/10/2017.

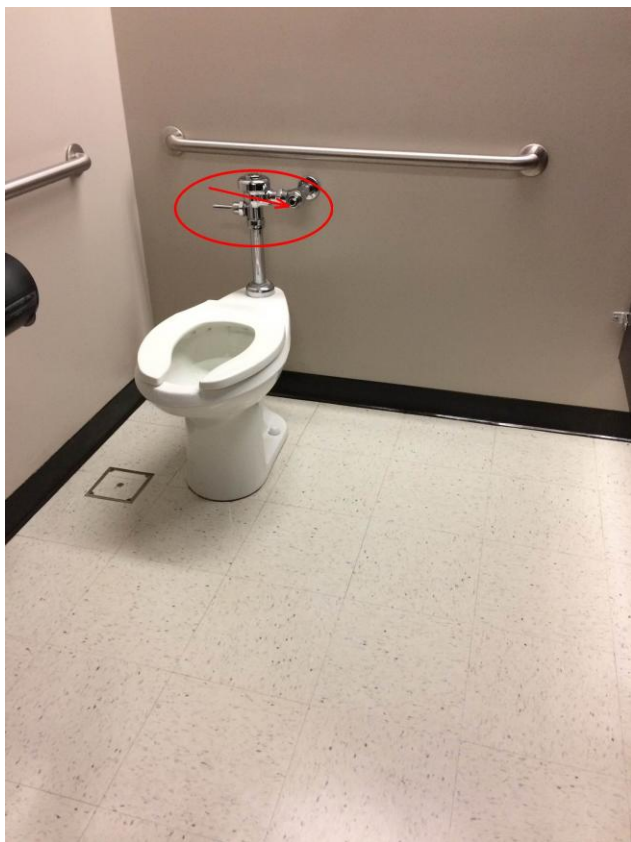
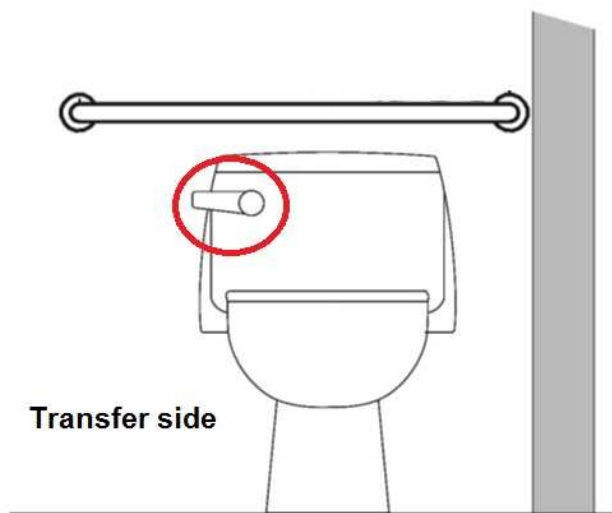
Finding 27941 Main Photo

The flush handle is located on the wrong side of the toilet.

2010 ADAS Section: 604.6

Flush handle located
on closed side

Relocate flush handle to opposite side (open side of toilet area).

Corrective Action: W/O 381193 submitted. Installed new sensor type flush valve 3/14/2017.

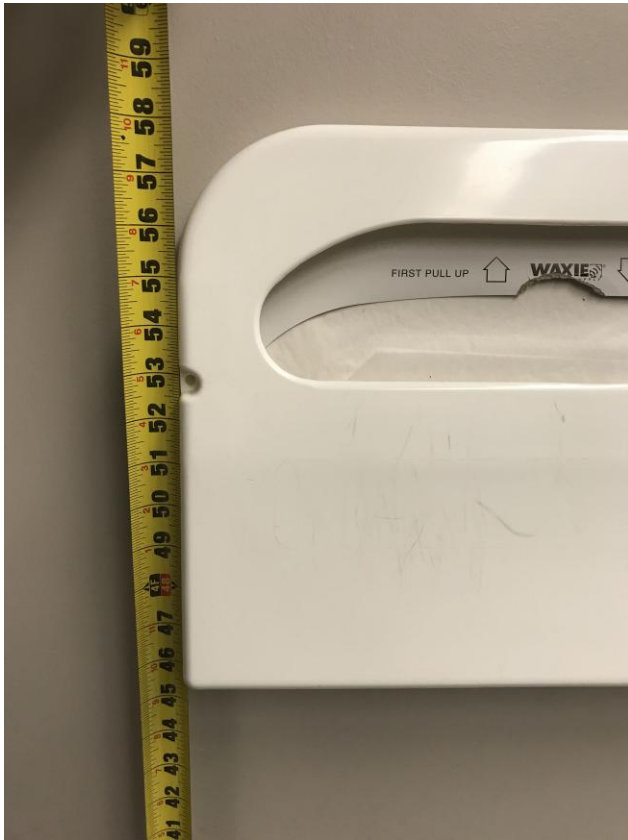
Finding 27942 Main Photo

The toilet seat cover dispenser is mounted too high.

2010 ADAS Section: 308.1

53 inches above
finished floor

Re-locate toilet seat cover dispenser below either grab bar at least 1.5 inches minimum below grab bars but no less than 15 inches above finished floor to meet compliance.

Corrective Action: W/O 392073 submitted. Relocated seat cover dispenser-Completed, 3/10/2017.

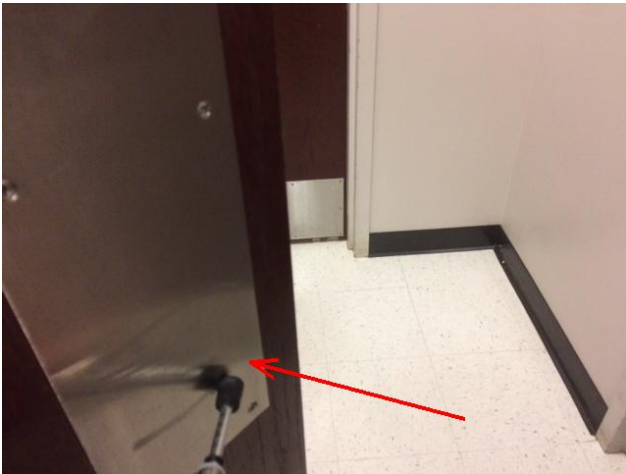
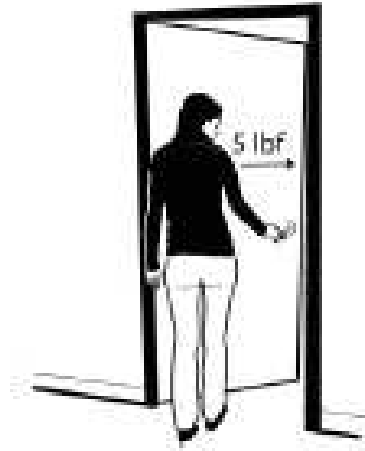
Finding 33407 Main Photo

The door exceeds the maximum pressure to open the door.

2010 ADAS Section: 404.2.9

Both doors to men's restroom required 9 lbs of pressure

Adjust door closers to 5 lbs. of pressure or less.

Corrective Action: W/O 386077 submitted 1/26/2017.

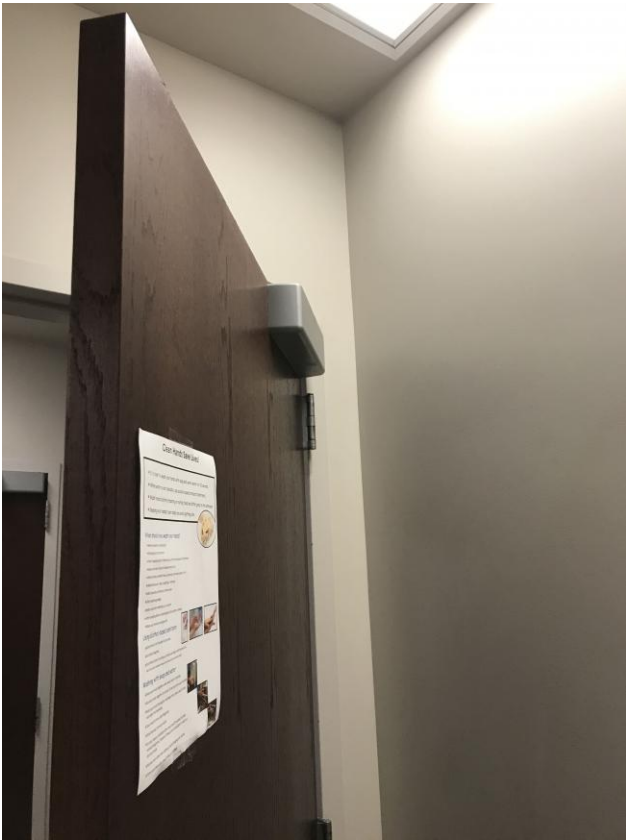
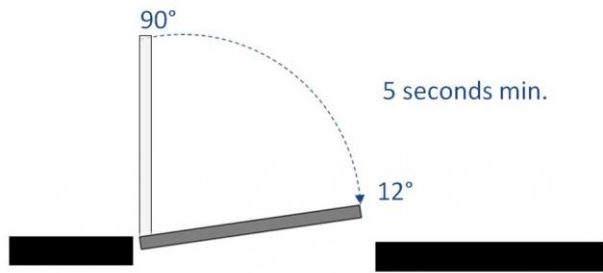
Finding 33726 Main Photo

2010 ADAS Section 404.2.8.1

Corrective Action: W/O 386077 submitted.

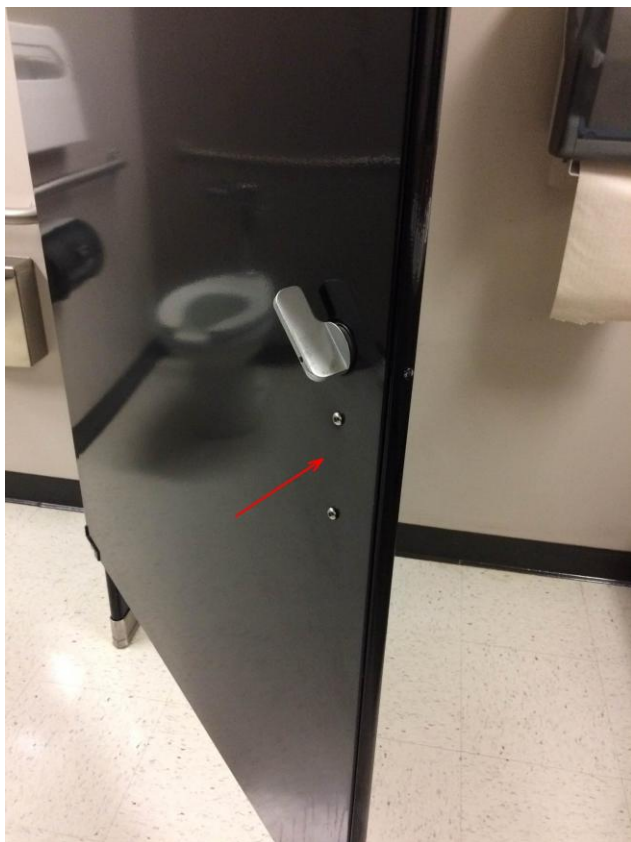
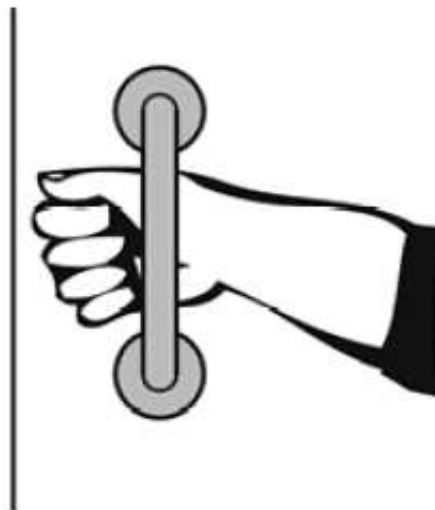
Finding 27945 Main Photo

The water closet compartment door is missing a loop handle on the inside.

Missing inside loop handle on compartment door

Corrective Action: W/O 381188 submitted. Installed loop handles on inside/outside of stall door-completed, 3/10/2017.

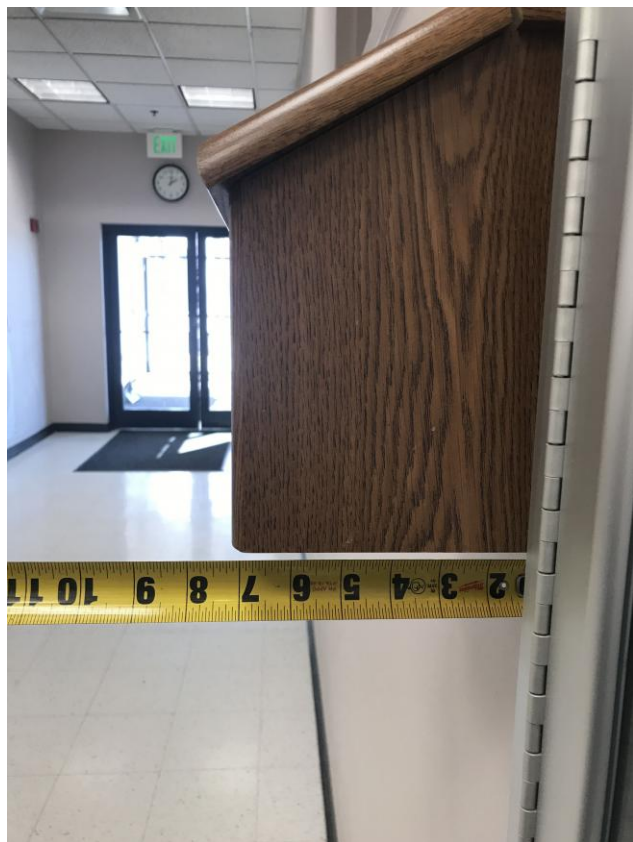
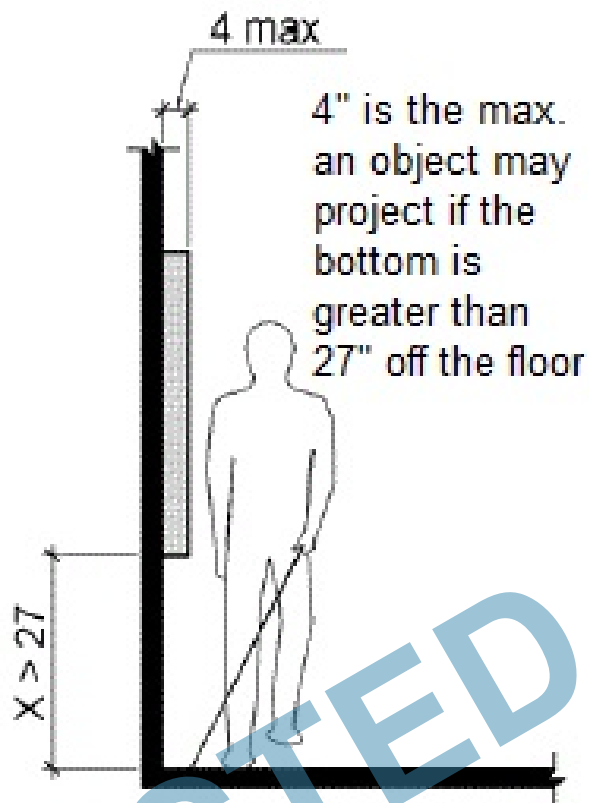
Finding 299210 Main Photo

Wall-mounted objects that have leading edges between 27 inches and 80 inches from the floor must not project more than 4 inches into the circulation path. Protruding objects that extend to the floor or within 27 inches of the floor are cane detectable and are therefore not hazardous. Where it is necessary or desirable to have objects protrude from the wall, a manner of cane detection must be provided.

Replace suggestion box with low profile box or place existing suggestion box in different location and not in a main path of travel.
