# Site Accessibility Evaluation

### Department of Human Services

**5850 Championship View  
Colorado Springs, CO  
80922**

**Accessibility Evaluation**

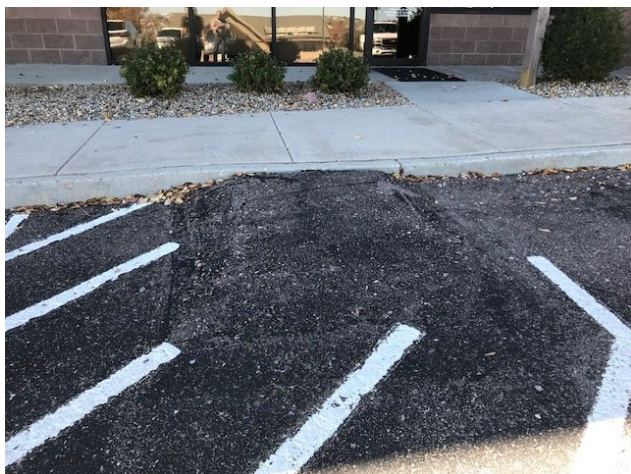
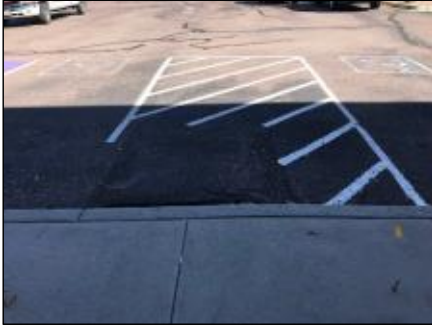
Finding #1 Continued

The accessible parking stall's access aisle contains a built up curb ramp which results in significant slopes greater than 2 percent.

*2010 ADAS Section 502.4*

Built up curb ramp protrudes into parking access aisle with a running slope of 12.3%

Remove protruding ramp and design/construct parallel curb ramp into existing sidewalk not to exceed 8.33% running slope, a landing on top a minimum of 48 inches with a cross and running slope not to exceed 2%.

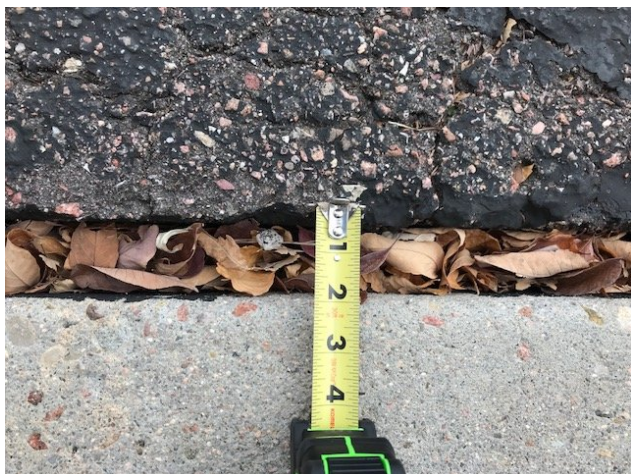
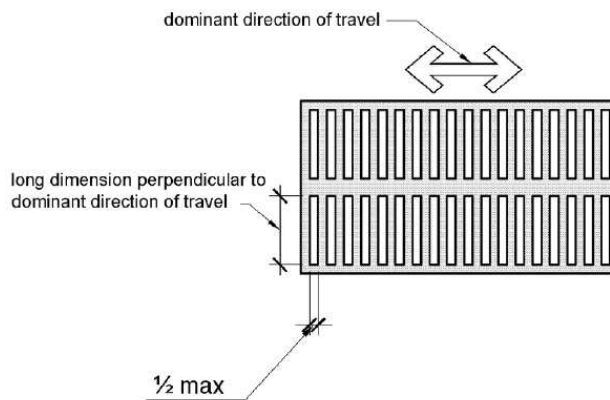
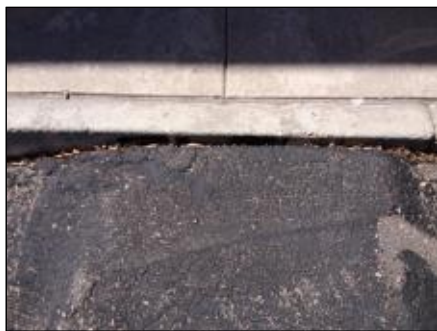
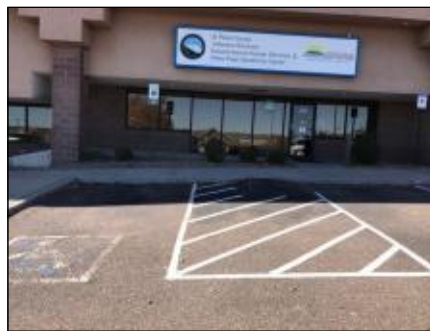
Finding #2 Continued

The concrete expansion joint is spaced greater than 1/2 inch.

*2010 ADAS Section 302.3*

Opening on top of  
protruding curb ramp  
2 inches wide

Remove protruding built up curb ramp and reconfigure sidewalk to incorporate a parallel curb ramp.

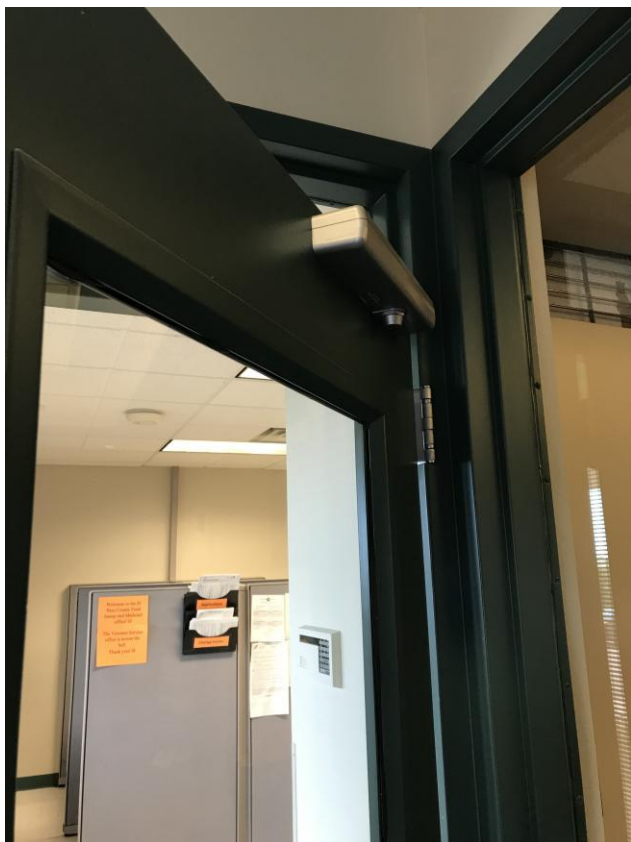
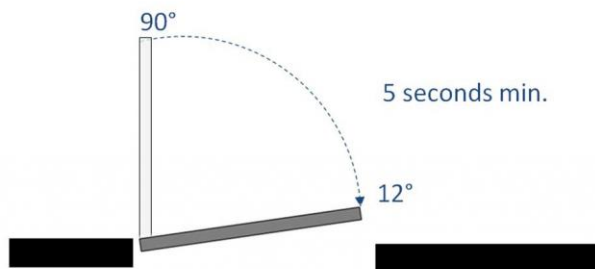
Finding #3 Continued

The door is equipped with a door closer and returns to a closed position too quickly.

*2010 ADAS Section 404.2.8.1*

2.8 seconds to a position of 12 degrees from the latch

Adjust door opener to a minimum of 5 seconds from an open position to a position of 12 degrees from the latch.

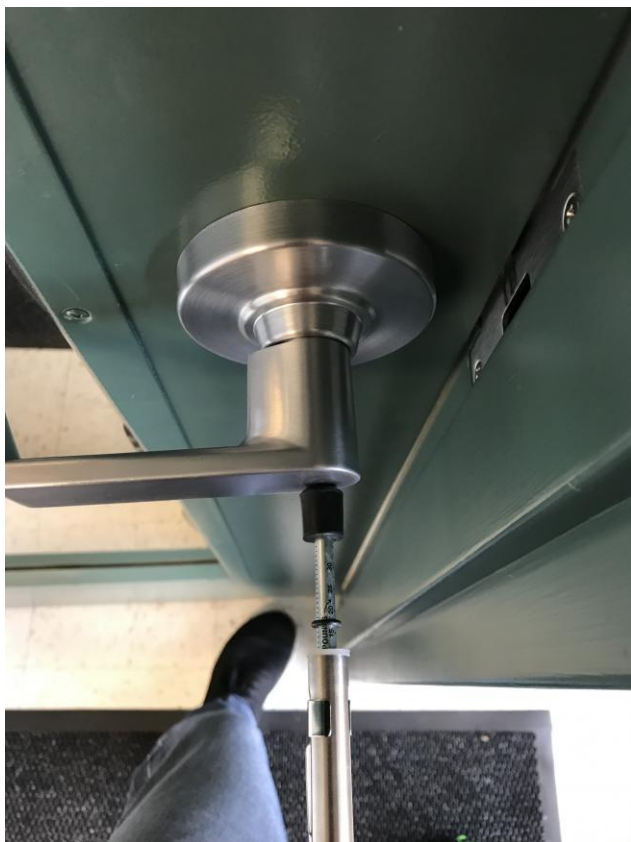
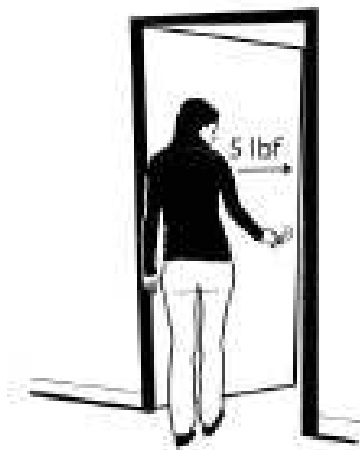
Finding #4 Continued

The door exceeds the maximum pressure to open the door.

*2010 ADAS Section 404.2.9*

20 lbs of force  
required to open door

Adjust door opener to ensure no more than 5 lbs of force is required to open the main door leading into the lobby. Door and/or door frame may require further adjustments.

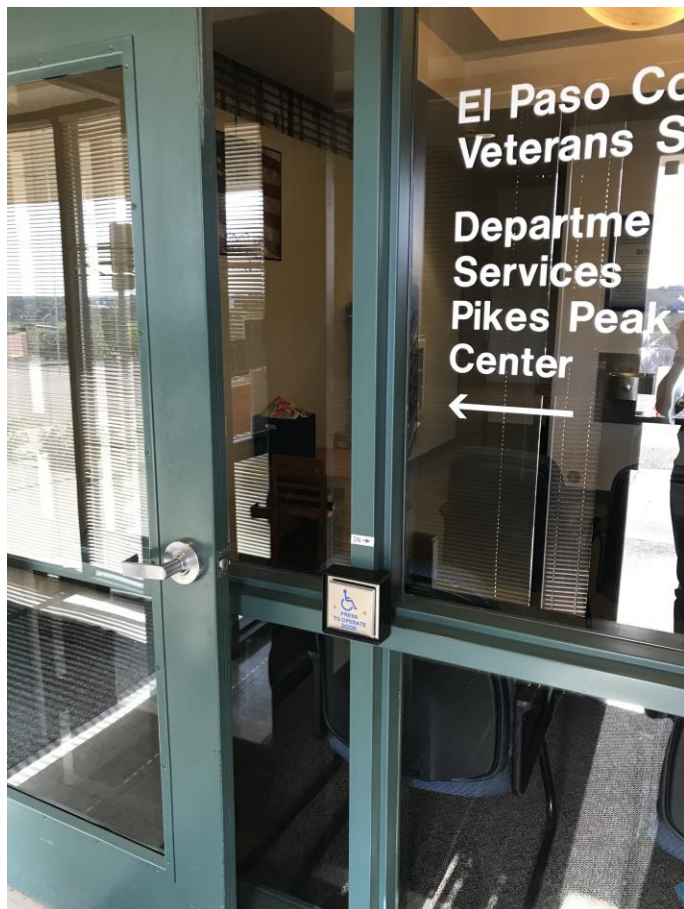
**Finding #5 Continued**

Automatic door openers are not required under ADA standards but recommended if budget allows.

No automatic door  
openers

Due to Veterans Service Office located inside the same building, sharing the main entrance door that's is equipped with an automatic door opener and the Veterans Service Office lobby entrance door also equipped with an automatic door opener, if budget allows an automatic door opener is highly recommended.
