# Site Accessibility Evaluation

## Americans with Disabilities Act Title II (Public Services: State and Local Government)

**EPC Public Health South**

**Accessibility Evaluation**

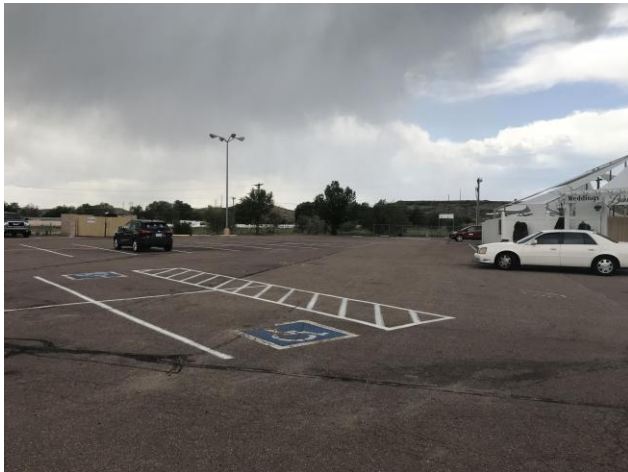
Finding 299327 Main Photo

There are not enough accessible stalls.

There are 2 accessible parking stalls including 0 designated for a van.

There should be a minimum of 4 accessible parking stalls including a minimum of 1 van accessible stall.

Not enough accessible parking stalls

Restripe and provide a minimum of 4 accessible parking stalls to include 2 van designated stalls with an 8 foot access aisle.

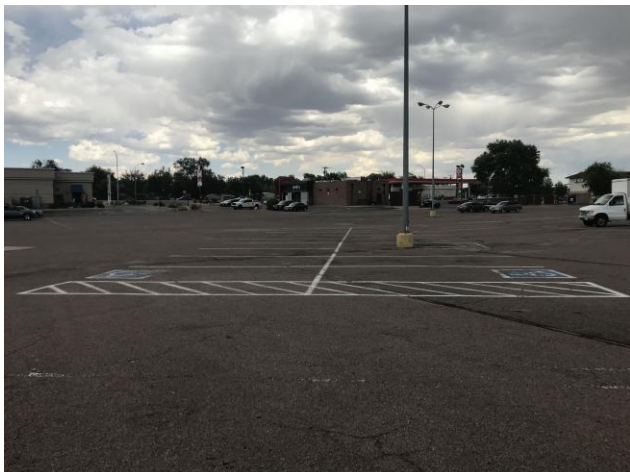
Finding 299328 Main Photo

The van stall is missing a sign identifying it as a van accessible stall.

ADA parking signage missing

Install proper accessible parking signage to include "van accessible" verbiage where applicable.

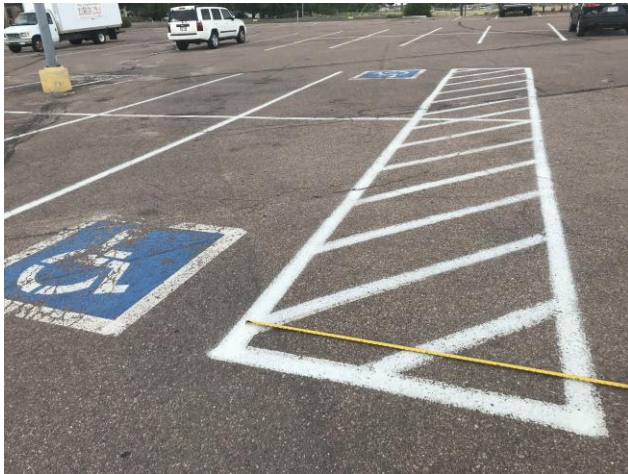
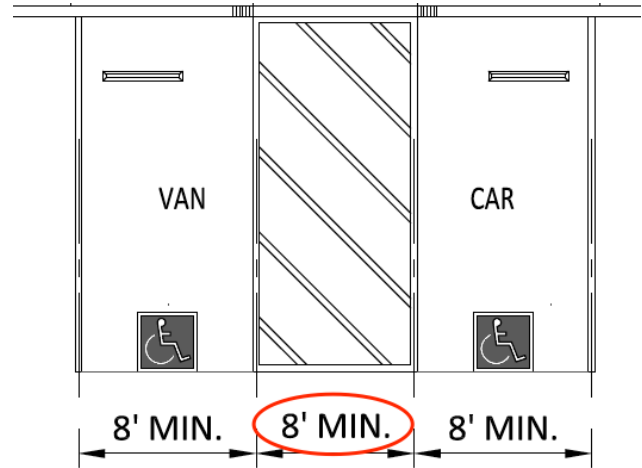
Finding 299329 Main Photo

The access aisle is not a minimum 8 feet to the centerline of the stripe.

Designated access aisle not van accessible

Ensure van access aisle is a minimum of 8 feet wide.

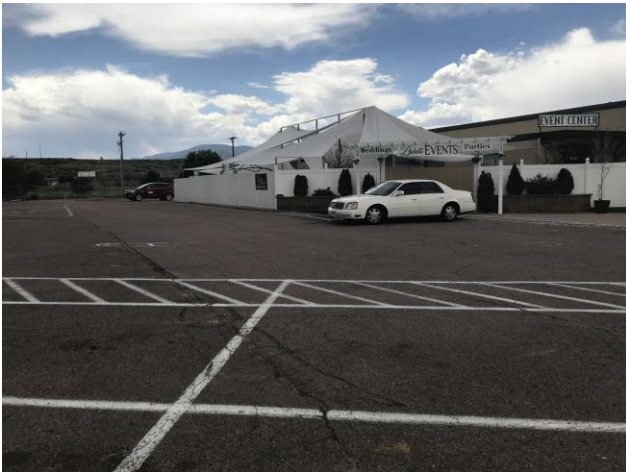
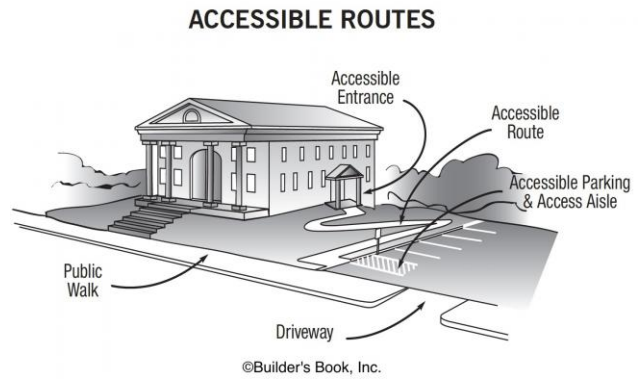
Finding 299330 Main Photo

The access aisle is not located on an accessible route of travel to the accessible building entrance.

Accessible route from parking lot not defined

Ensure a designated path of travel from the access aisle to the front entrance is well defined.

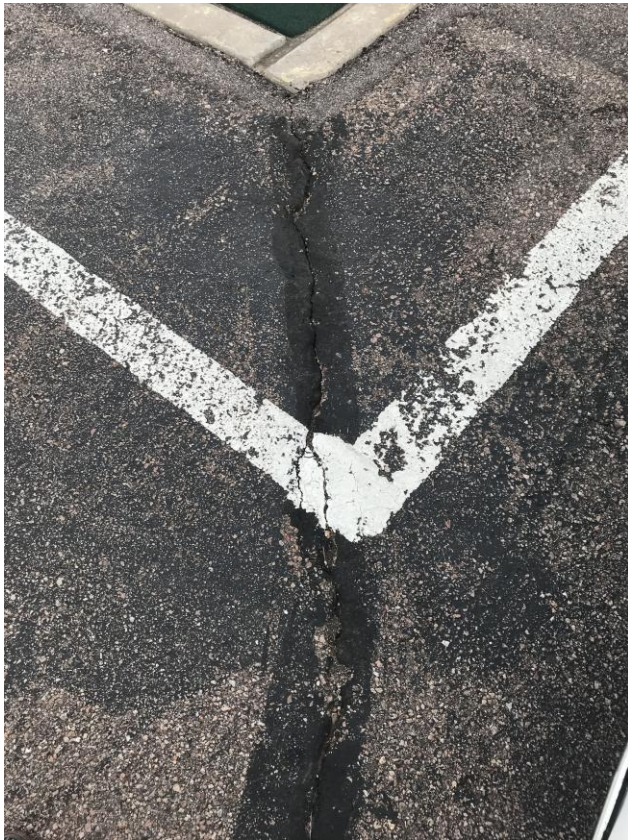
Finding 299331 Main Photo

The concrete expansion joint is spaced greater than 1/2 inch.

Ground surface  
openings exceed the  
1/2 inch maximum

Elongated openings and/or expansion joints shall not be greater than 1/2 inch. Back fill ground openings greater than 1/2 inch along path of travel up to front entrance of building.

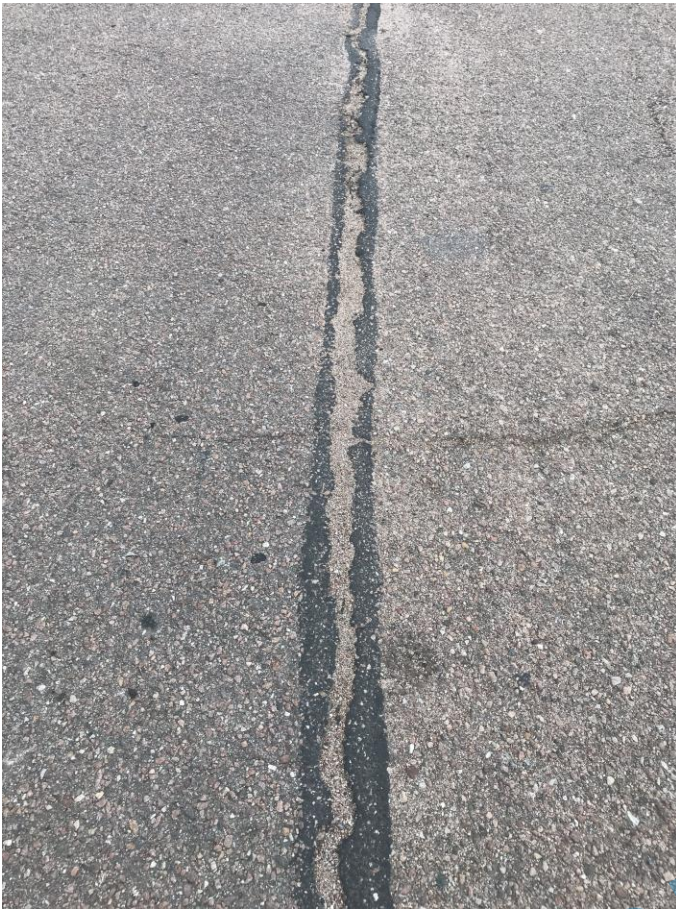
Finding 299332 Main Photo

Parking lot needs to be asphalt patched, crack filled, sealed and re striped. Also, the accessible parking stalls need to be located as close as possible to the front entrance and ensure a designated path of travel from the access aisle to the front entrance is well defined.

Parking lot needs crack fill and sealant throughout

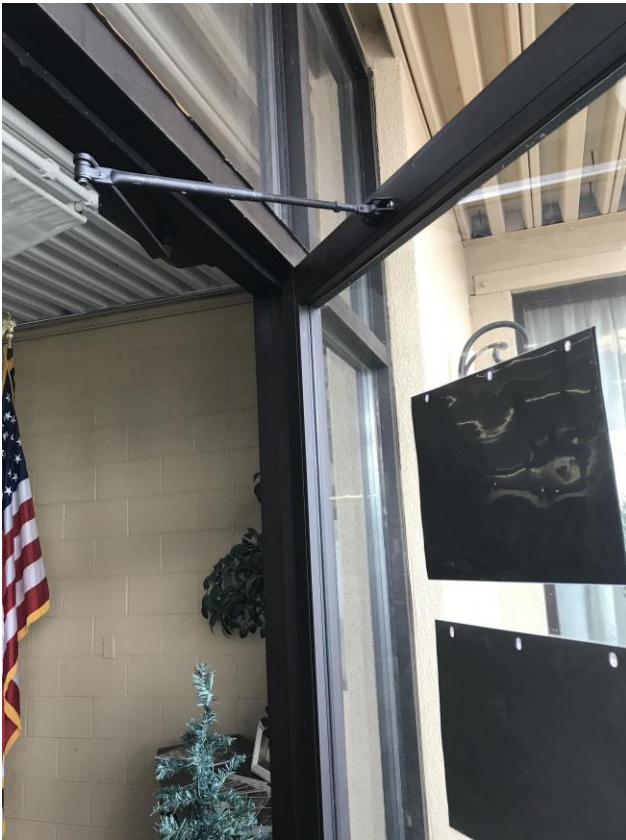
Finding 299334 Main Photo

The door is equipped with a door closer and returns to a closed position too quickly.

3.82 seconds to closed position

Adjust both door closers to allow a minimum of 5 seconds to move from the open position at 90 degrees to 12 degrees from the latch/locking mechanism.

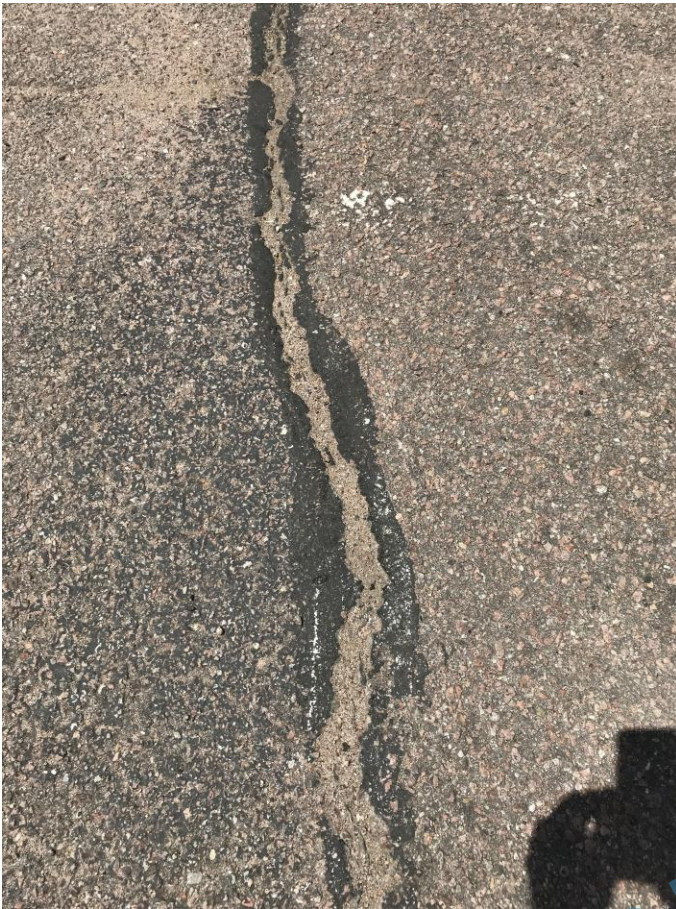
Finding 299370 Main Photo

Parking lot needs to be asphalt patched, crack filled, sealed and re striped. Also, the accessible parking stalls need to be located as close as possible to the front entrance and ensure a designated path of travel from the access aisle to the front entrance is well defined.

Parking lot needs crack fill and sealant throughout

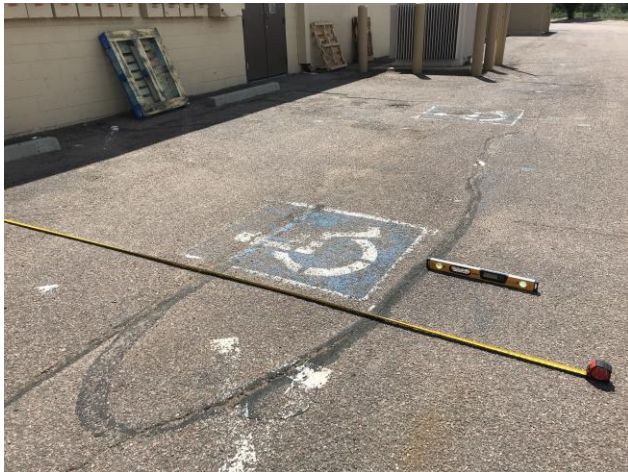
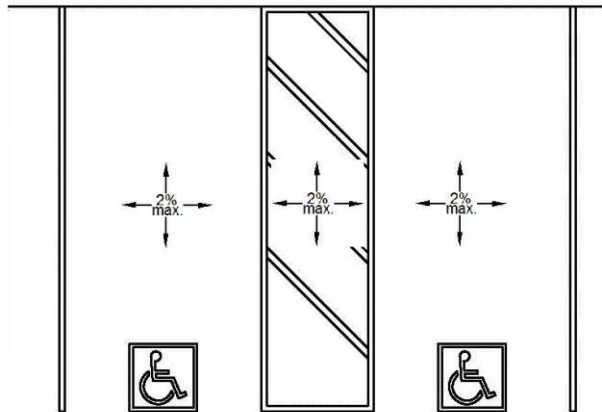
Finding 299371 Main Photo

The running slope (long dimension) of the accessible parking stall exceeds 2%.

Running slope  
between 2.4 % and 3.8  
%

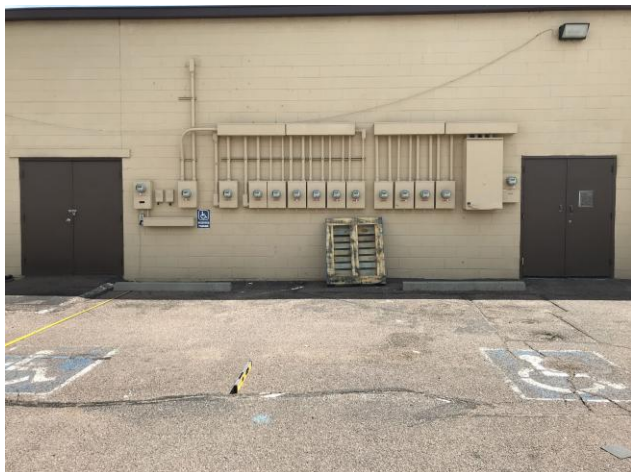
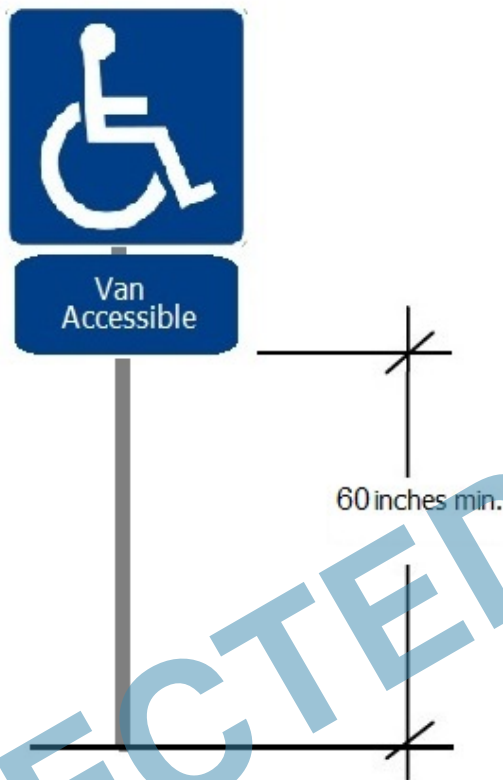
Finding 299373 Main Photo

The required parking signage is missing.

Accessible parking  
signage missing  
and/or non-compliant

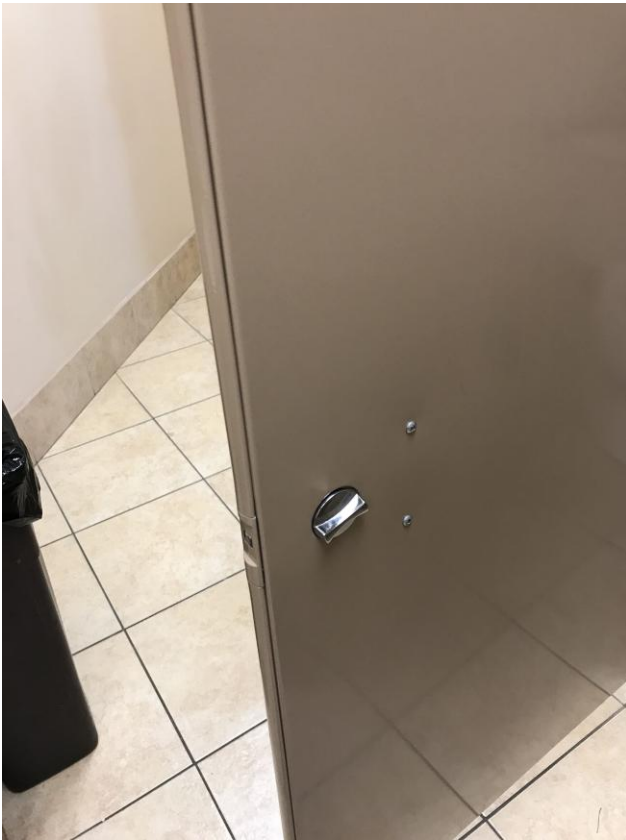
Finding 299339 Main Photo

The water closet compartment door is missing a loop handle on the inside.

Missing inside loop handle

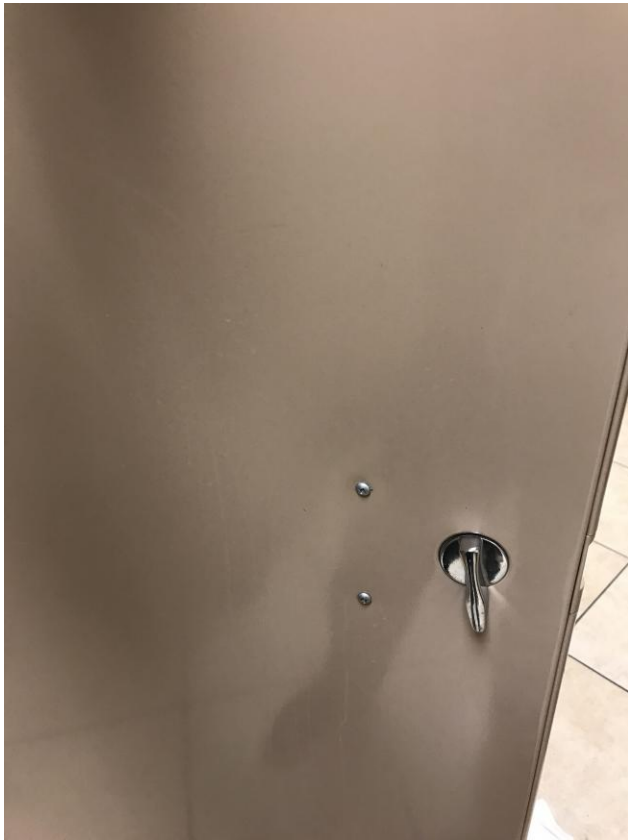
Finding 299351 Main Photo

The water closet compartment door is missing a loop handle on the inside.

Missing inside loop handle

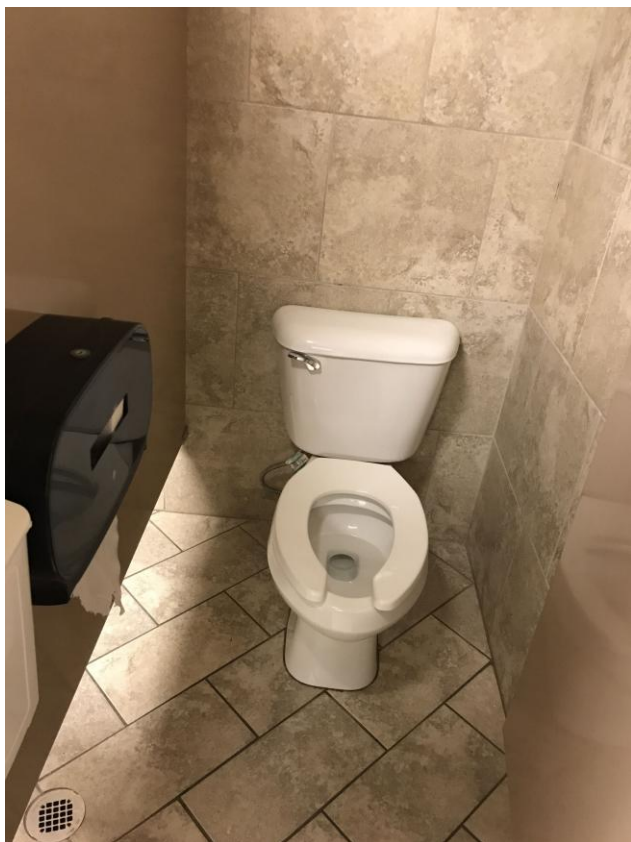
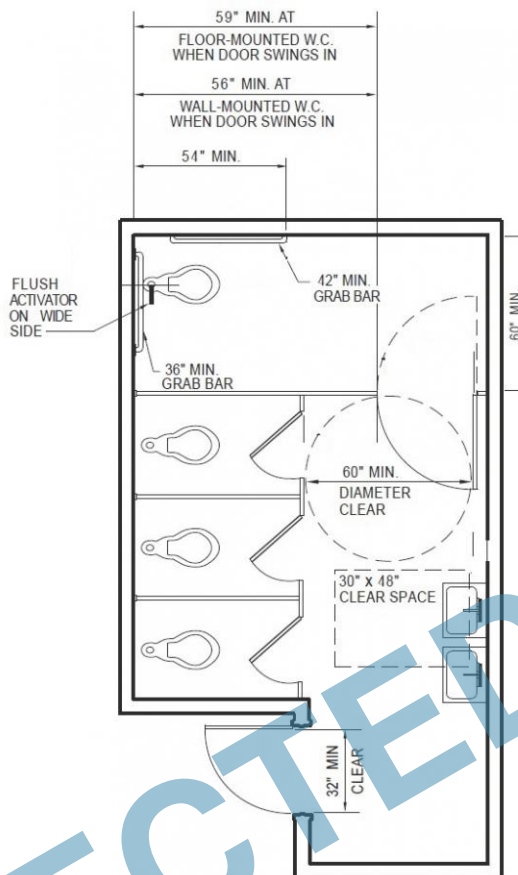
Finding 299362 Main Photo

The stall does not have the required minimum clear floor space or maneuvering clearances for the toilet, Grab bars are missing, toilet paper dispenser is not within range of toilet, compartment door swings inwards and is missing loop handles, locking hardware requires tight grasping, pinching and twisting of the wrist and toilet height is 16 inches instead of 17 inches minimum required.

Recommend code study to determine if adjacent toilet can be removed to provide minimum maneuvering clearances and install grab bars inside toilet compartment.

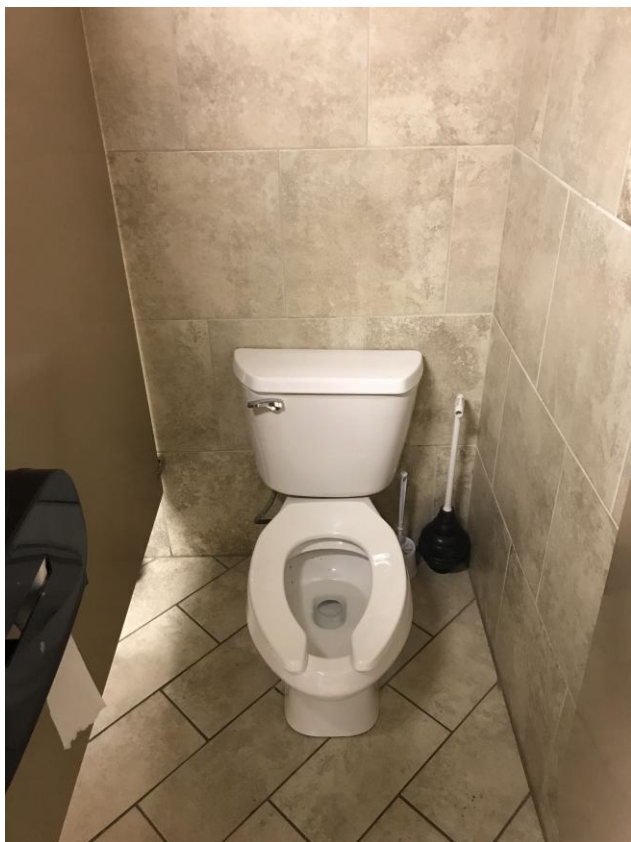
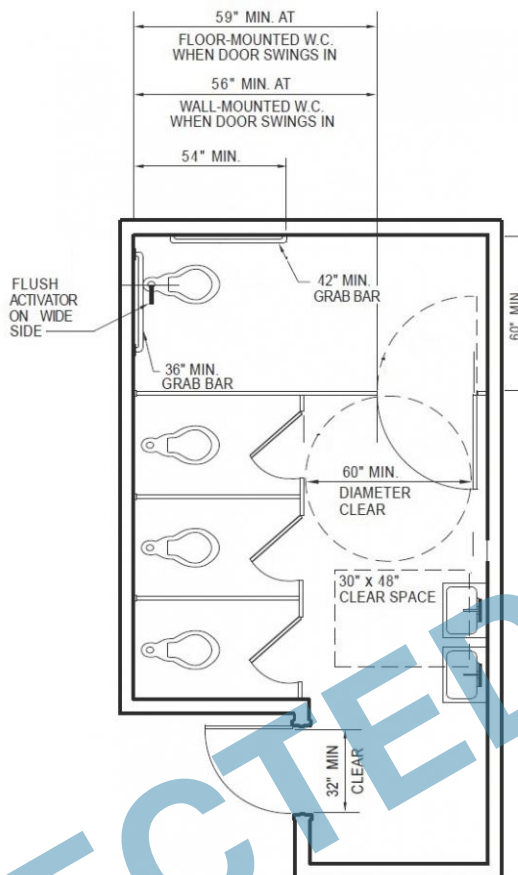
Finding 299367 Main Photo

The stall does not have the required minimum clear floor space or maneuvering clearances for the toilet, Grab bars are missing, toilet paper dispenser is not within range of toilet, compartment door swings inwards and is missing loop handles, compartment door is not self closing, locking hardware requires tight grasping, pinching and twisting of the wrist and toilet height is 16 inches instead of 17 inches minimum required.

Recommend code study to determine if adjacent toilet can be removed to provide minimum maneuvering clearances and grab bars inside toilet compartment.
