Site Accessibility Evaluation

Environmental Building

**3255 Akers Dr
Colorado Springs, CO
80922**

***Inspection Date: 02/21/2018
Inspector: David Mejia***

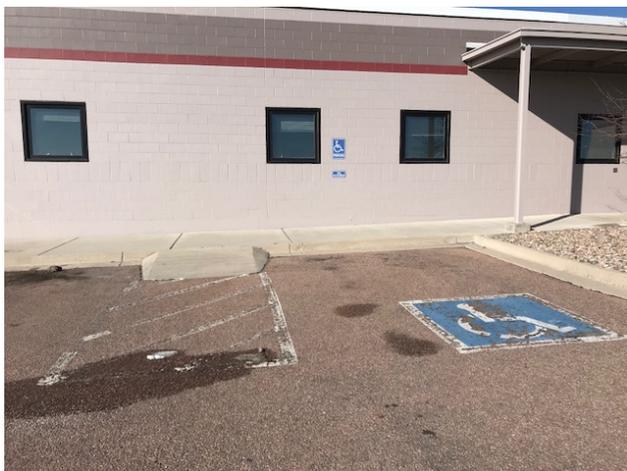
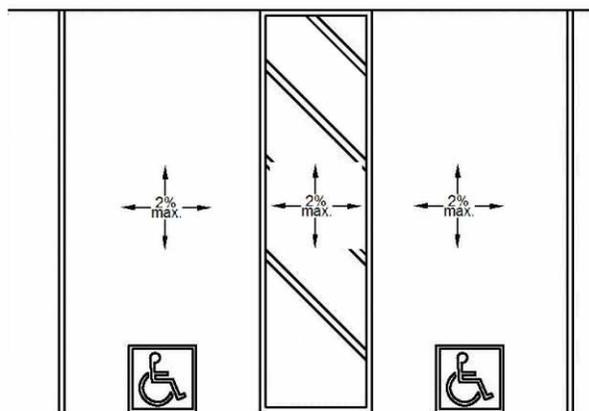
Finding 116961 Main Photo

The accessible parking stall's access aisle contains a built up curb ramp which results in significant slopes greater than 2 percent.

2010 ADAS Section 502.4

Asphalt ramp
protruding into
parking access aisle

1 (High): Should be completed immediately. (Includes; Findings that have little or no cost, were in violation of the codes at the time of construction, or pose an imminent safety threat)

1. Remove protruding asphalt ramp from parking access aisle. 2. Extend existing access aisle into sidewalk and provide flare sides at no steeper than 8.33% (1:12) or add ramp adjacent to current access aisle.

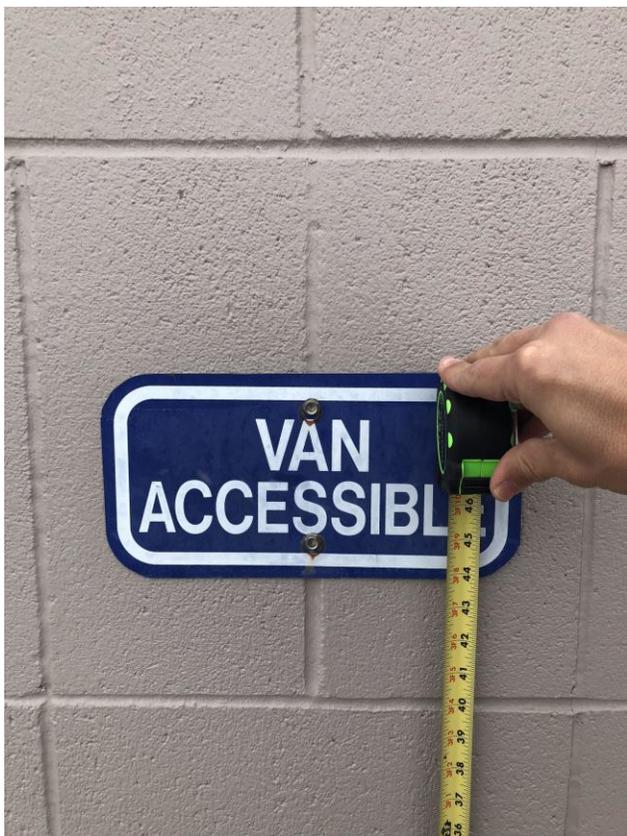
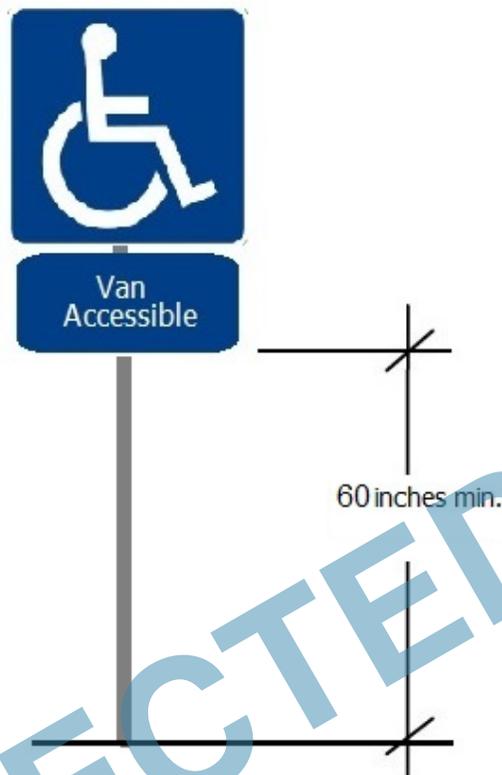
Finding 117860 Main Photo

The parking sign is mounted too low.

2010 ADAS Section 502.6

Van accessible sign is mounted to low (43.5 in)

Ensure new parking van sign is placed no lower than 60 inches minimum measured from the bottom edge of the sign above the finished floor and includes the International Symbol of Accessibility (ISA).

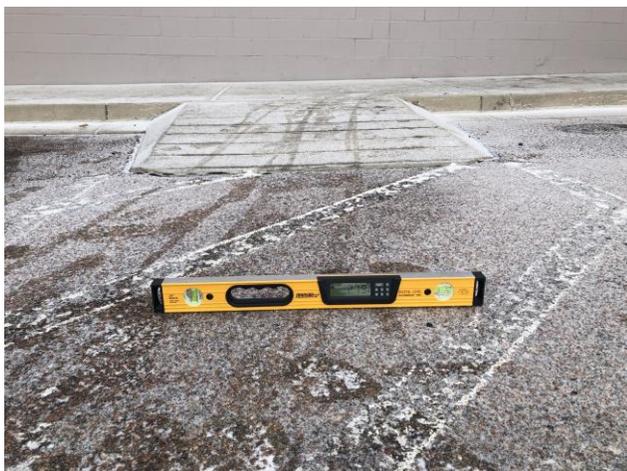
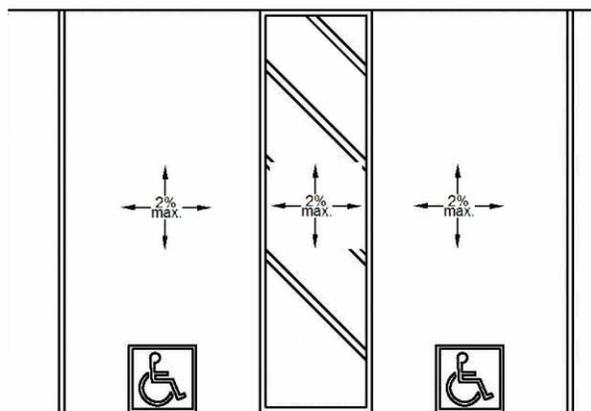
Finding 117885 Main Photo

The cross slopes (narrow dimension) and/or running slopes (long dimension) of the access aisle exceeds 2%.

2010 ADAS Section 502.4

Running Slope @
2.71% Cross Slope @
2.79%

During next re-paving project of parking area, ensure access aisles and parking stalls do not exceed 2% running and cross slopes.

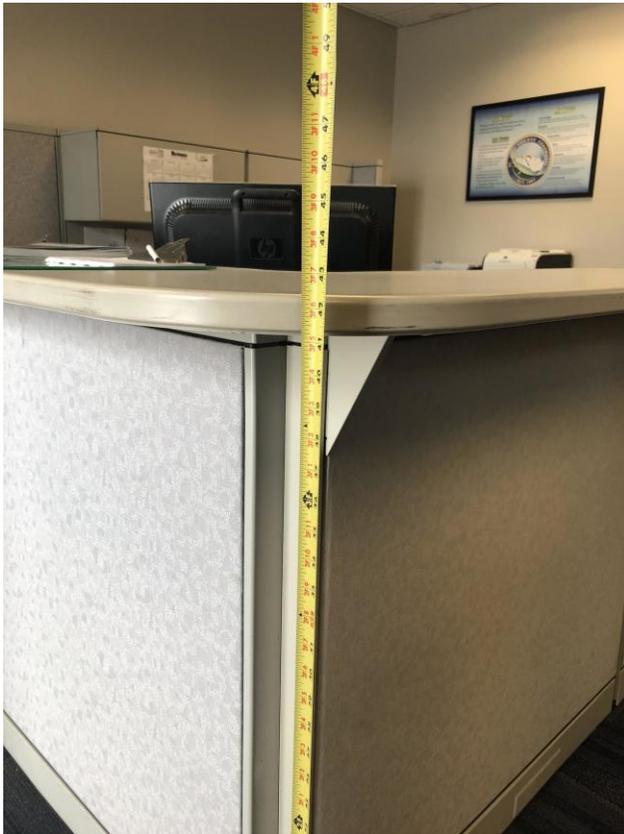
Finding 117888 Main Photo

The transaction counter is too high.

2010 ADAS Section 904.4.1

Counter measured at
42.5 inches from
surface to floor.

Modify or extend existing service counter or install new counter/section that includes a section of counter surface that is 36 inches long minimum and 36 inches high maximum.

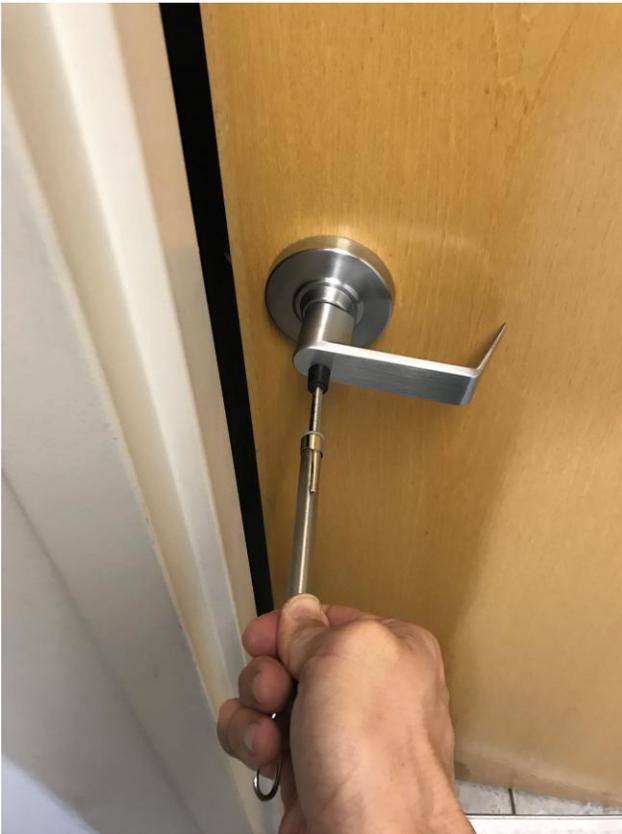
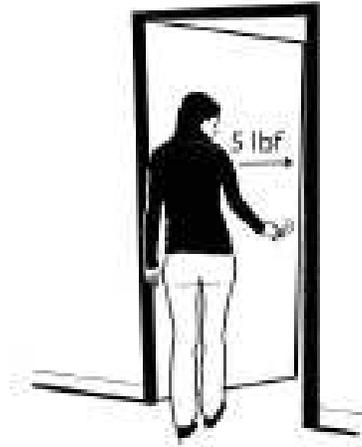
Finding 299173 Main Photo

The door exceeds the maximum pressure to open the door.

2010 ADAS Section 404.2.9

Requires 9 pounds of force to open

Adjust door closer to 5 lbs. of pressure or less.

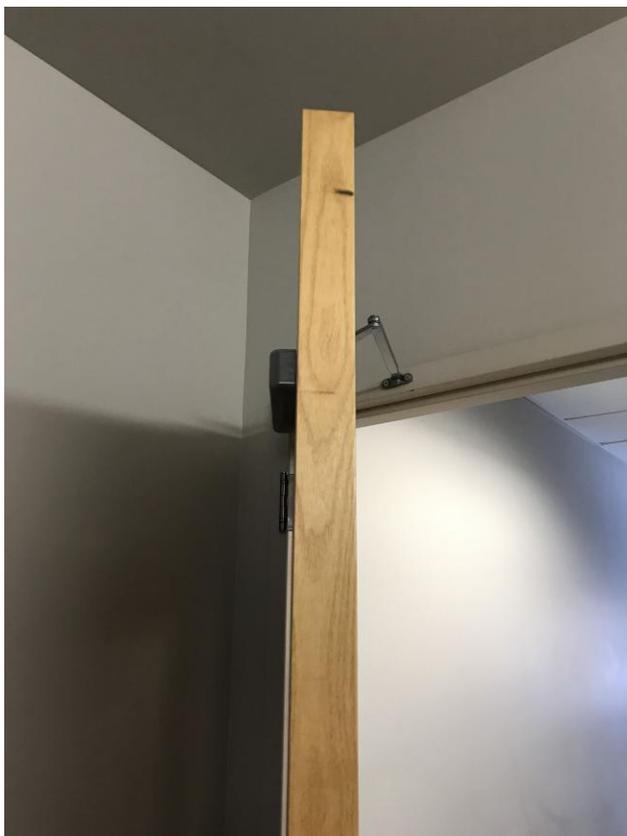
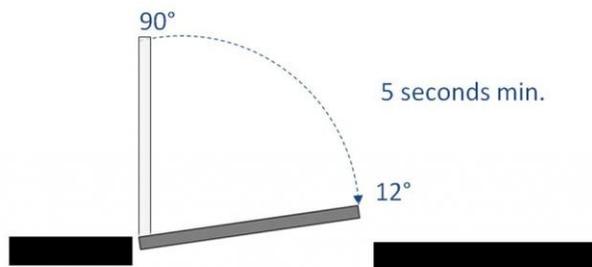
Finding 299174 Main Photo

The door is equipped with a door closer and returns to a closed position too quickly.

2010 ADAS Section 404.2.8.1

3.5 seconds to closed position

Adjust door closer to allow a minimum of 5 seconds to move from the open position at 90 degrees to 12 degrees from the latch/locking mechanism.

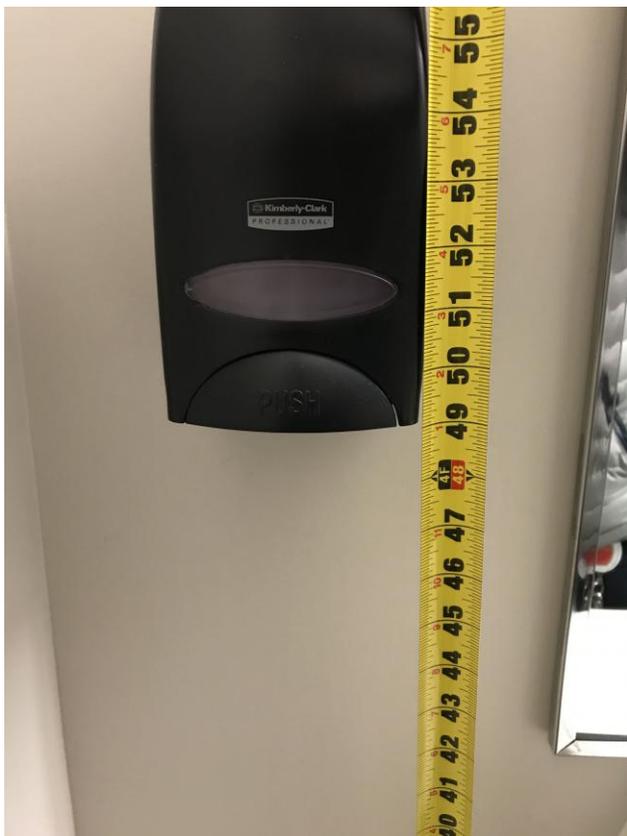
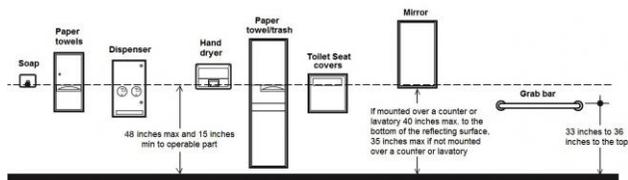
Finding 299175 Main Photo

The soap dispenser's operation mechanism is too high off the floor.

2010 ADAS Section 308.2.1

49 inches above
finished floor

Lower soap dispenser 2 inches to meet compliance. 48 inches maximum height above finished floor to operable part.

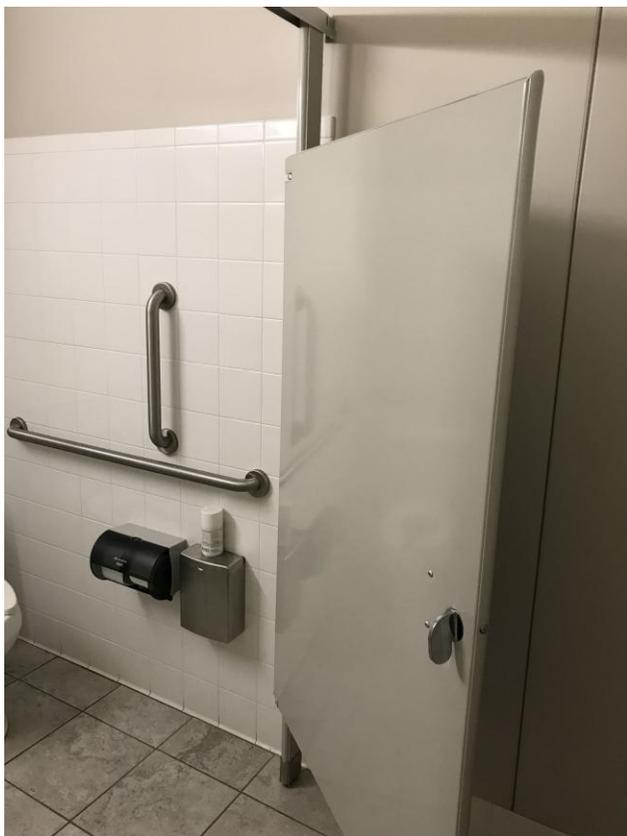
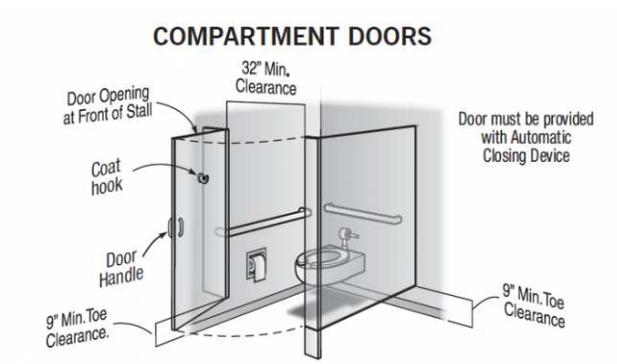
Finding 299176 Main Photo

The compartment door is not self closing.

2010 ADAS Section 604.8.1.2

Compartment door not self-closing

Adjust or install automatic closing hinges.

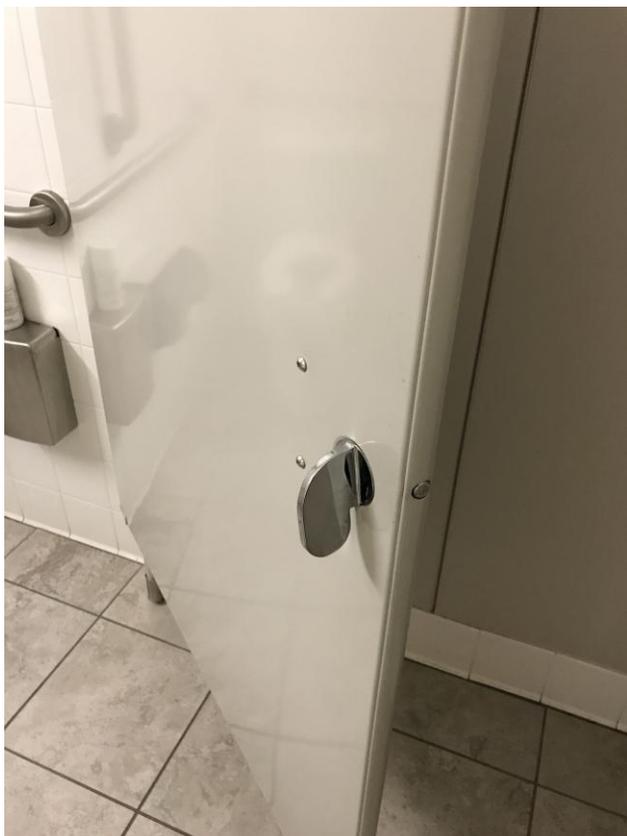
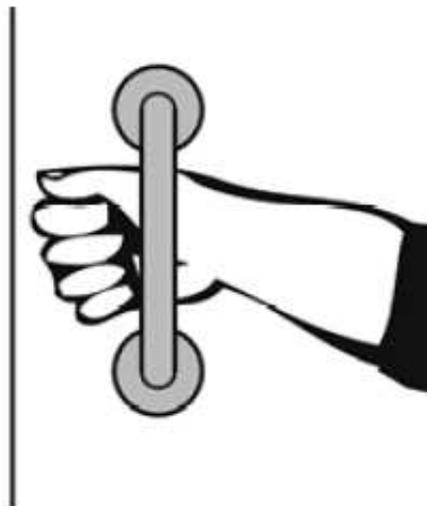
Finding 299177 Main Photo

The water closet compartment door is missing a loop handle on the inside.

2010 ADAS Section 604.8.1.2

Missing loop handle
on inside of door

Install loop or U-shape handle on the inside of the compartment door.

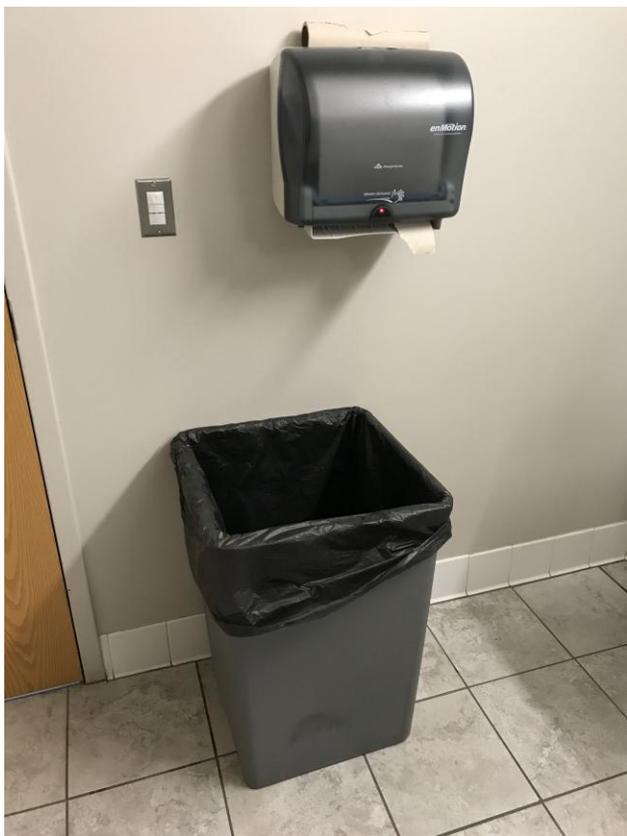
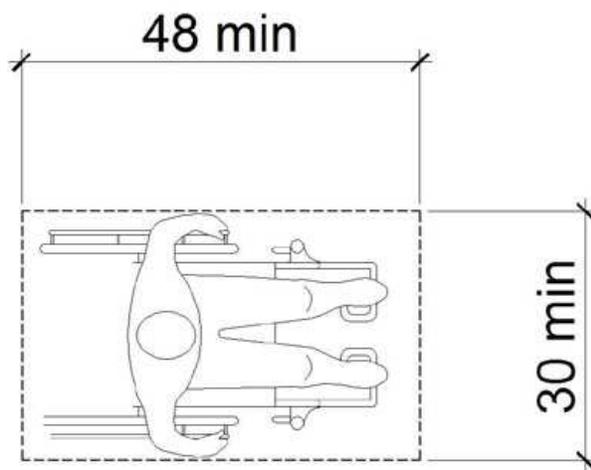
Finding 299178 Main Photo

The paper towel dispenser is not accessible because there is not adequate clear floor space for either a forward or side approach.

2010 ADAS Section 305.3

Trash bin obstructs the required clear floor space of the lavatory and paper towel dispenser

Relocate trash bin to other area and recommend using smaller size trash bin.

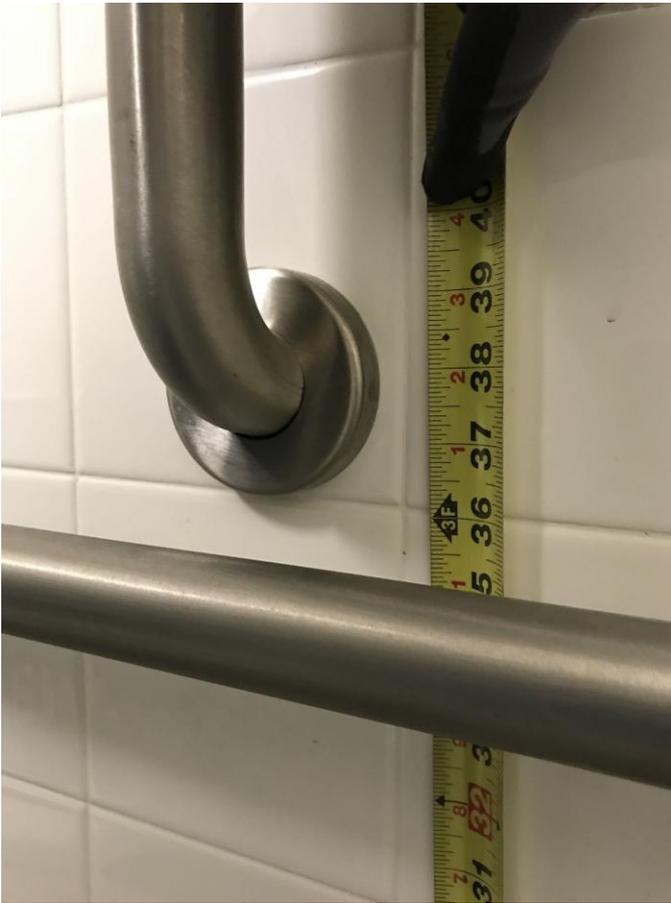
Finding 299473 Main Photo

Although not required per ADA Standards, but required under the ICC/ANSI A117.1

Vertical grab bar 37
inches above finished
floor

Re-position vertical grab bar so that bottom of grab bar measures a maximum of 41 inches but no less than 39 inches above finished floor.

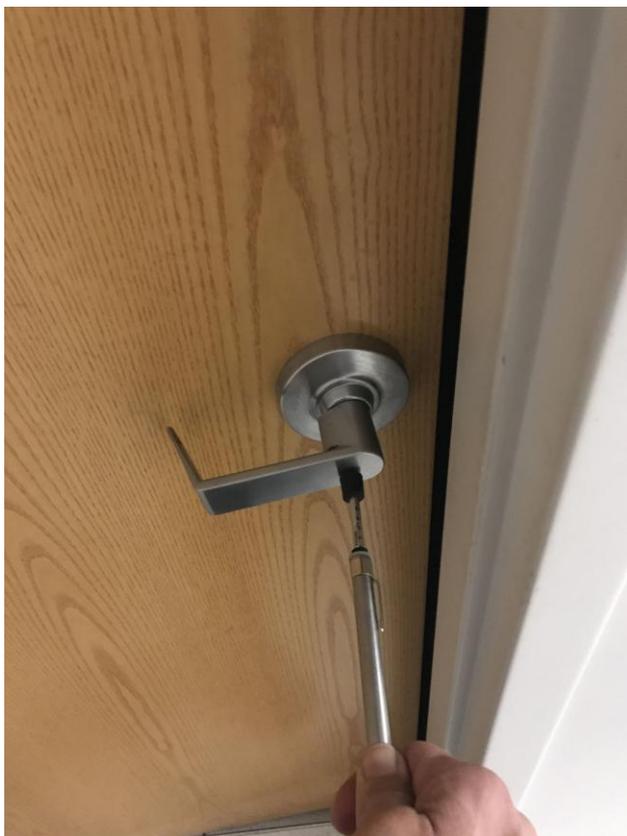
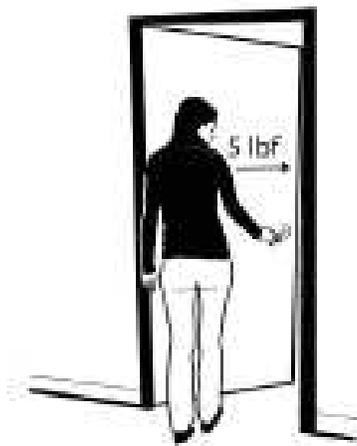
Finding 299179 Main Photo

The door exceeds the maximum pressure to open the door.

2010 ADAS Section 404.2.9

Requires 9 pounds of force to open

Adjust door closer to 5 lbs. of pressure or less.

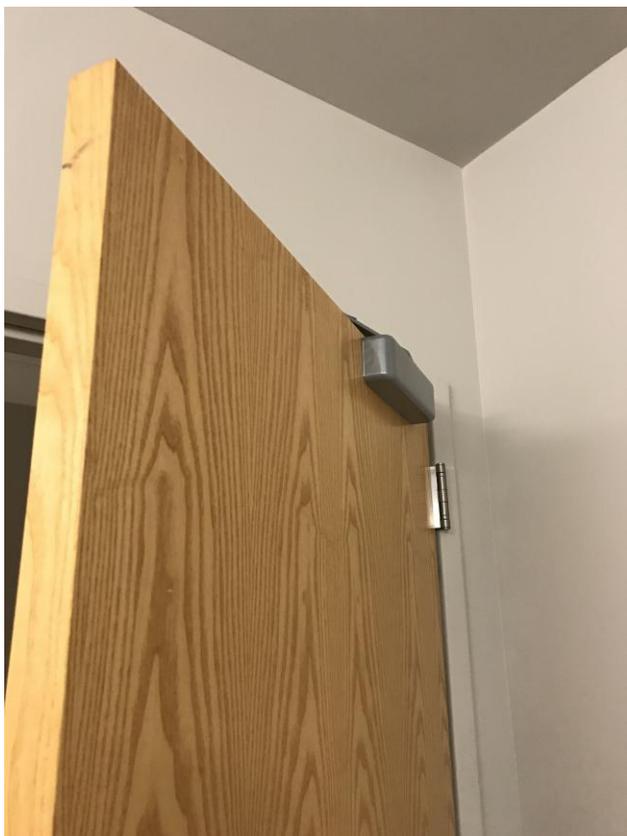
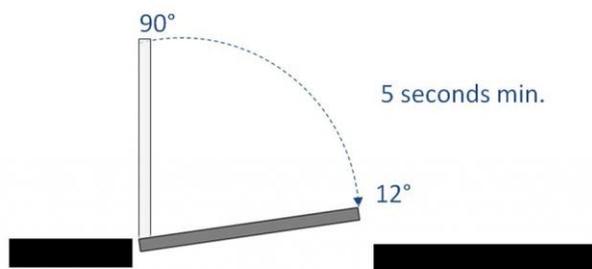
Finding 299180 Main Photo

The door is equipped with a door closer and returns to a closed position too quickly.

2010 ADAS Section 404.2.8.1

4.5 seconds to closed position

Adjust door closer to allow a minimum of 5 seconds to move from the open position at 90 degrees to 12 degrees from the latch/locking mechanism.

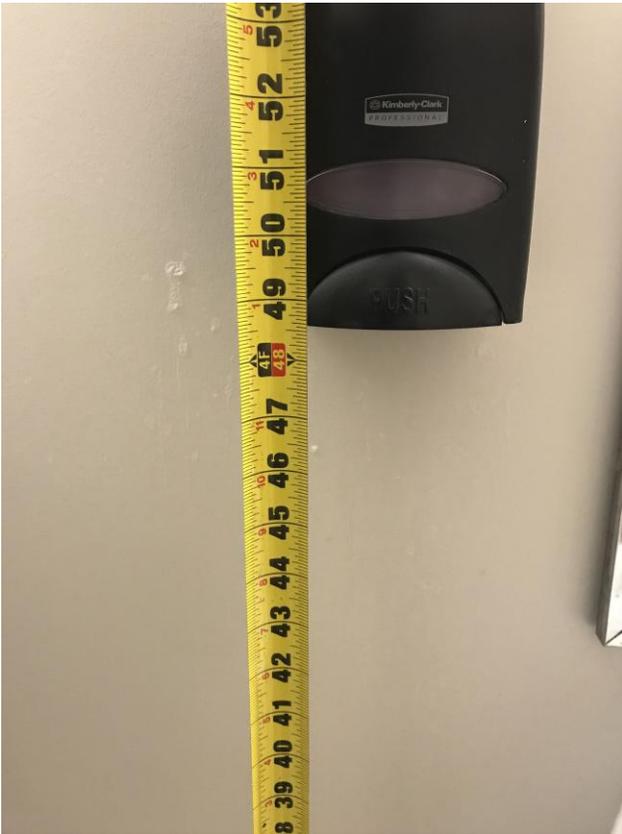
Finding 299181 Main Photo

The soap dispenser's operation mechanism is too high off the floor.

2010 ADAS Section 308.2.1

48.5 inches above
finished floor

Lower soap dispenser 2 inches to meet compliance. 48 inches maximum height above finished floor to operable part (push button).

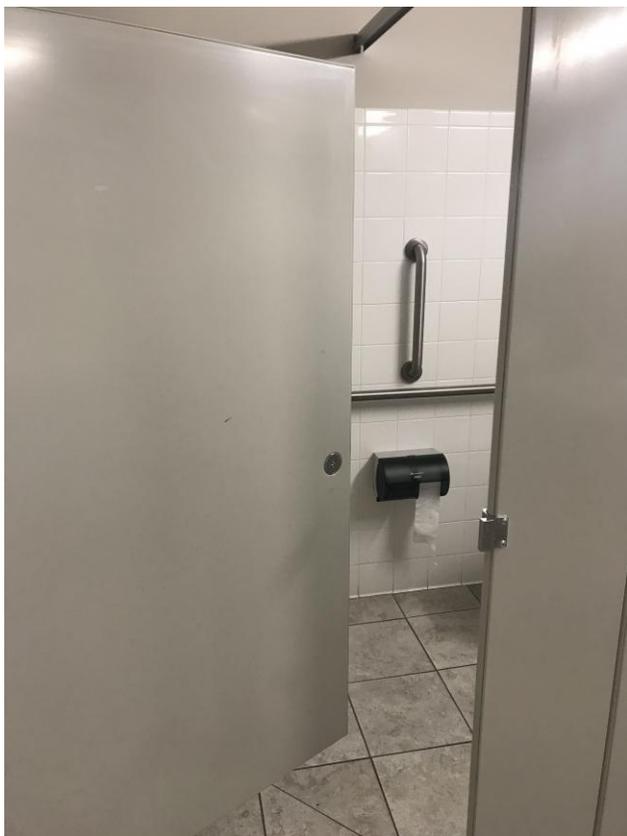
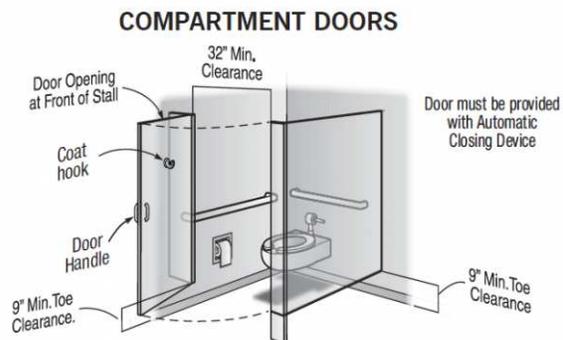
Finding 299182 Main Photo

The compartment door is not self closing.

2010 ADAS Section 604.8.1.2

Compartment door not self-closing

Adjust or install automatic closing hinges.

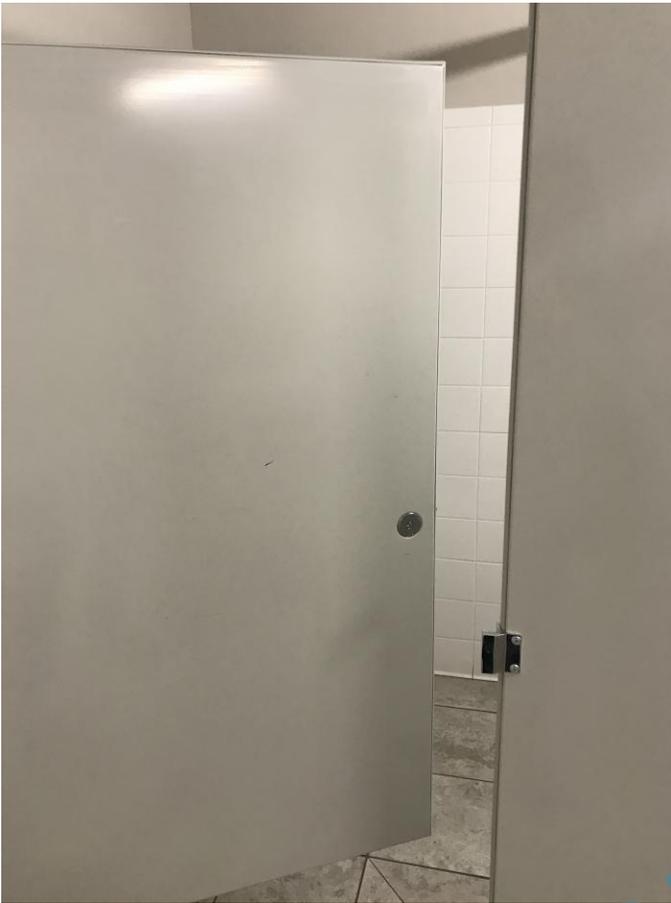
Finding 299183 Main Photo

The water closet compartment door is missing a loop handle on the outside.

2010 ADAS Section 604.8.1.2

Missing loop handle
on outside of door
