Site Accessibility Evaluation

Homestead Ranch Regional Park

Accessibility Evaluation

Inspection Date: 01/30/2018

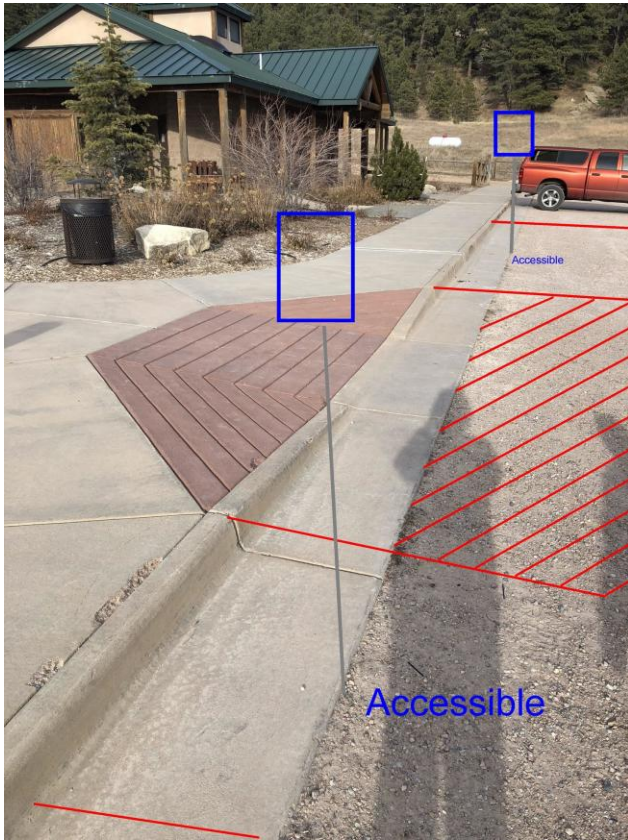
Finding 99591 Main Photo

There are no accessible parking stalls.

No accessible aisles
nor accessible stalls.

Based on 9 ft - width parking stall measurements it was determined that there are 50 stalls available, which would require two accessible parking stalls. Recommend making both Van accessible w/proper international symbol of accessibility signage. This means that the area that needs to be paved would include two accessible parking stalls with accessible aisle leading directly to pedestrian ramp.

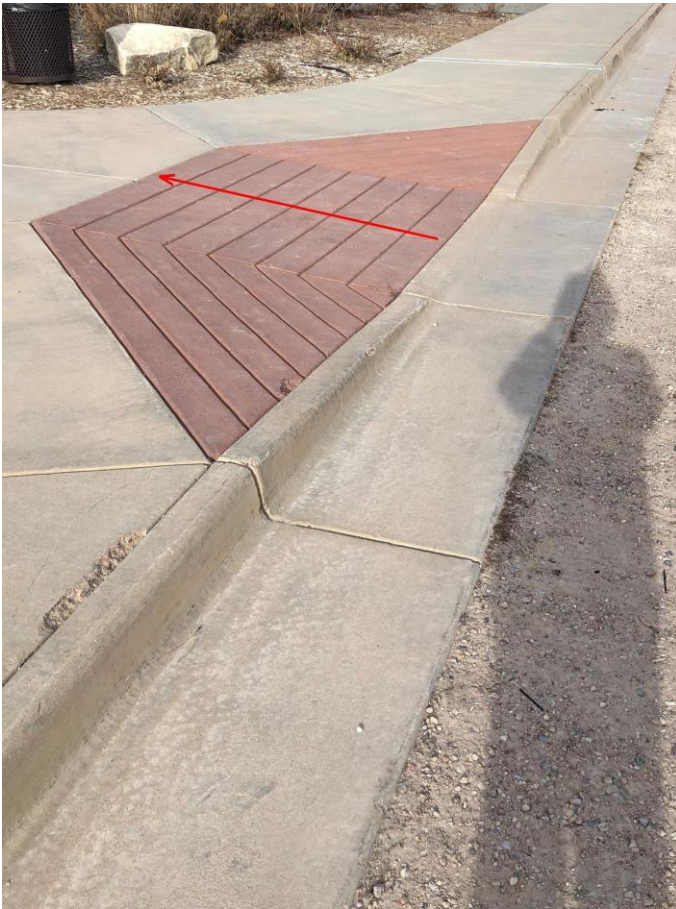
Finding 100876 Main Photo

The curb ramp slope exceeds the maximum running slope (direction of travel) allowable of 8.33%.

Curb ramp slope is
10.07%

Curb ramp must be reconstructed to meet the maximum running slope allowed of 8.33%.

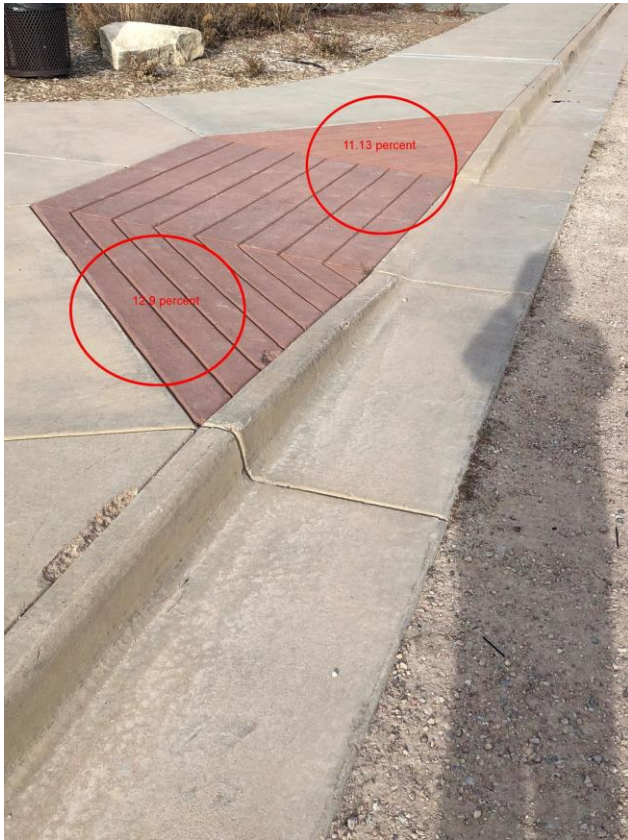
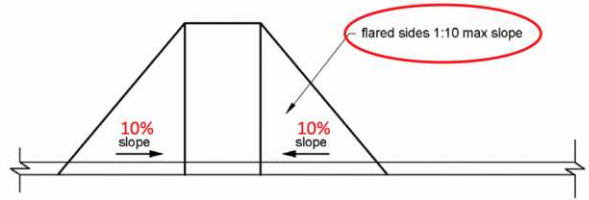
Finding 100878 Main Photo

The curb ramp side flares are too steep.

Ramp flares exceed the maximum allowed. Left 12.19% and Right 11.13%

Reconstruct flares/ramp to meet the maximum 1:10 slope.

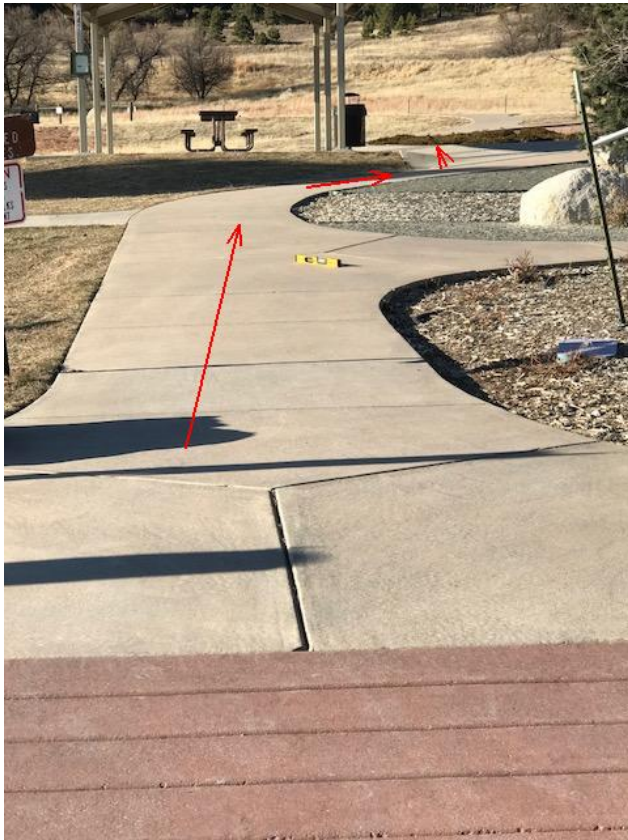
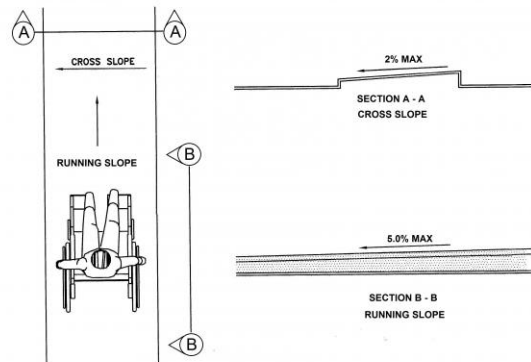
Finding 103411 Main Photo

The accessible route contains running slopes greater than 5 percent and cross slopes greater than 2 percent across the width of the walk and has not been constructed as a ramp (i.e. handrails, wheel guides, etc.).

Some sections of the route exceed the maximum running and cross slope allowed.

Replace and/or adjust each section to meet ADA requirements.

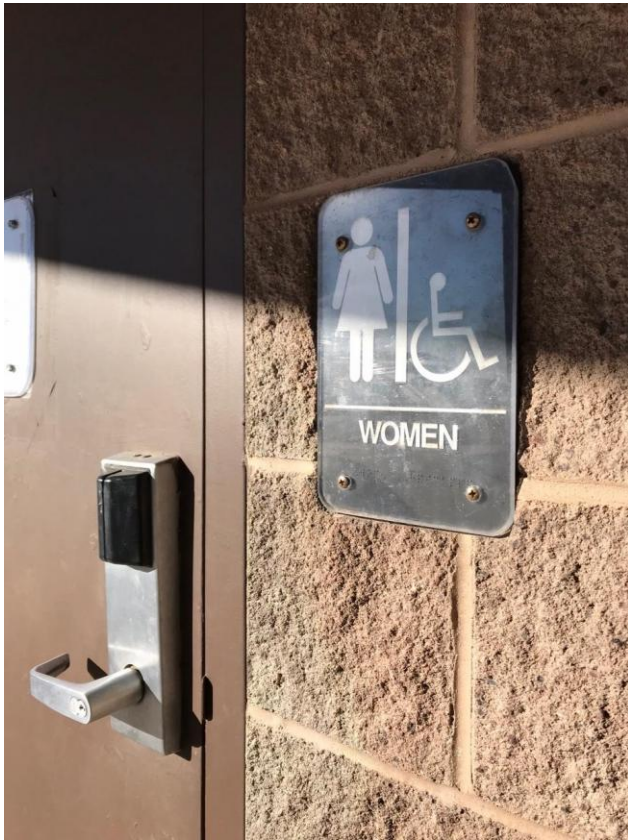
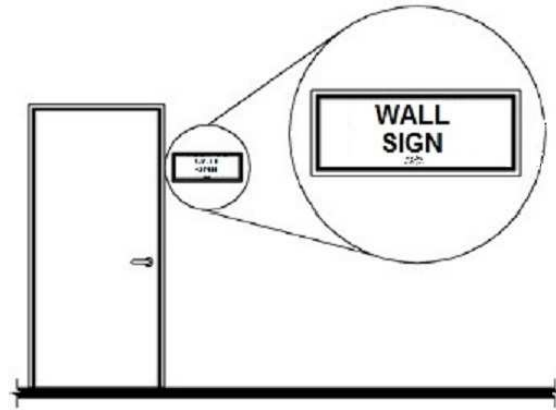
Finding 100797 Main Photo

The tactile sign is incorrectly installed behind acrylic polymer.

Sign installed behind acrylic polymer

Remove acrylic polymer.

Corrective Action: work order # 420302 submitted on 1/31/18.

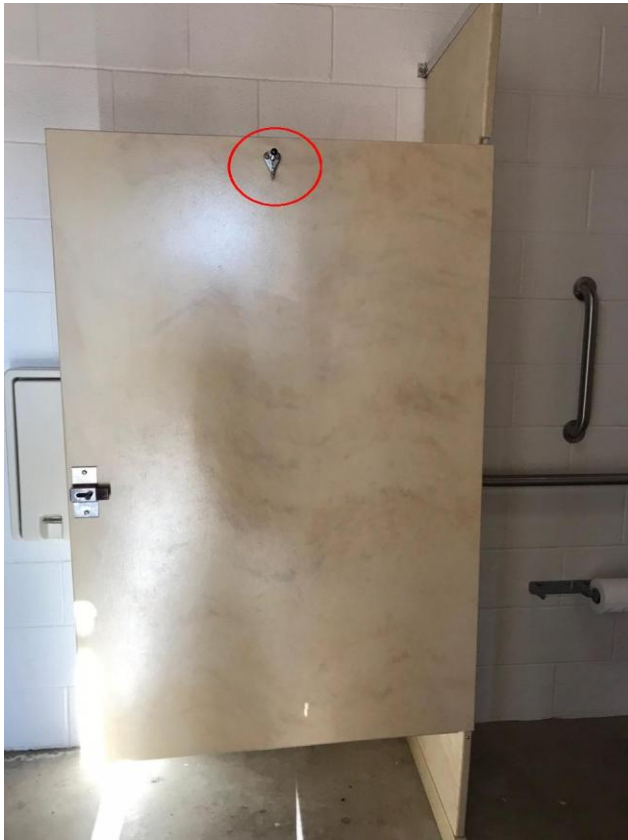
Finding 100806 Main Photo

The coat hook is installed greater than 48 inches above the finished floor.

Coat hook is installed at 60 inches above finished floor.

Lower coat hook 13 inches minimum or install another coat hook not to exceed a maximum height of 48 inches above finished floor.

Corrective Action: work order # 420303 submitted on 1/31/18.

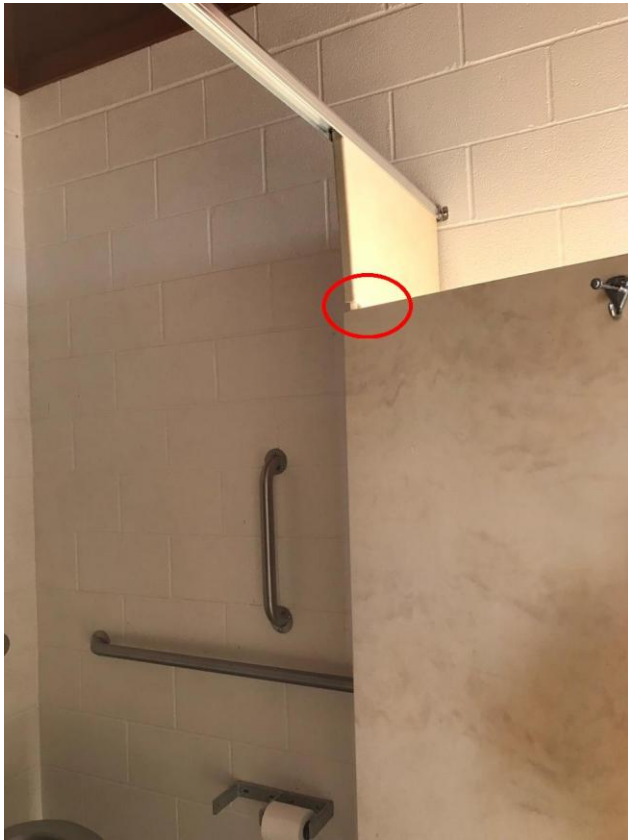
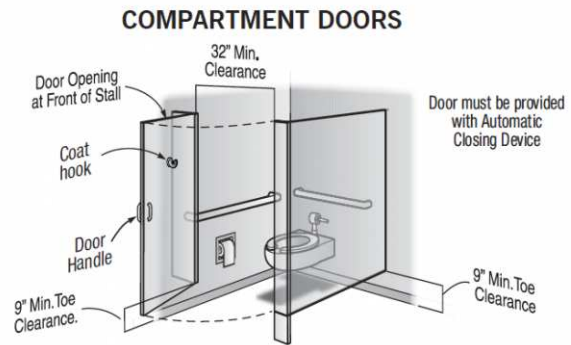
Finding 100820 Main Photo

The water closet compartment door is missing a loop handle on the inside.

Compartment door
missing inside loop
handle

Corrective Action: work order # 420329 submitted on 1/31/2018
