# Site Accessibility Evaluation

**Human Services 17 N.  
Spruce**

**Accessibility Evaluation**

***Inspection Date: 04/08/2019***

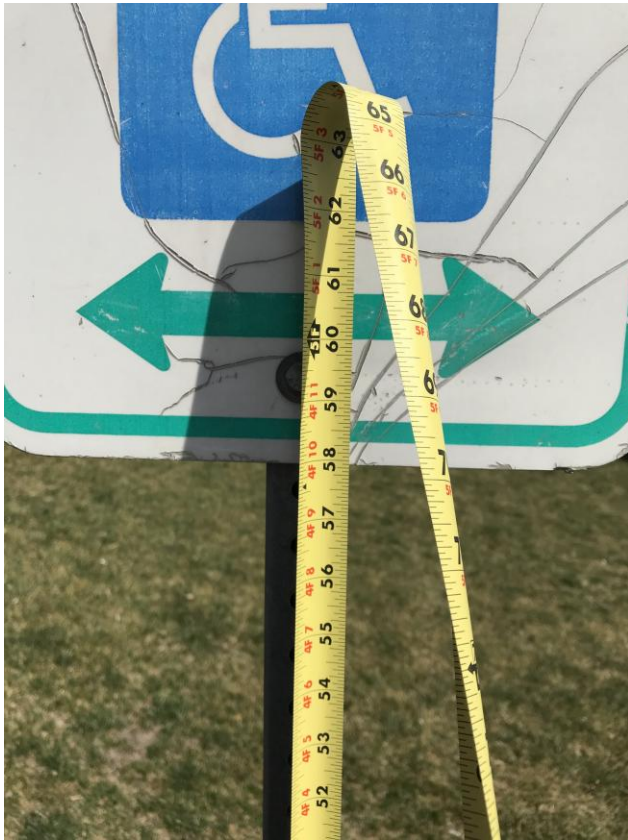
Finding #2 Continued

The van stall is missing a sign identifying it as a van accessible stall.

Van accessible signage is missing

Install 2 "van accessible" signs to include the International Symbol of Accessibility. Also, adjust all accessible parking signs to 60 inches minimum above the finish floor or ground to the bottom edge of the sign.

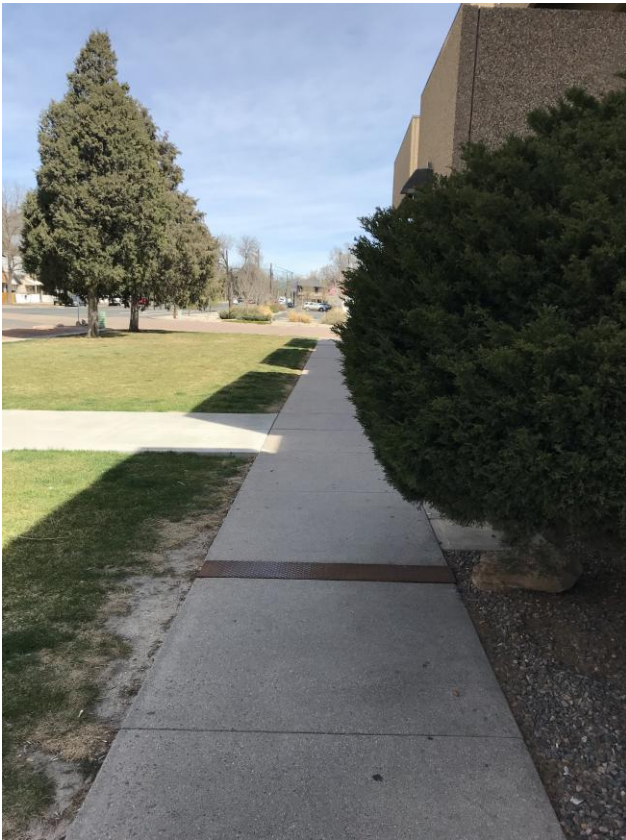
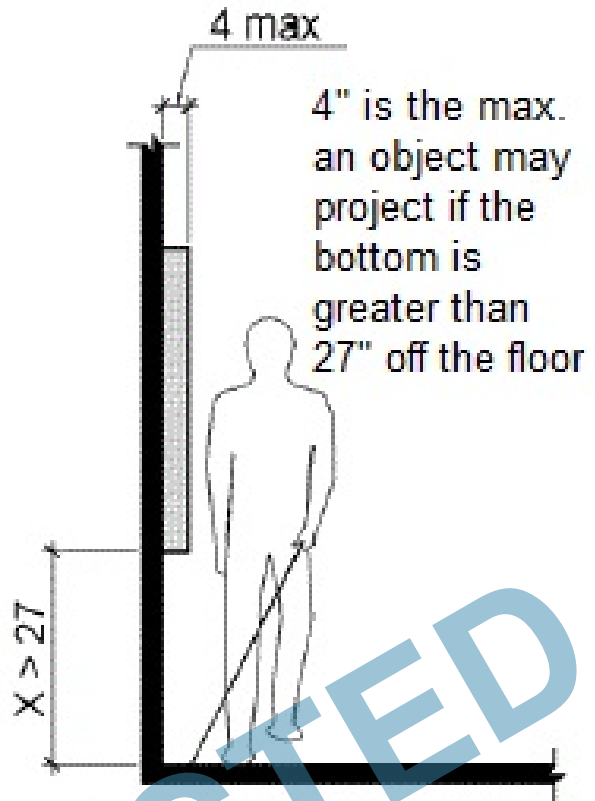
Finding #3 Continued

The shrub projects more than 4 inches into the exterior circulation path of travel.

Shrub protrudes into exterior circulation path

Trim brush to meet ADA compliance.

Corrective action: Work order # 458711 submitted on 4/11/19. Work order completed in-house on 4/18/19

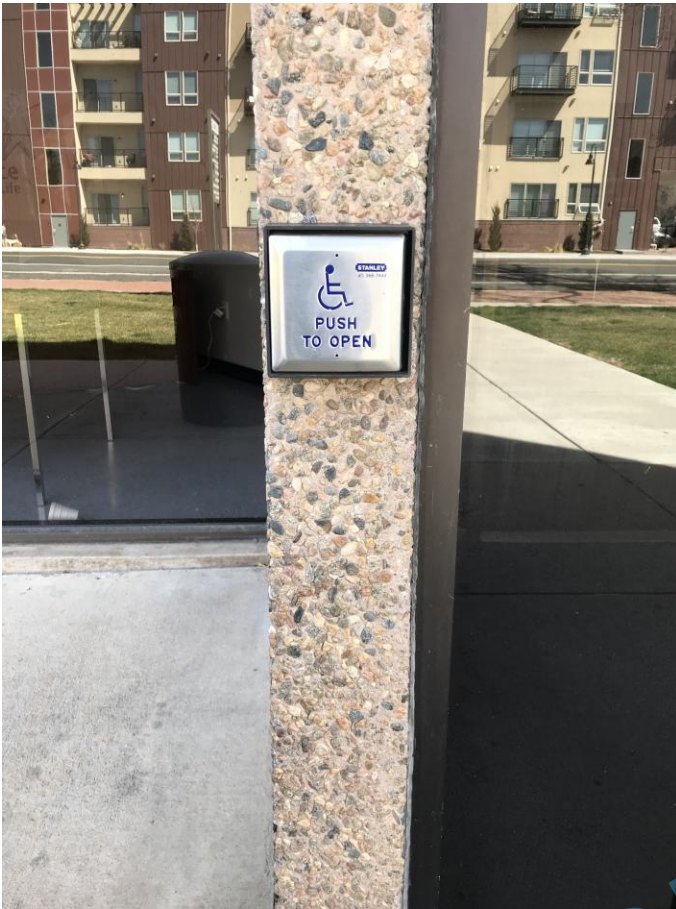
Finding 289466 Main Photo

Front entrance automatic door opener pushbuttons not functioning.

Front door push plates  
malfunctioning /  
inoperable

Inspect and replace if necessary both ADA push plates to the front entrance.

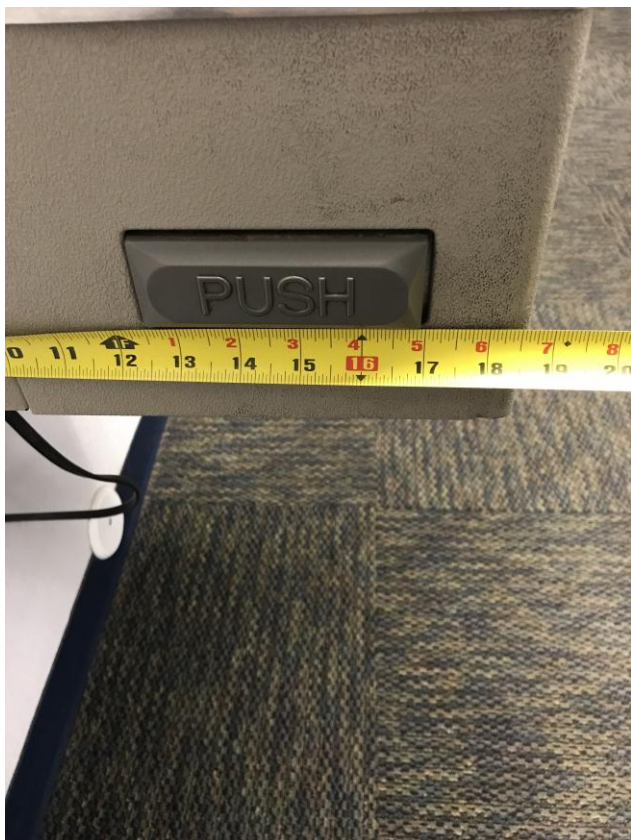
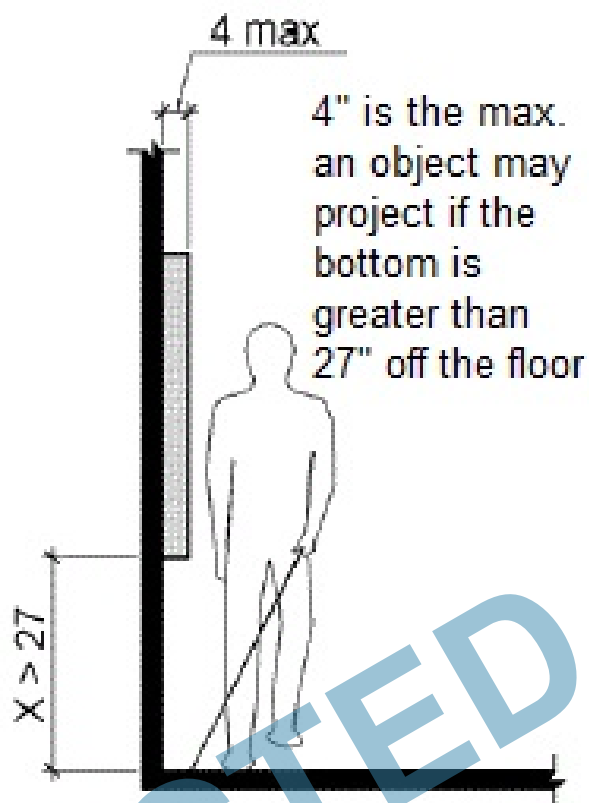
Finding #6 Continued

The drinking fountain projects more than 4 inches into the circulation path.

Drinking fountain  
protrudes 19 inches  
from the wall

Replace drinking fountain with new drinking fountain due to fountain skirt no longer manufactured.

Corrective Action: Work order #463262 submitted on 5/20/19

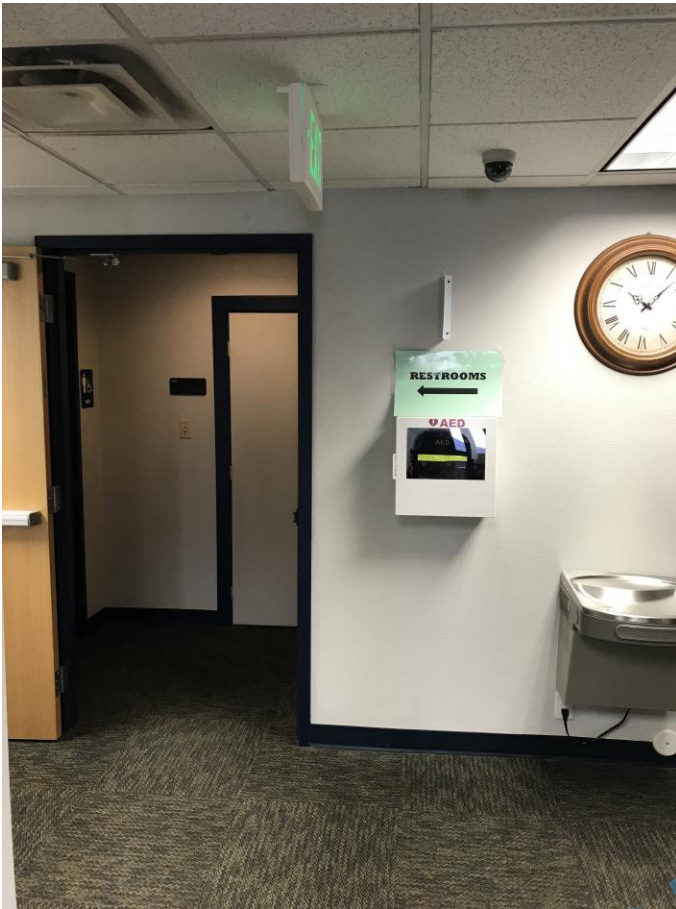
Finding #7 Continued

Missing directional sign identifying location of accessible unisex restroom.

No directional sign  
identifying accessible  
restroom

Install a directional sign indicating accessible unisex restroom.

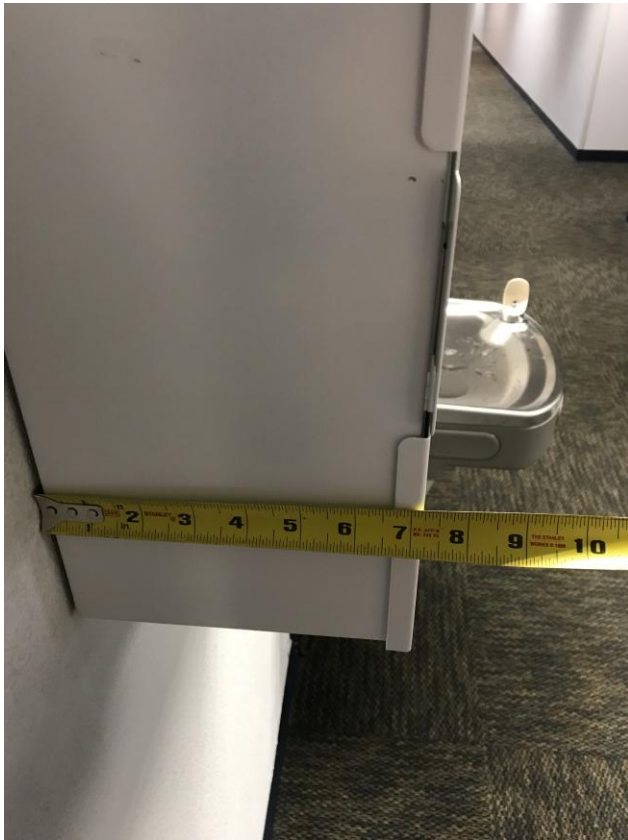
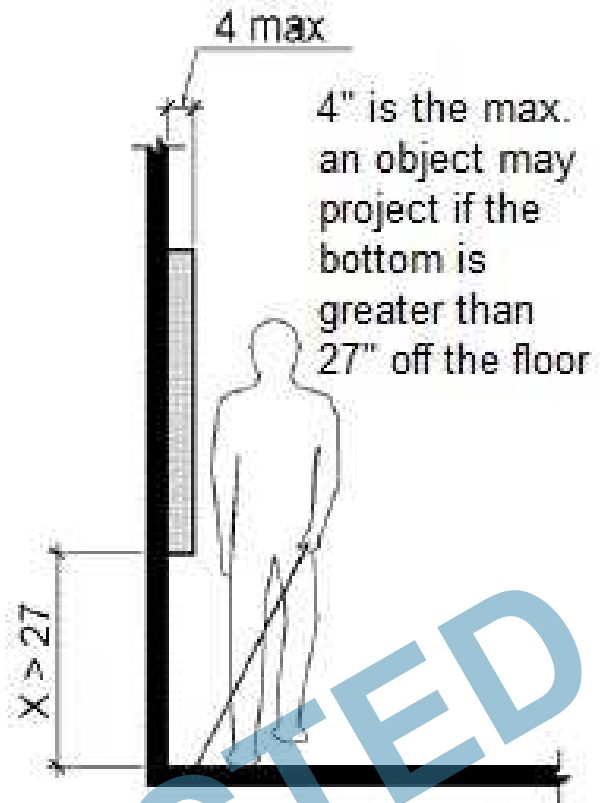
Finding #8 Continued

The AED defibrillator projects more than 4 inches into the circulation path.

AED defibrillator enclosure protrudes 7.25 inches into circulation path

Re-locate defibrillator to a maximum height of 27 inches from the bottom edge of the casing to the finished floor or recess defibrillator housing into wall and ensure casing protrusion is no more than 4 inches.

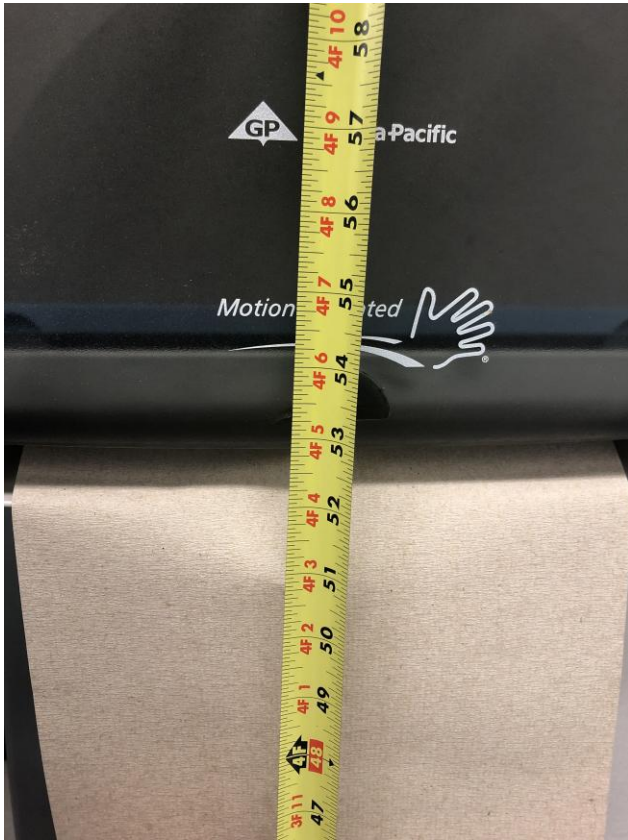
Finding 291399 Main Photo

The paper towel dispenser's operation mechanism is too high off the floor.

Operable part is positioned at 53 inches above finished floor

Lower paper towel dispenser a minimum of 6 inches.

Corrective Action: Work order #463266 submitted on 5/20/19

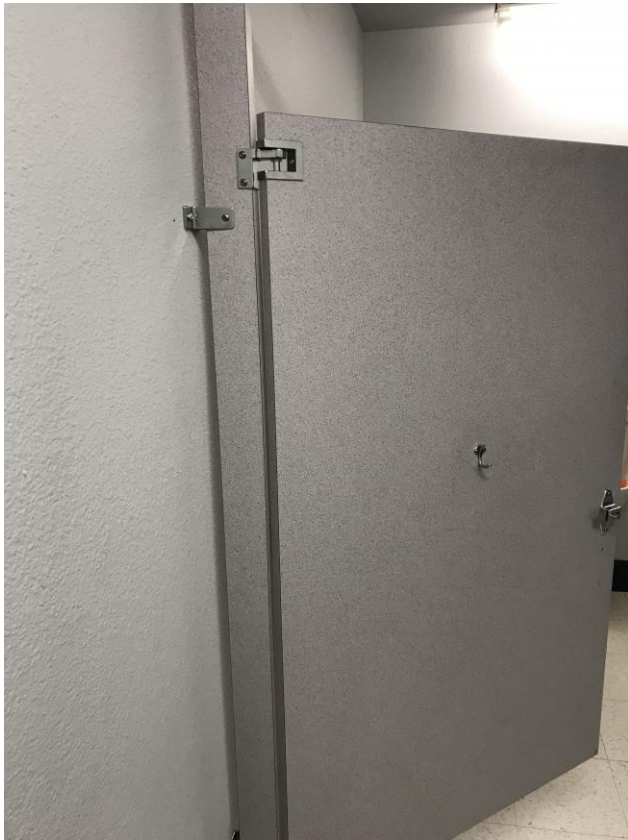
Finding 297197 Main Photo

The compartment door is not self closing.

Stall compartment  
door not self closing

Re-adjust or replace door hinges to ensure door is self closing.

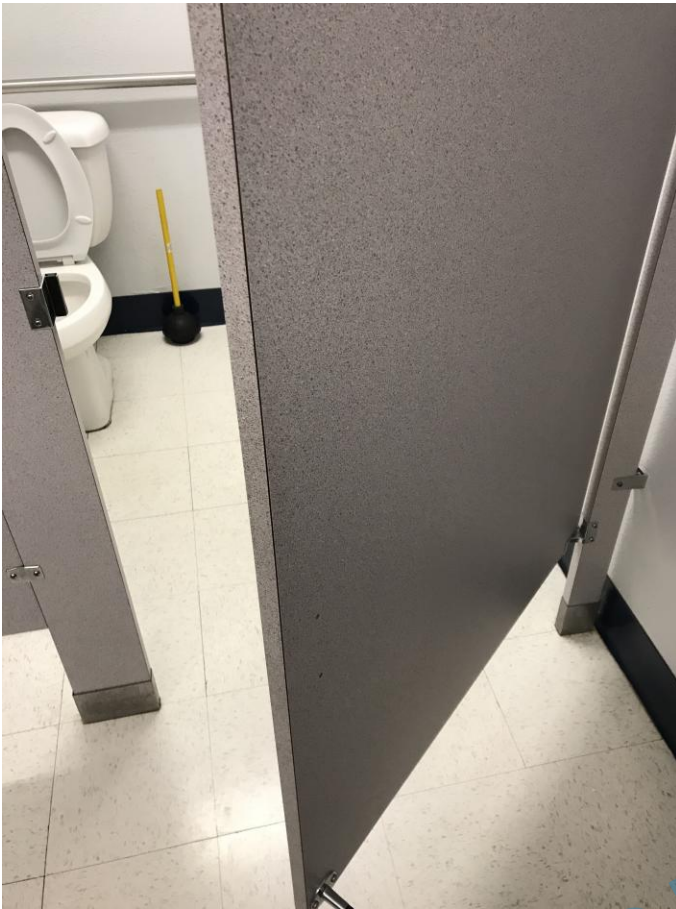
Finding 297198 Main Photo

The water closet compartment door is missing a loop handle on the outside.

Missing loop handle on the outside of compartment door

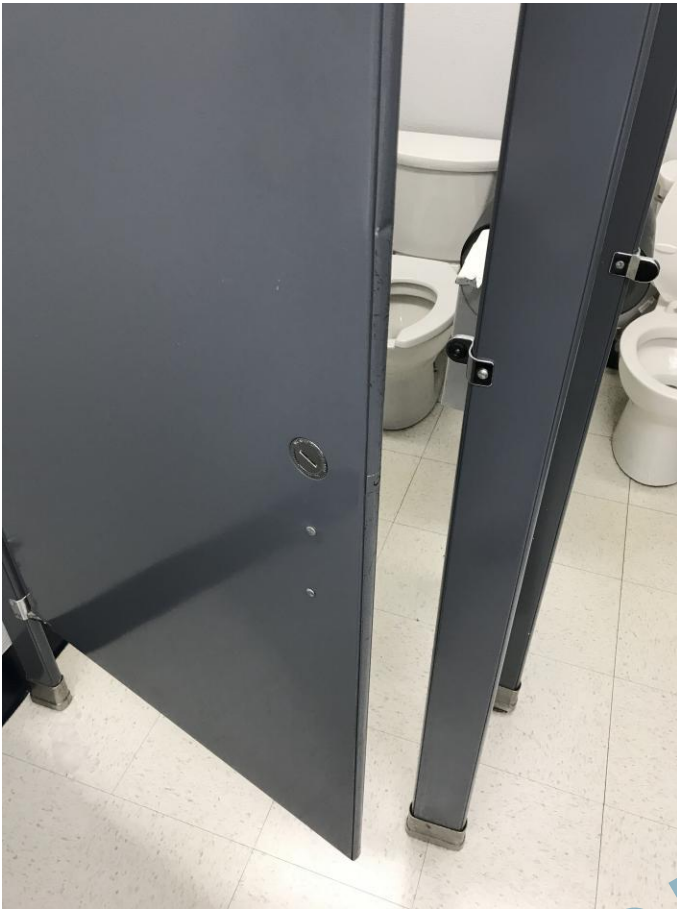
Finding 297215 Main Photo

The water closet compartment door is missing a loop handle on the outside.

Missing loop handle  
on the outside

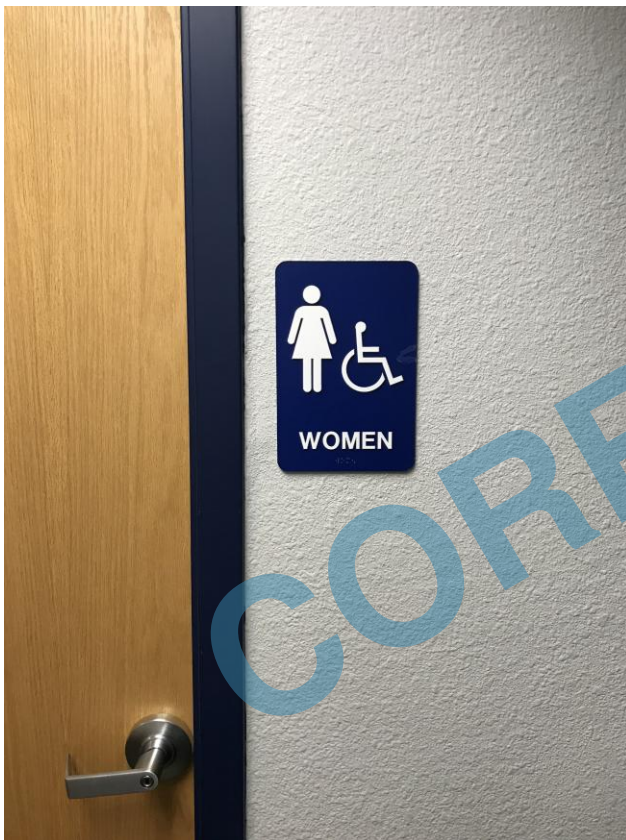
Finding 297219 Main Photo

**Compliant room identification signs are missing.**

**Missing unisex  
restroom signage**

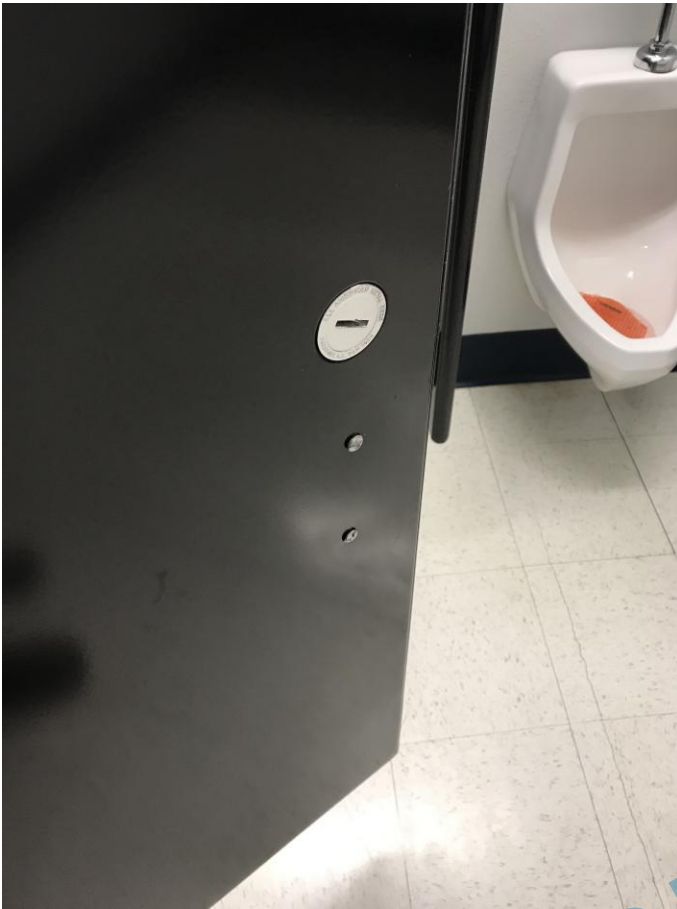
Finding 297193 Main Photo

The water closet compartment door is missing a loop handle on the outside.

Missing loop handle  
on outside of door

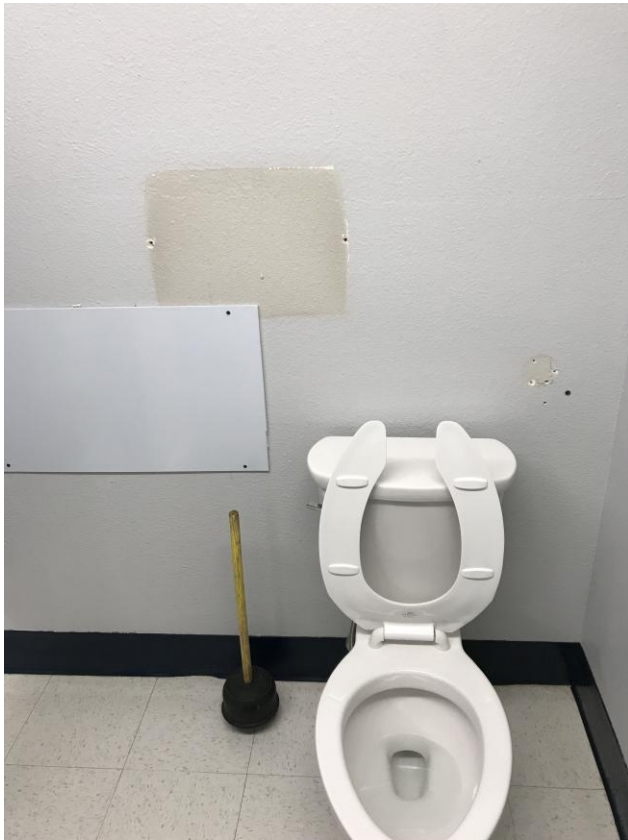
Finding 297220 Main Photo

The rear grab bar is missing.

Missing rear grab bar

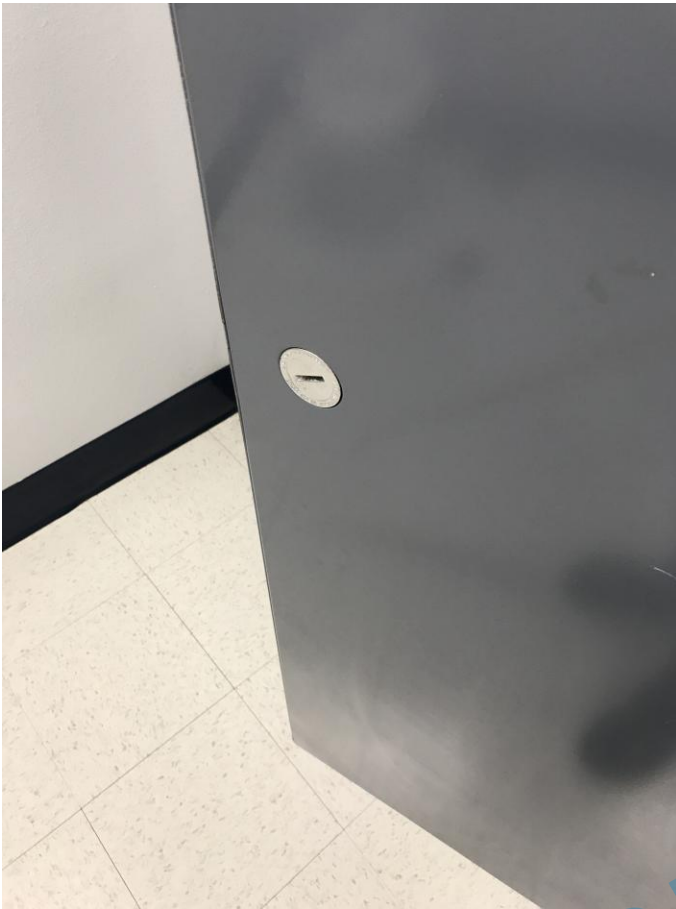
Finding 297223 Main Photo

The water closet compartment door is missing a loop handle on the outside.

Missing loop handle on the outside of compartment door
