Site Accessibility Evaluation

Palmer Lake Recreation Area

Accessibility Evaluation

Inspection Date: 03/10/2020

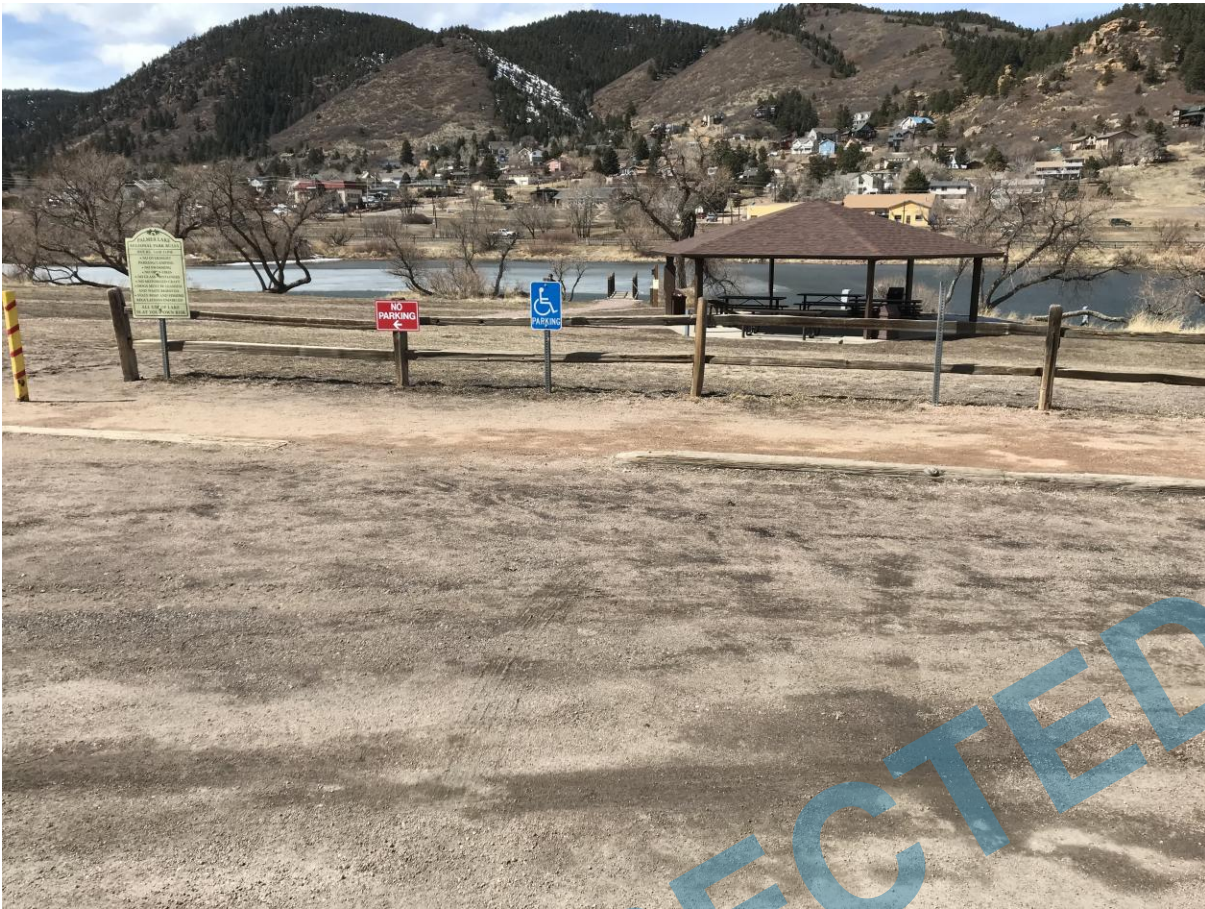
Finding 299219 Main Photo

The surfaces of the accessible parking spaces and access aisles are not firm, stable, and slip resistant.

Designated accessible parking stall surface is not firm, stable nor slip resistant

Construct 2 diagonal accessible parking stalls 8 feet wide with an access aisle also measuring 8 feet in width in either asphalt or concrete (recommended). The access aisle should connect to the path of travel leading up to the unisex restroom.

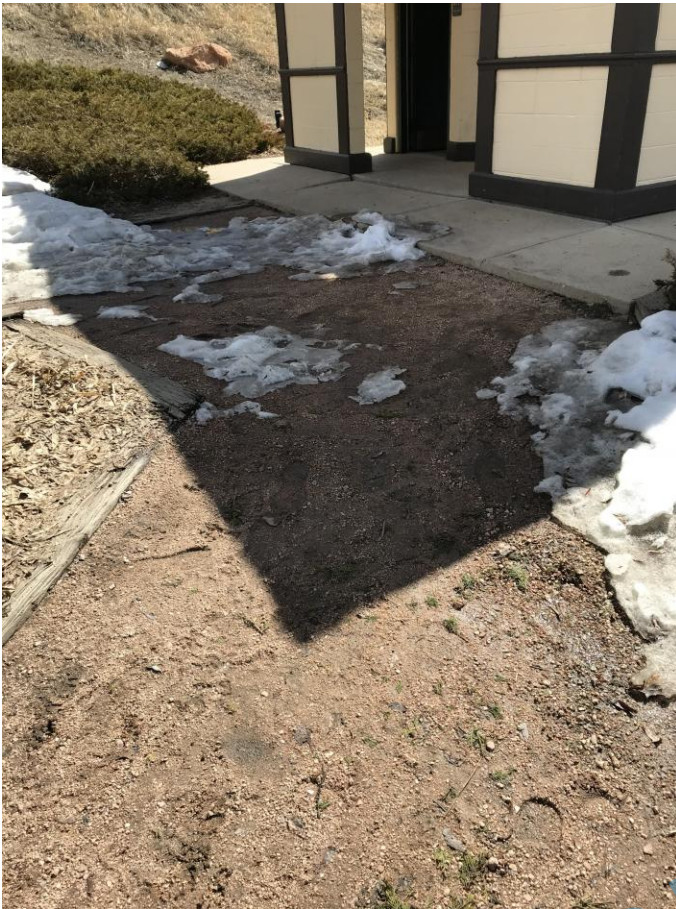
Finding #2 Additional Finding Photos

The public use restroom serving the facility is not on an accessible route.

Route to restroom consists of loose dirt, gravel and mud

Construct a path of travel that is firm, stable and slip resistant from the accessible parking stalls and access aisle up to the concrete sidewalk in front of the unisex restroom.

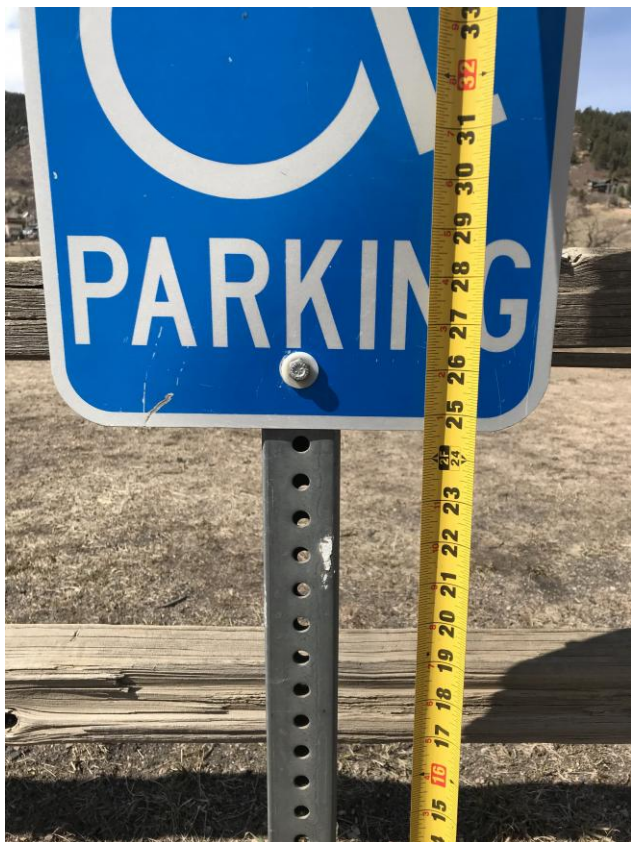
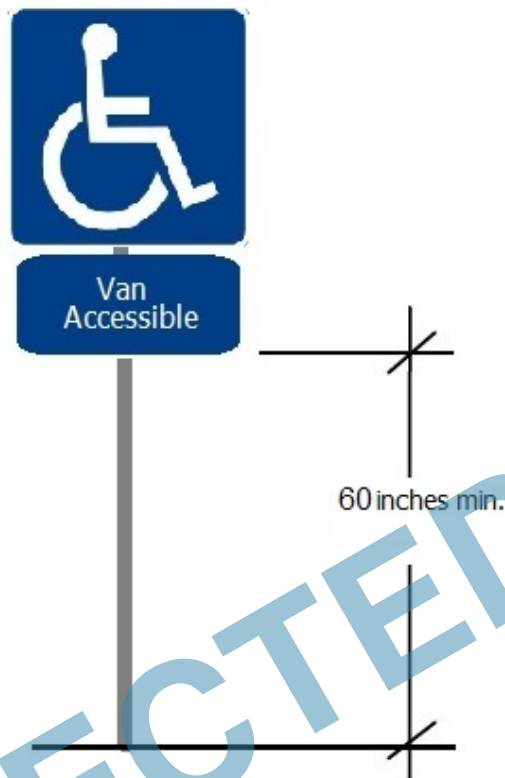
Finding #3 Continued

The parking sign is mounted too low.

24.5 inches above
ground surface

Raise ADA parking sign to measure 60 inches above ground surface measured from the bottom edge of the sign. Also, add "Van Accessible" sign below existing sign and ensure "Van Accessible" sign measures 60 inches minimum above the ground surface.

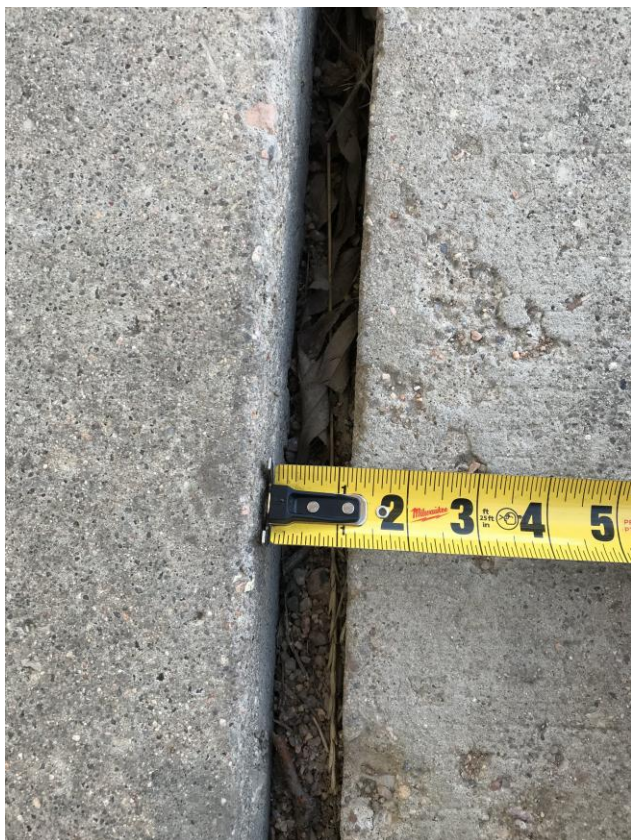
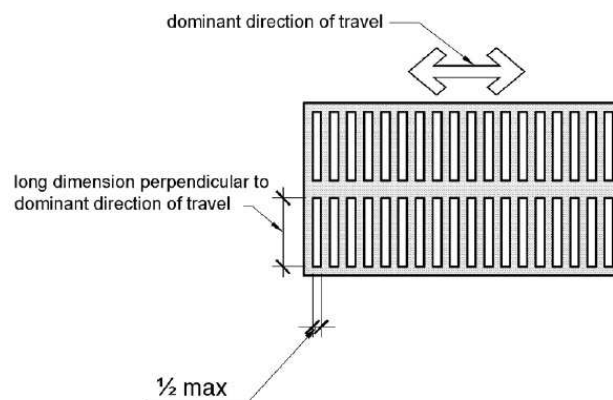
Finding #4 Continued

The concrete expansion joint is spaced greater than 1/2 inch.

Concrete expansion joint in front of bathroom is spaced at 1.25 inches

Fill in expansion joint or replace that section of concrete/sidewalk.

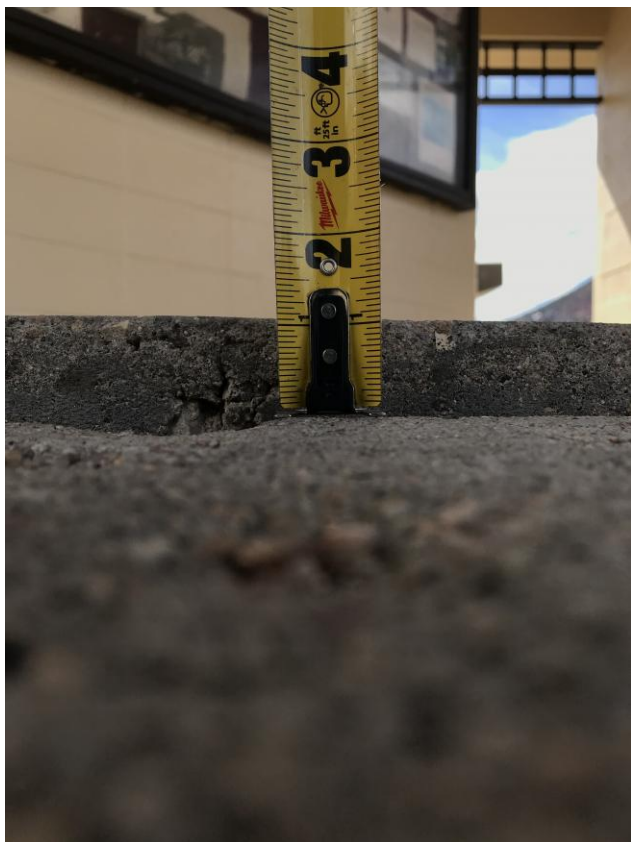
Finding #5 Continued

The walkway contains abrupt vertical edges and/or variations over a 1/4 inch.

Walkway contains a 1 inch abrupt vertical change

Shave concrete edge down to 1/4 of an inch, 1/2 inch beveled, or pump/lift, or replace section of concrete/sidewalk.

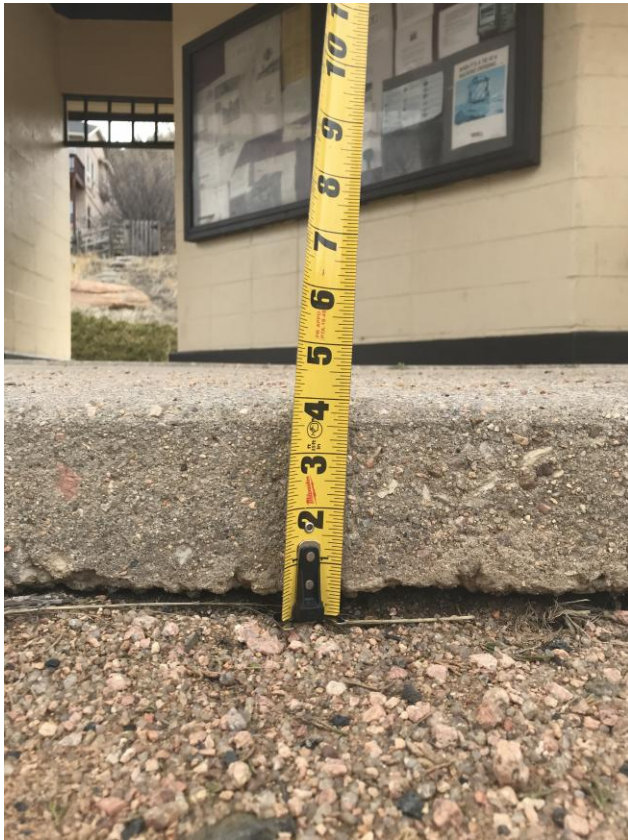
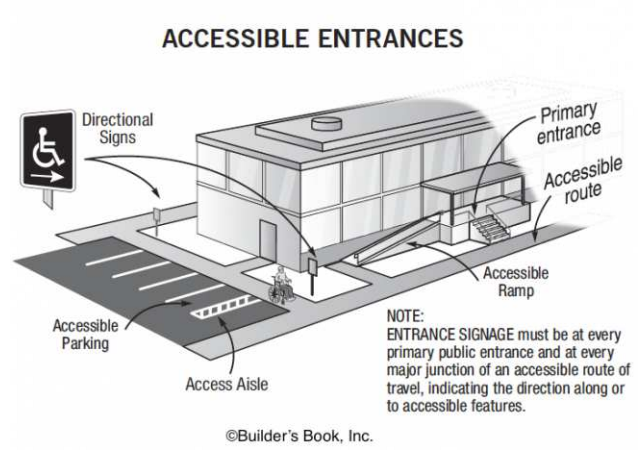
Finding #6 Continued

There is no accessible route of travel from the public way.

Gravel route to restroom obstructed by 3 to 4 inches of concrete sidewalk

Construct asphalt or concrete accessible route from parking stall/s to restroom.

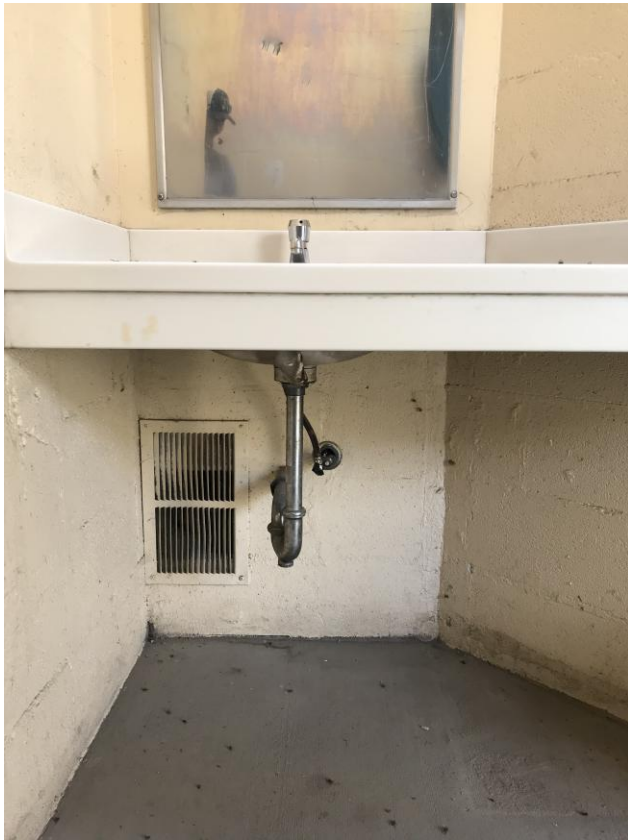
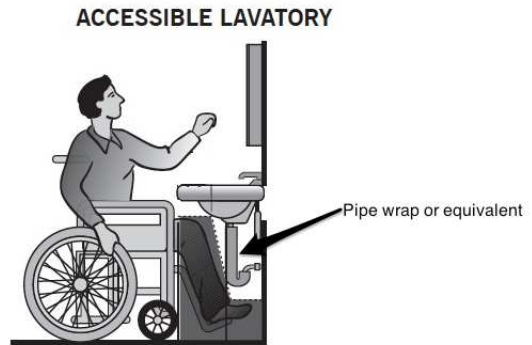
Finding #7 Continued

The water and drain pipes under the lavatory are not adequately insulated.

Pipe insulation
missing

Insulate drainpipes underneath lavatory.

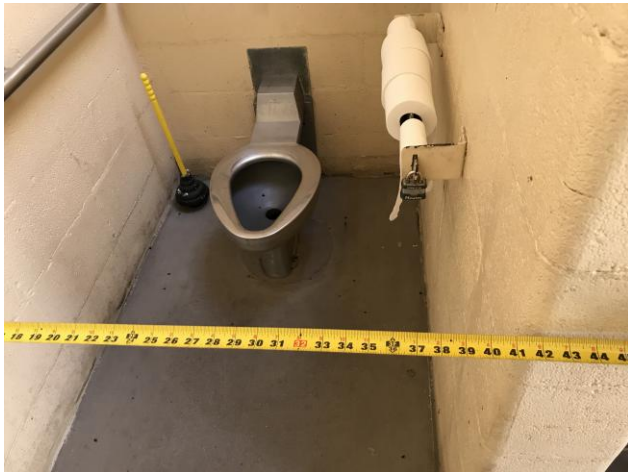
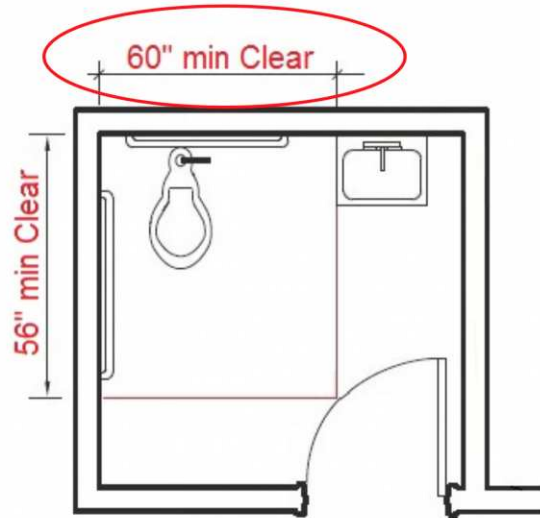
Finding #8 Continued

The width of the toilet room is too narrow.

41 inches in width

Remodel will be required for restroom to meet width clearance. A remodel will meet the current ADA Standards.

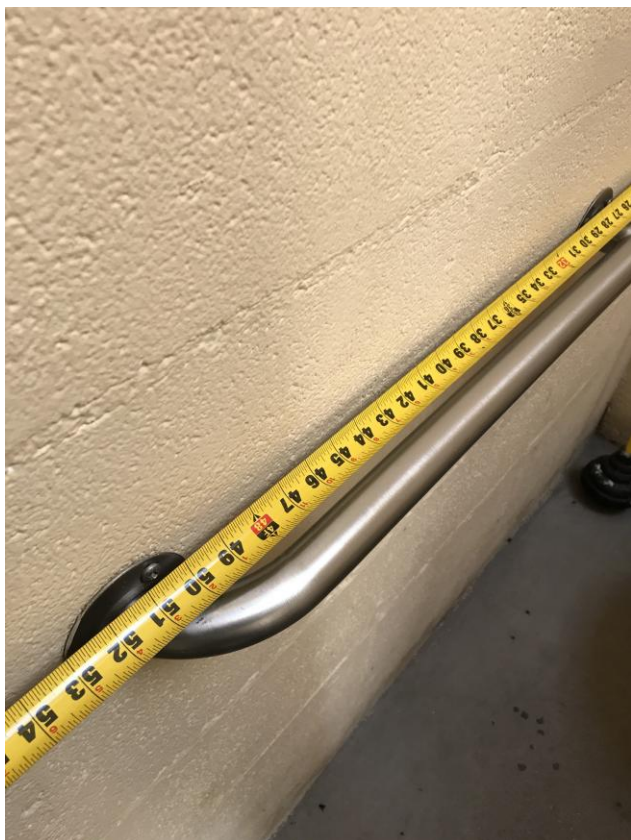
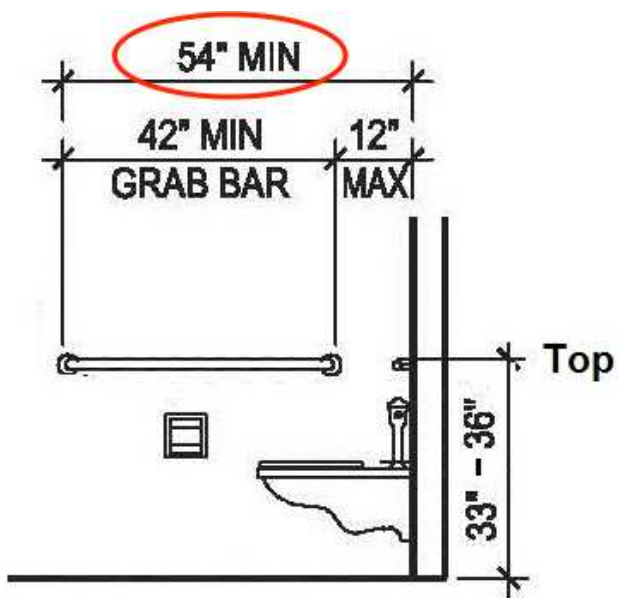
Finding #9 Continued

The side grab bar does not extend far enough from the rear wall.

51.25 inches from rear wall

Adjust one side of the grab bar not to exceed 12 inches from rear wall measured to the centerline of the grab bar. The side grab bar must be 42 inches minimum in length and extend at least 54 inches minimum beyond the rear wall.

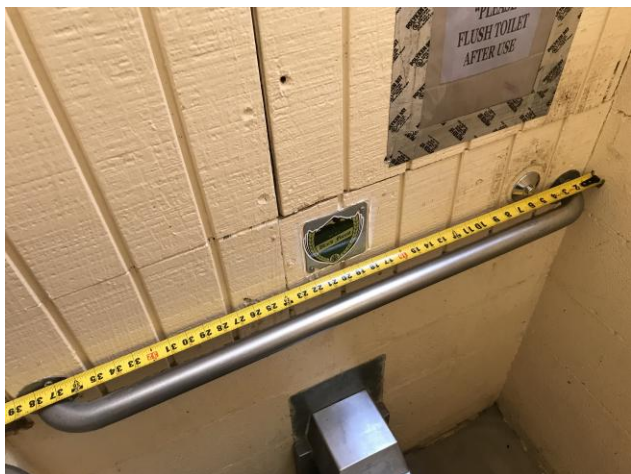
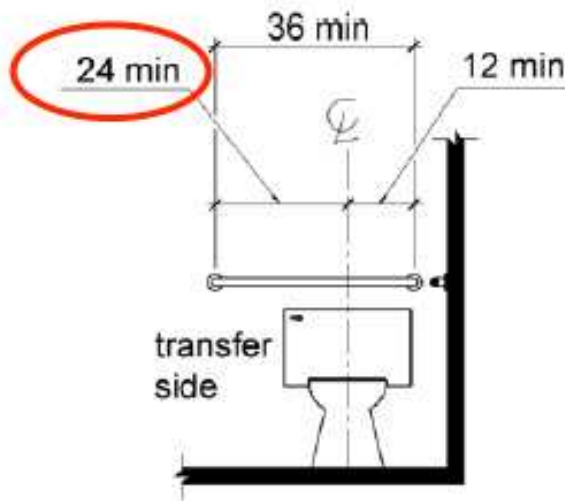
Finding #10 Continued

The rear grab bar does not extend adequately past the toilet on the wide side.

19 inches from the side wall

Due to pre-existing conditions, the rear grab bar will not meet current ADA compliance but it's considered compliant due to structural barrier. Once a remodel of the restroom is complete, rear grab bar shall meet or exceed current ADA Standards.

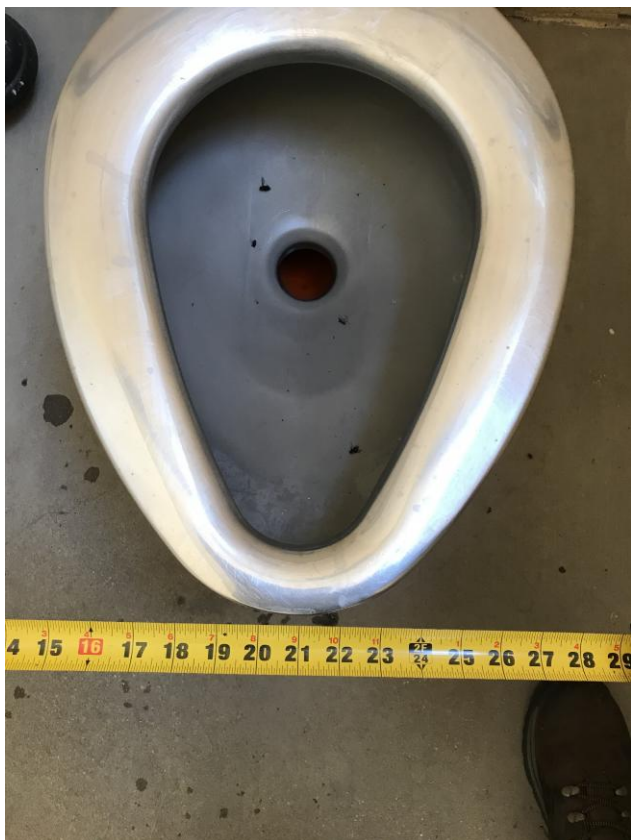
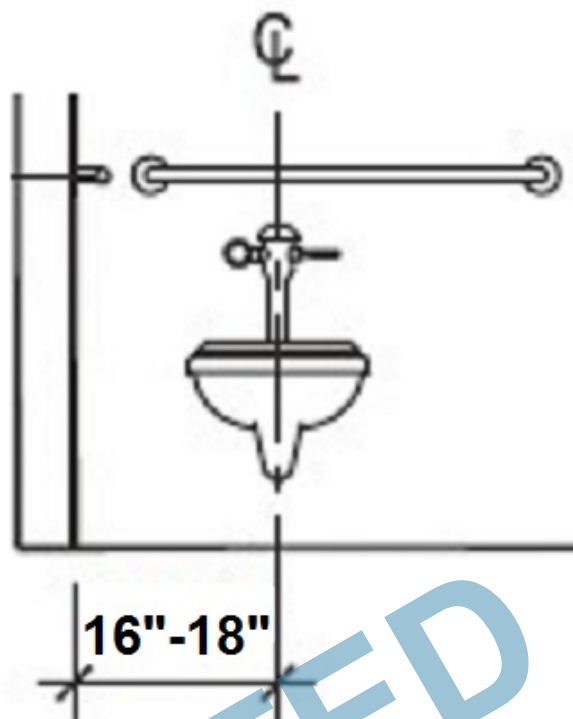
Finding #11 Continued

The toilet is not located within the range allowed from the side wall or partition.

21 inches from side wall

Re-position toilet between 16 inches minimum and 18 inches maximum from centerline of toilet to side wall. May require plumbing alteration.

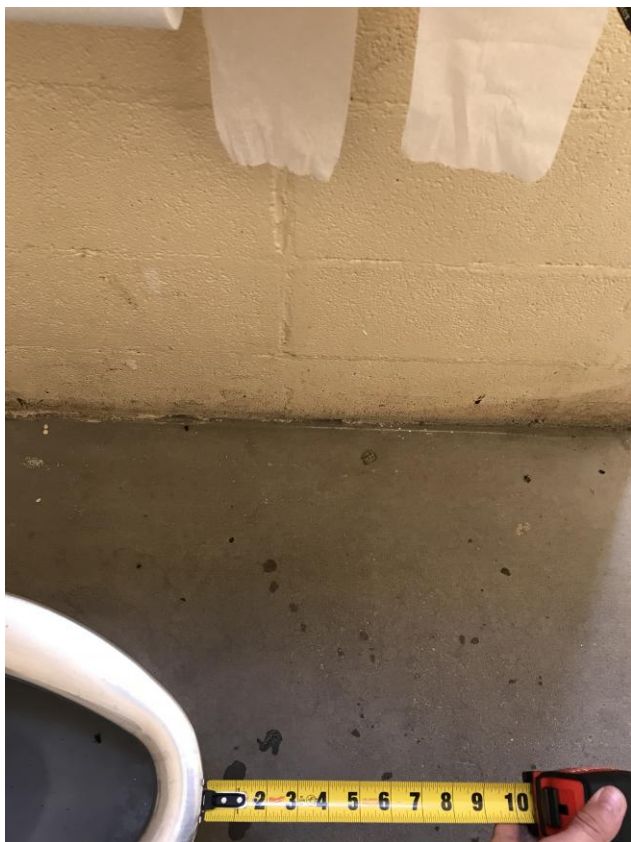
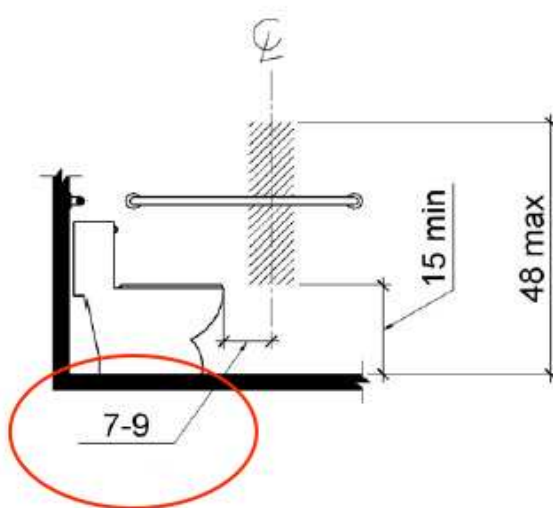
Finding #12 Continued

The toilet paper is not installed within the compliant range in front of the toilet.

5 inches from front of toilet

Re-position toilet paper dispenser to be within 7 inches minimum to 9 inches maximum in front of the toilet measured to the centerline of the dispenser.

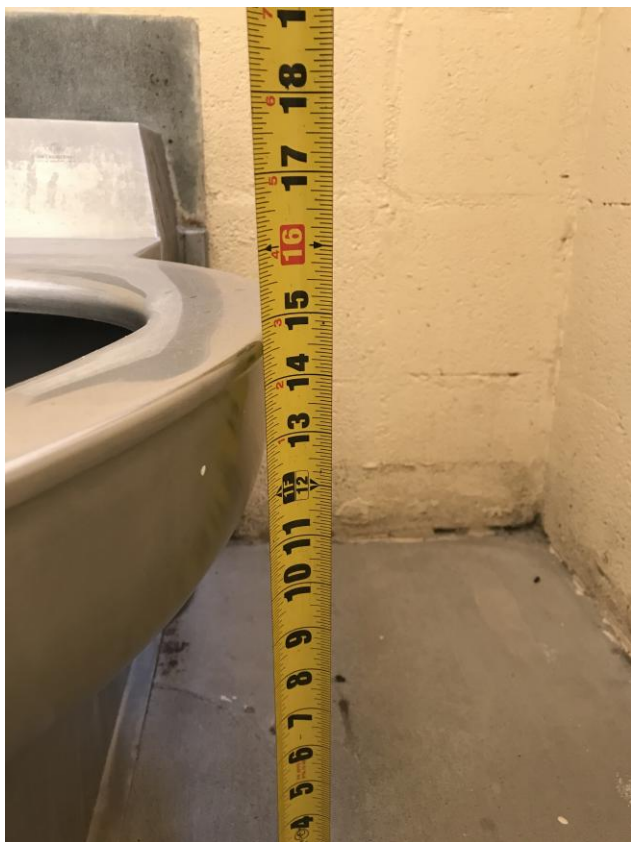
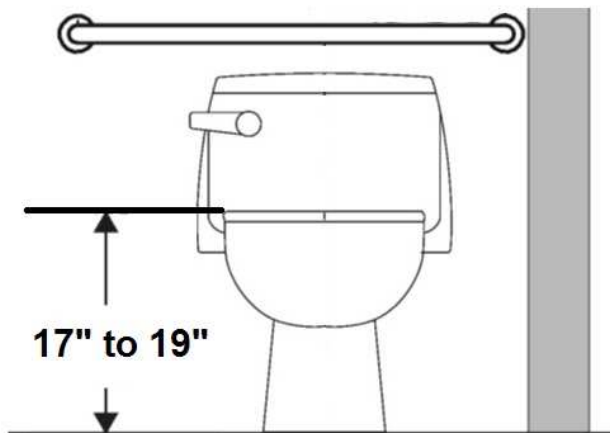
Finding #13 Continued

The toilet seat is not located within the range allowed off the floor.

14.75 inches above
finished floor

Adjust toilet height, replace toilet or replace toilet seat with one that will meet the minimum height of 17 inches but no more than maximum height of 19 inches.
