Site Accessibility Evaluation

Sahwatch Parking Garage

**255 Sahwatch St
Colorado Springs, CO
80903**

Accessibility Evaluation

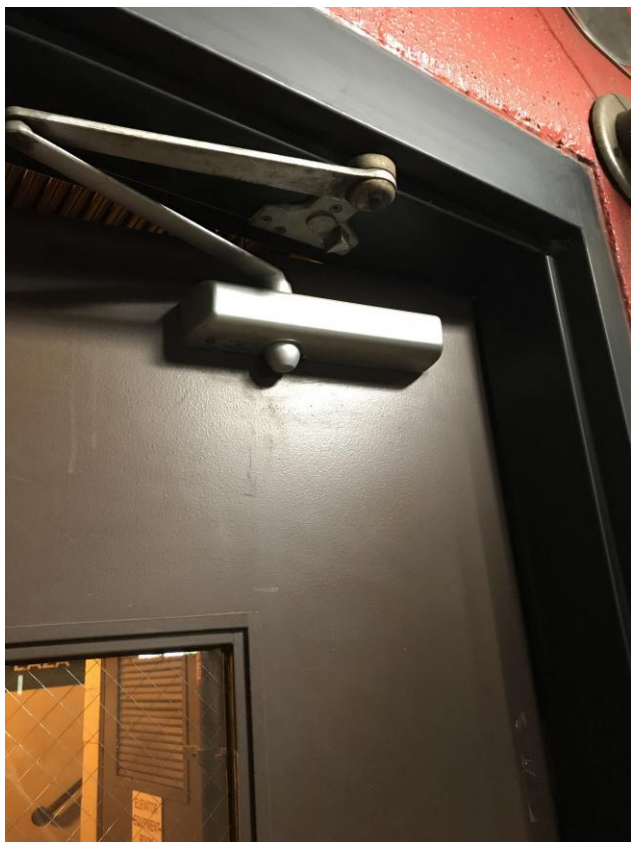
Finding 297982 Main Photo

The door is equipped with a door closer and returns to a closed position too quickly.

2010 ADAS Section 404.2.8.1

2.5 seconds to closed position

Adjust door closer to allow a minimum of 5 seconds before returning to a position of 12 degrees from the latch/locking mechanism.

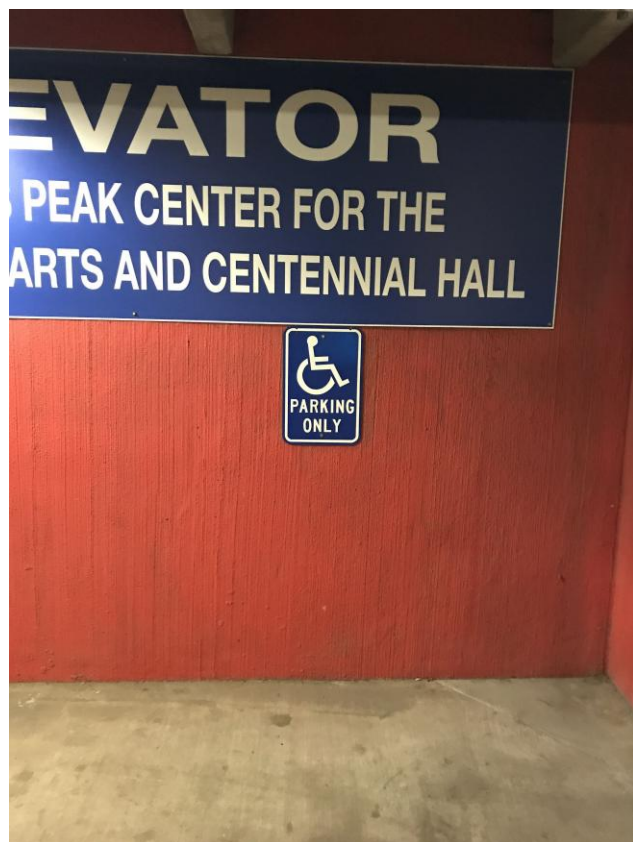
Finding 297983 Main Photo

The van stall is missing a sign identifying it as a van accessible stall.

2010 ADAS Section 502.6

Van accessible sign missing

Replace existing sign with ISA sign that also includes "Van Accessible" verbiage.

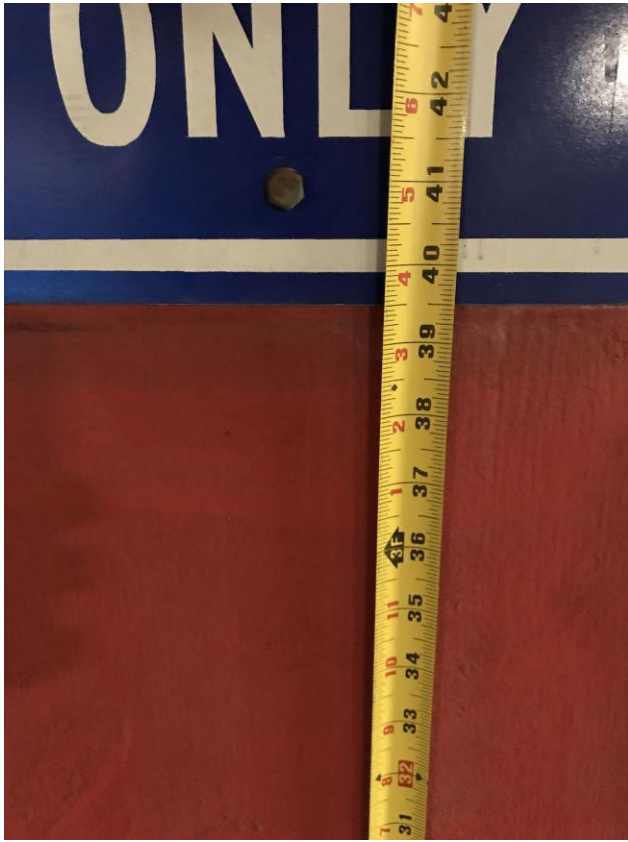
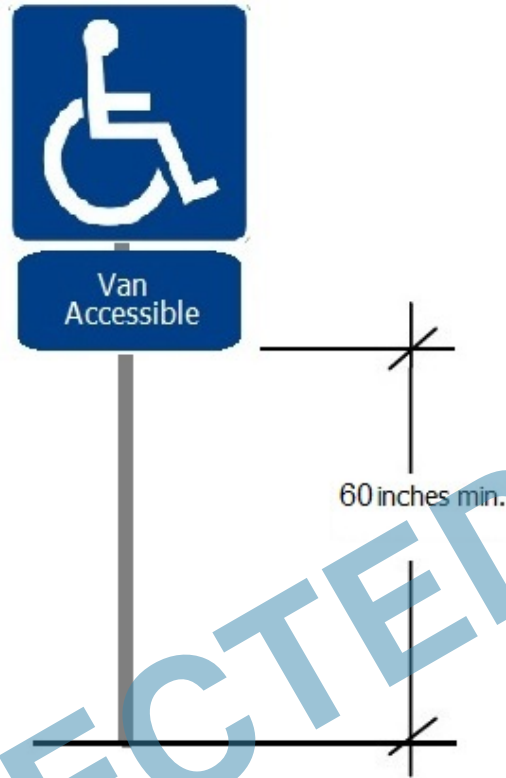
Finding 297984 Main Photo

The parking sign is mounted too low.

2010 ADAS Section 502.6

39.5 inches above
finished floor

Ensure new ISA van sign is placed no lower than 60 inches minimum measured from the bottom edge of the sign above the finished floor.

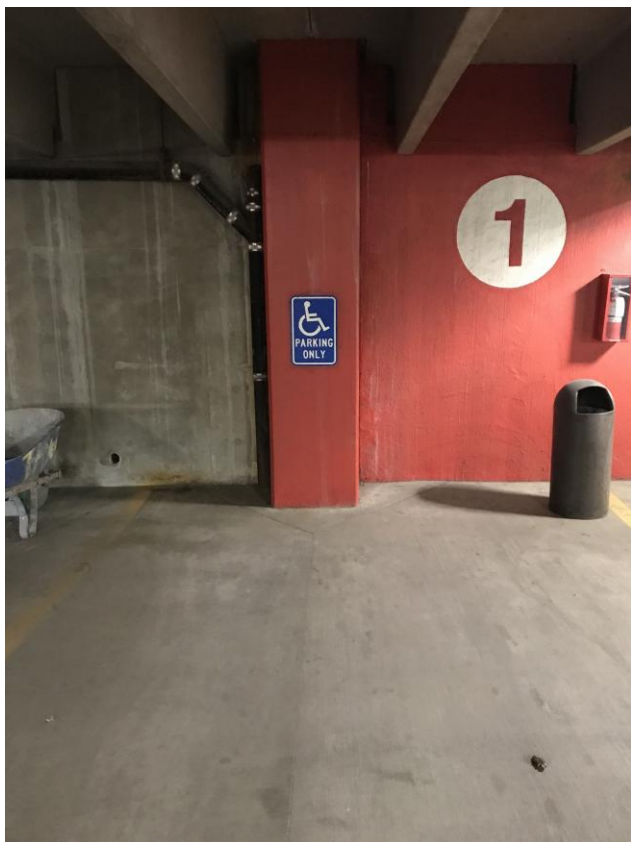
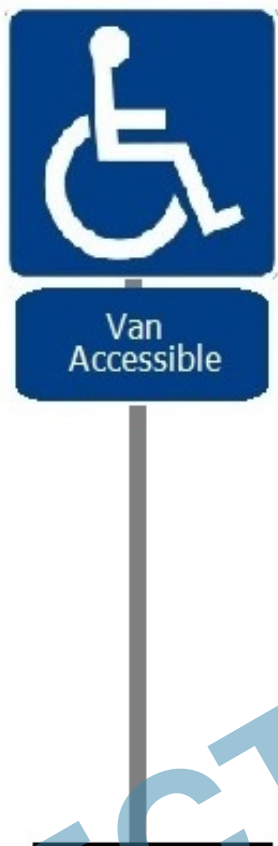
Finding 297985 Main Photo

The van stall is missing a sign identifying it as a van accessible stall.

2010 ADAS Section 502.6

Van accessible sign missing

Replace existing sign with ISA sign that also includes "Van Accessible" verbiage.

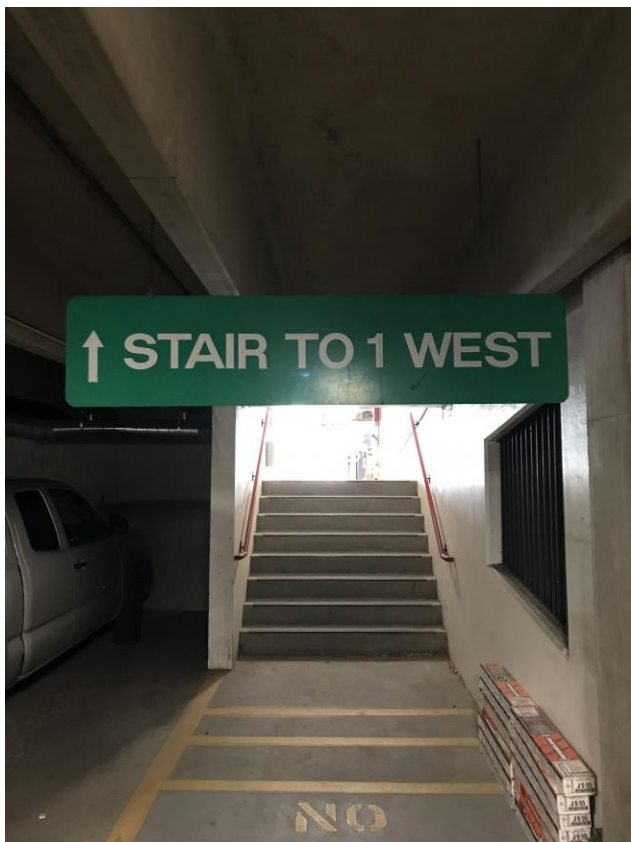
Finding 297987 Main Photo

The “Stair to 1 West” overhanging sign extends down too close to the route of travel.

2010 ADAS Section 307.4

75.5 inches above
finished floor

Adjust overhanging sign to provide a minimum of 80 inches above the walking surface measured from the bottom edge of the sign.

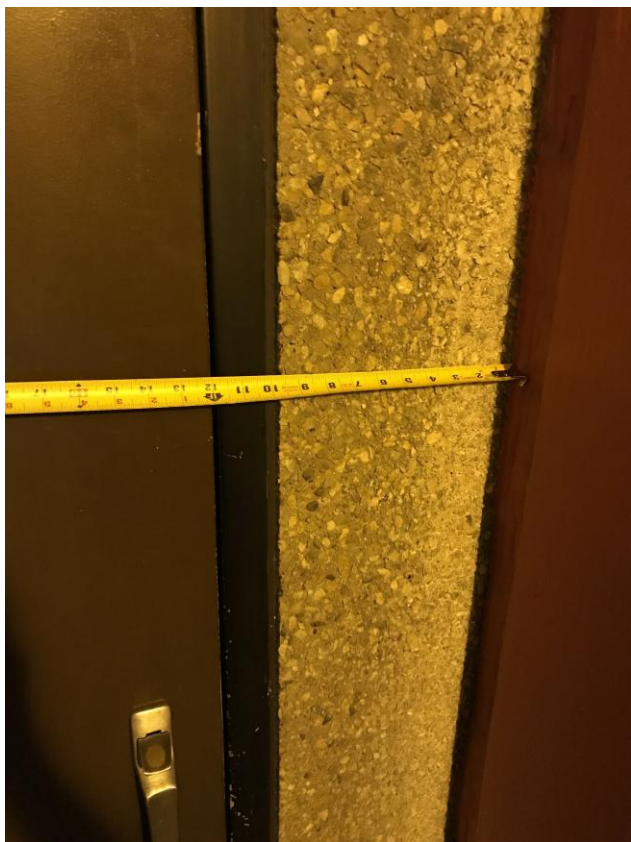
Finding 297988 Main Photo

The maneuvering clearance on the pull side of the door extends less than 18 inches beyond the latch side of the door.

2010 ADAS Section 404.2.4.1

12 inches of maneuvering space on the pull side

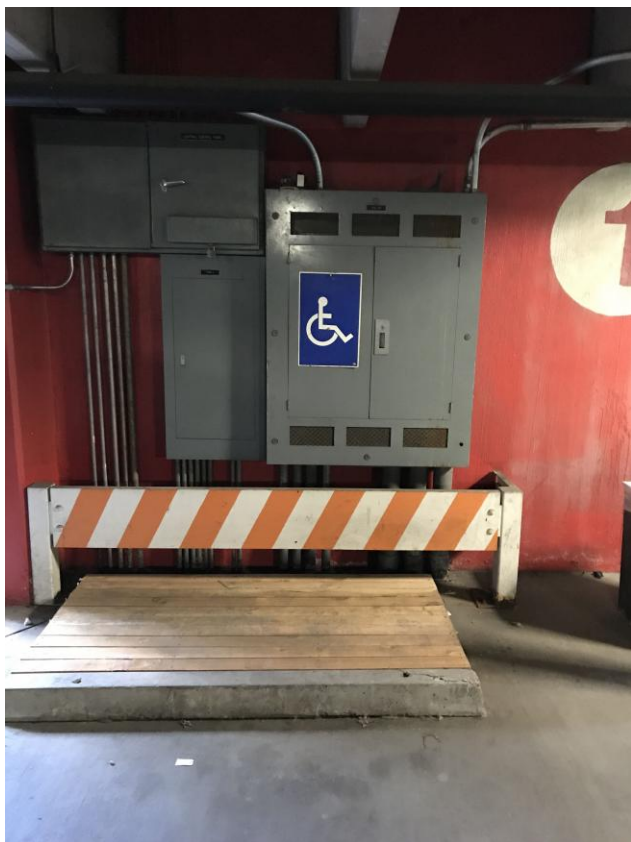
Finding 297989 Main Photo

The van stall is missing a sign identifying it as a van accessible stall.

2010 ADAS Section 502.6

Van accessible sign missing

Replace existing sign with ISA sign that also includes "Van Accessible" verbiage.

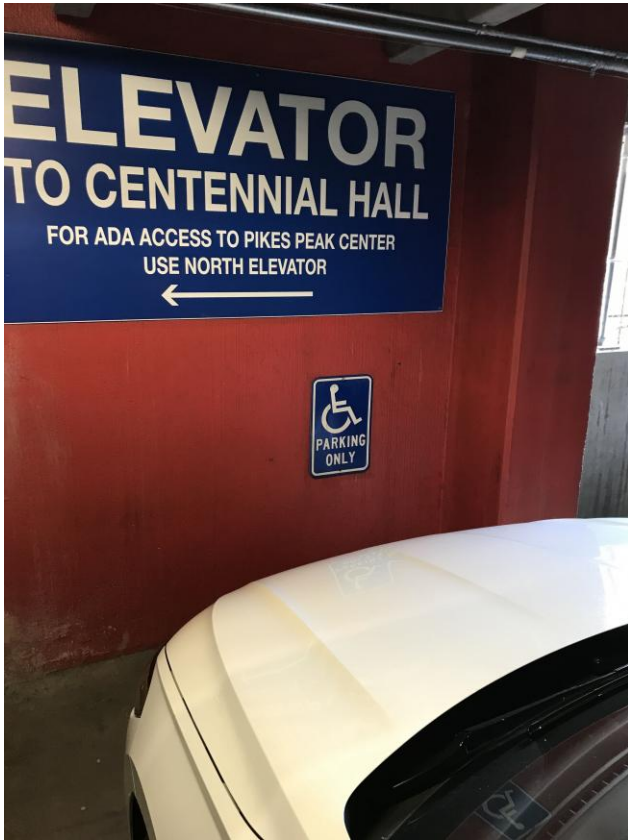
Finding 297990 Main Photo

The van stall is missing a sign identifying it as a van accessible stall.

2010 ADAS Section 502.6

Van accessible sign missing

Replace existing sign with ISA sign that also includes "Van Accessible" verbiage.

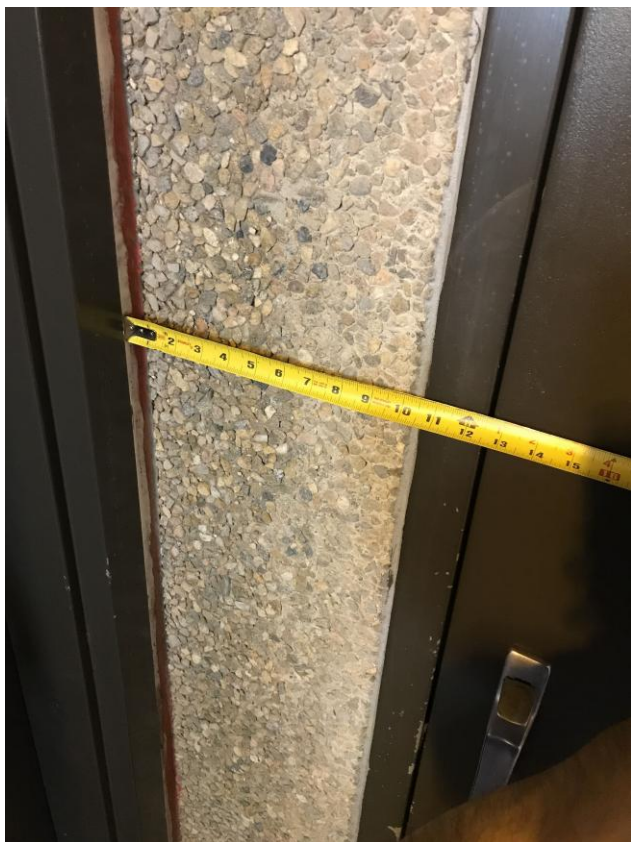
Finding 297991 Main Photo

The landing on the pull side of the door extends less than 18 inches on the latch side.

2010 ADAS Section 404.2.4.1

12 inches of
maneuvering space on
the pull side

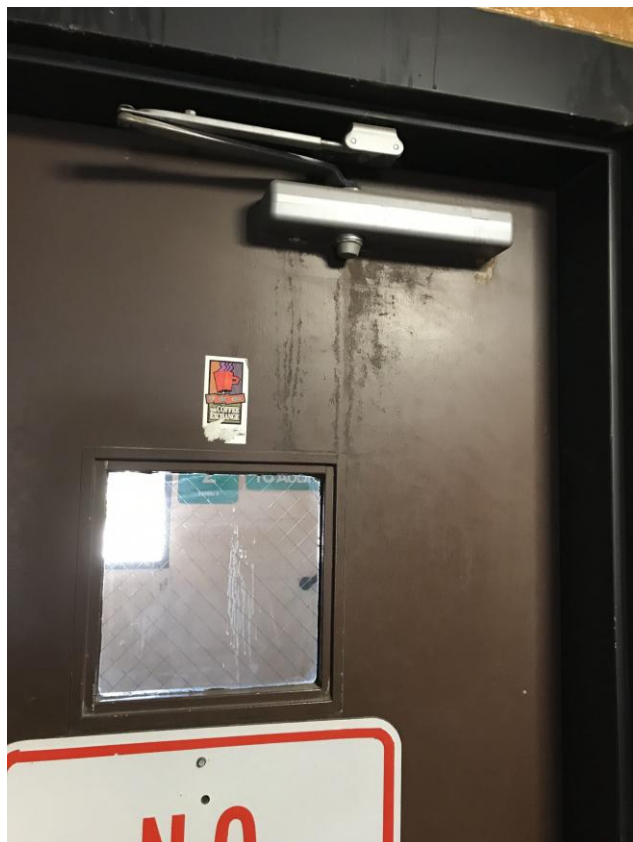
Finding 297992 Main Photo

The door is equipped with a door closer and returns to a closed position too quickly.

2010 ADAS Section 404.2.8.1

3.63 seconds to closed position

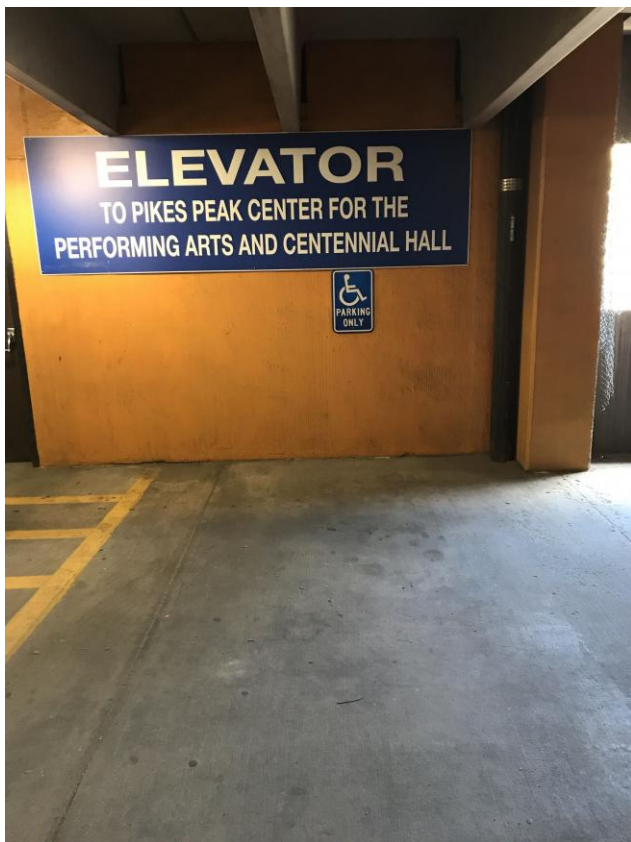
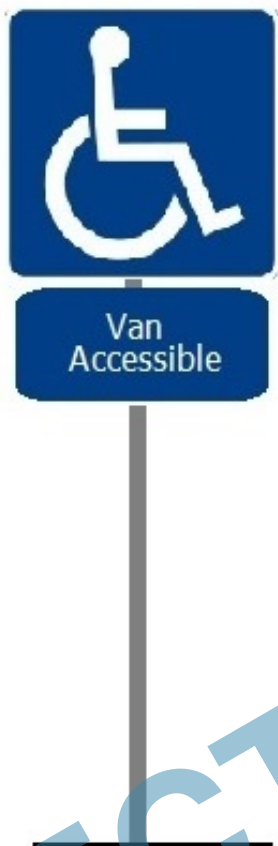
Finding 297993 Main Photo

The van stall is missing a sign identifying it as a van accessible stall.

Van accessible sign missing

Replace existing sign with ISA sign that also includes "Van Accessible" verbiage.

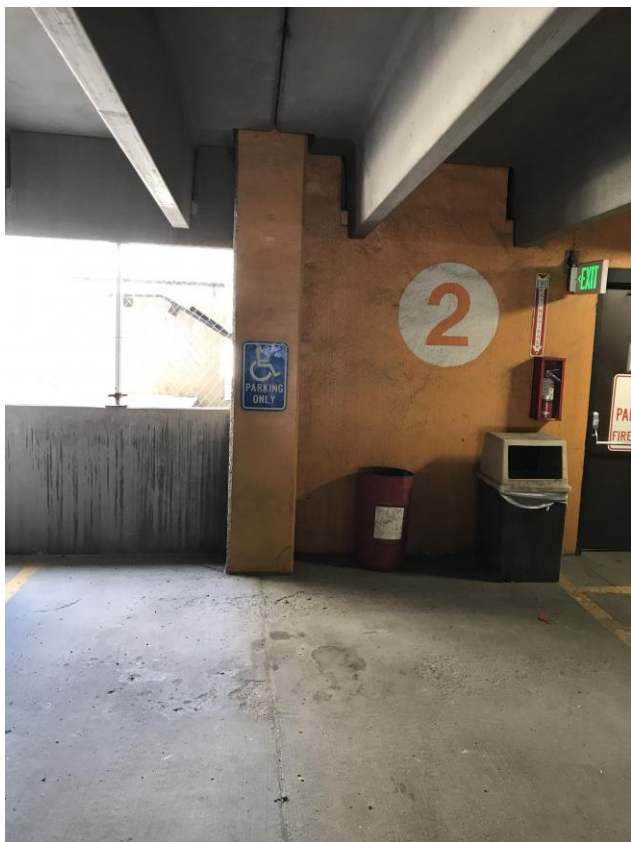
Finding 297994 Main Photo

The van stall is missing a sign identifying it as a van accessible stall.

Van accessible sign missing

Replace existing sign with ISA sign that also includes "Van Accessible" verbiage.

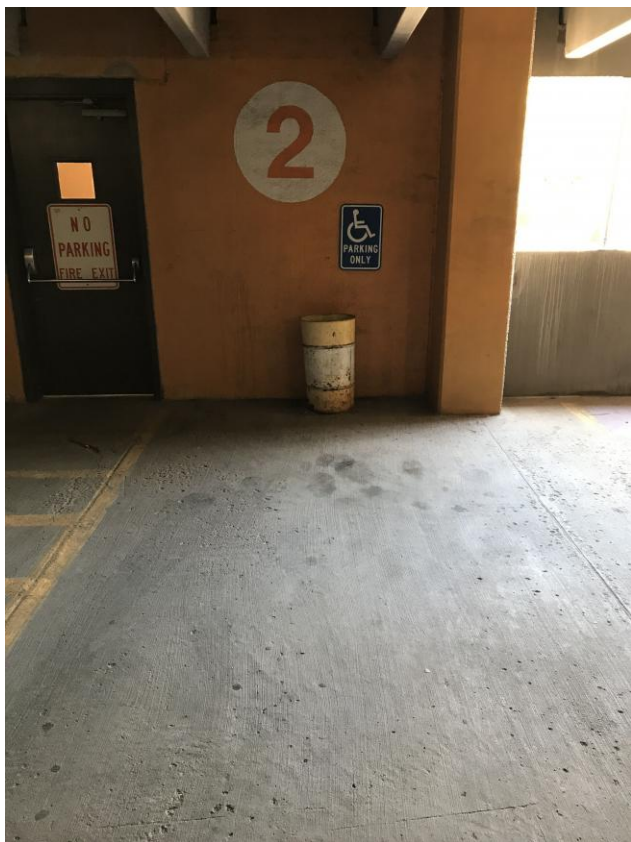
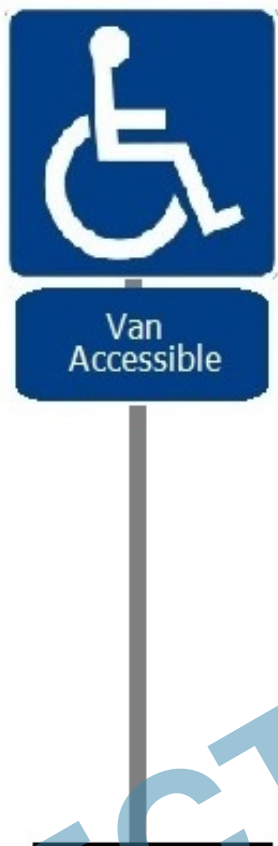
Finding 298017 Main Photo

The van stall is missing a sign identifying it as a van accessible stall.

Van accessible sign missing

Replace existing sign with ISA sign that also includes "Van Accessible" verbiage.

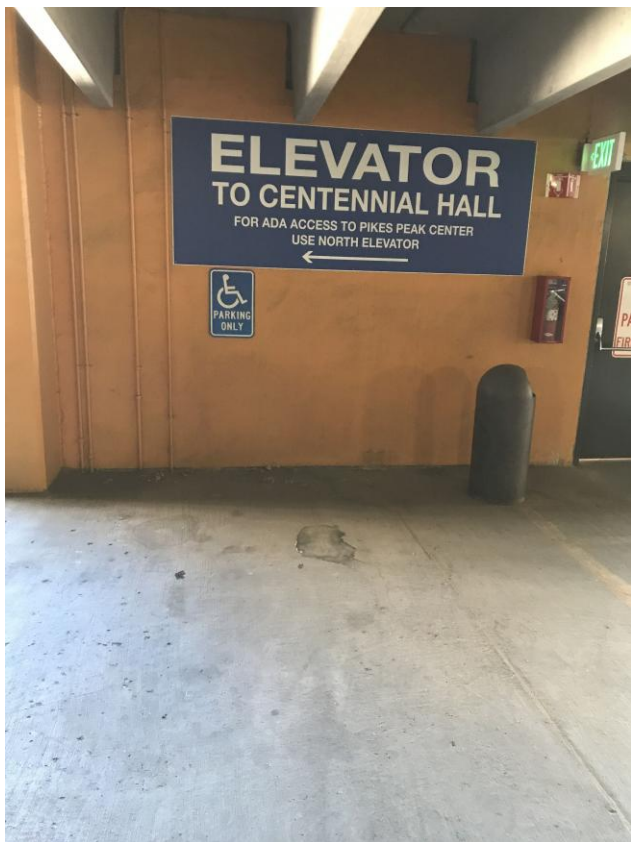
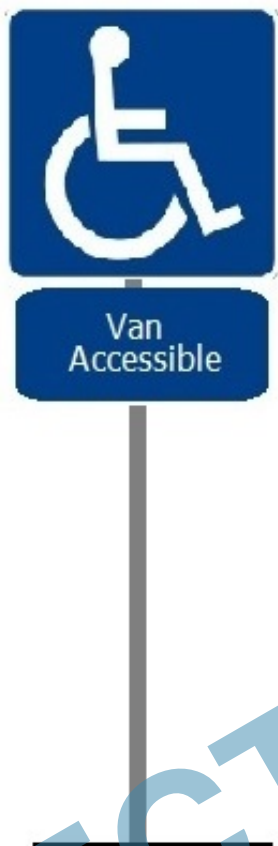
Finding 298019 Main Photo

The van stall is missing a sign identifying it as a van accessible stall.

Van accessible sign missing

Replace existing sign with ISA sign that also includes "Van Accessible" verbiage.

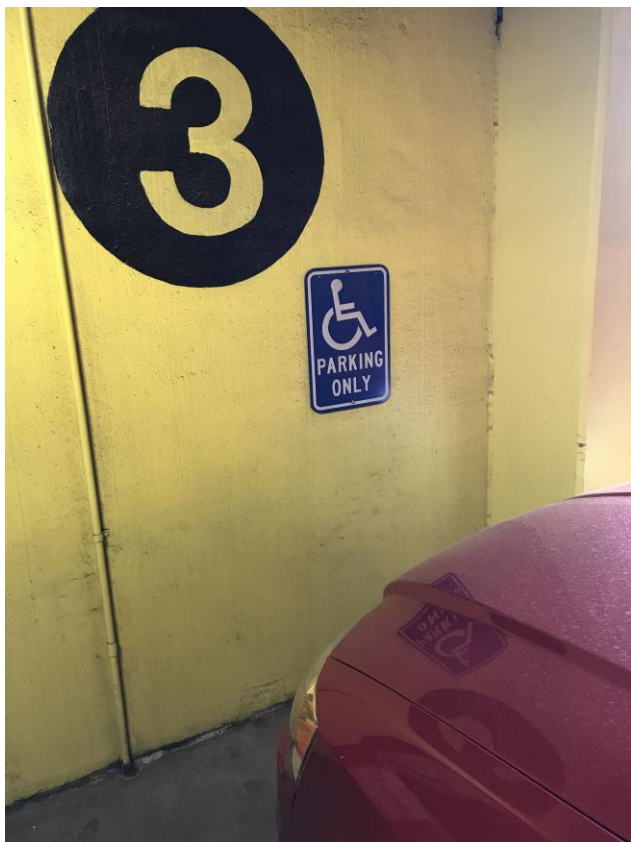
Finding 298022 Main Photo

The van stall is missing a sign identifying it as a van accessible stall.

Van accessible sign missing

Replace existing sign with ISA sign that also includes "Van Accessible" verbiage.

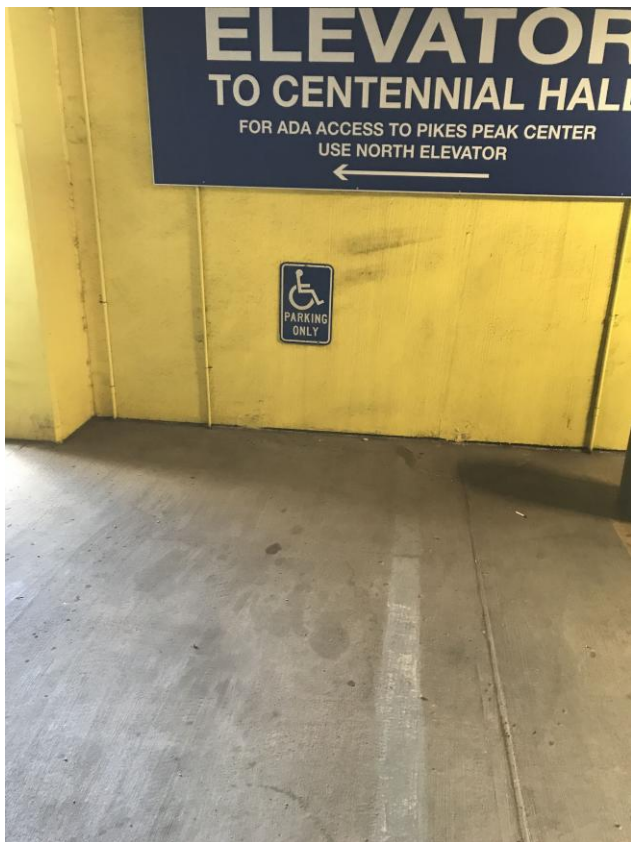
Finding 298023 Main Photo

The van stall is missing a sign identifying it as a van accessible stall.

Van accessible sign missing

Replace existing sign with ISA sign that also includes "Van Accessible" verbiage.

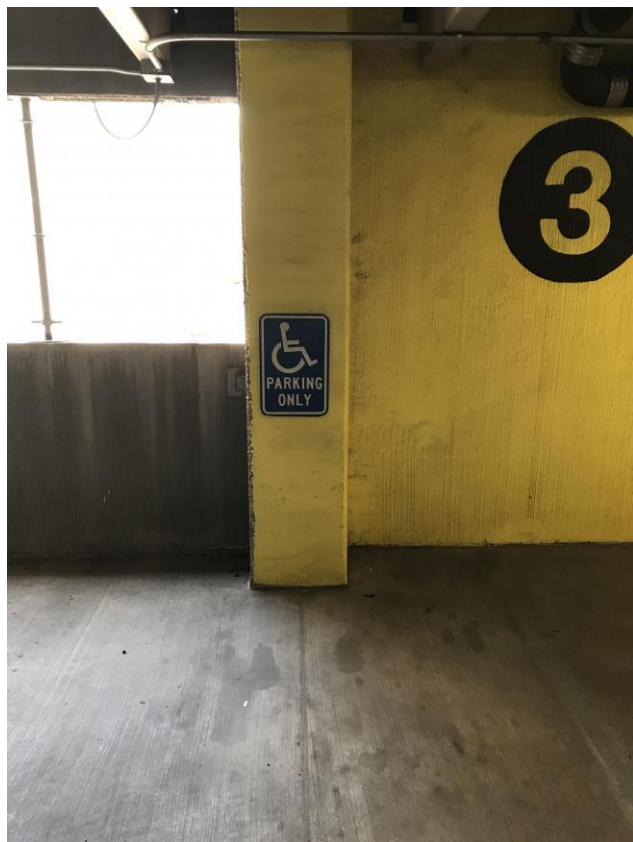
Finding 298027 Main Photo

The van stall is missing a sign identifying it as a van accessible stall.

Van accessible sign missing

Replace existing sign with ISA sign that also includes "Van Accessible" verbiage.

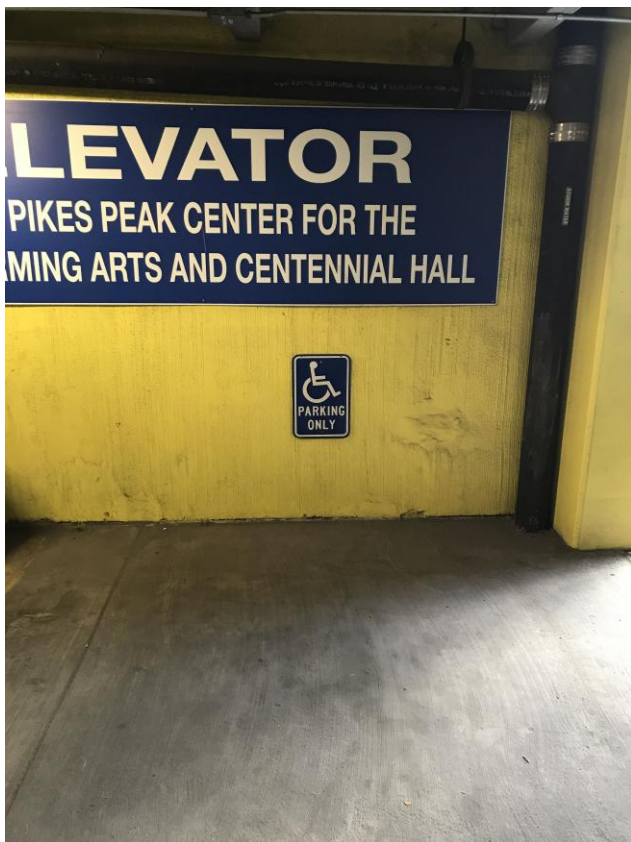
Finding 298028 Main Photo

The van stall is missing a sign identifying it as a van accessible stall.

Van accessible sign missing

Replace existing sign with ISA sign that also includes "Van Accessible" verbiage.

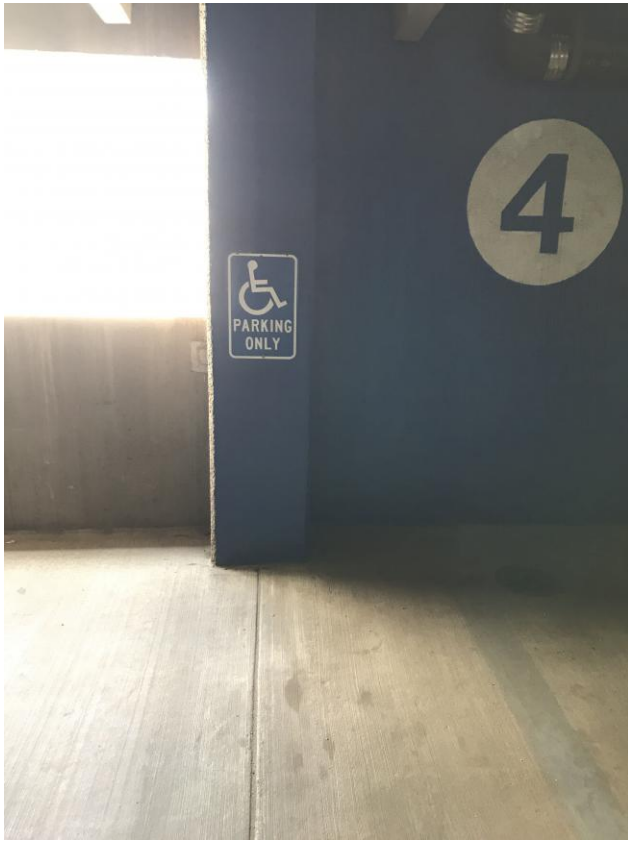
Finding 298032 Main Photo

The van stall is missing a sign identifying it as a van accessible stall.

Van accessible sign missing

Replace existing sign with ISA sign that also includes "Van Accessible" verbiage.

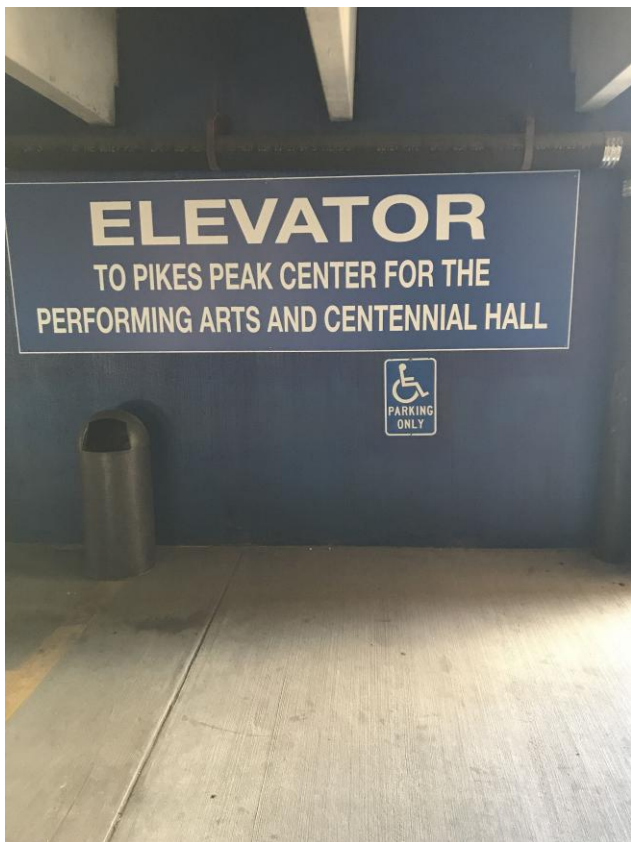
Finding 298033 Main Photo

The van stall is missing a sign identifying it as a van accessible stall.

Van accessible sign missing

Replace existing sign with ISA sign that also includes "Van Accessible" verbiage.

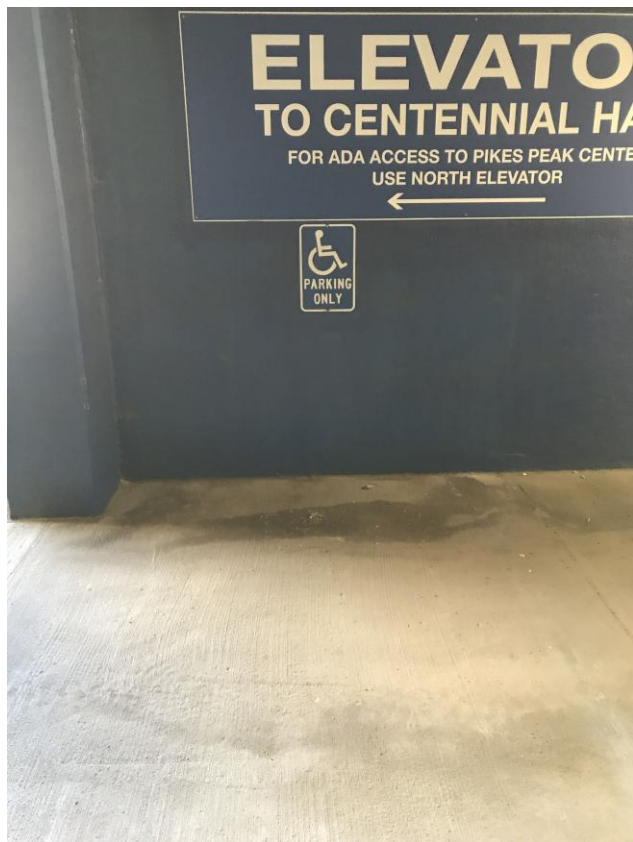
Finding 298038 Main Photo

The van stall is missing a sign identifying it as a van accessible stall.

Van accessible sign missing

Replace existing sign with ISA sign that also includes "Van Accessible" verbiage.

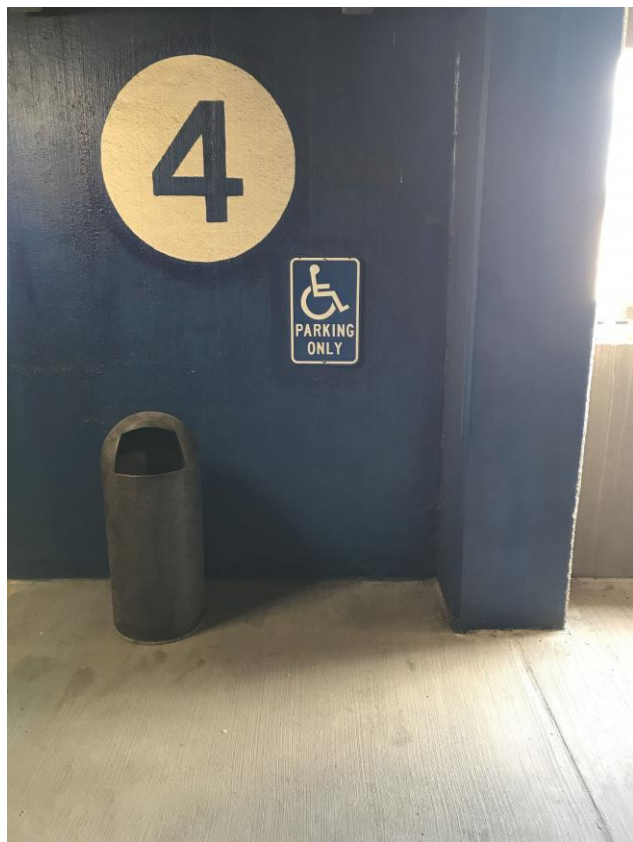
Finding 298039 Main Photo

The van stall is missing a sign identifying it as a van accessible stall.

Van accessible sign missing

Replace existing sign with ISA sign that also includes "Van Accessible" verbiage.

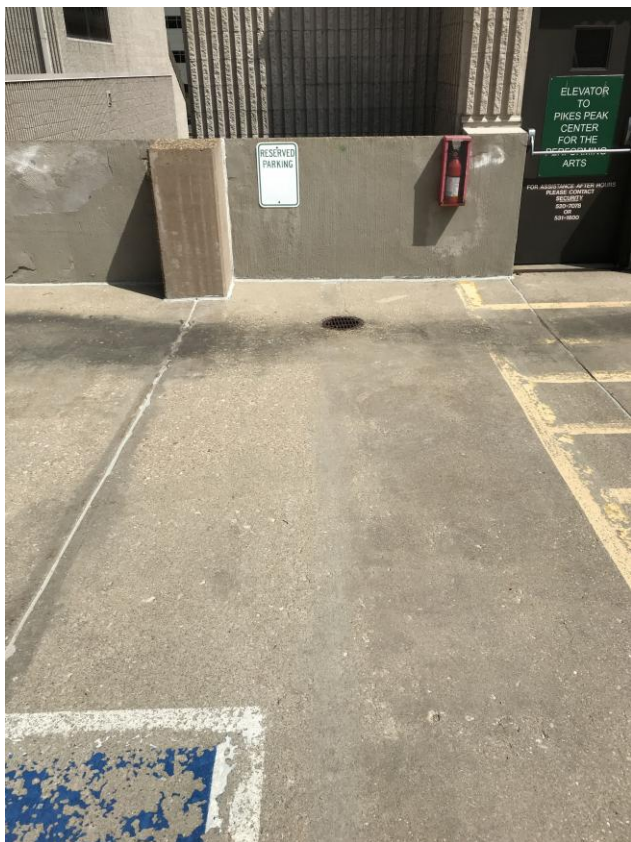
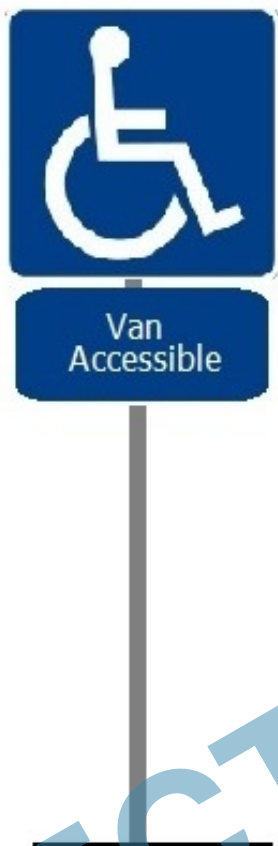
Finding 298043 Main Photo

The van stall is missing a sign identifying it as a van accessible stall.

Van accessible sign missing

Replace existing sign with ISA sign that also includes "Van Accessible" verbiage.

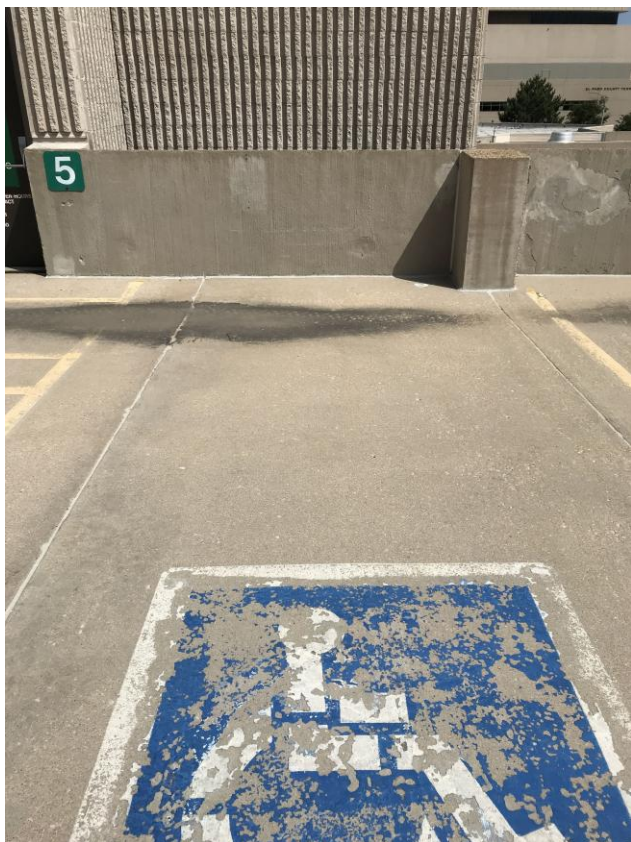
Finding 298044 Main Photo

The van stall is missing a sign identifying it as a van accessible stall.

Van accessible sign missing

Replace existing sign with ISA sign that also includes "Van Accessible" verbiage.

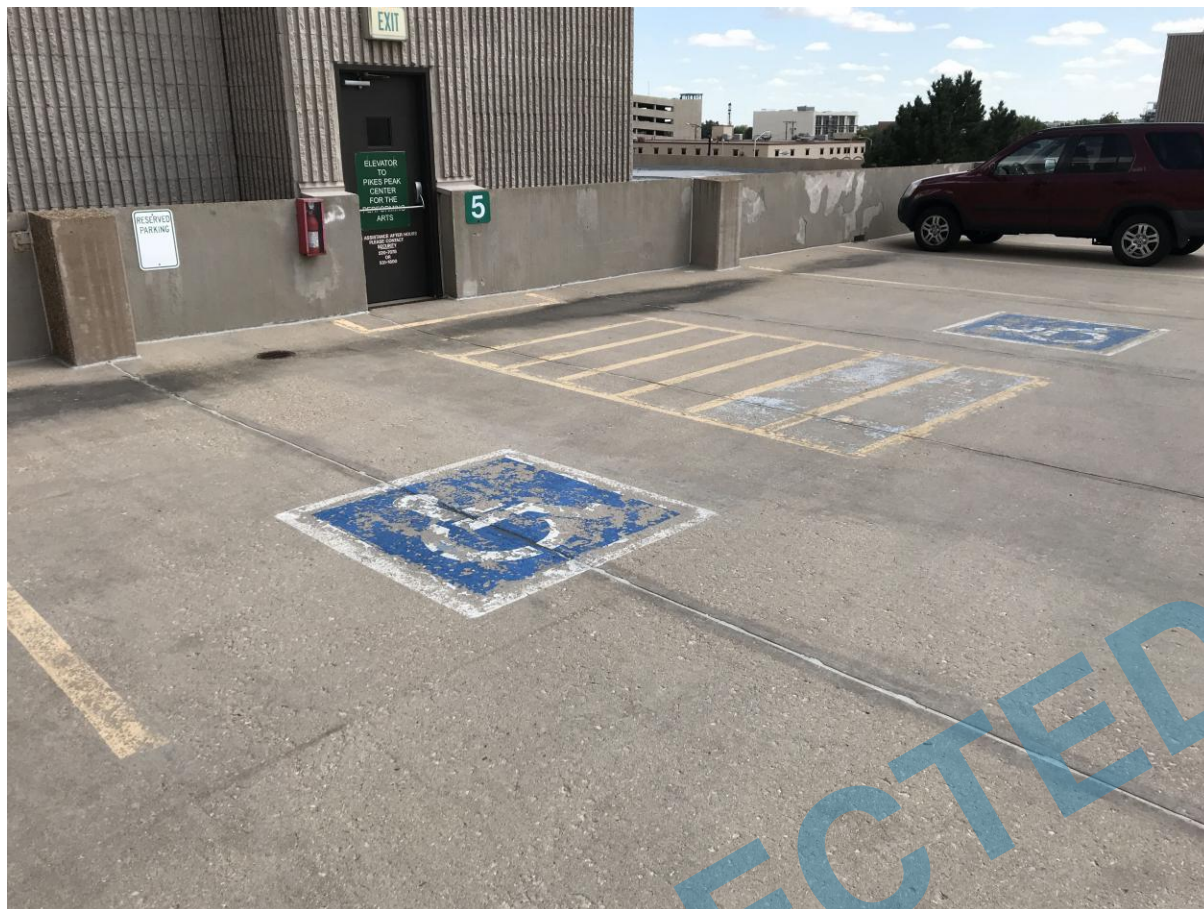
Finding 298045 Main Photo

The striping and markings for the accessible parking stall, loading/unloading access aisle are dilapidated and in need of repair and/or maintenance.

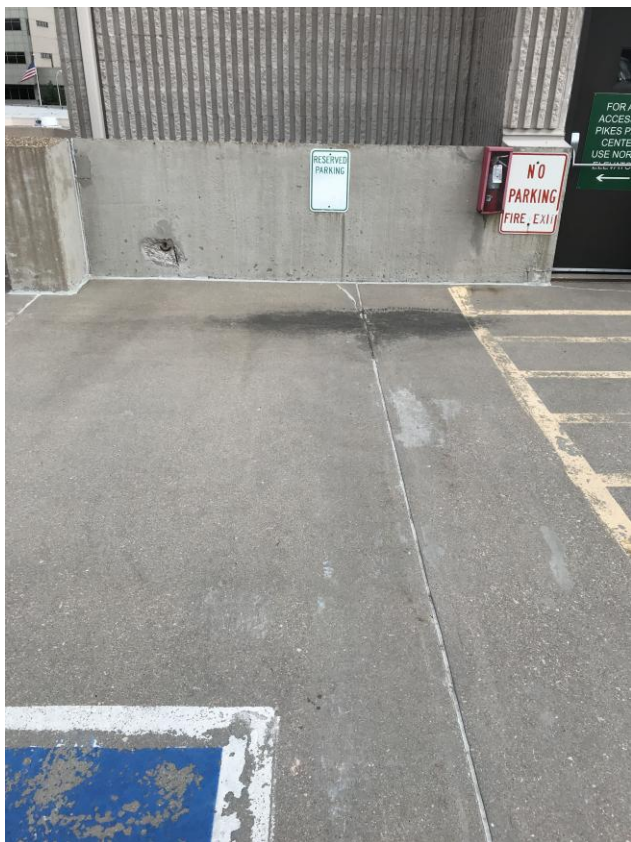
Finding 298048 Main Photo

The van stall is missing a sign identifying it as a van accessible stall.

Van accessible sign missing

Replace existing sign with ISA sign that also includes "Van Accessible" verbiage.

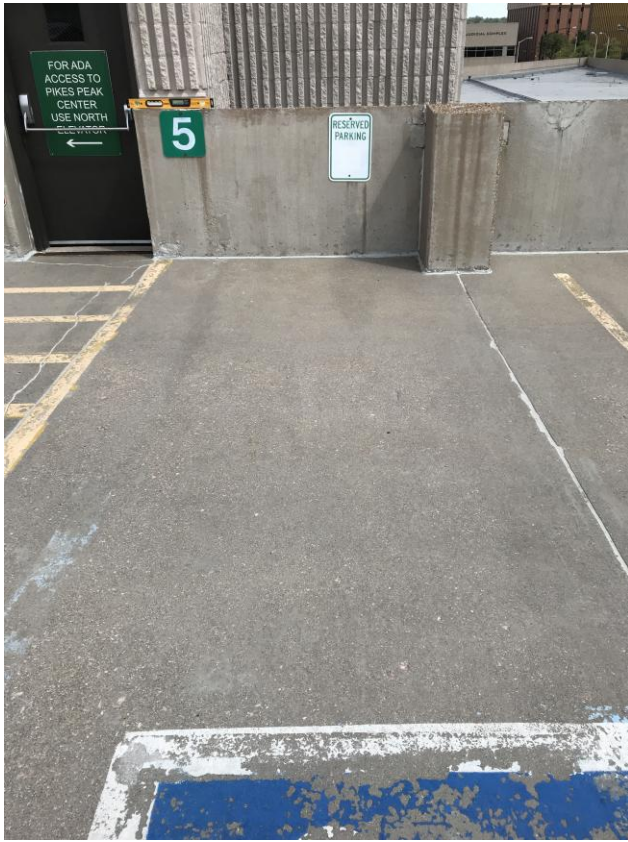
Finding 298049 Main Photo

The van stall is missing a sign identifying it as a van accessible stall.

Van accessible sign missing

Replace existing sign with ISA sign that also includes "Van Accessible" verbiage.

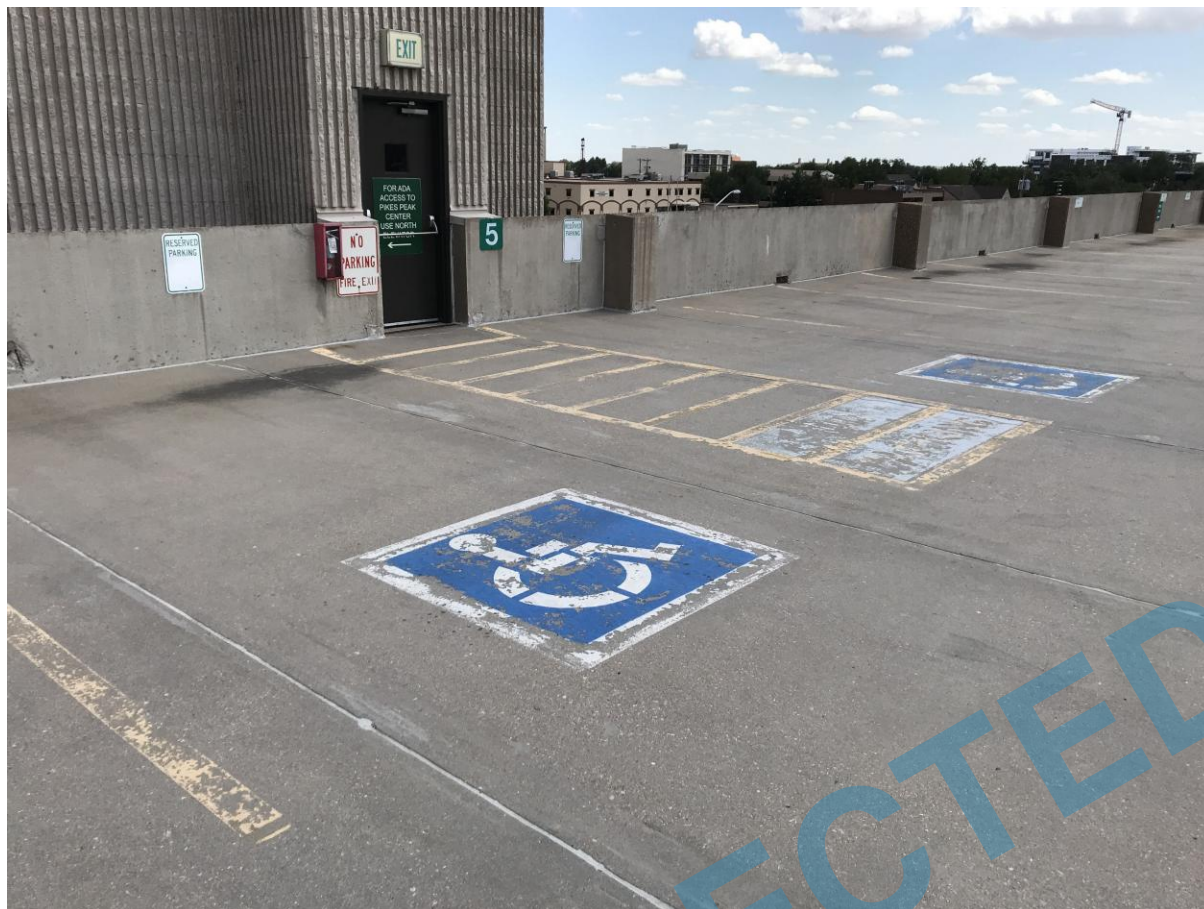
Finding 298052 Main Photo

The striping and markings for the accessible parking stall, loading/unloading access aisle are dilapidated and in need of repair and/or maintenance.
