**Inspection No: 2016082569742232**

**Certificate: 41-B-0239**

**DAN MOULTON**

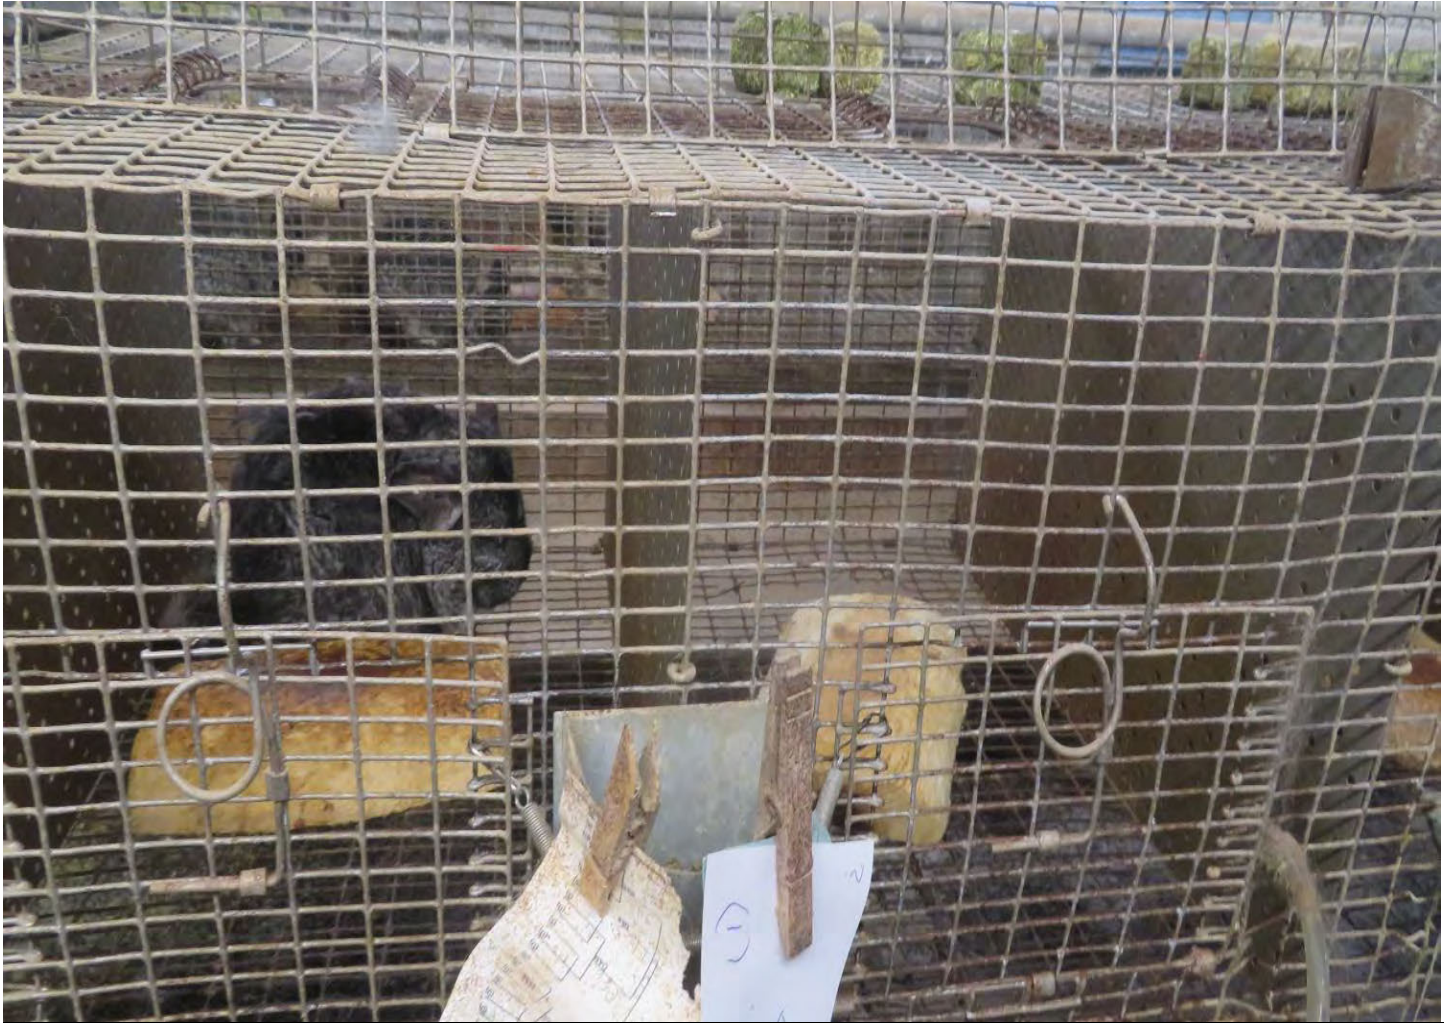
CFR : 3.125(a)

Enclosure 4B with hole in floor behind block of wood (right side of picture); licensee had moved chinchilla to new enclosure when hole was pointed out.

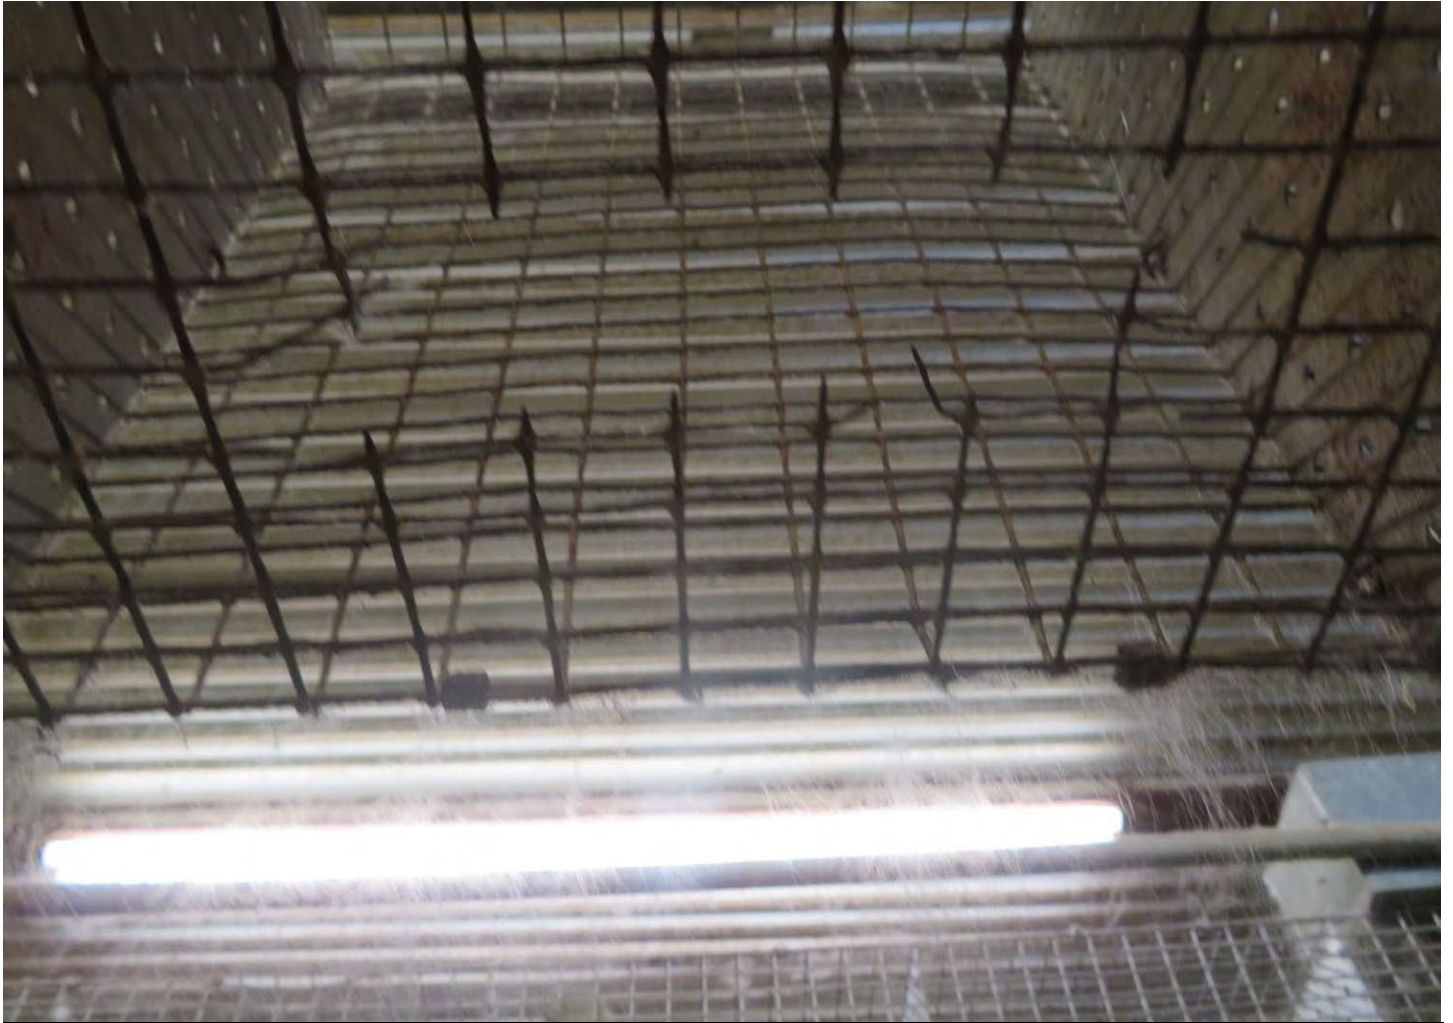
Enclosure 4B; looking up through hole in floor.

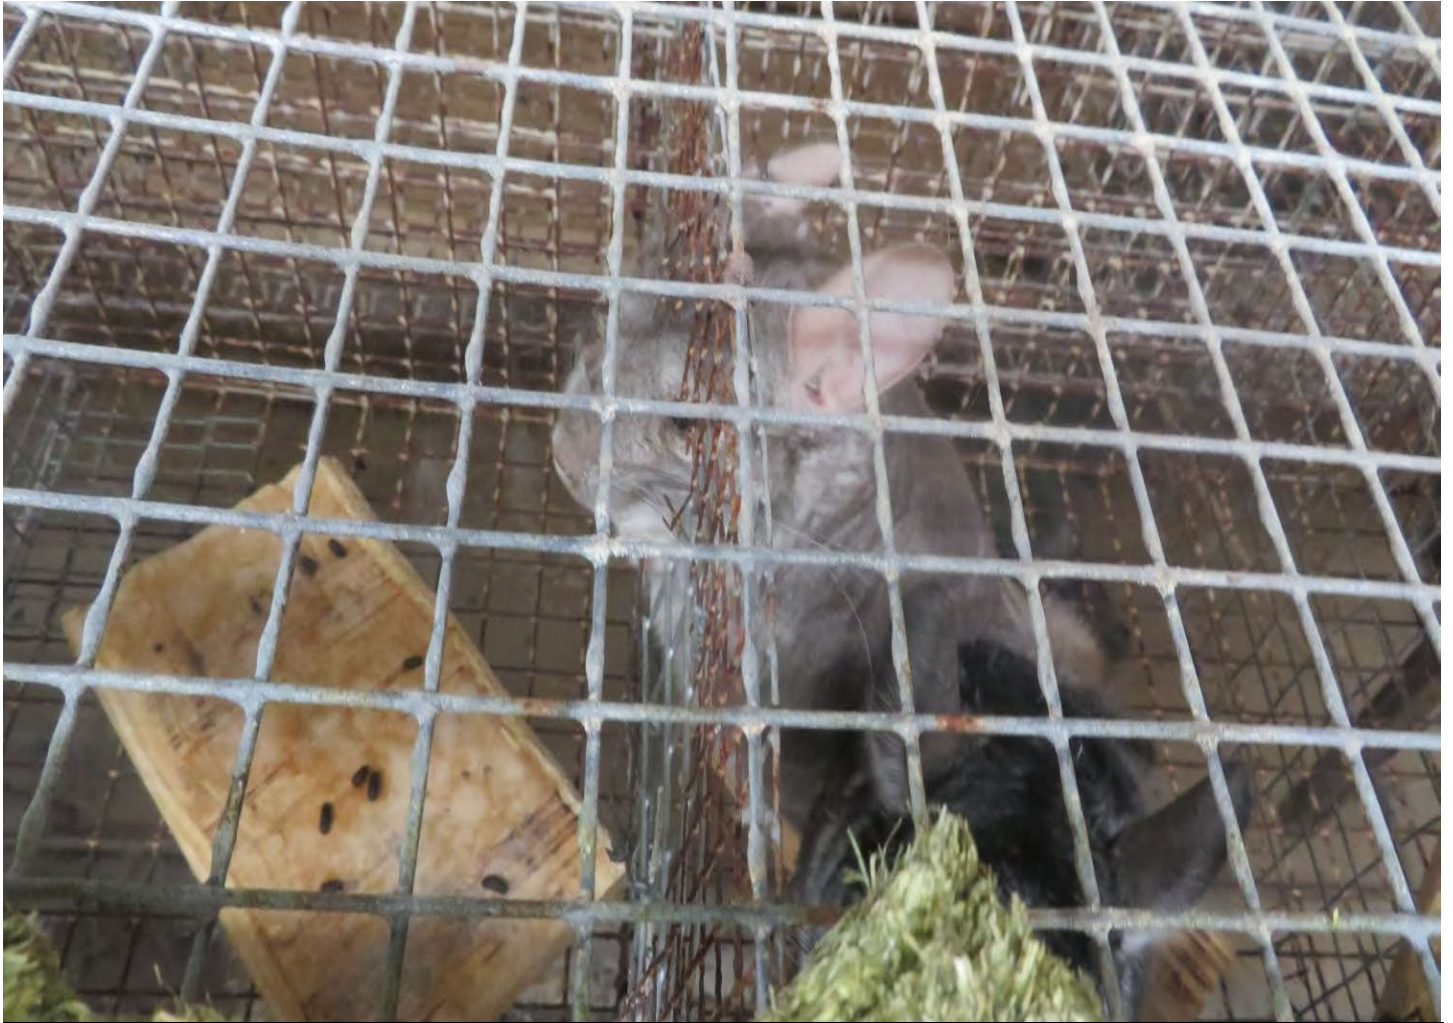
Middle room enclosure with hole in divider towards back of enclosure; chinchilla's nose is through hole.

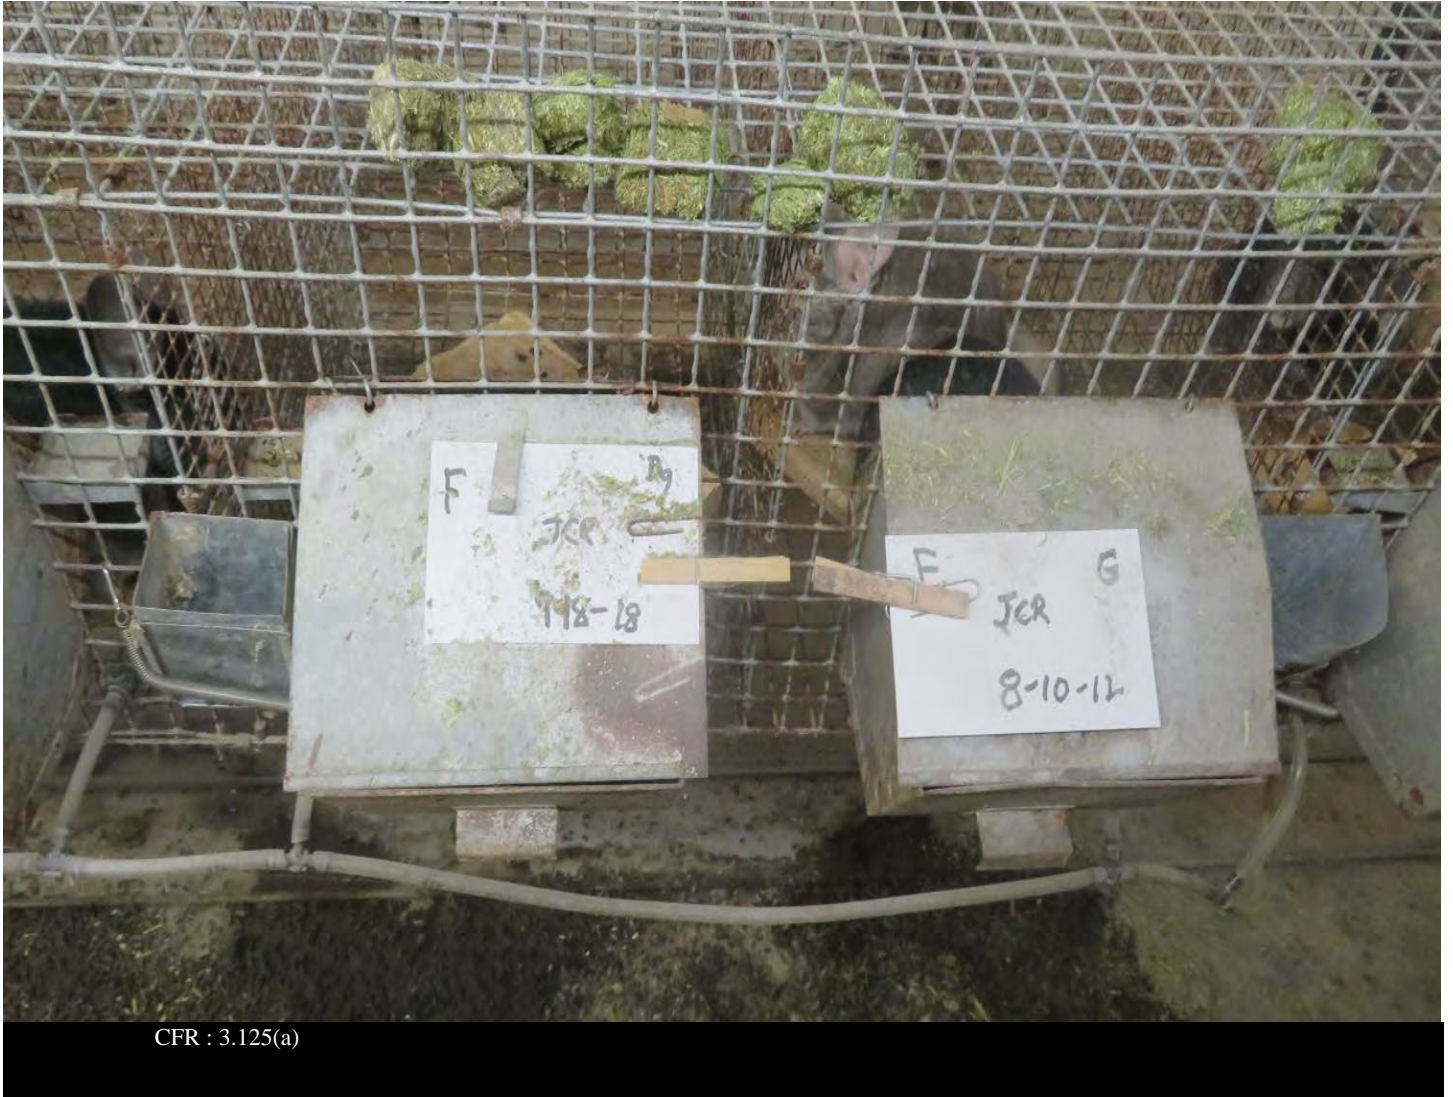
Enclosure in middle room with a hole in the divider towards back of enclosure;  
photo for location purposes. Chinchillas were seen passing back and forth through  
the hole.

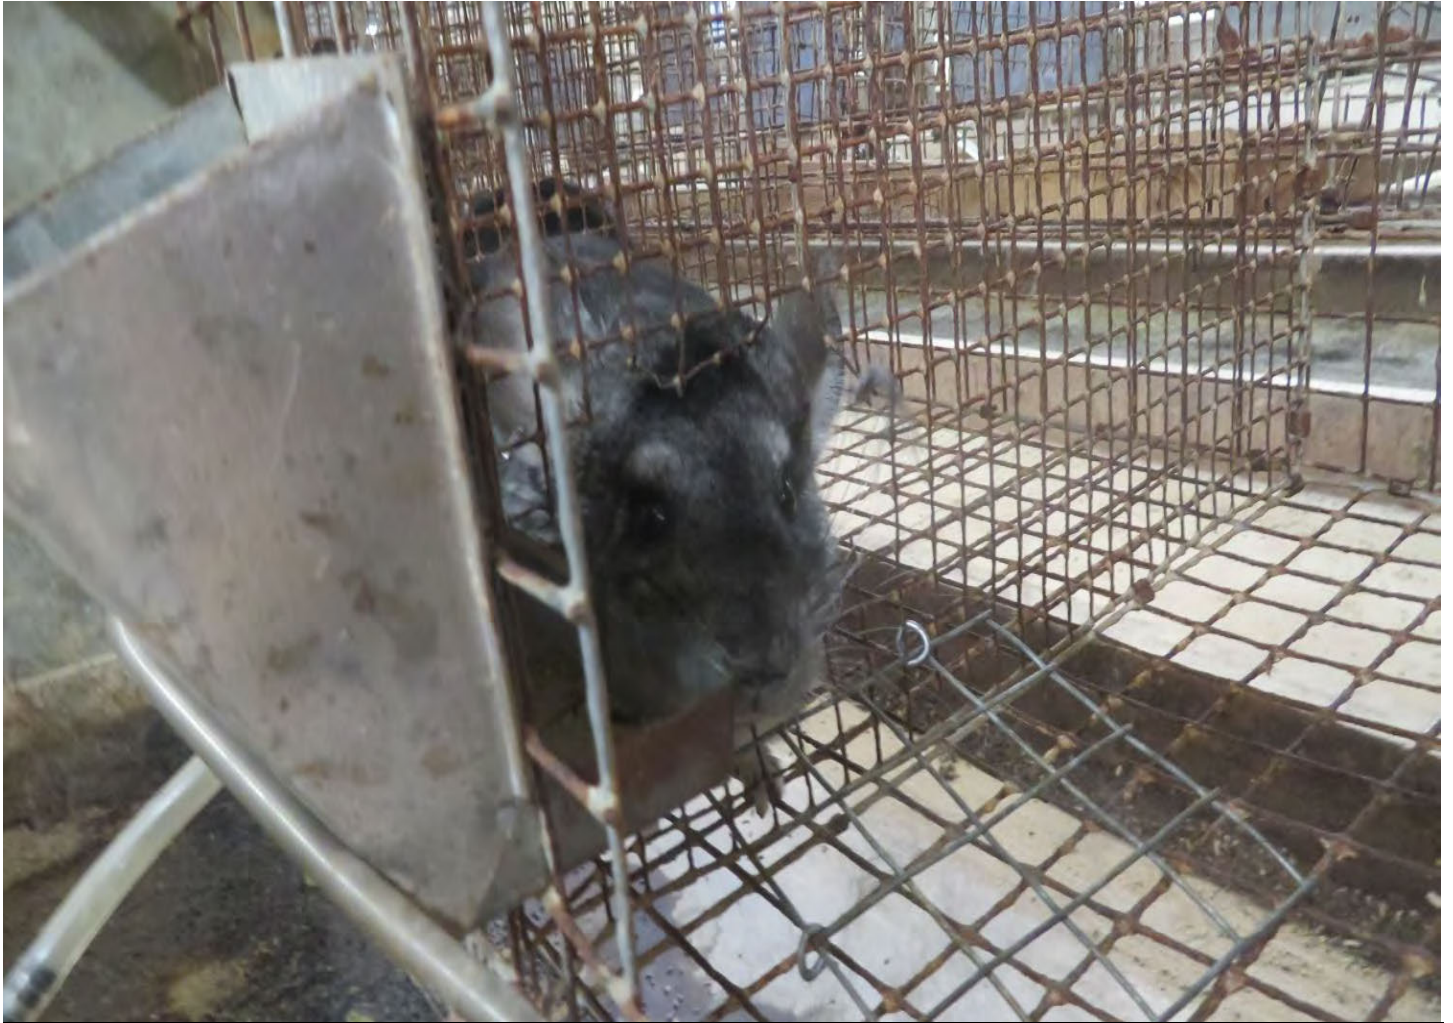
Second enclosure in middle room with a hole in divider between two enclosures close to front of enclosure.

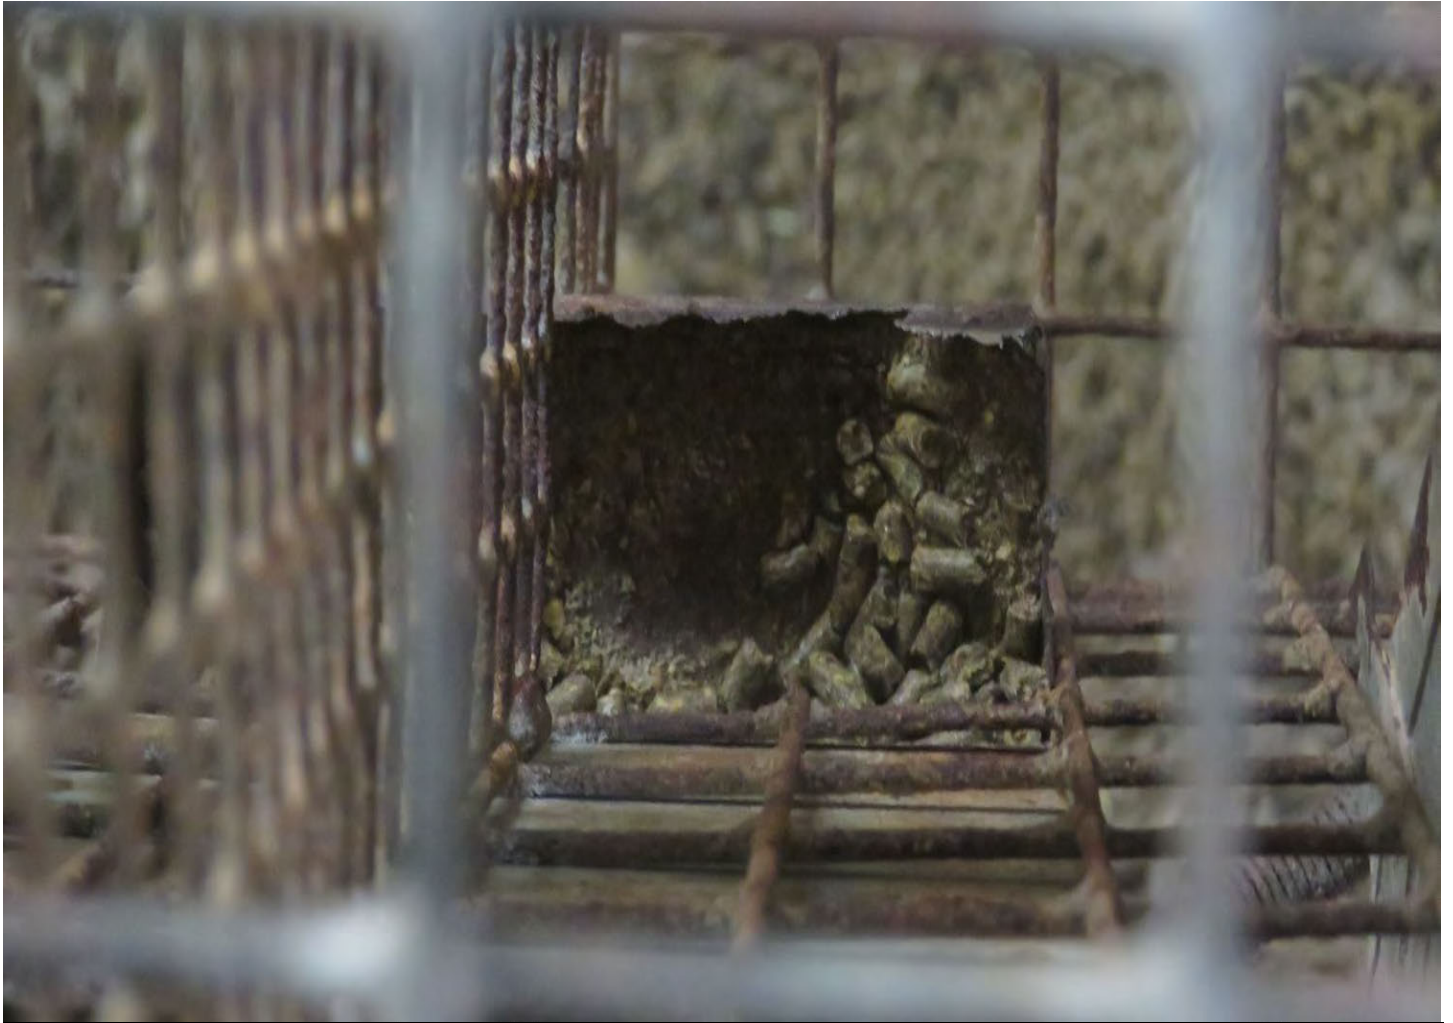
Feeder with rusted edges that were rough and sharp; representative of the feeders we pointed out during inspection that need repaired or replaced.

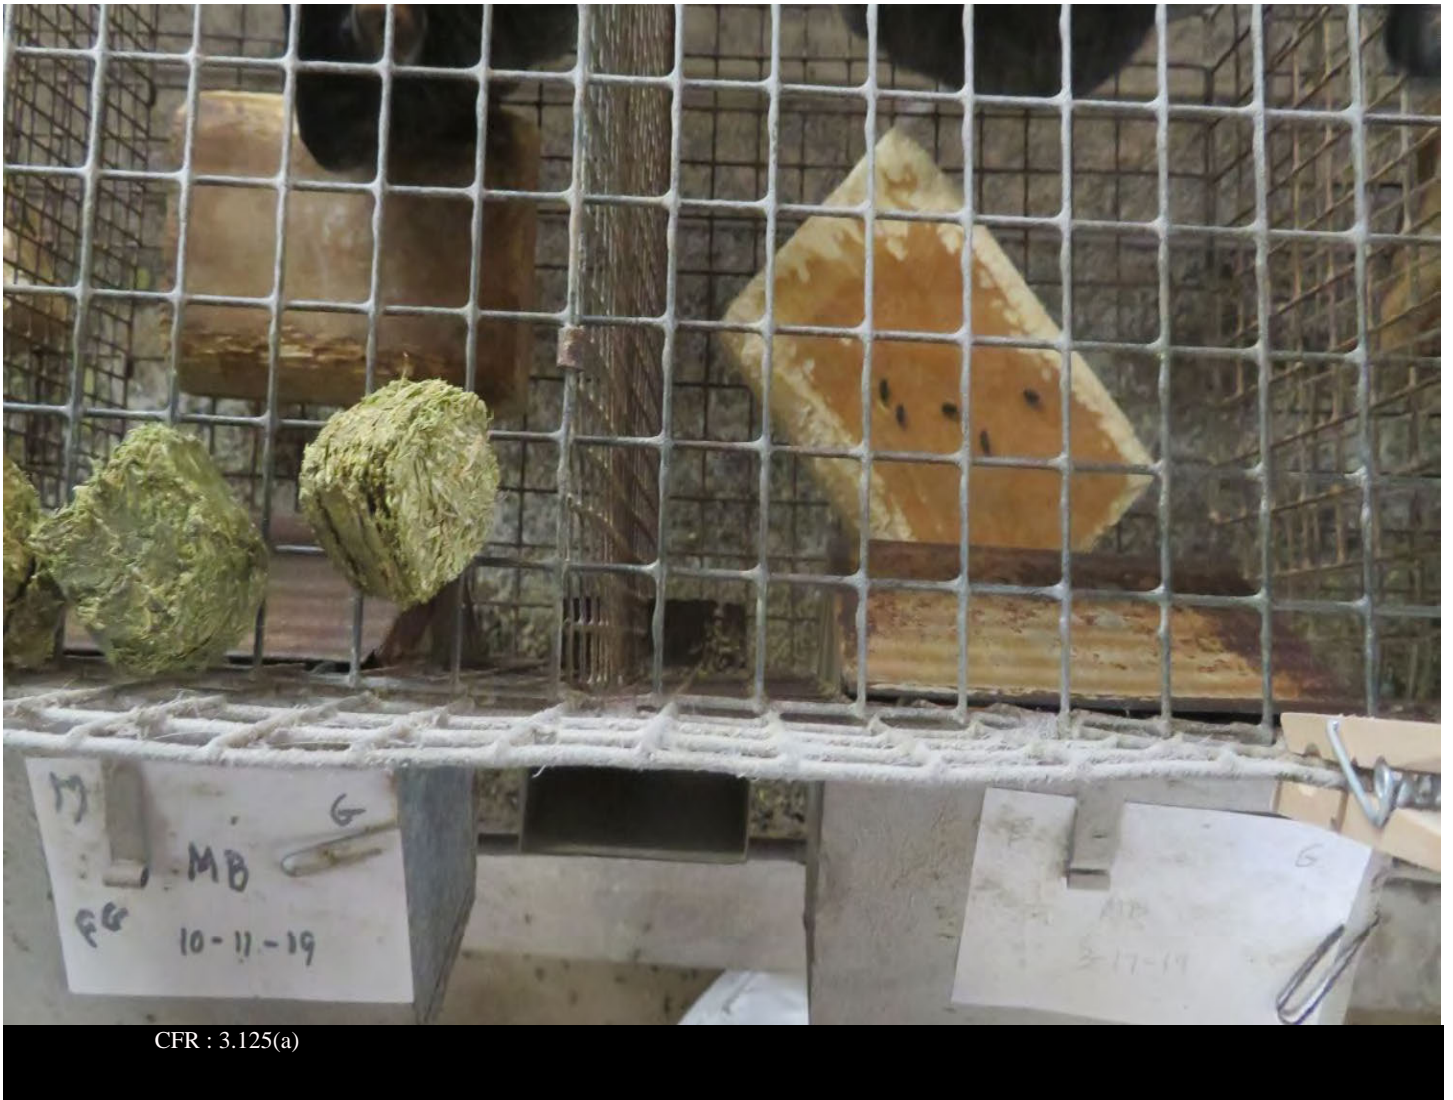
Feeder with rusted edges that were rough and sharp; representative of the feeders we pointed out during inspection that need repaired or replaced.

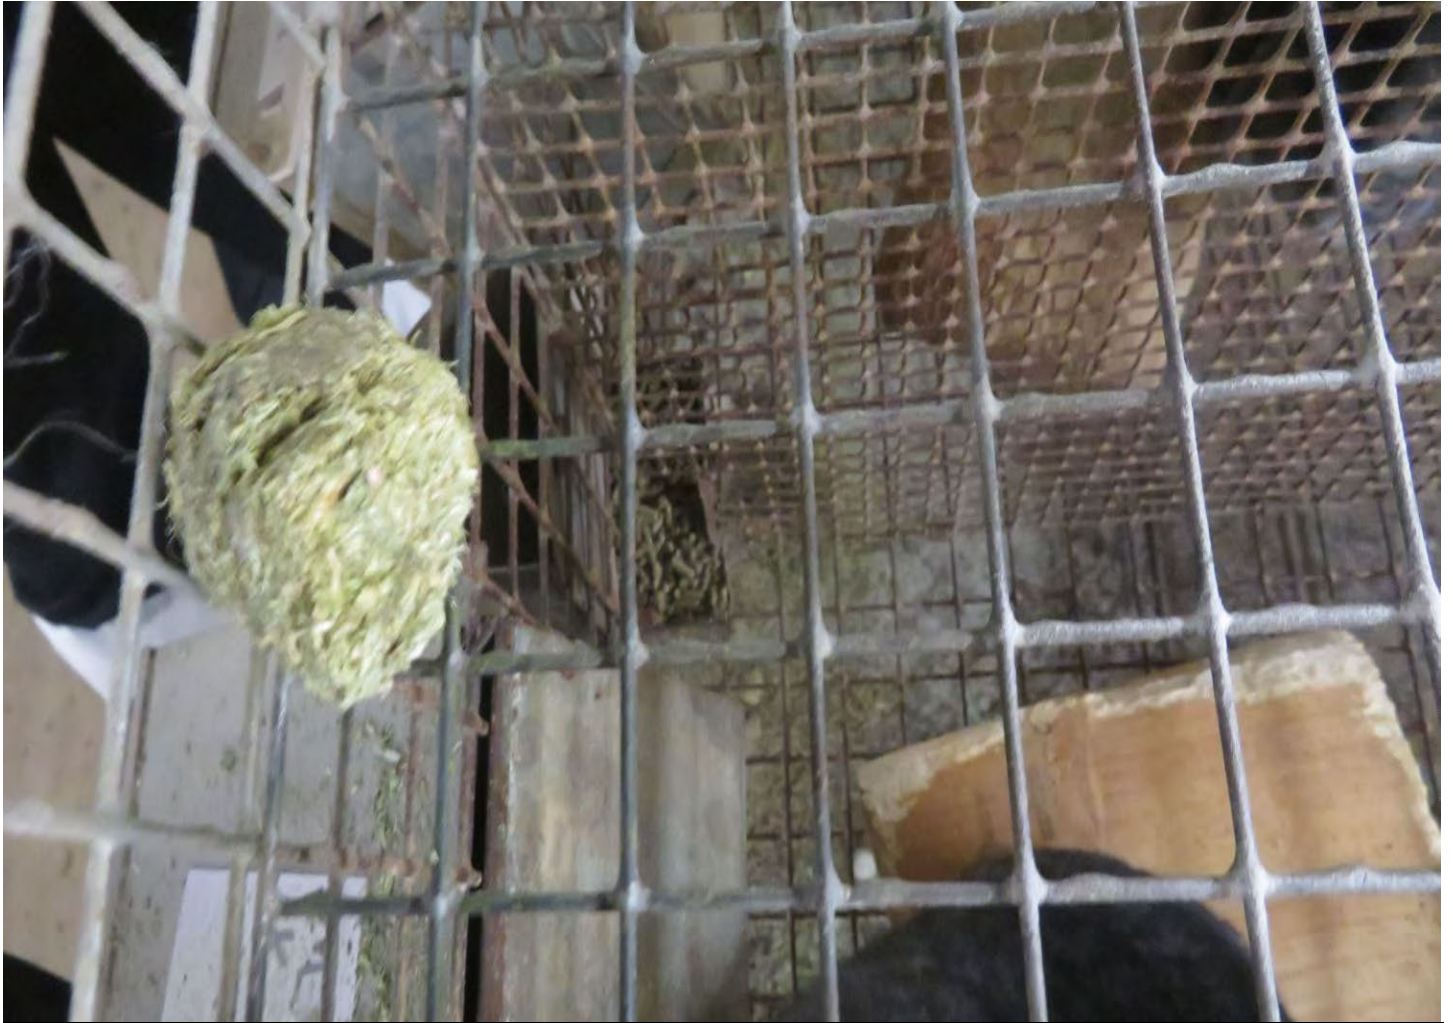
Feeder with rusted edges that were rough and sharp; representative of the feeders we pointed out during inspection that need repaired or replaced.

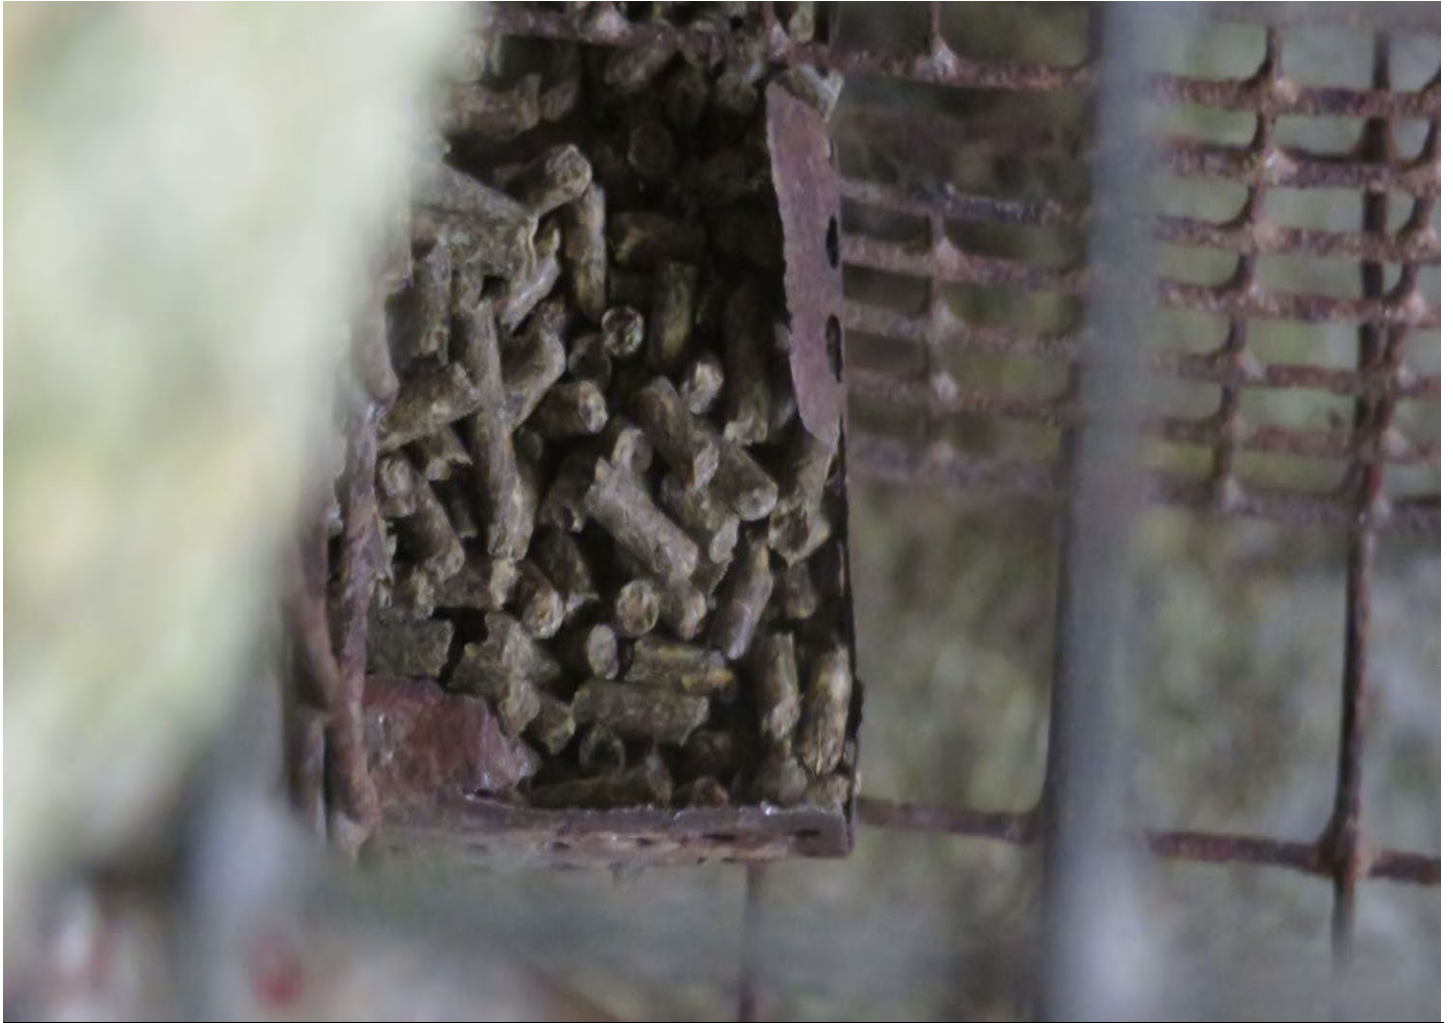
Close-up of feeder with rusted edges that were rough and sharp; representative of the feeders we pointed out during inspection that need repaired or replaced.

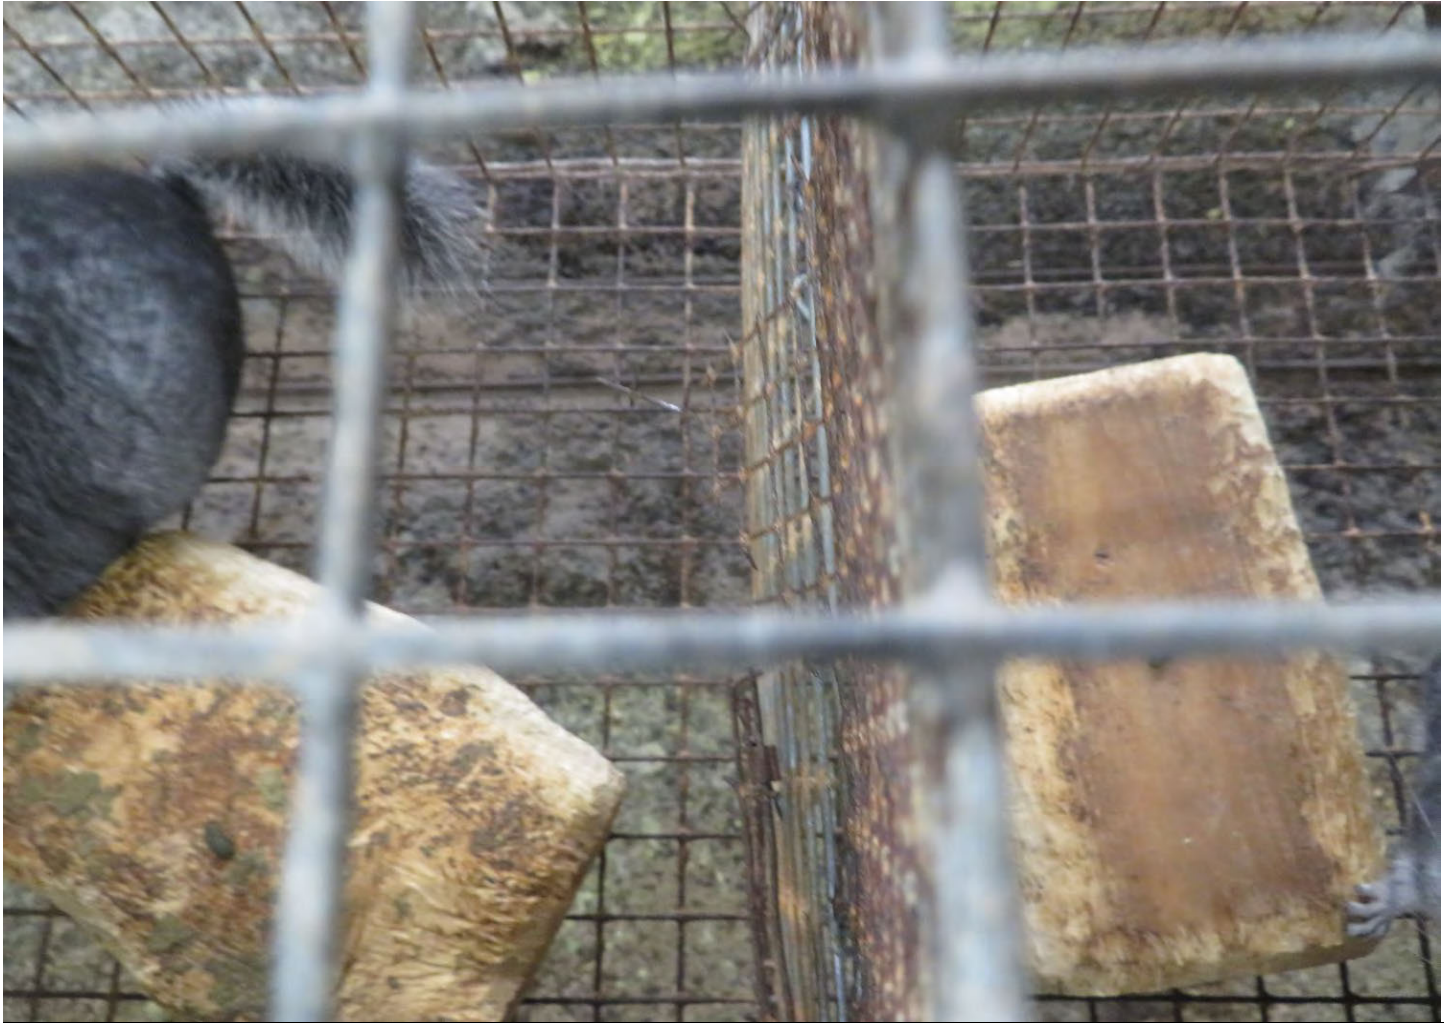
Enclosure divider with a loose wire point.

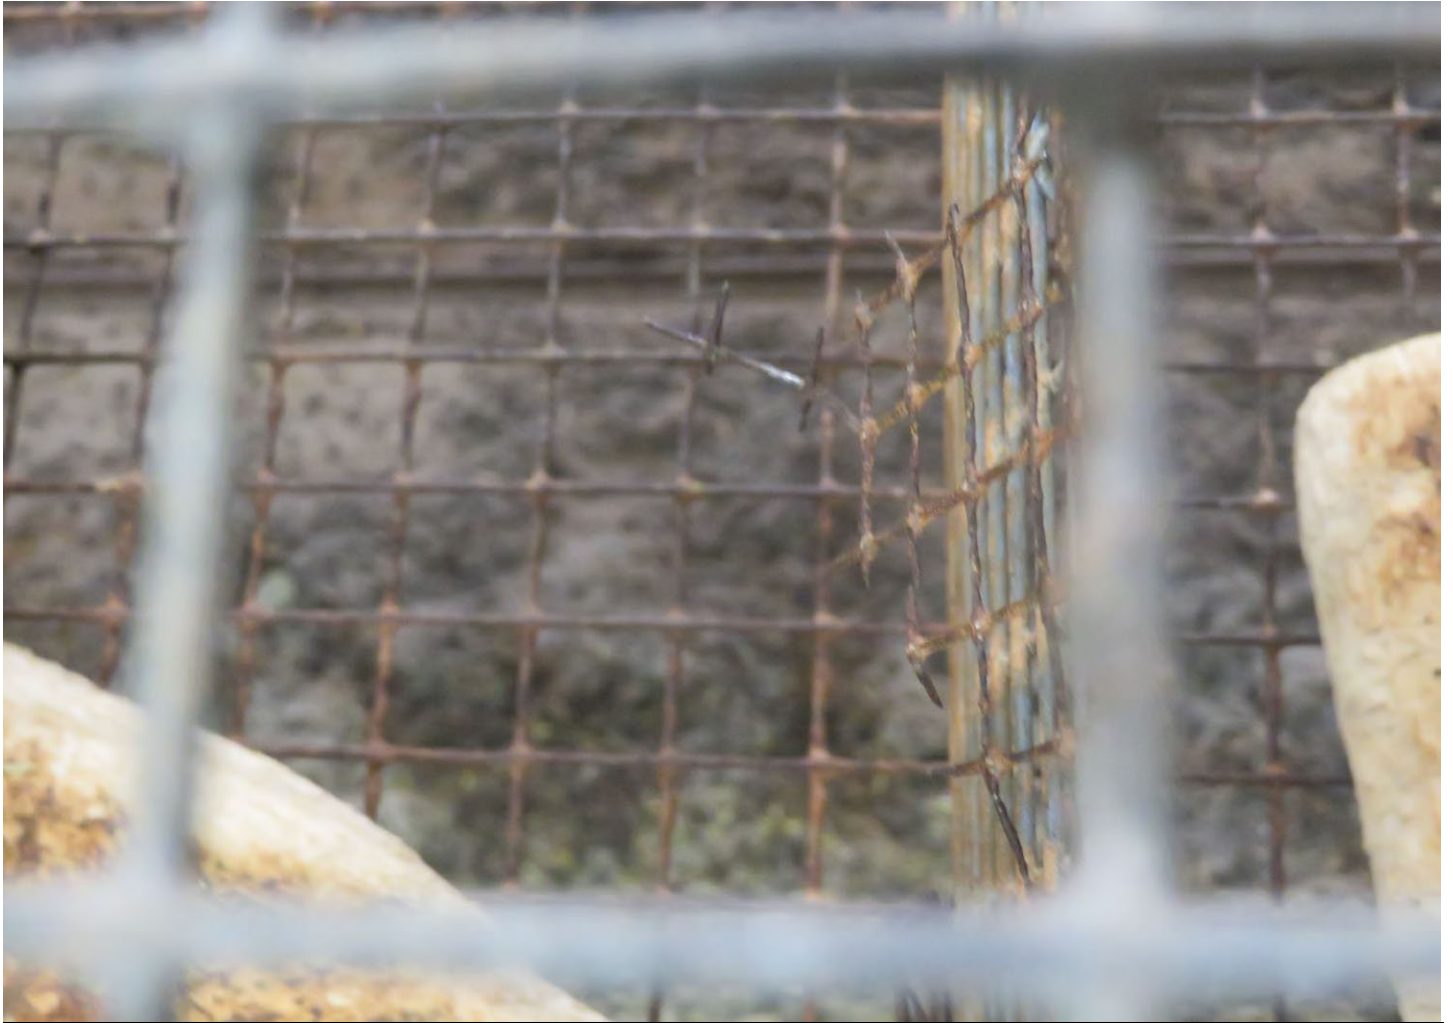
Close-up of enclosure divider with a loose wire point.

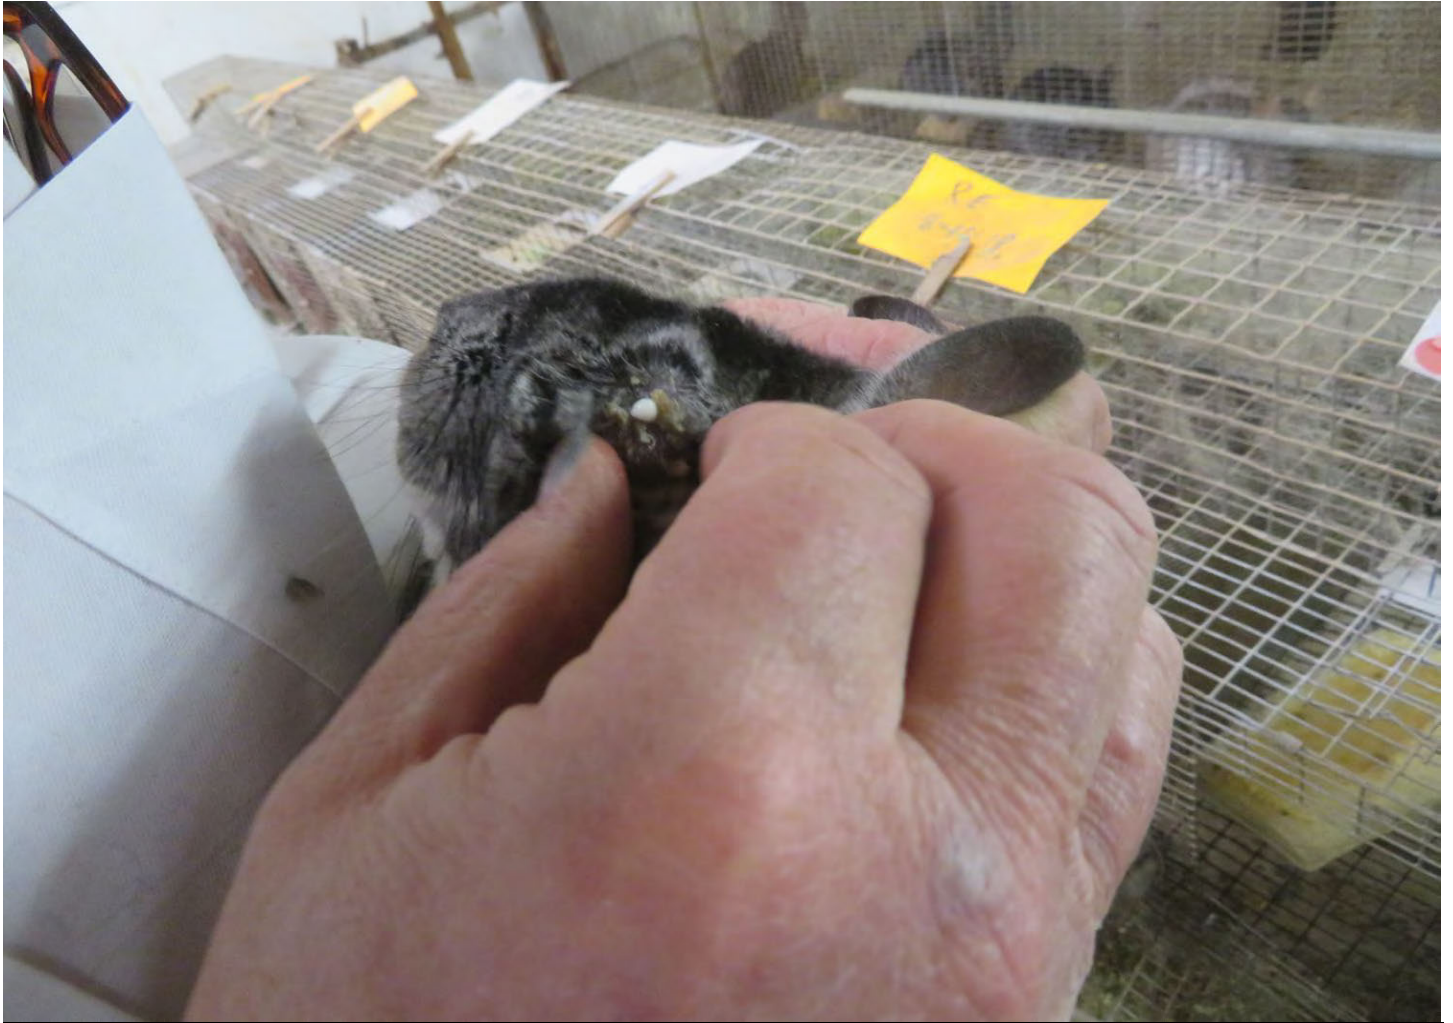
RVDK J144's left eye that has thick pale discharge when licensee handles it.

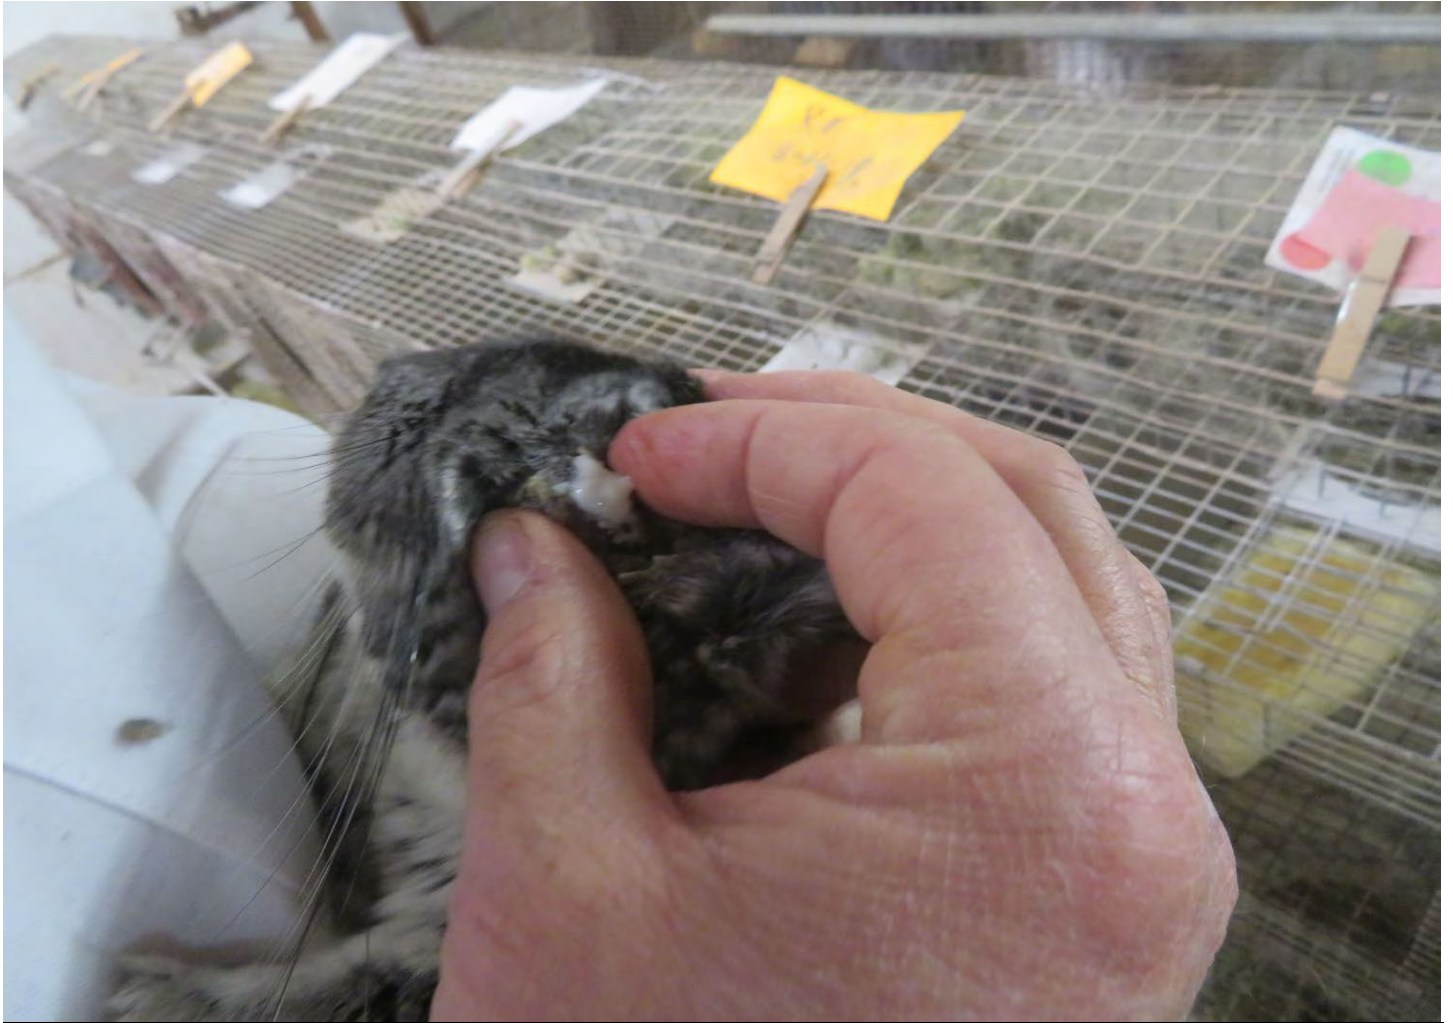
RVDK J144's left eye that has thick pale discharge when licensee handles it.

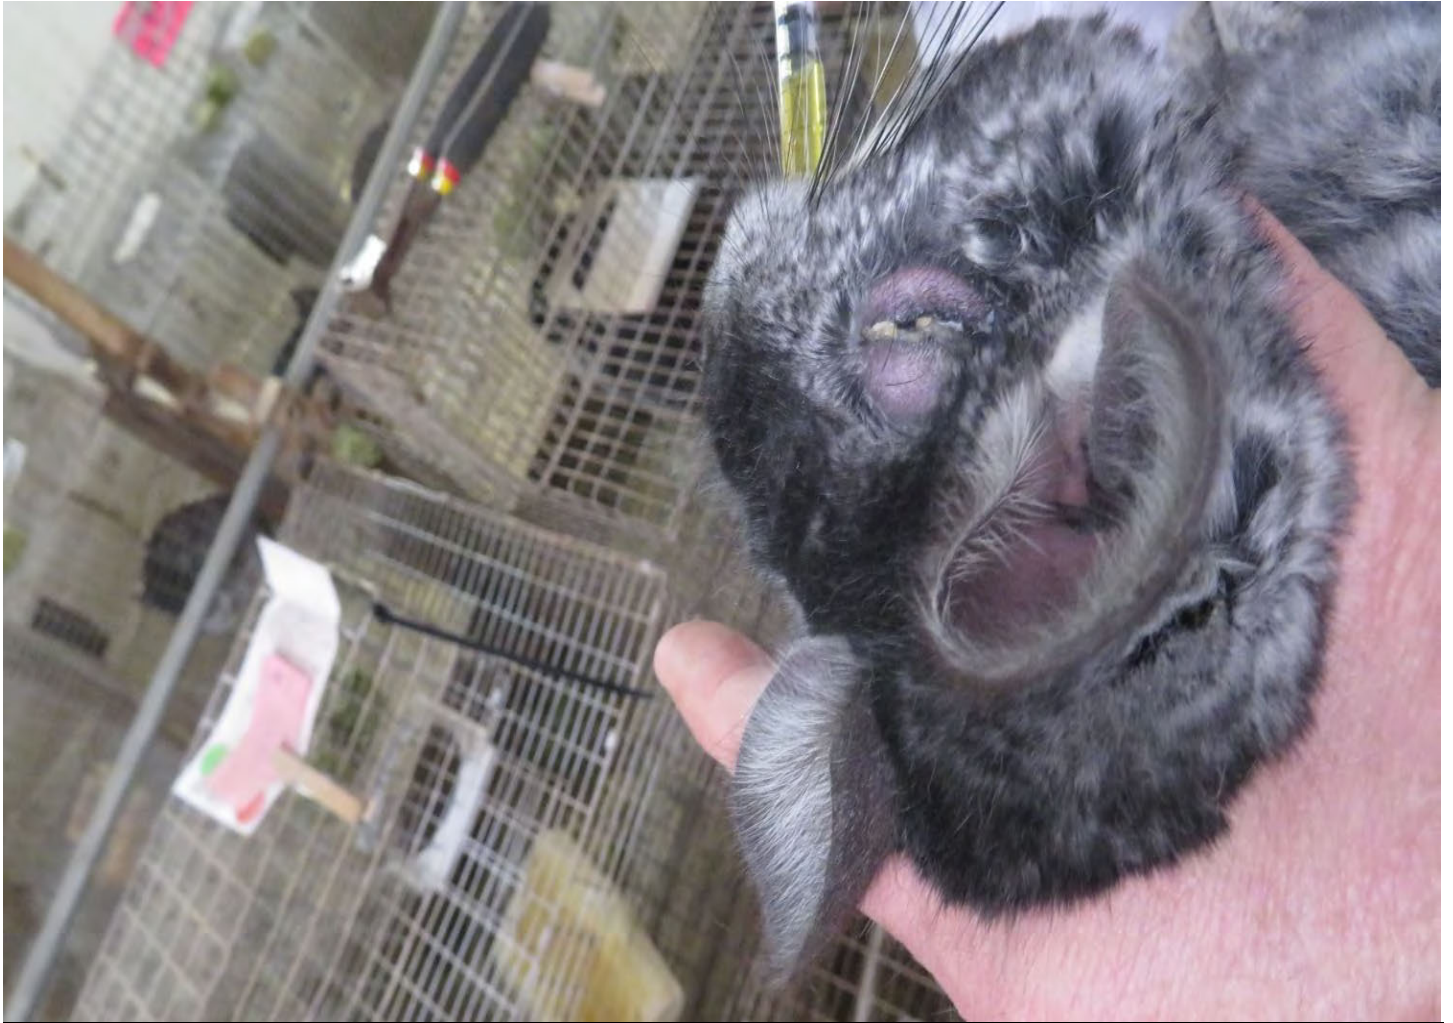
RVDK J144's right eye; close-up image taken while licensee administered treatment. Right eyelids are notably swollen and have hair loss.

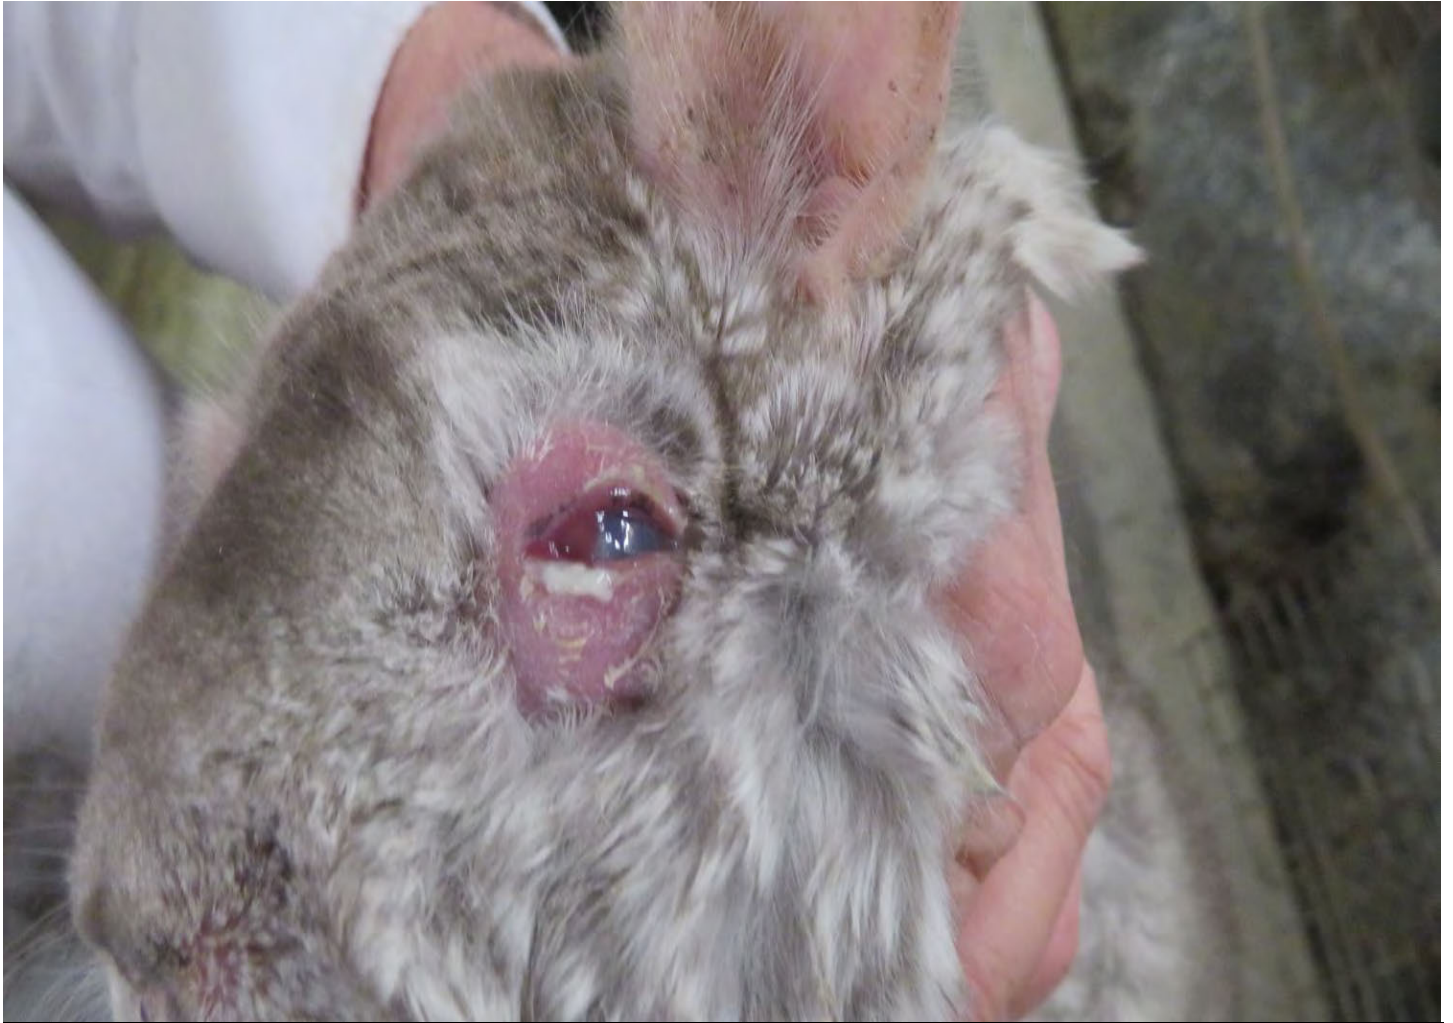
White female chinchilla in 30C; her left eyelids are swollen and have hair loss.
