**Inspection No: 2016082569742232**

**Certificate: 41-B-0239**

**DAN MOULTON**

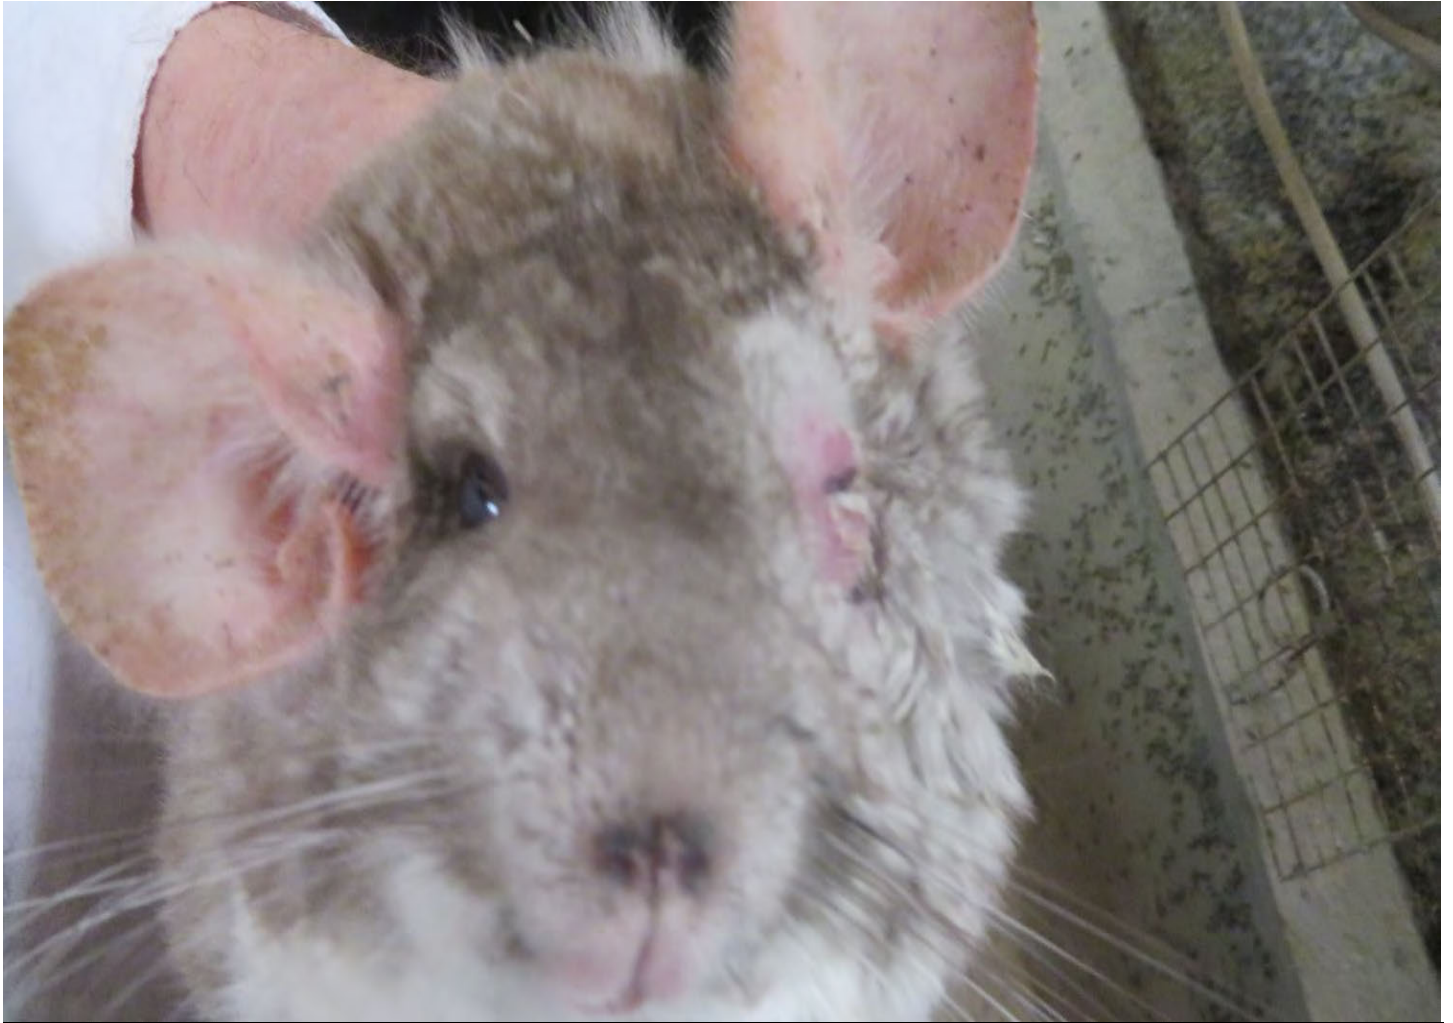
White female chinchilla in 30c; her affected left eye can be seen in comparison to her normal right eye.

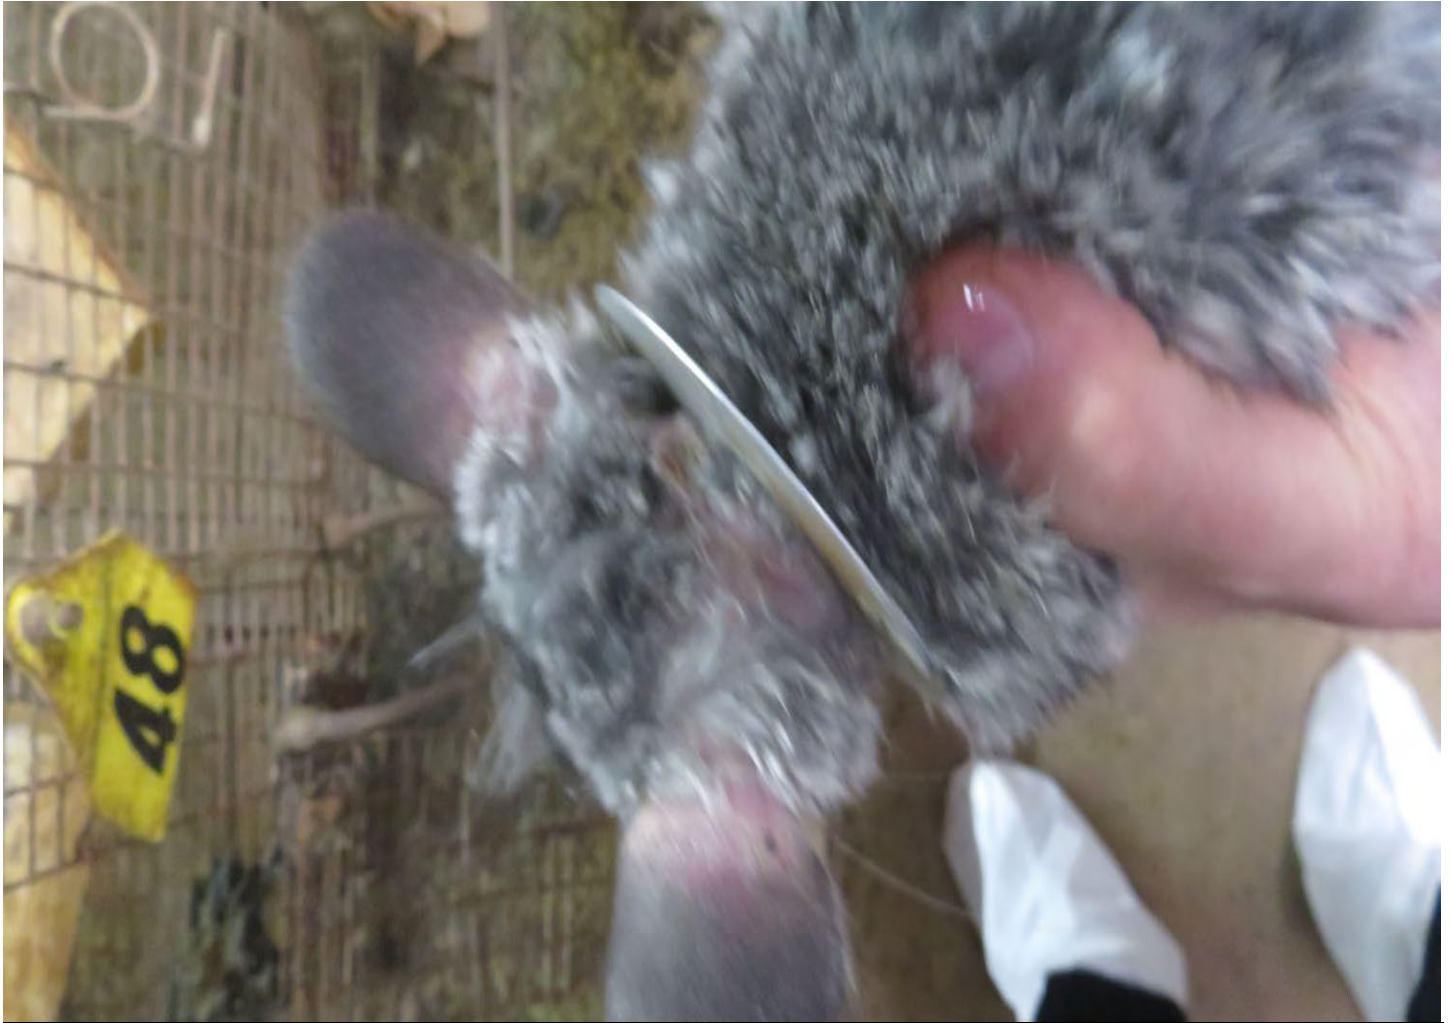
Grey female in 47D; scab on top (dorsal) of neck under collar.

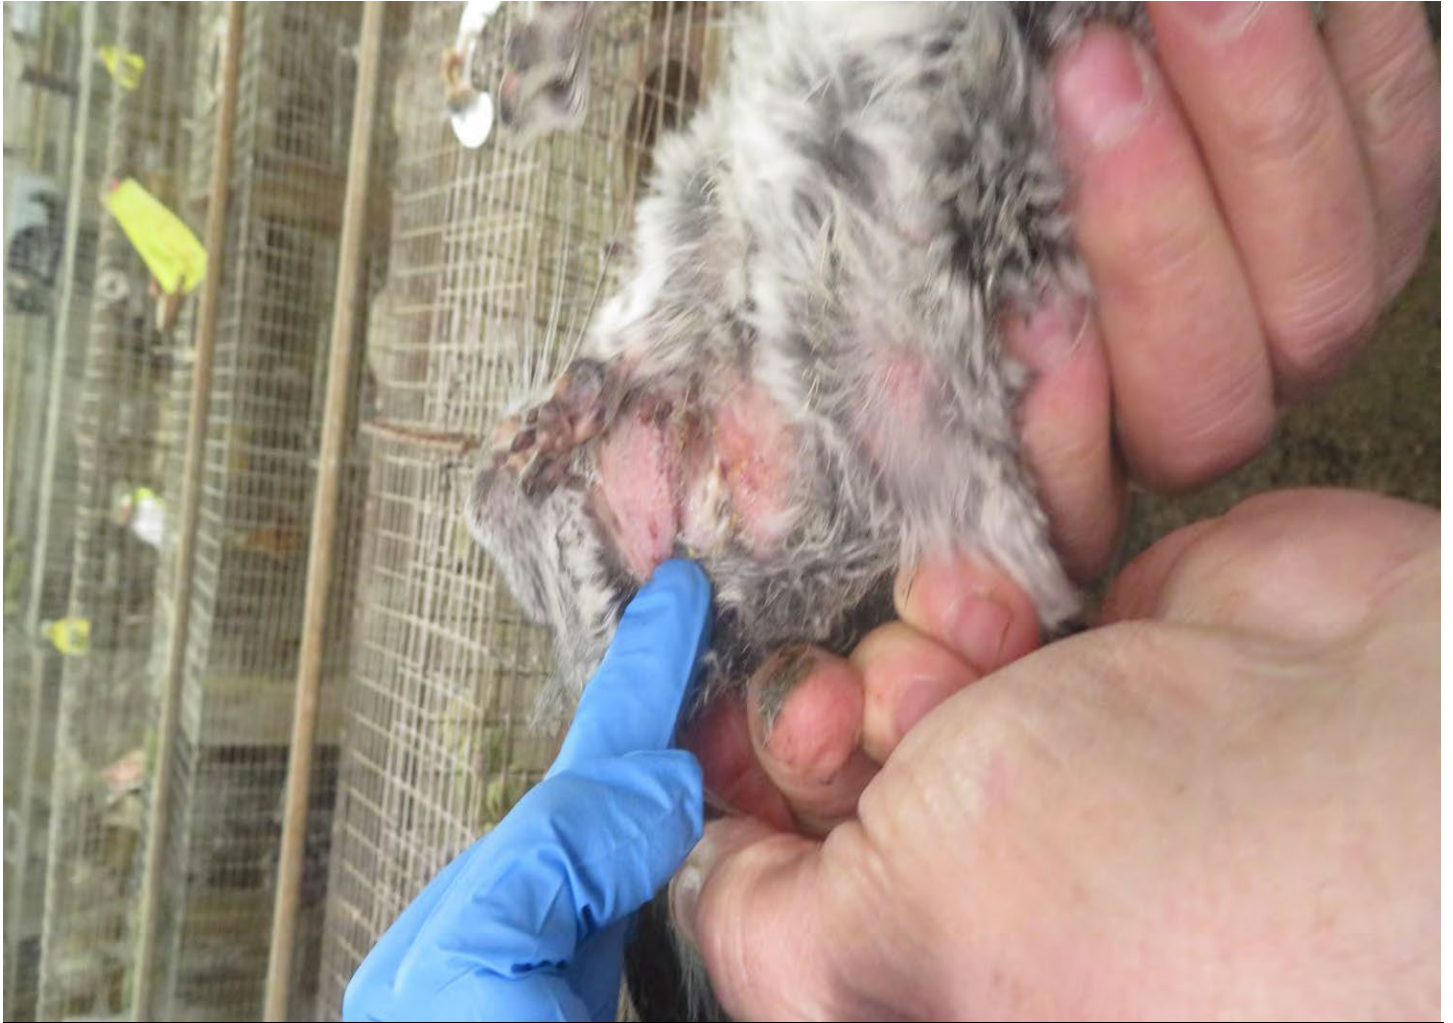
Grey female in 47D; underside (ventral) of neck after collar removed. Pale moderate granular and liquid discharge is noted in area by gloved fingers.

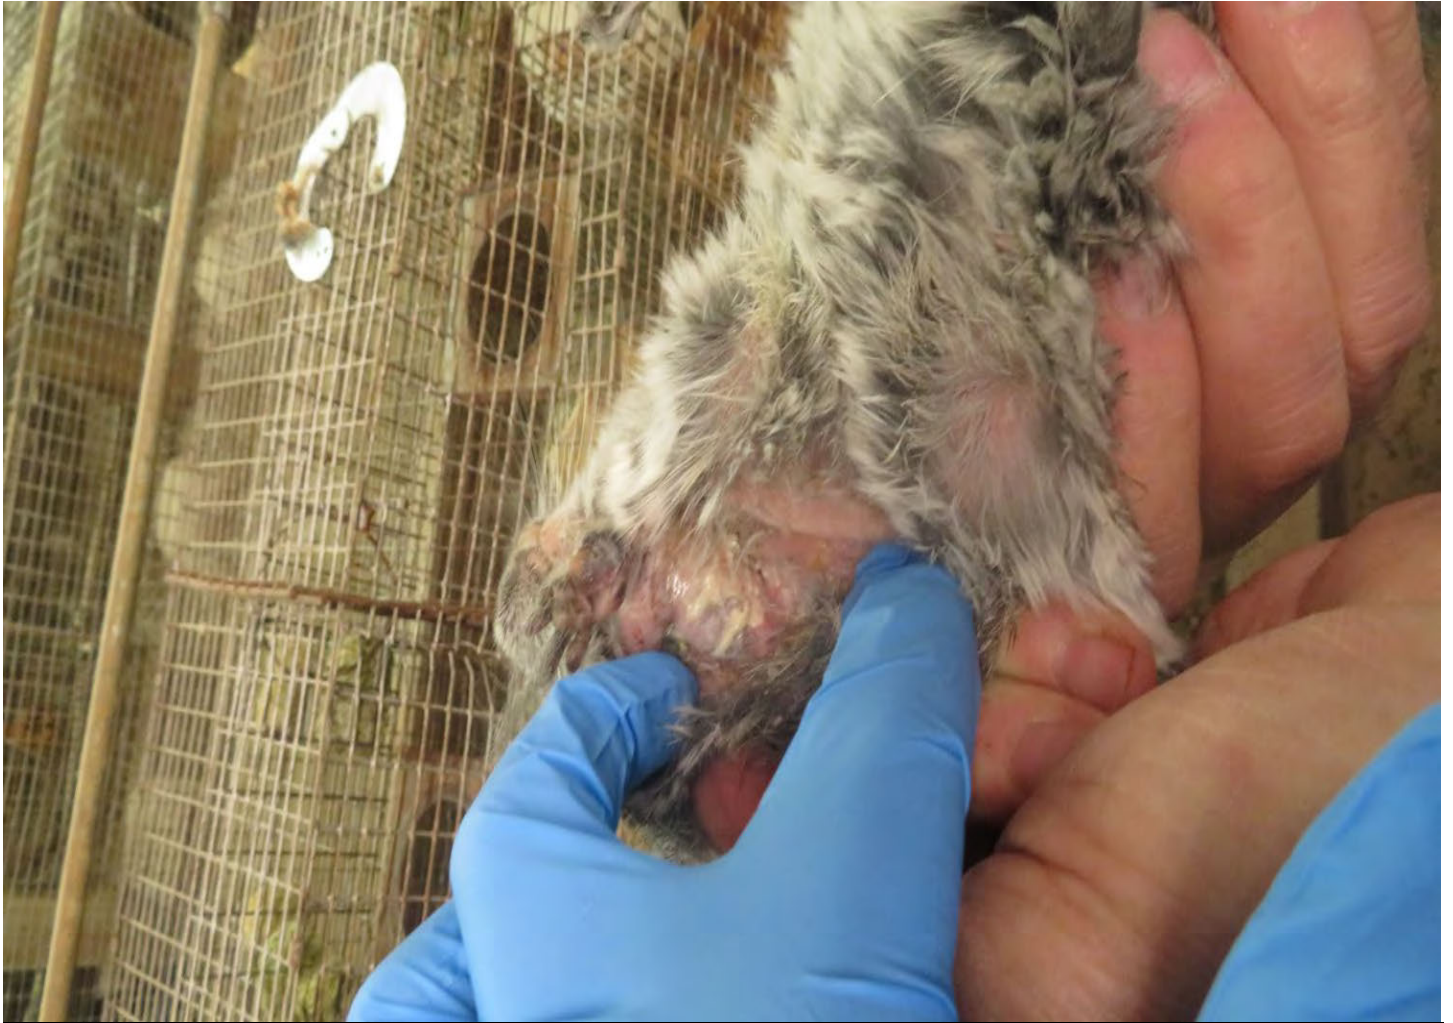
Grey female in 47D; underside (ventral) of neck after collar removed. Pale moderate granular and liquid discharge is noted in area between gloved fingers.

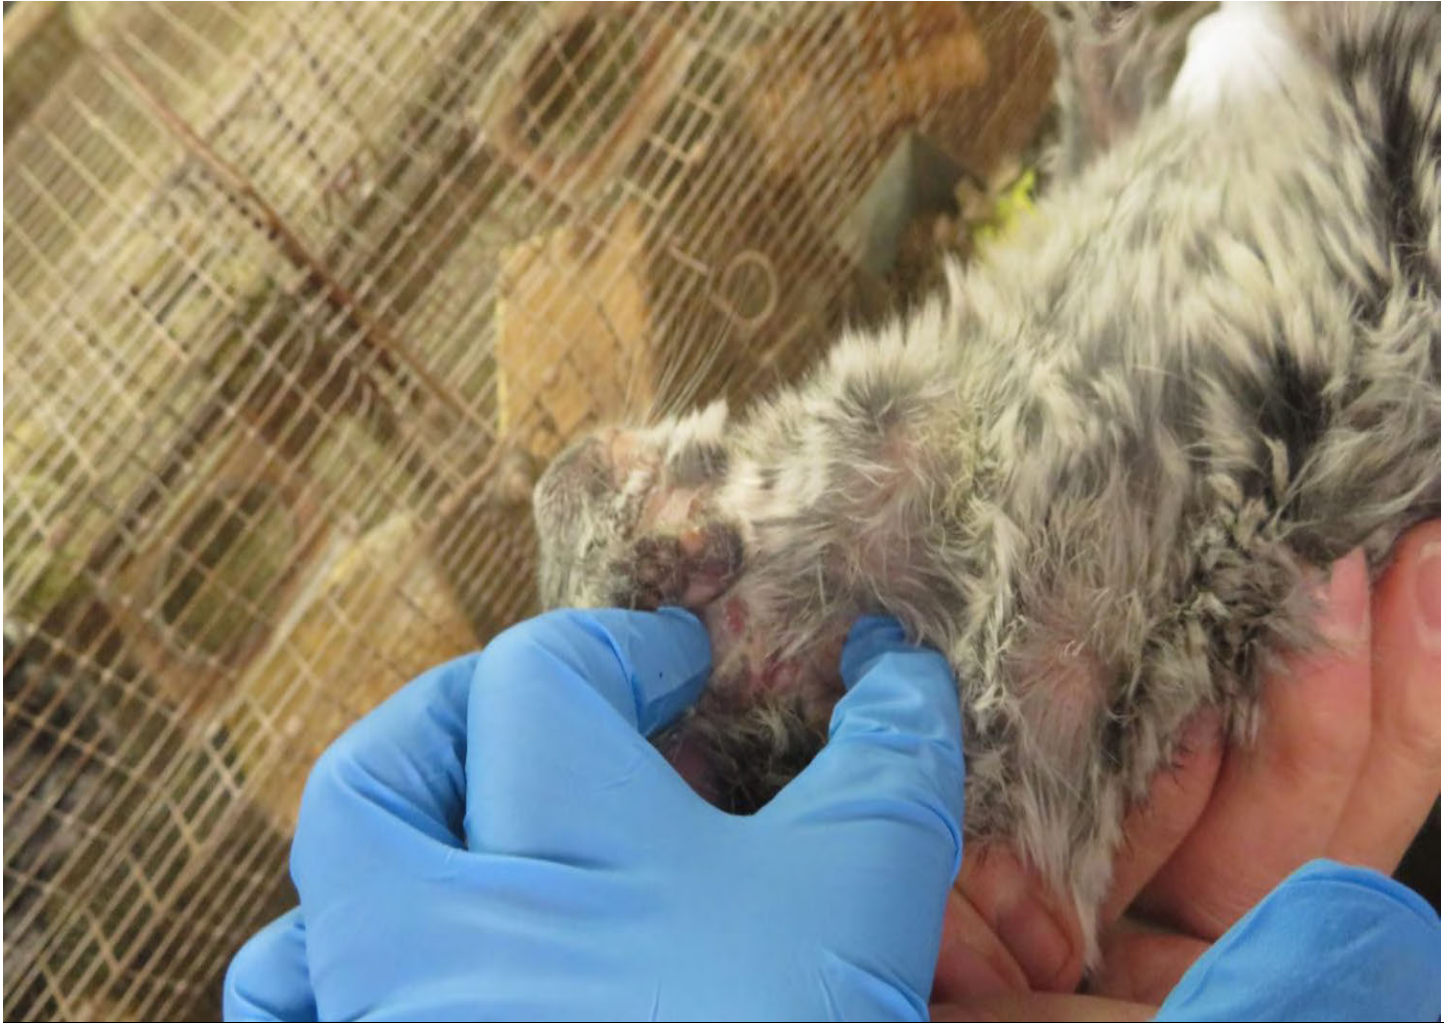
Grey female in 47D; underside (ventral) of neck after collar removed. Pale moderate granular and liquid discharge is noted in area between gloved fingers.

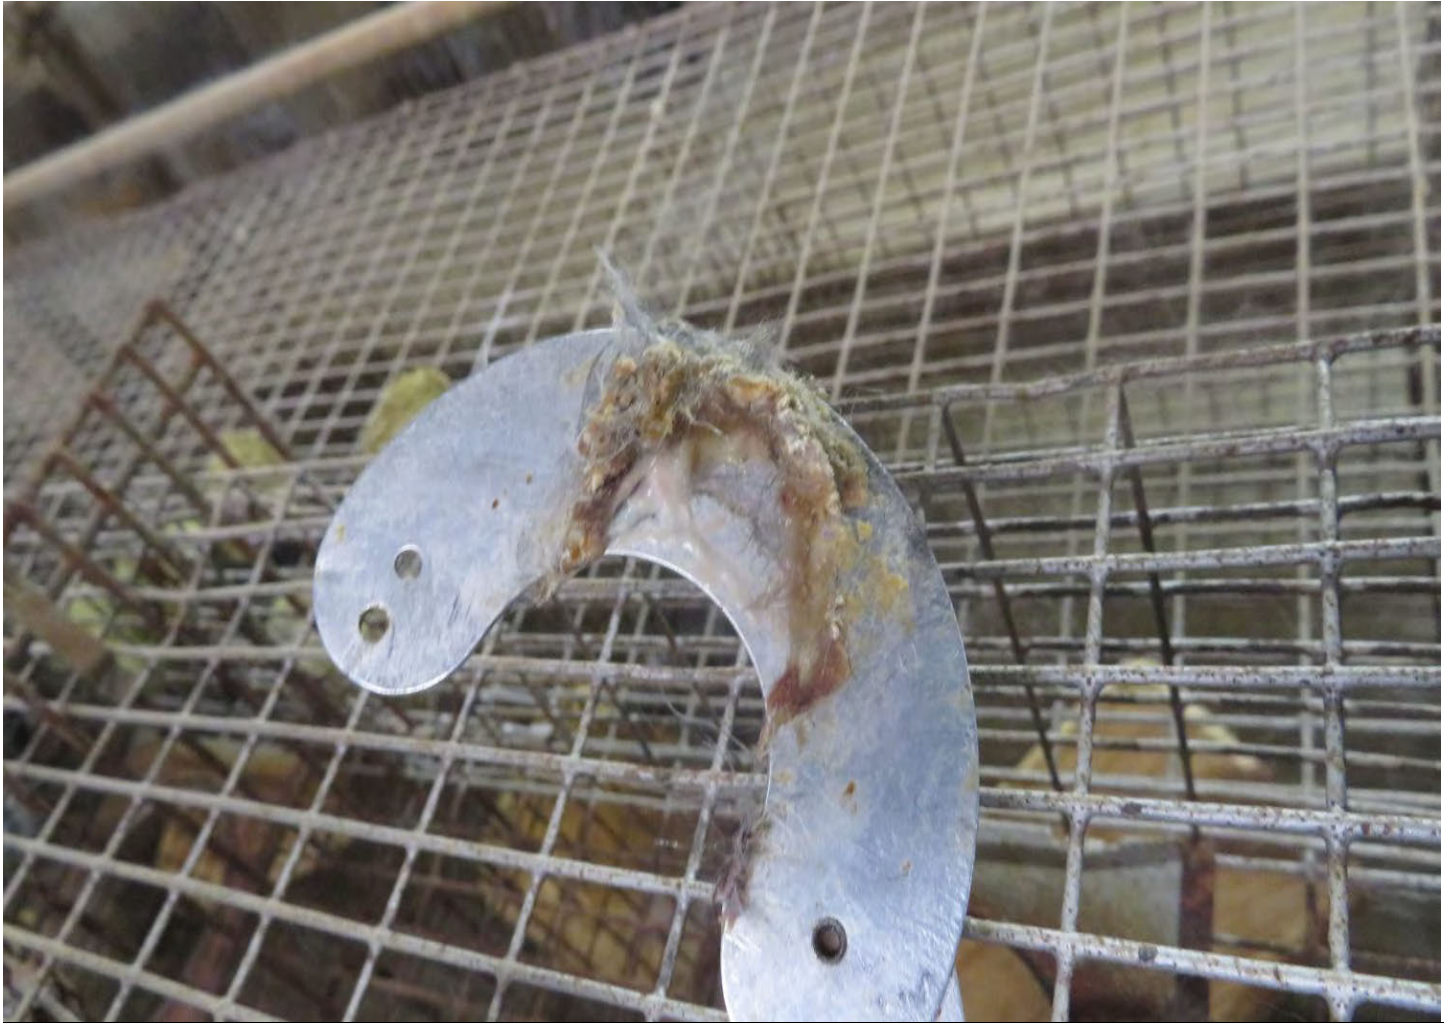
Collar that was on 47D female; crusted tissue and pale liquid discharge on area of collar that was embedded in neck.

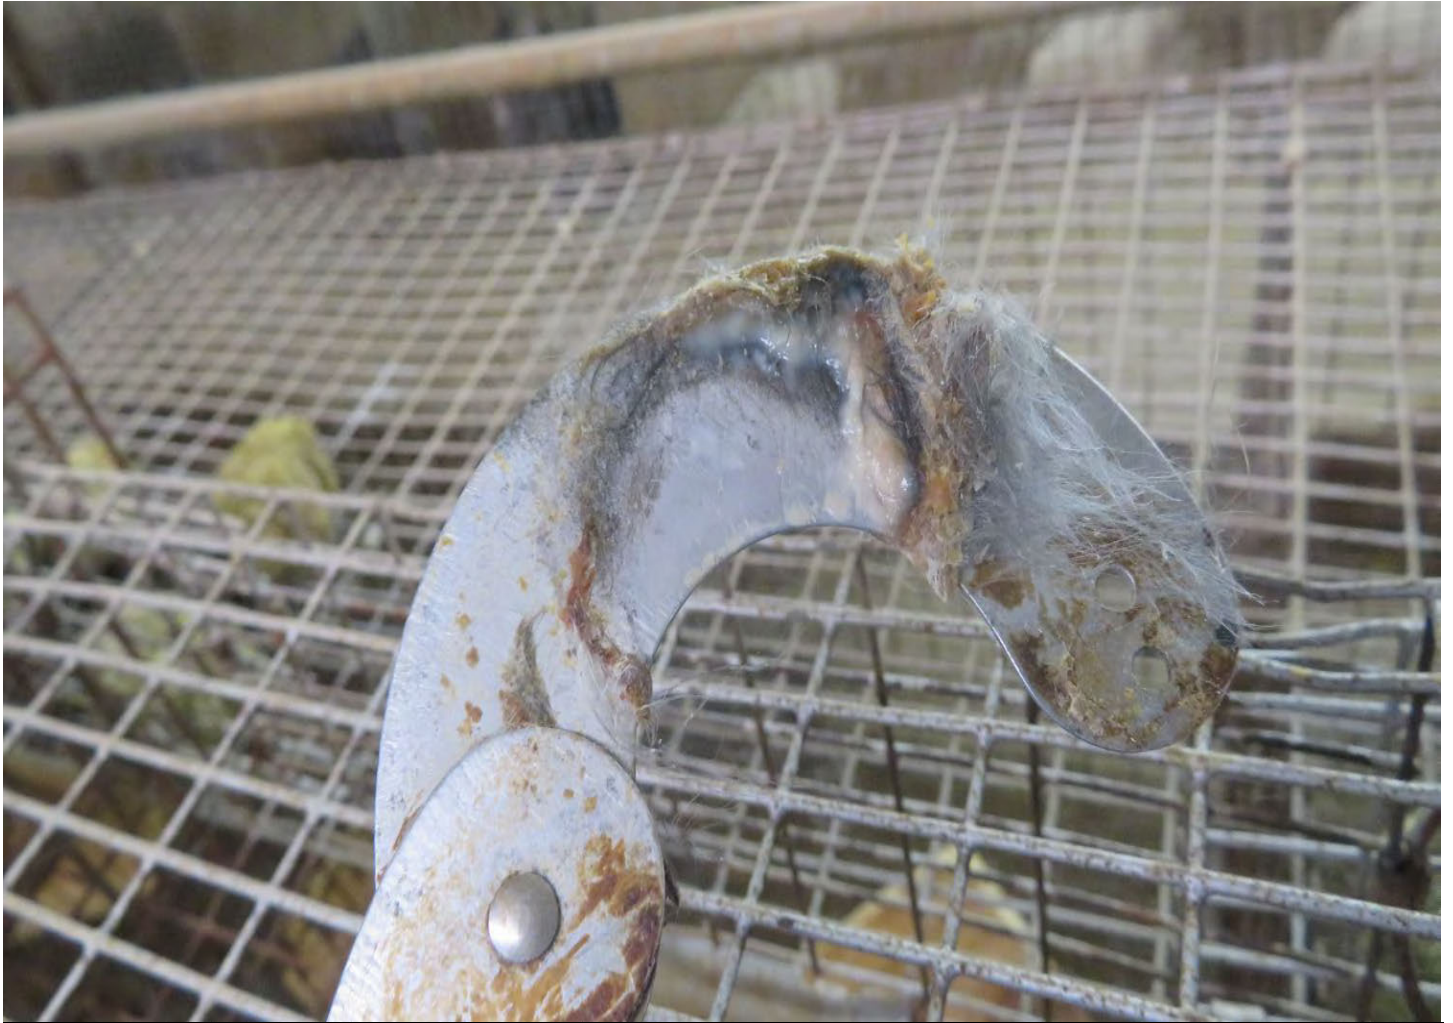
Flip-side of collar that was on 47D female; crusted tissue and pale liquid discharge on area of collar that was embedded in neck.

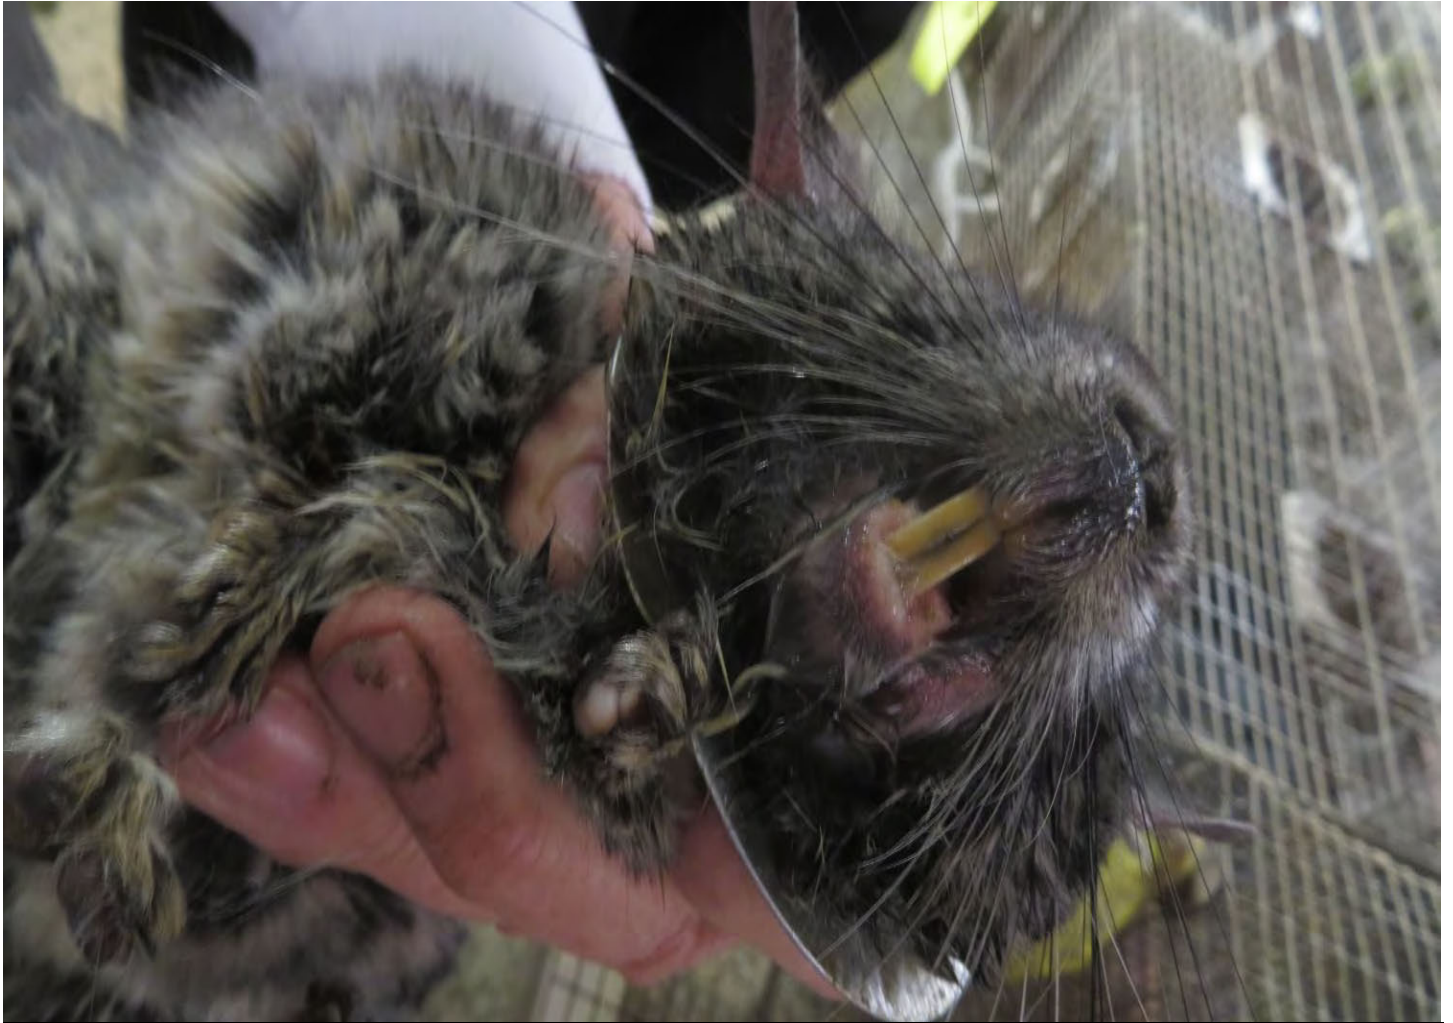
Overgrown teeth in female that is housed in 75; drooling/wet hair noted under her chin and she was not able to close her mouth likely because her lower teeth were too long and hitting the upper gums.

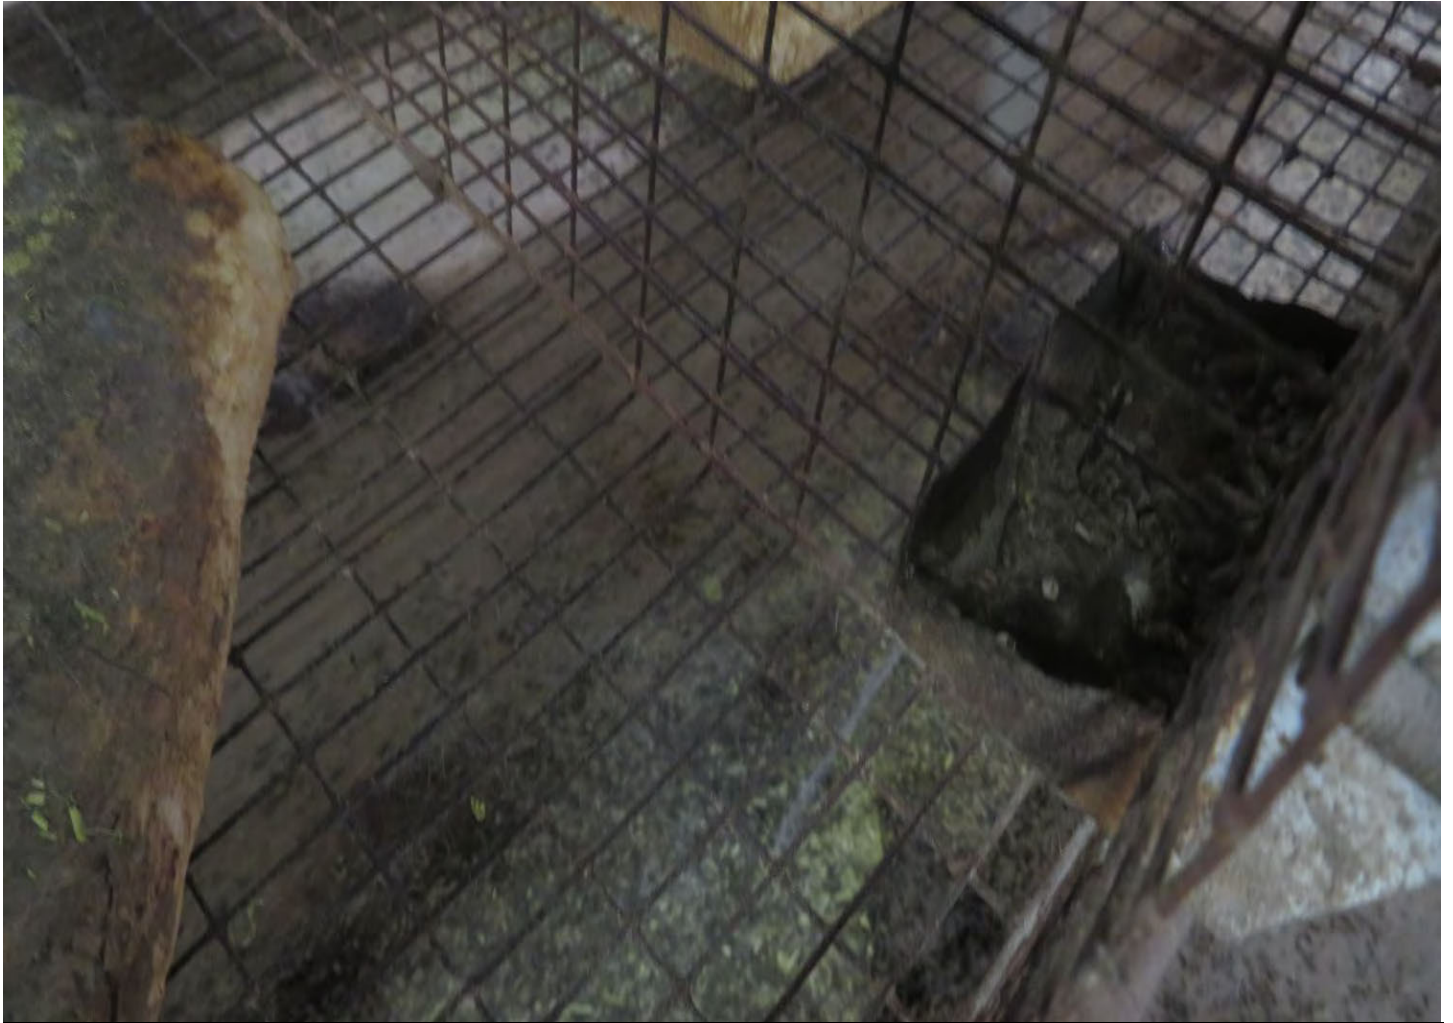
Close-up of a feeder with rusted edges that make the edges rough and sharp.

Representative of feeders seen that need replaced/repared.

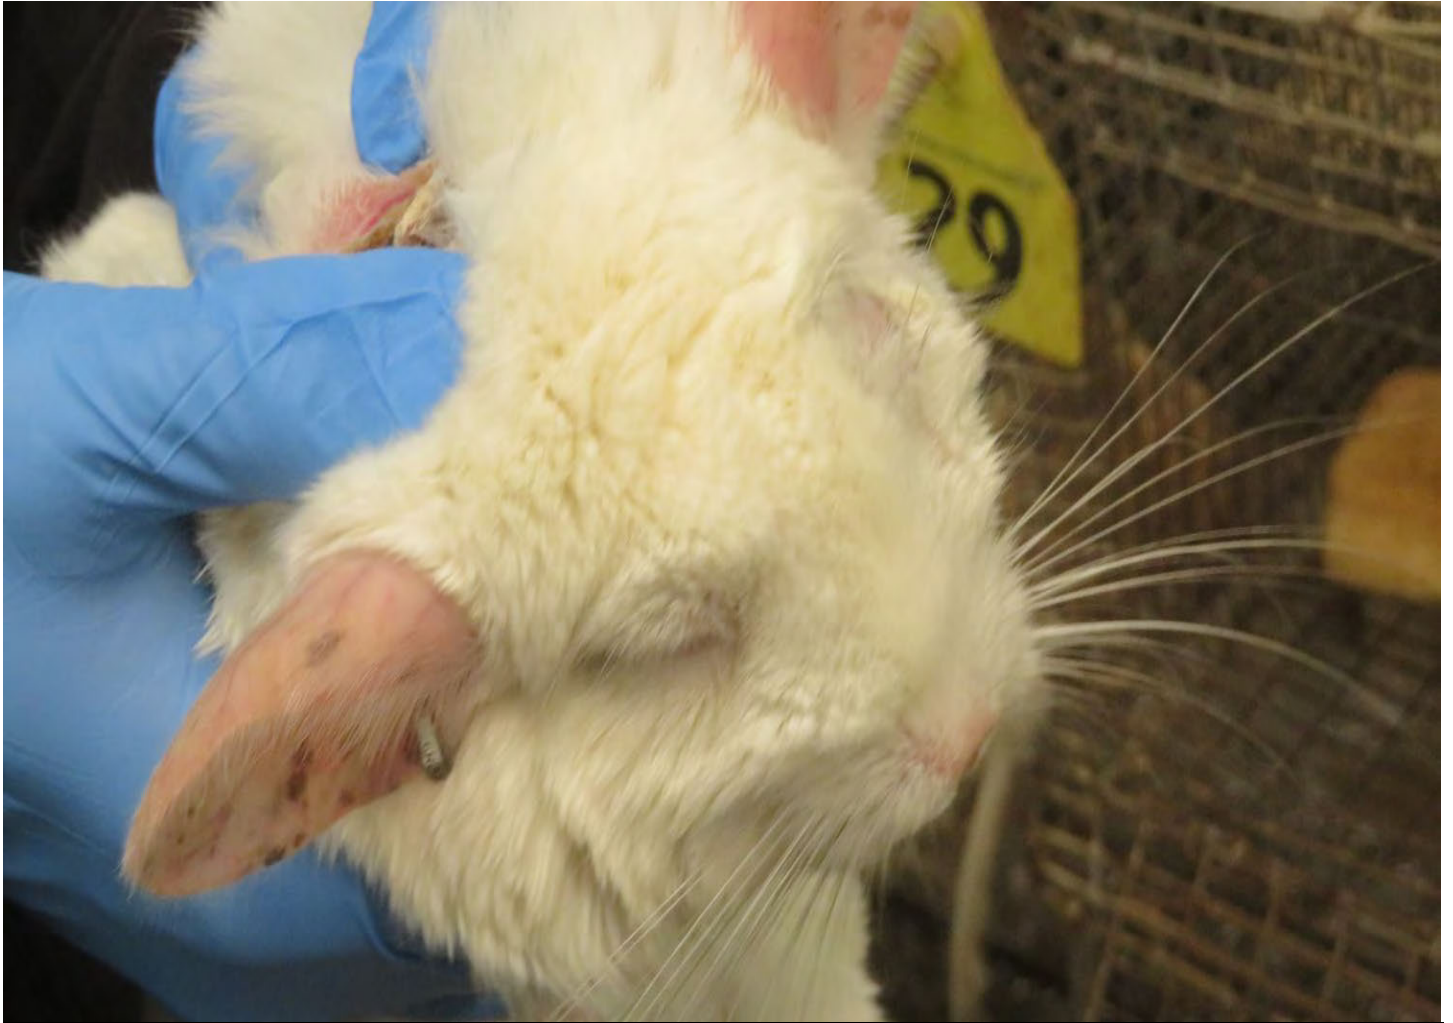
Overview of chinchilla with neck lesions

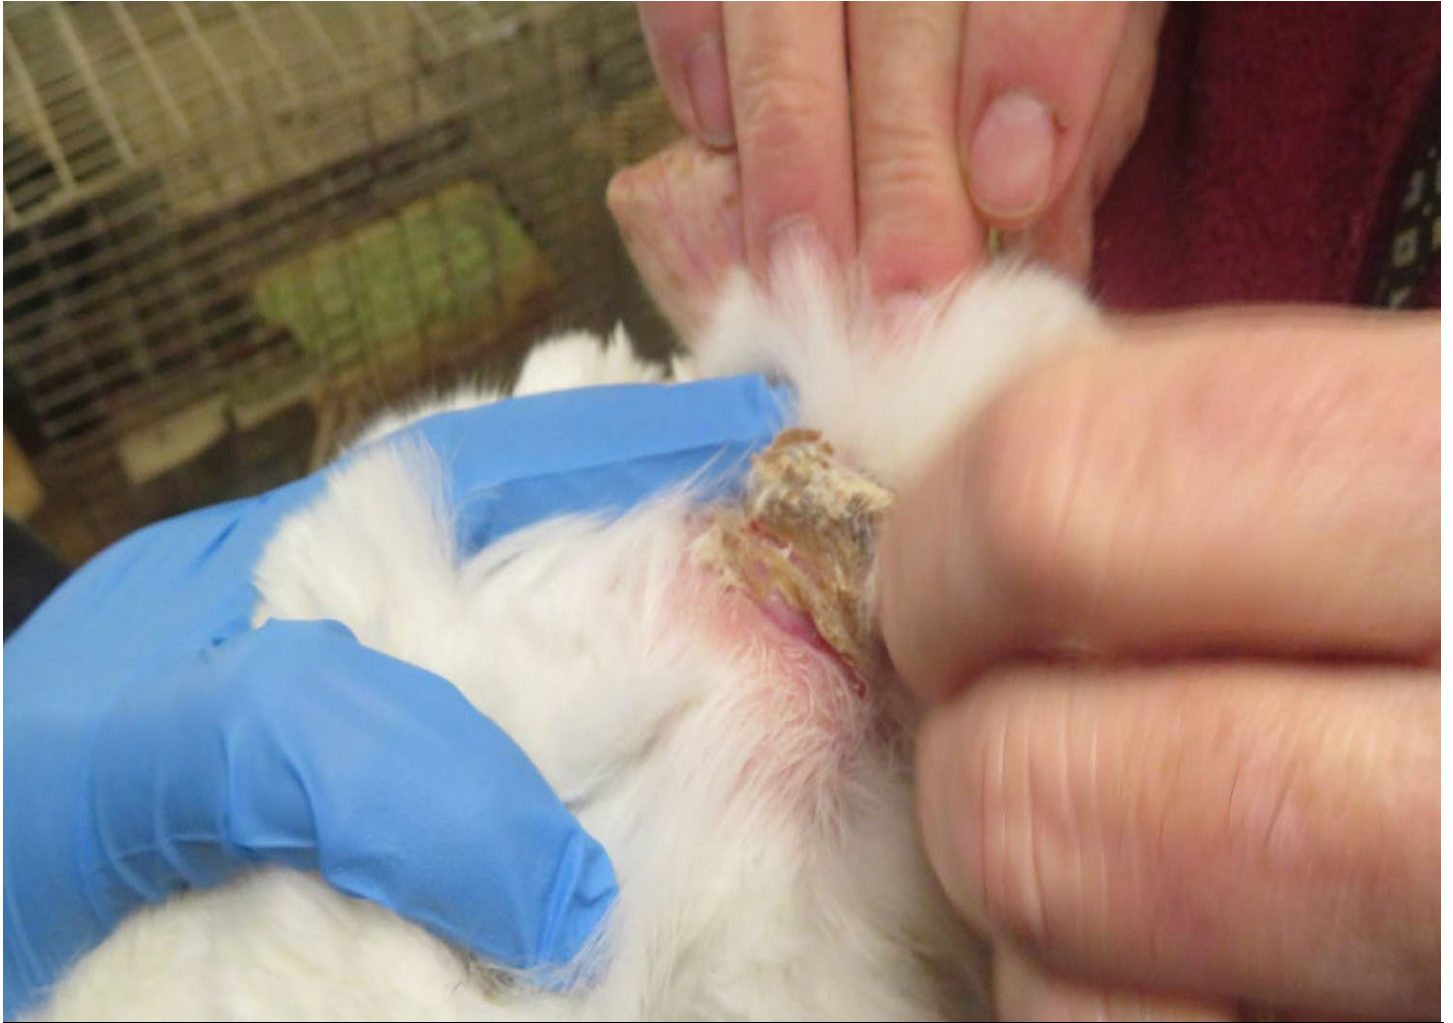
Dorsal view neck lesion from collar.

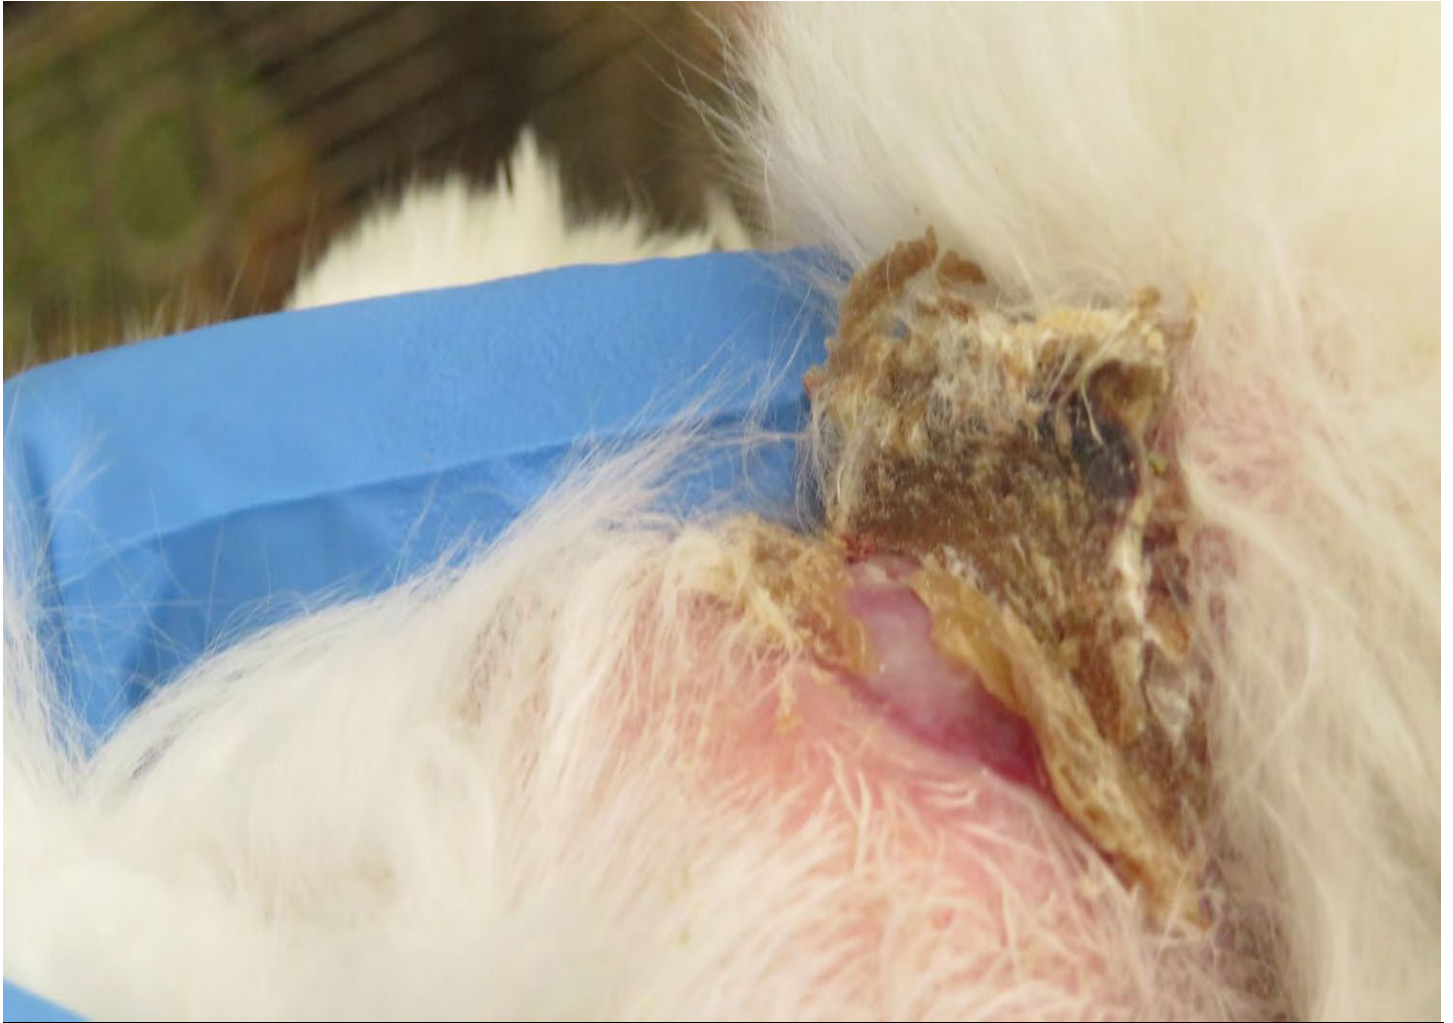
Dorsal view neck lesion from collar.

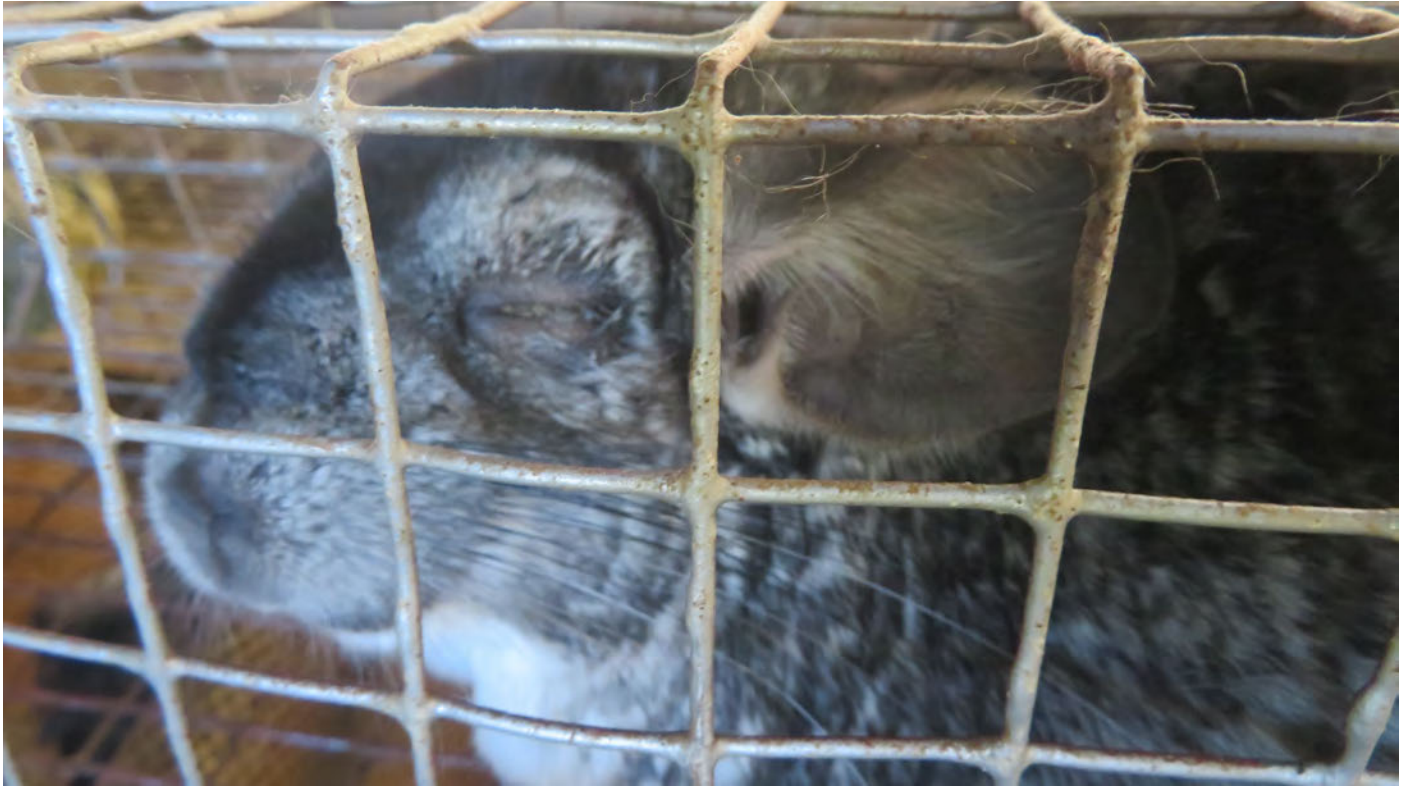
**Description:** Male (housed in bank 104) chinchilla's left eye had swollen eyelids with some hair-loss and was crusted shut.

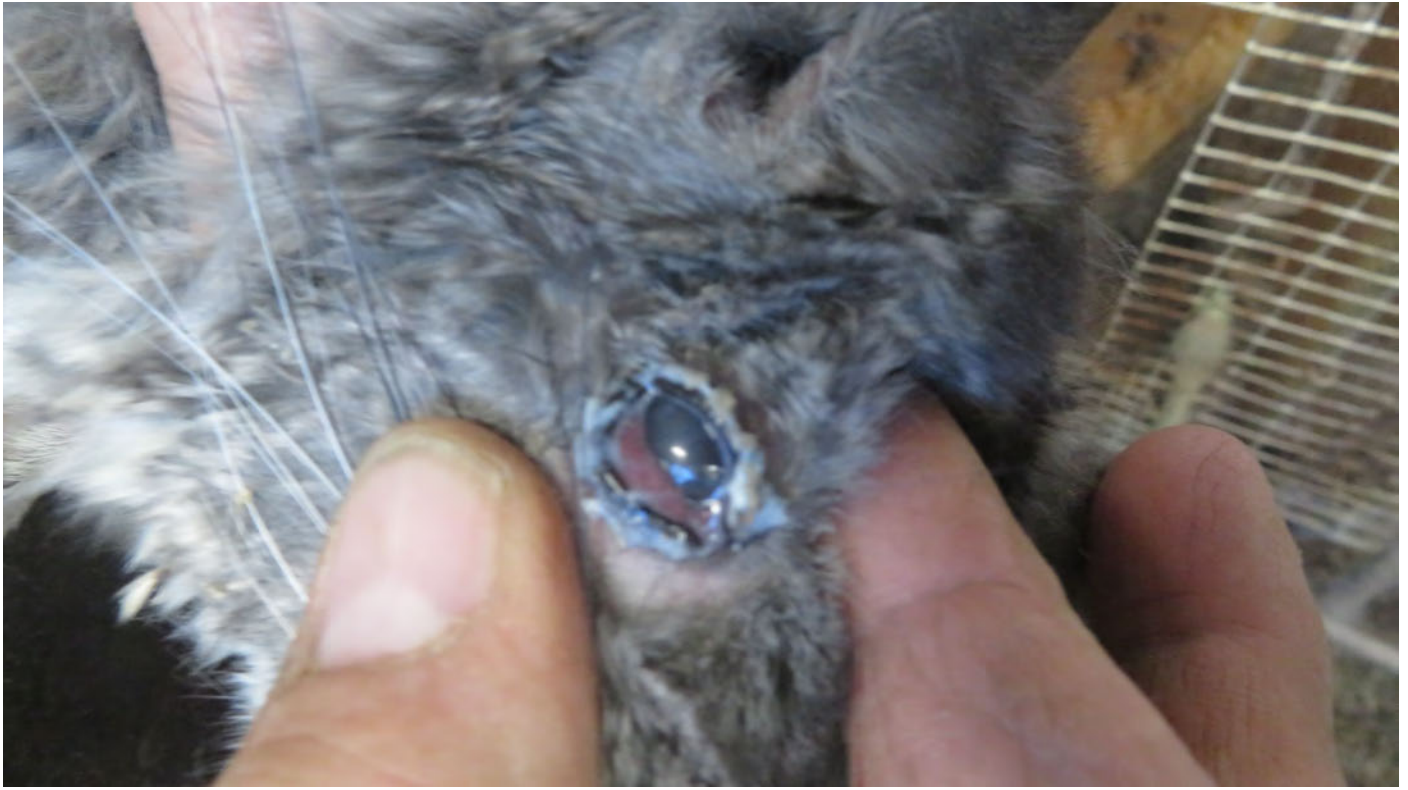
**Description:** Chinchilla in 119D; its right eye had some crusting and some discharge in its eye that had not been recognized by the facility prior to inspection.

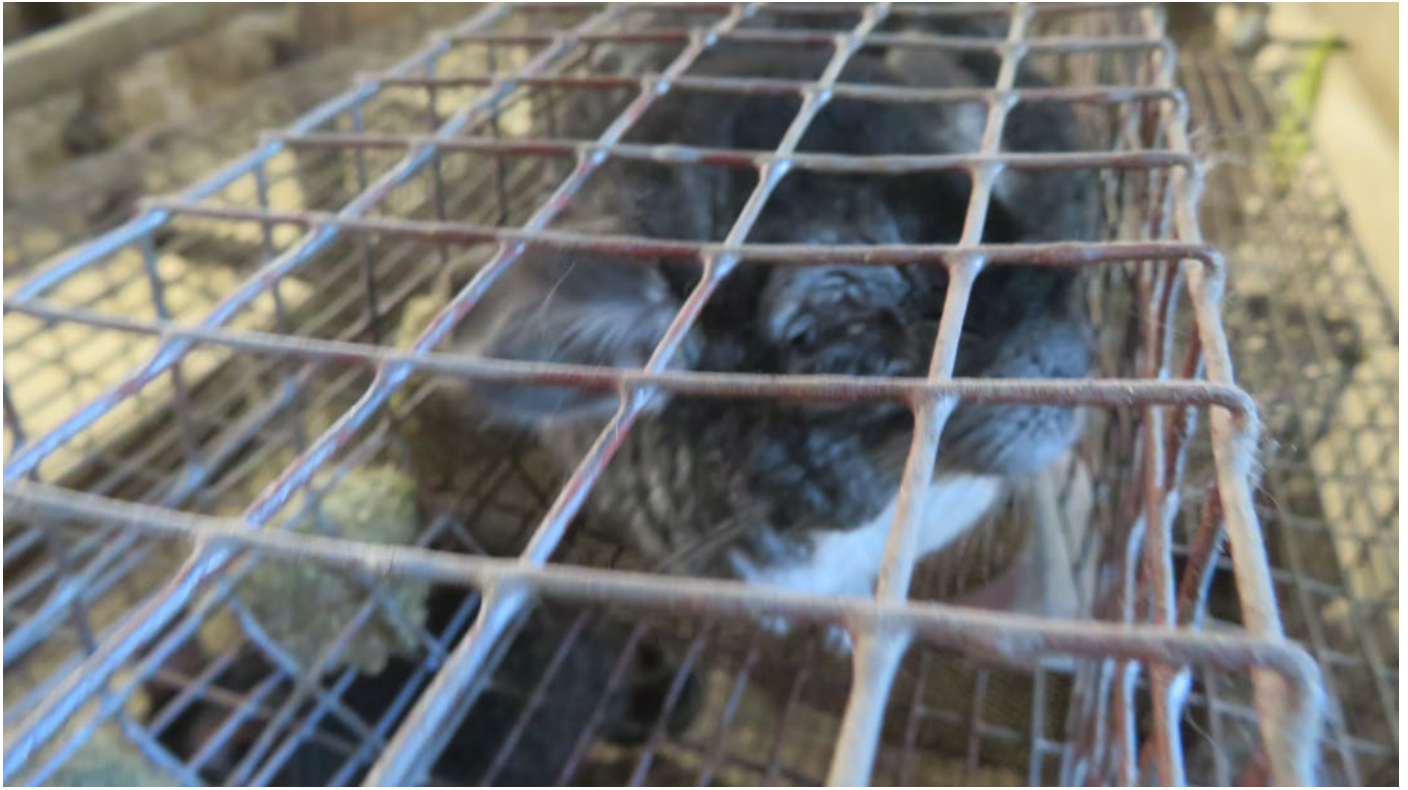
**Description:** Male chinchilla's right eye (housed in bank 104); crusting was seen by the eyelids. This is the same chinchilla with swollen eyelids on its left eye.

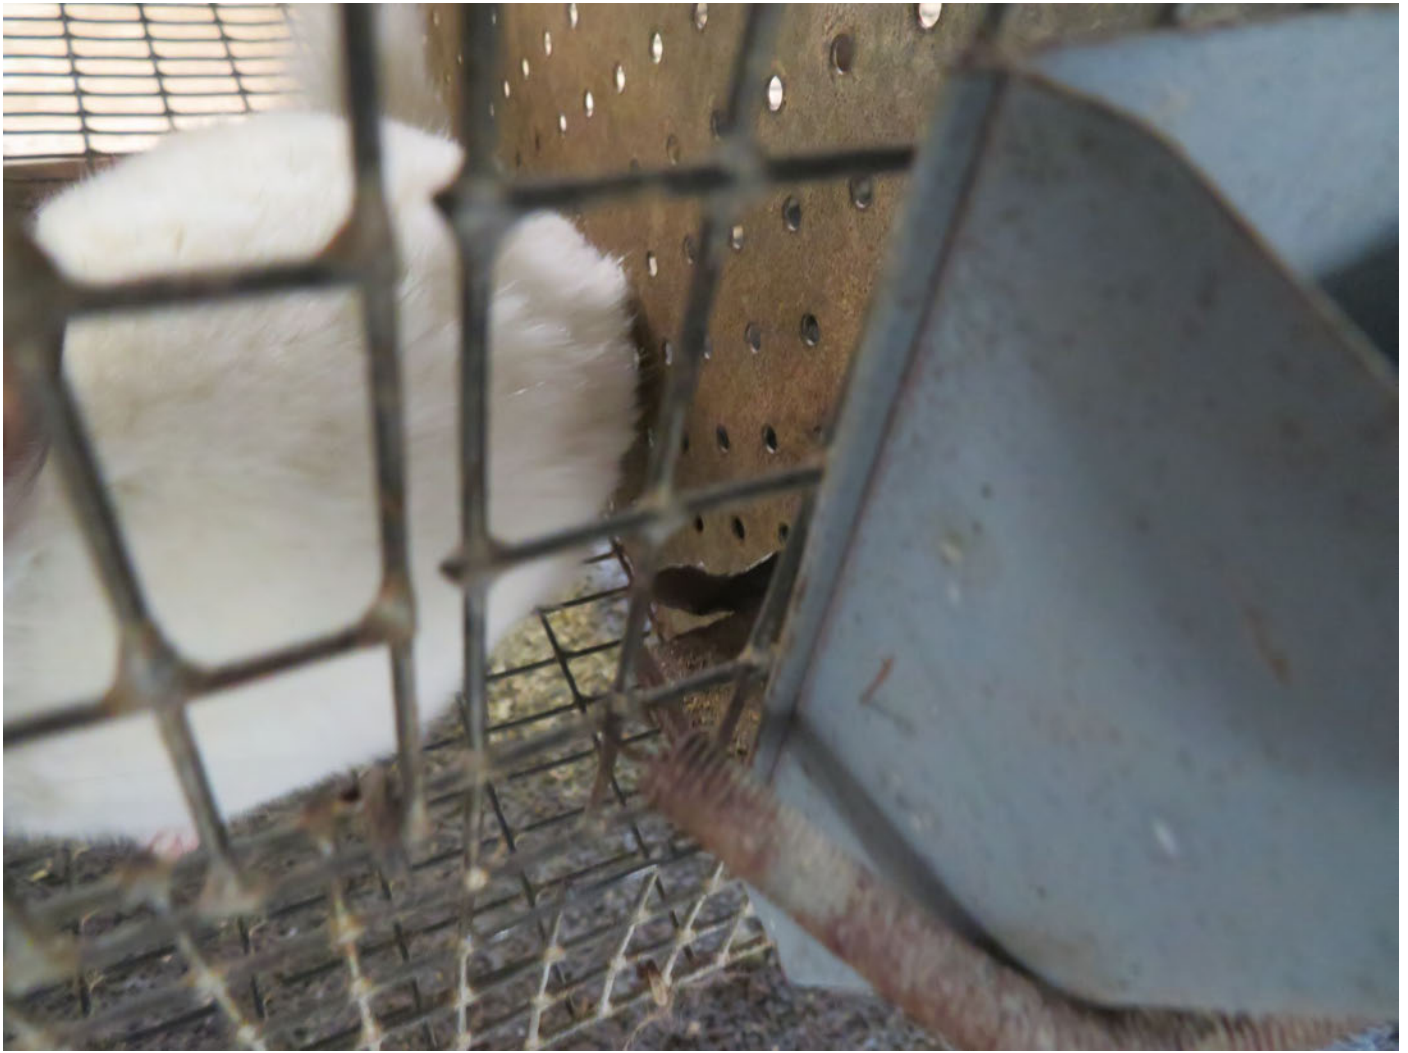
**Description:** Feeder with jagged, rusted edges exposed to the animal. This is representative of other affected feeders we observed.
