**Inspection No: 2016082569742232**

**Certificate: 41-B-0239**

**DAN MOULTON**

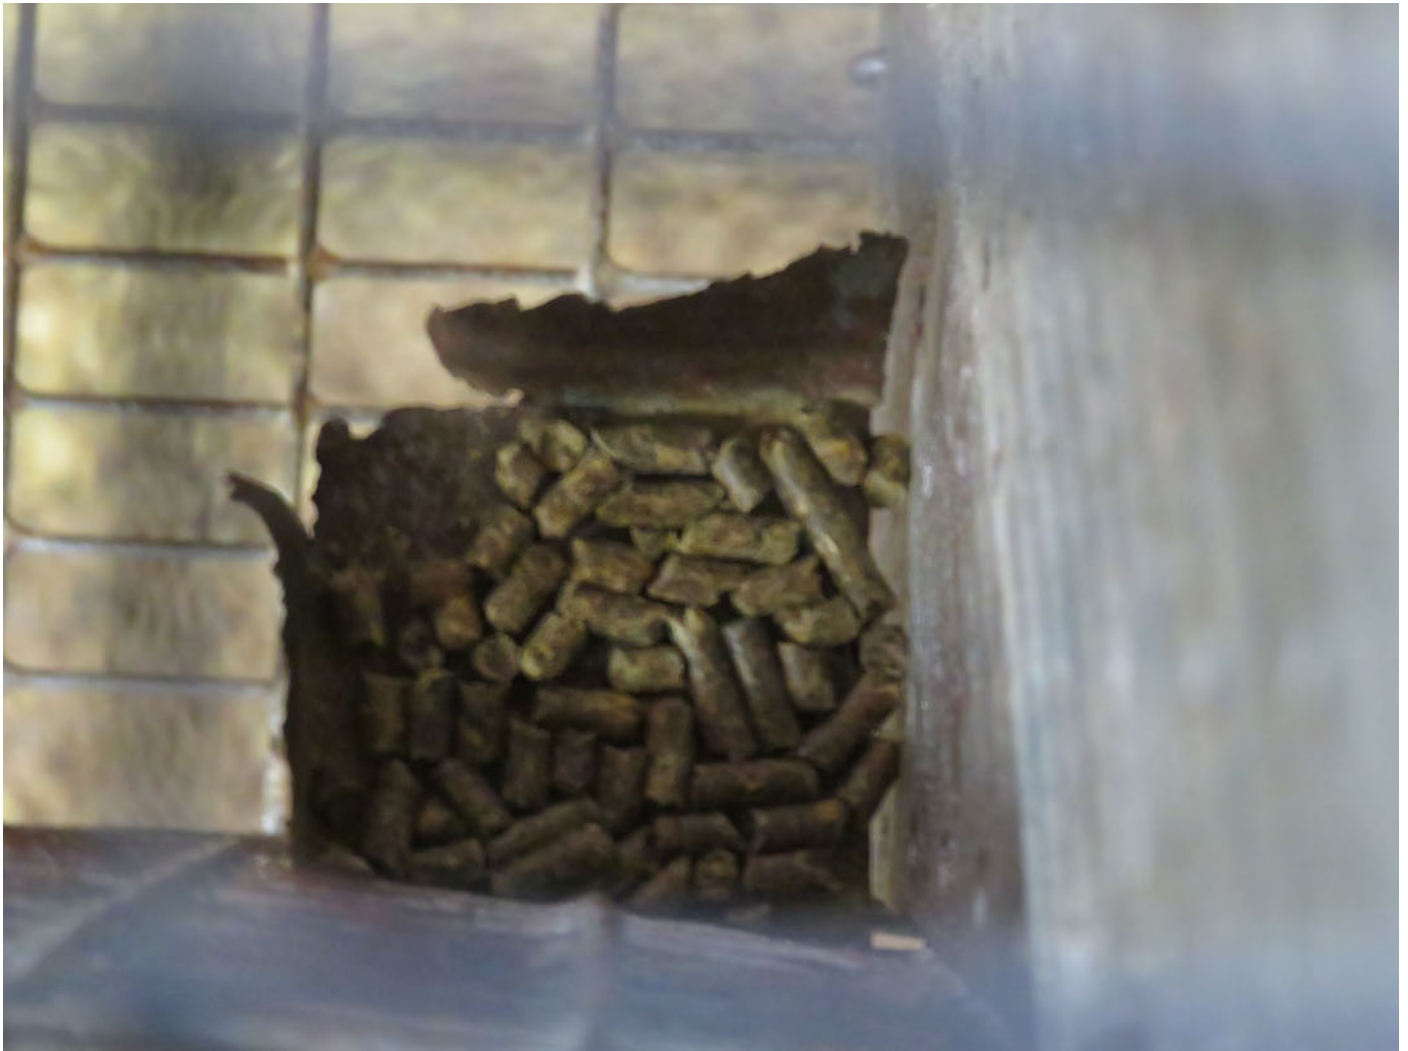
**Description:** Feeder with jagged, rusted edges exposed to the animal. This is representative of other affected feeders we observed.

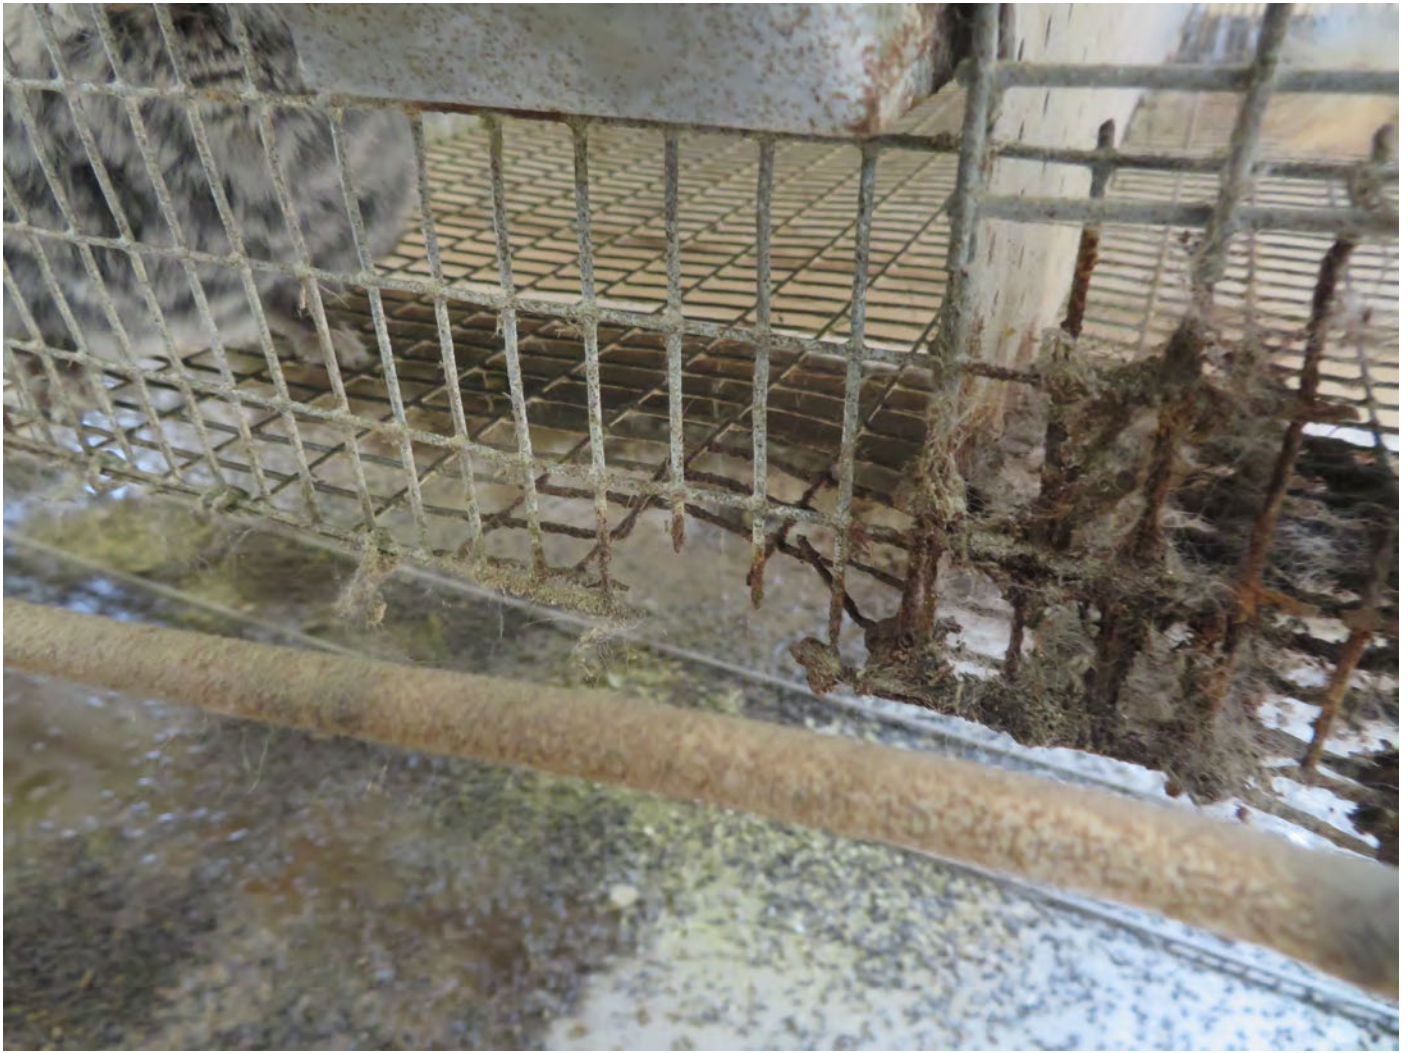
**Description:** Broken wires in enclosure floor, representative of other 6 enclosures with broken wires and points in floor. During inspection, the licensee moved the chinchillas out of affected enclosures to enclosures without points.
