Water Hazard Assessment in Active Shafts in Upper Silesian Coal Basin Mines

Przemysław Bukowski

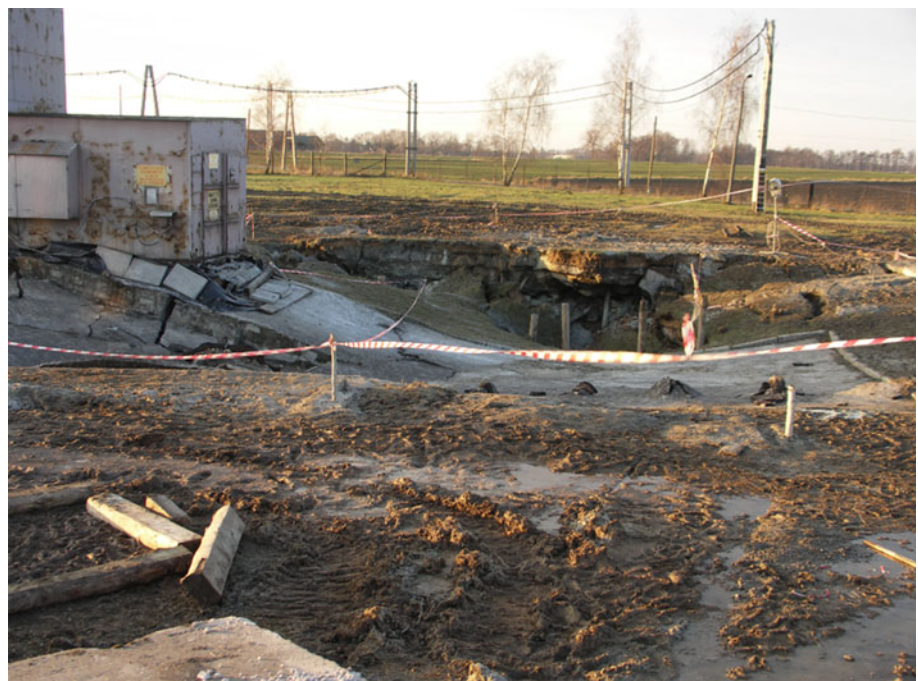
In December, 2007, a fast progressing subsidence basin was observed near ventilation shaft V above mine ‘A’ (Fig. 4). The surface deformations corresponded with relatively shallow horizontal mine workings (locally referred to as a ventilation lunette) that connected the shaft with the main ventilation station. Meanwhile, underground, water

Fig. 4 Subsidence funnel next to ventilation shaft V of Mine A and uncovered cores of freezing bore-holes along ventilation lunette

The Quaternary strata in which the ventilation lunette was constructed consisted mainly of tills and silty clay. Unfortunately, the ventilation lunette connecting the shaft with the ventilator station (diffusers) was located at the bottom of a clay layer. During construction in the 1970s, a thixotropic silty-sand zone beneath the clay layer was penetrated. Construction in such conditions was possible using the rock mass freezing method (Yang and Wang 2005). The initial cause of the inrush in the shaft was probably associated with the use of this construction method atop the water-saturated sand. Technical difficulties in constructing the shaft and its underground connection with the ventilation station are evidenced by the many borehole cores from the freezing process appearing along its route (Fig. 4).

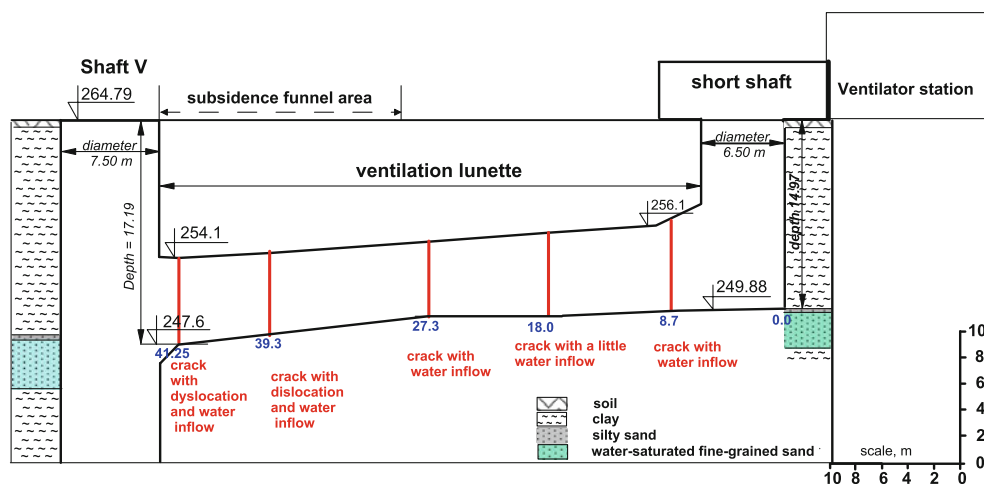
The event caused several potential hazards: the incursion of the water-saturated overburden material, subsidence, the danger of instability of the ventilation shaft, and as a consequence, a ventilation hazard (methane), which could have ended mining at the site. Observers stated that during the failure, that the connection of the ventilation lunette with the shaft pipe separated from the shaft entry and the lunette appeared to be “sinking” in the water-saturated fine-grained sand (Fig. 5).

Although it is possible that suffusion and liquefaction of the water-bearing strata caused the failure, it appears more likely that a rock mass tremor caused by the mining, or vibrations associated with either the mining or the nearby station of ventilators, liquefied the thixotropic sands, essentially creating flowing quicksand. The lunette was located on the sand layer and so it started to crack laterally, and descend, under its own weight and the vertical pressure of the material lying above it, into the sand. The movement resulted in the exposure of the shaft pipe entry, through which water and water with suspended material, as well as fragments of the damaged lunette and shaft lining, fell.

Fig. 5 The nature of shaft V and ventilation lunette construction at Mine ‘A’ and the initial symptoms of failure

The water hazard rapidly became a ventilation hazard for a significant part of the mine. The potential increase in methane concentrations and the hazards potentially associated with the subsidence funnel required rapid emergency operations, which proceeded with scientific support, including support from the Central Mining Institute. This resulted in closure of the entry to the shaft and water and rock mass immobilization (Tor et al. 2008). The outflow was dammed, reestablishing a water table within the

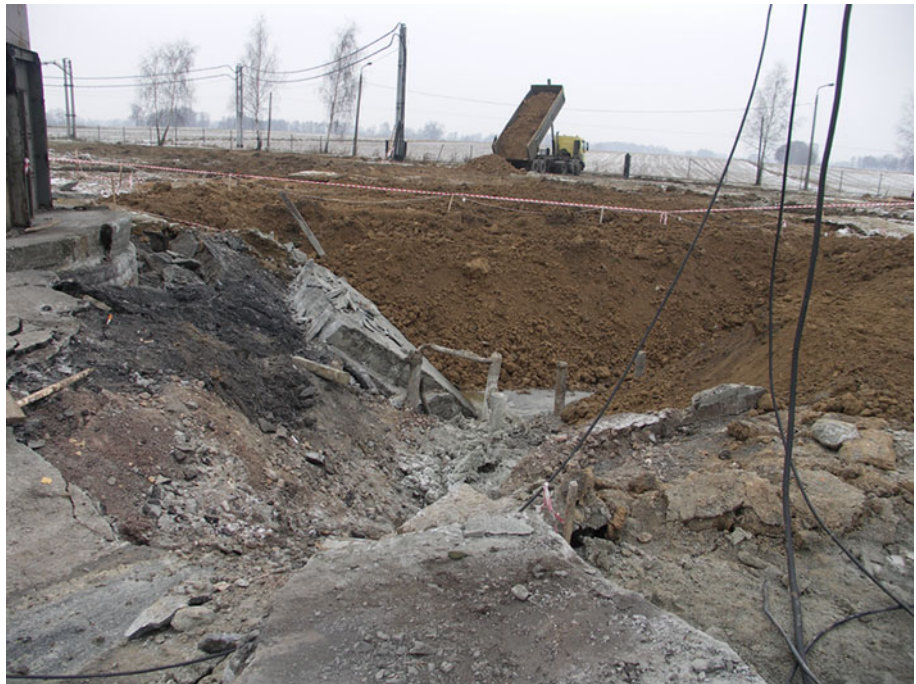
Fig. 6 The subsidence basin as it was being filled with clay— Occurrence of water in the subsidence basin after closure of the entry to shaft V

water-bearing stratum, revealed by the accumulation of water in the subsidence basin before it was filled (Fig. 6).

The water hazard was also fought from within the mine. At the bottom of shaft V, at the 1,000 m level, a gypsum seal was established; from behind the seal, a series of drainage boreholes were drilled from within the mine workings to the shaft, allowing the water and suspended material to be drained. This reduced the rate at which the shaft was filling and helped reduce the water level in the reservoir of water that was accumulating above.

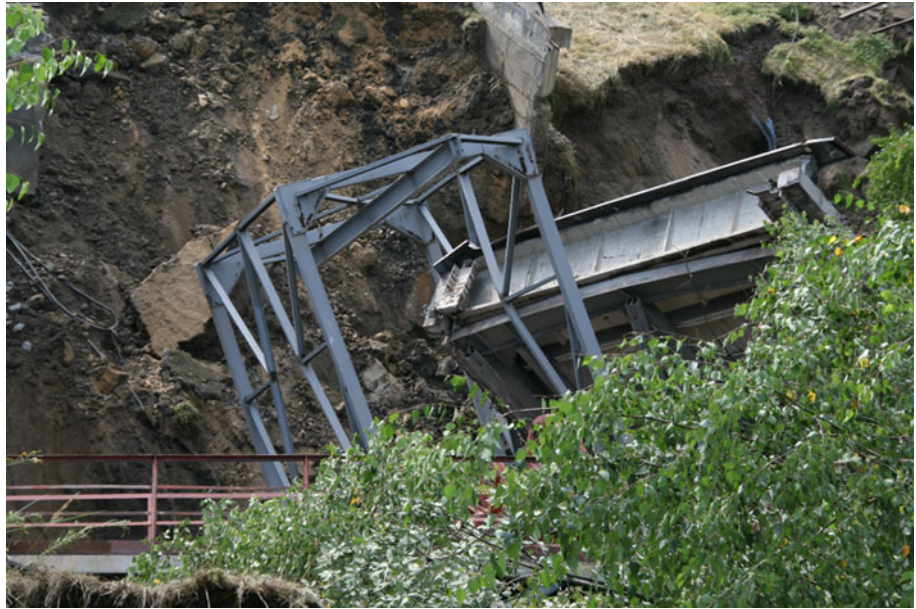
Mine ‘B,’ located in the western part of the Basin, had a near-catastrophe in September, 2008, as an undeveloped, unequipped exhaust shaft, also, ironically, referred to as shaft V, collapsed. Luckily, the event occurred on a Sunday and no one was injured or killed. After the event, a subsidence basin formed on the surface with a diameter of several tens of meters and a depth of about 15 m (Fig. 7).

In hindsight, the probable reasons for the shaft collapse were the intense influence of nearby exploitation, and changes in water circulation, which in turn affected geotechnical conditions and ground properties around the shaft. The influences of exploitation were strengthened by the occurrence of disjunctive tectonics; faults in the deposit series formations intersected the mine shaft. The influences of exploitation were revealed by shaft pipe subsidence and numerous discontinuous deformations within the shaft and shaft pillar. Discontinuous deformations with different density, gaps, and dislocation were observed at the surface. In the vicinity of the shaft pillar, these resulted in hydrogeological changes. Around the head of the shaft, underground water circulation, infiltration, surface flow, and flow through the local sewer system, were all significantly changed as a result of deformation caused by the exploitation. Conditions around the shaft deteriorated and along the whole lithostratigraphic profile, there were changes in the strength and strain parameters of the Quaternary rock around the shaft, as well as an overall increase in humidity within the mine.

Fig. 7 Results of the shaft failure in Coal Mine B; note remains of shaft tower in subsidence basin

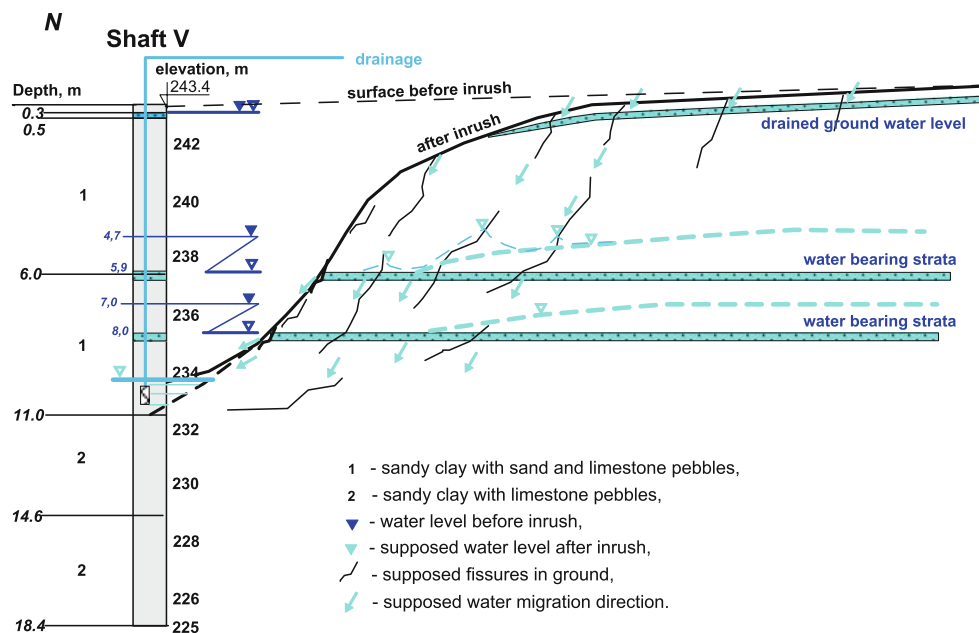
exposed to flowing water and/or water vapour condensation in the shaft, and fall into the shaft, destroying the shaft lining. Water-ground conditions that had been changed by the exploitation exposed small zones of unconsolidated water-bearing sands which, despite being small, intensified the movement of rock and water to the shaft. Increasing damage to the shaft lining, together with the increasing water load and the humid shaft atmosphere (a fog layer formed almost 200 m below the head of shaft) resulted in an unstable environment and the collapse of the shaft. This, in turn, led to the collapse of the surface structure, the

formation of a deep subsidence basin, changes in the hydrology of the rock formations near the shaft, the accumulation of methane in the mine, and disturbance of ventilation in the neighbouring mine (Fig. 8).

Fig. 8 Results of the inrush to the shaft and its influence on water conditions in the Quaternary formations around the shaft

All of the active mine workings in the area were threatened by the water-saturated material that filled the shaft conduit and the water that was accumulating in the subsidence basin, since the shaft provided a conduit for the water to reach all of the mine levels. Remedial action required the speedy construction of underground dams and seals in all mine workings connected to the shaft.
