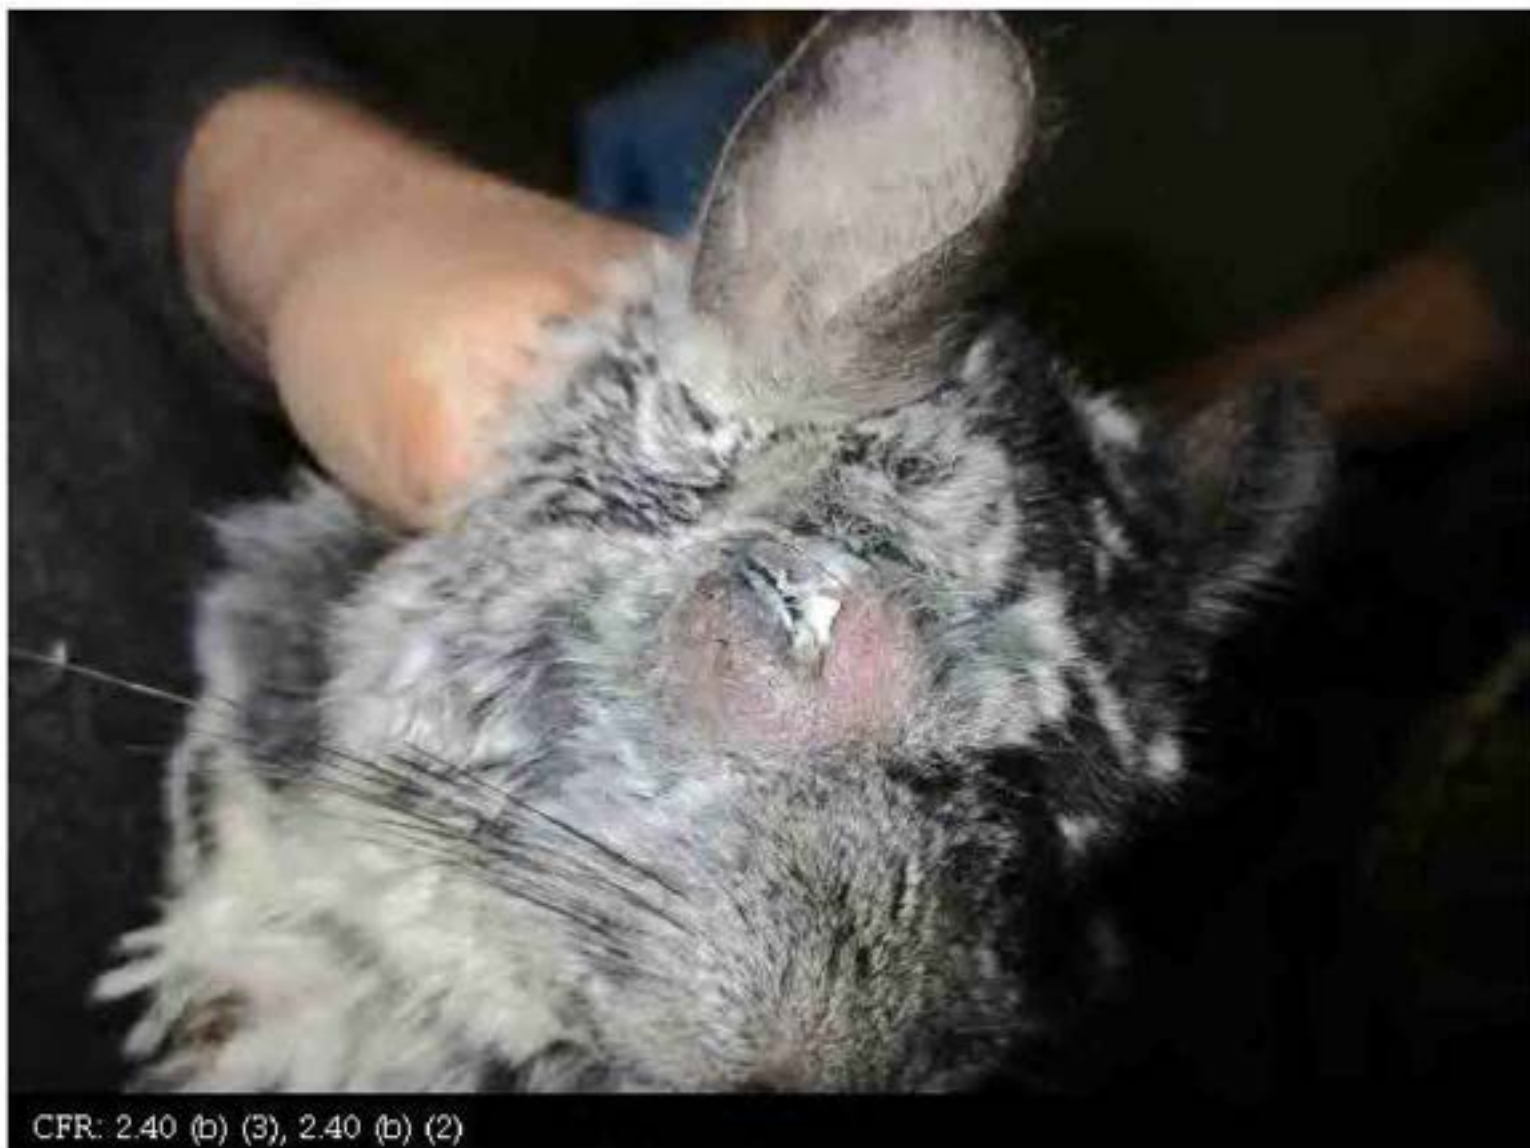
Photographer:	Kevin Wilken	Legal Name:	41-B-0239
Photo Taken:	Wed, Feb 3, '16	DAN MOULTON	
Inspection:	40161623280694		
Description:	Female with eartag "505"; close-up of its right eye.

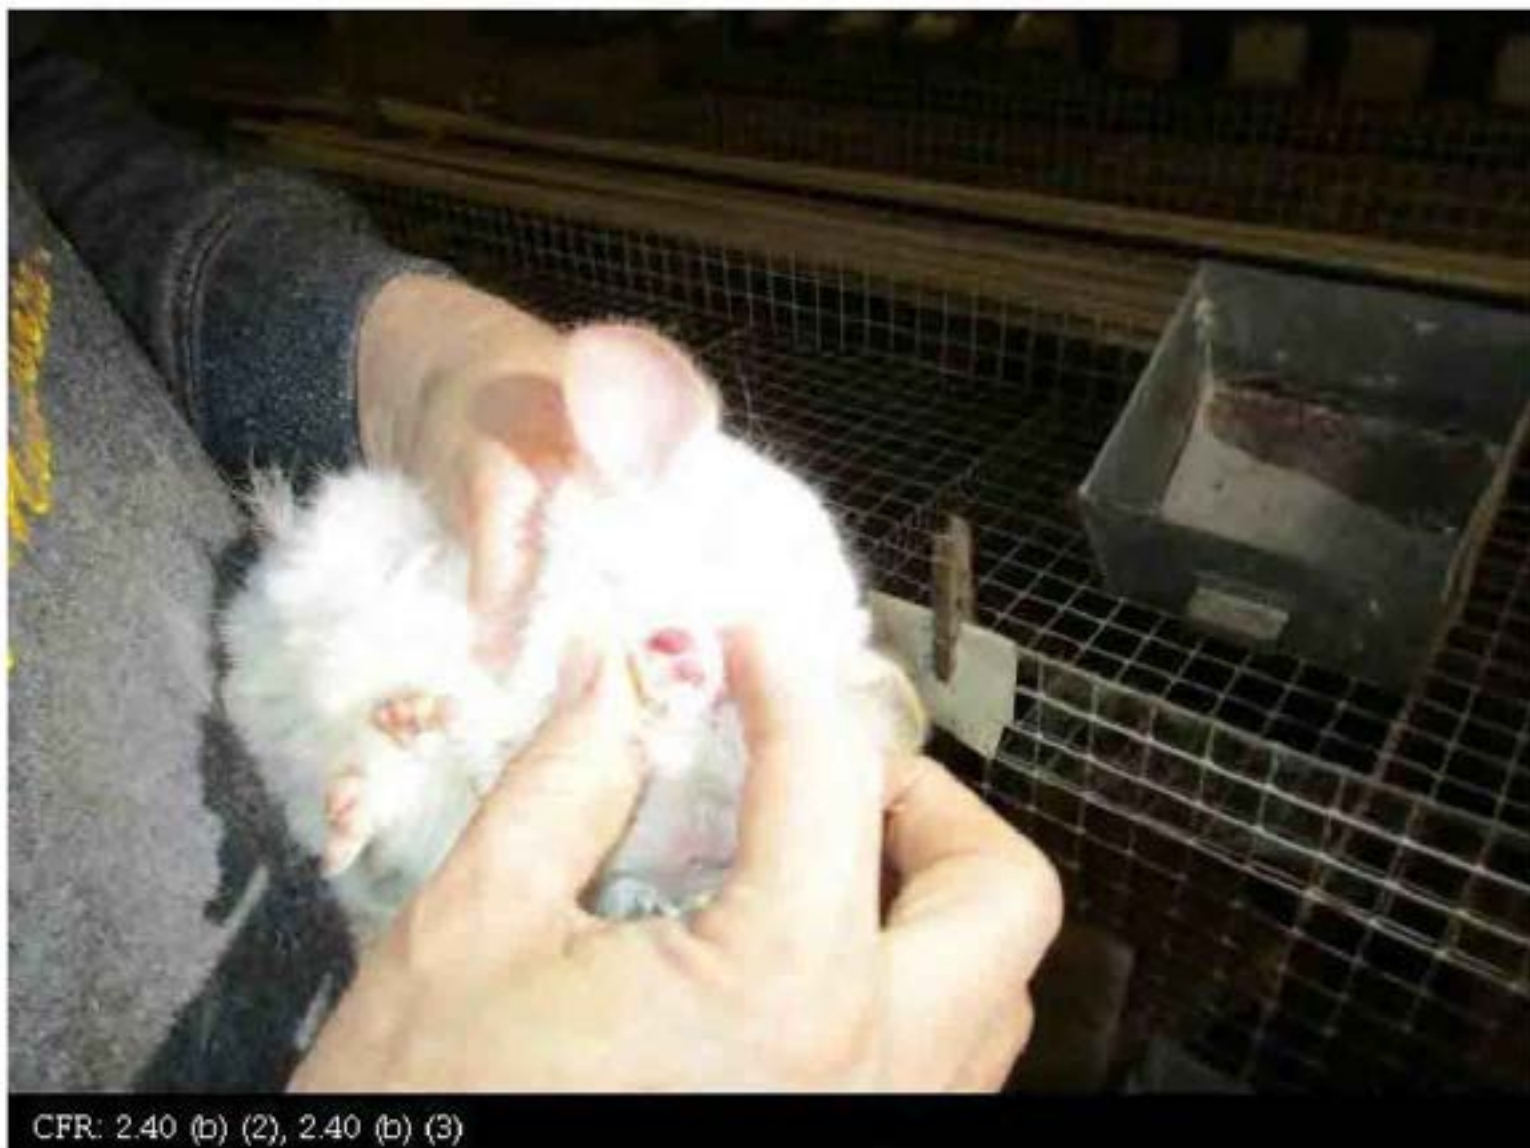
Photographer:	Kevin Wilken	Legal Name:	41-B-0239
Photo Taken:	Wed, Feb 3, '16	DAN MOULTON	
Inspection:	40161623280694		
Description:	Male (no id; cage card "4-8"); its right eye was crusted shut; eyelids swollen with hair loss and surrounding tissues under eyelids bright red.

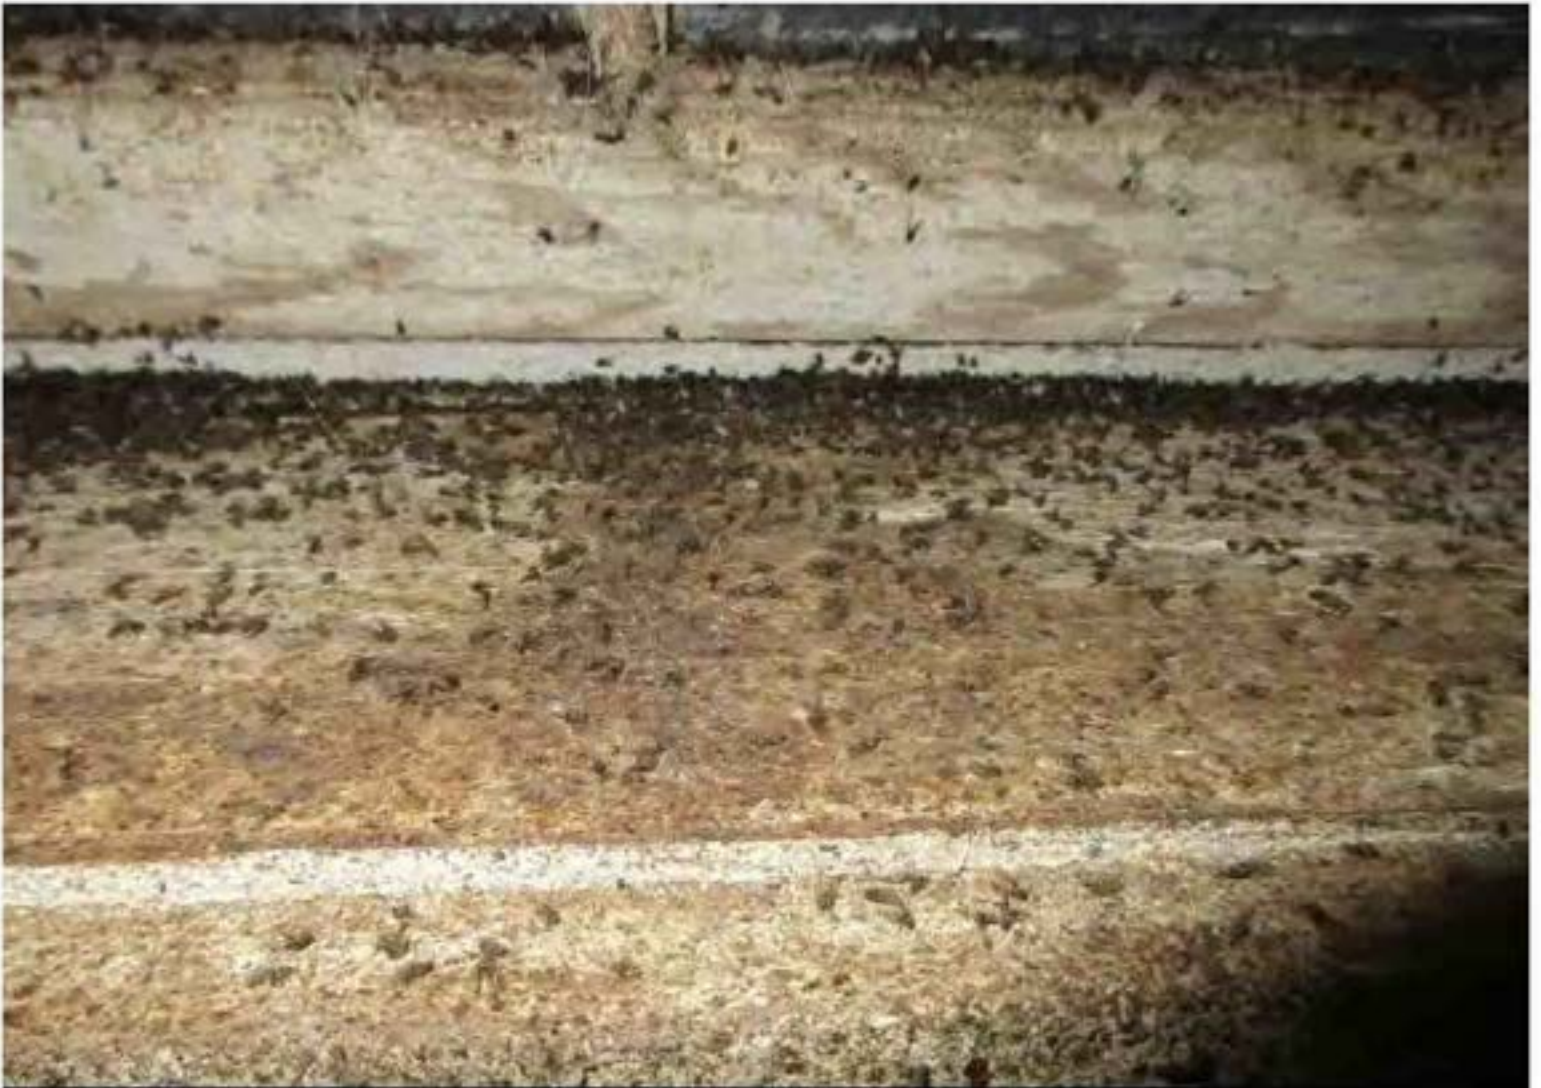
Photographer:	Kevin Wilken	Legal Name:	41-B-0239
Photo Taken:	Wed, Feb 3, '16	DAN MOULTON	
Inspection:	40161623280694		
Description:	Window sill covered with dead bugs and debris.

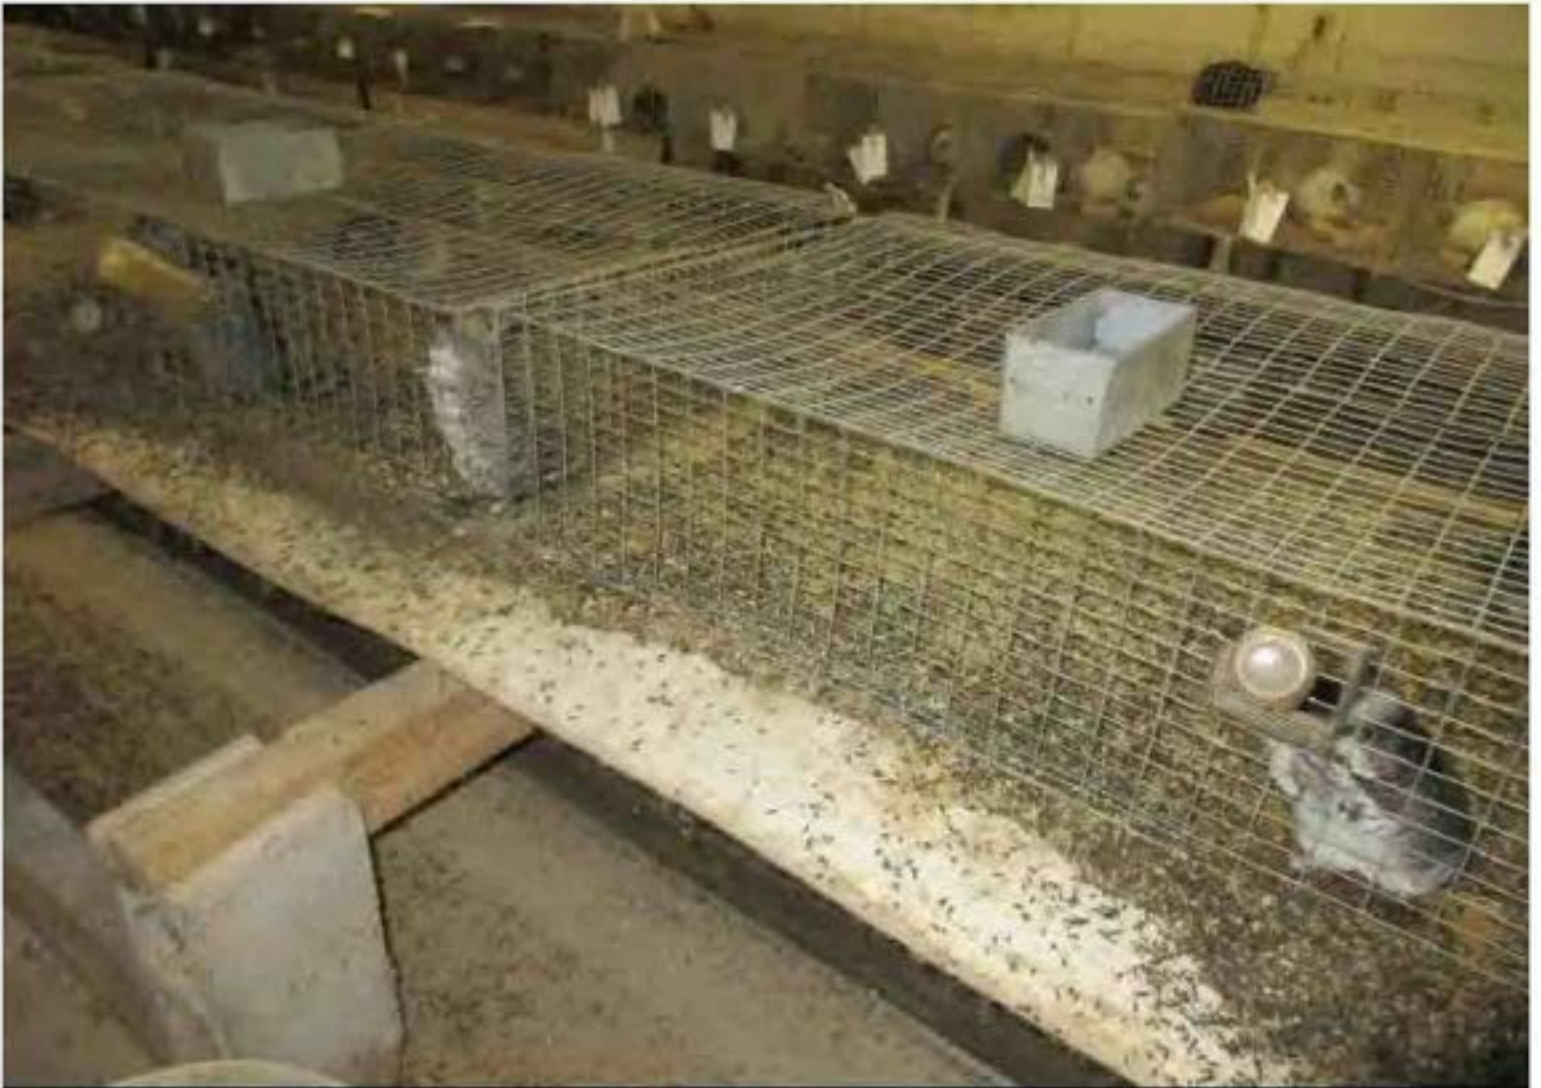
Photographer:	Kevin Wilken	Legal Name:	41-B-0239
Photo Taken:	Wed, Feb 3, '16	DAN MOULTON	
Inspection:	40161623280694		
Description:	Enclosure in back part of first room with excessive feces. Licensee stated it hadn't been cleaned in four weeks. Representative of enclosures housing about 38 animals in front room.

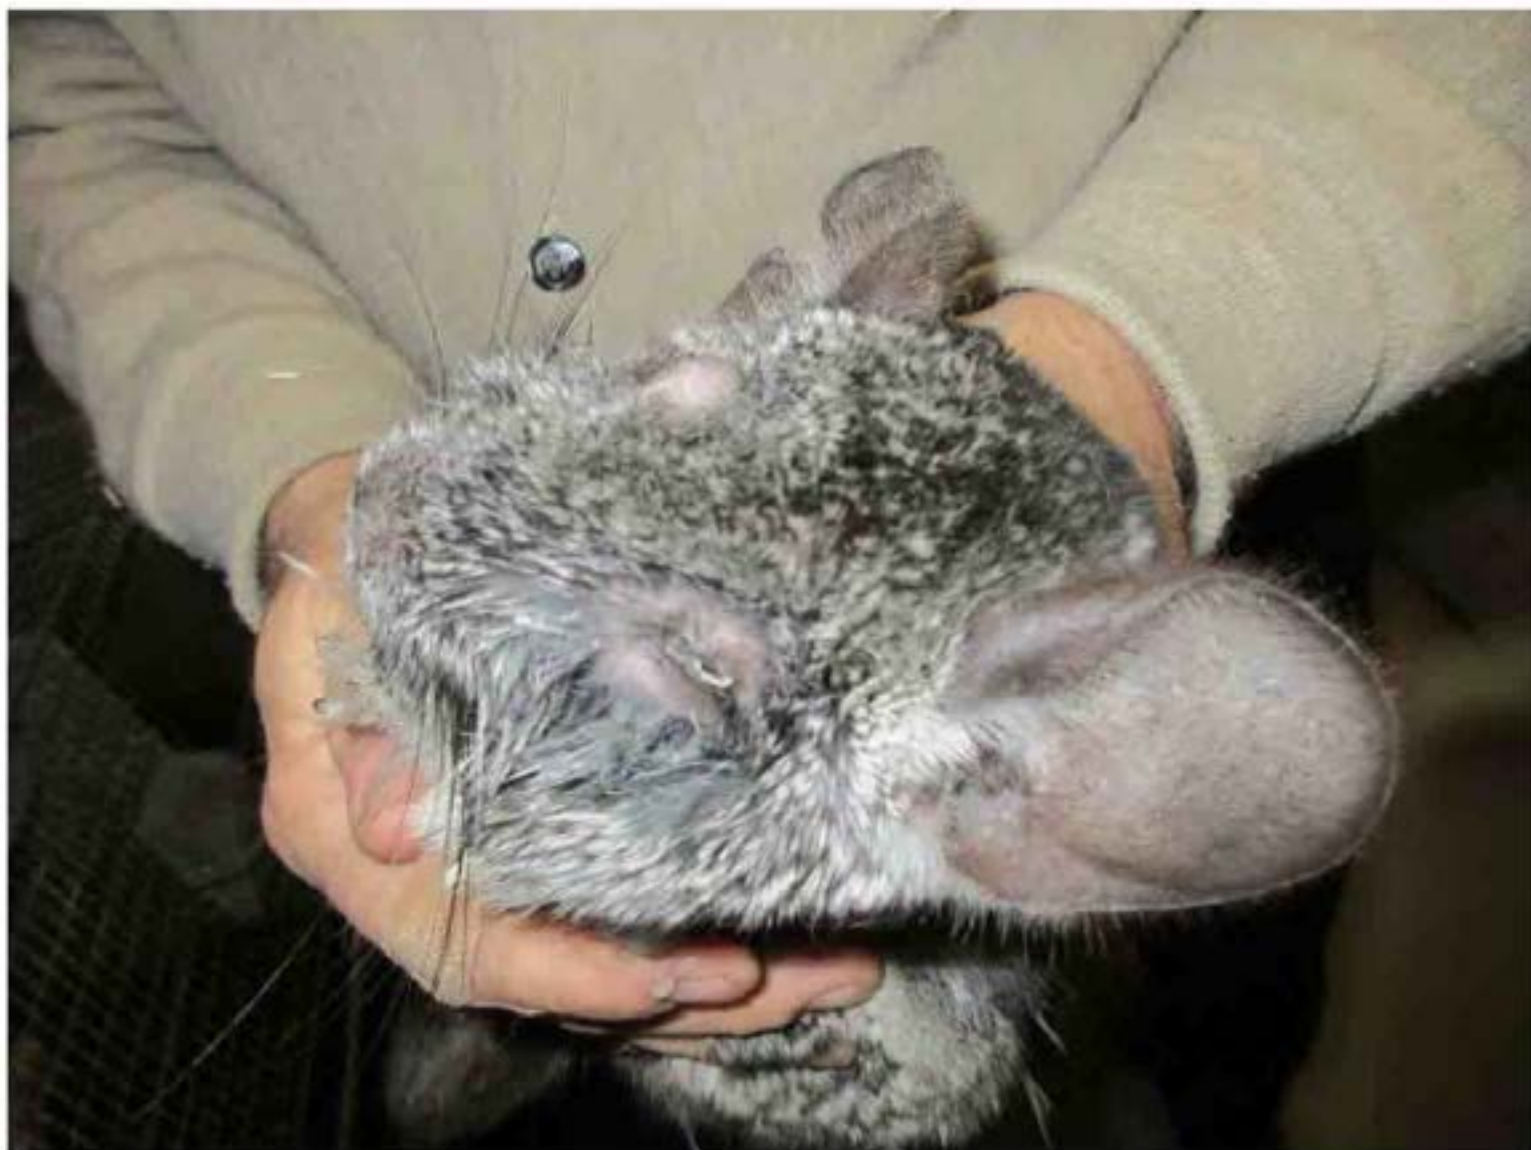
Photographer:	Scott Welch	Legal Name:	41-B-0239
Photo Taken:	Mon, Mar 14, '16	DAN MOULTON	
Inspection:	74161711400131		
Description:	Left eye black and silver female Chinchilla (eartag DJM 145). Per records, cage marker; and licensee, animal is receiving veterinary-prescribed treatment.

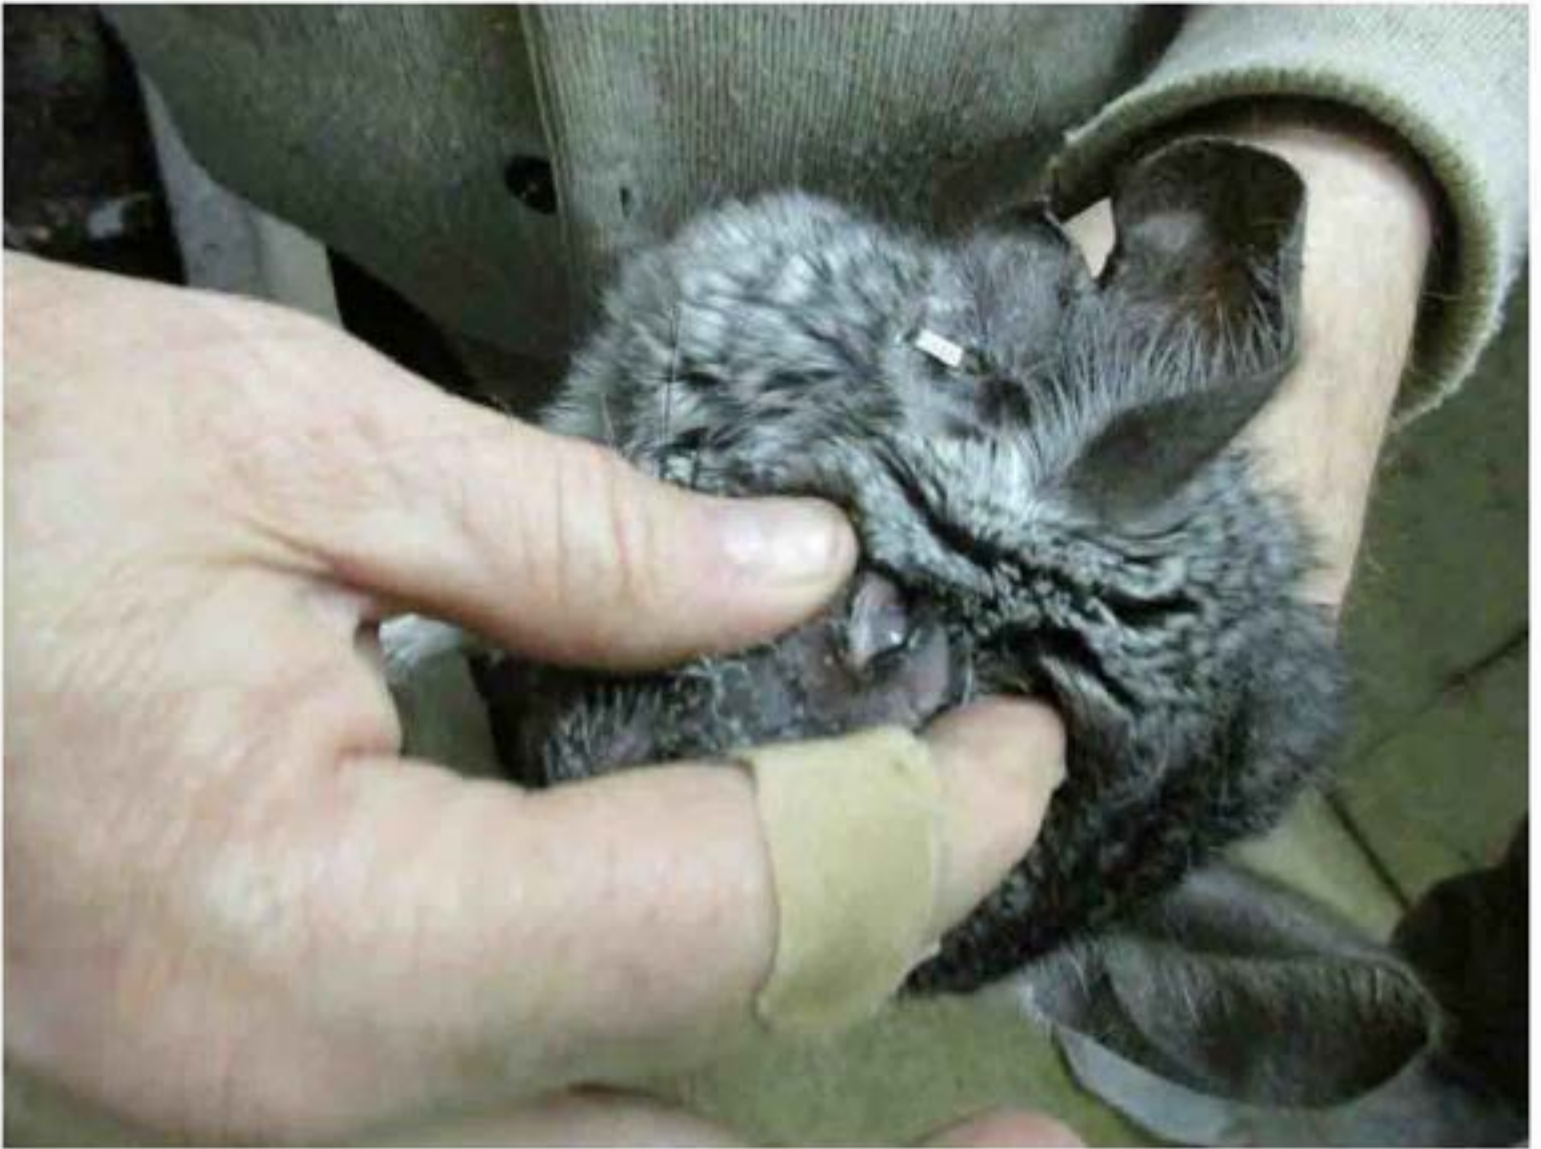
Photographer:	Kevin Wilken	Legal Name:	41-B-0239
Photo Taken:	Mon, Mar 14, '16	DAN MOULTON	
Inspection:	74161711400131		
Description:	Left eye of a silver and black female Chinchilla (eartag OKES108 or 801). Per records, cage marker; and licensee, animal is receiving veterinary-prescribed treatment.

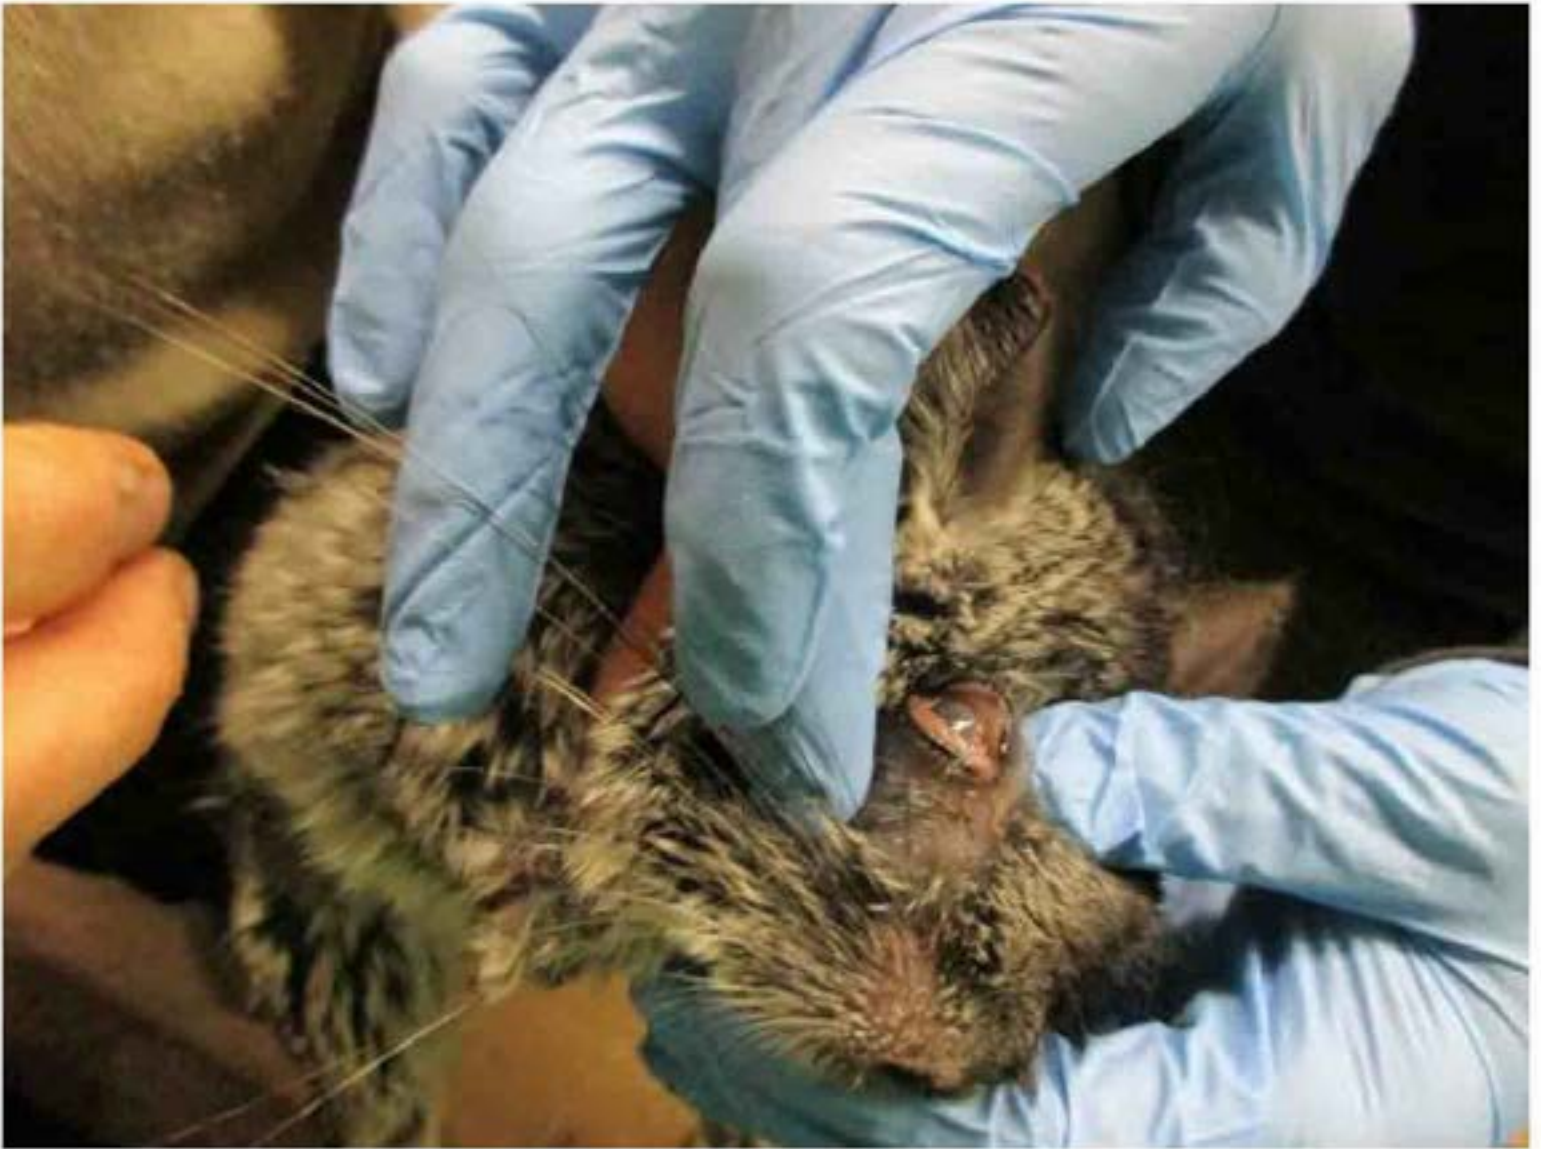
Photographer:	Kevin Wilken	Legal Name:	41-B-0239
Photo Taken:	Mon, Mar 14, '16	DAN MOULTON	
Inspection:	74161711400131		
Description:	Right eye of a silver and black female Chincilla (eartag OKES 108 or 801). Per records, cage marker; and licensee, animal is receiving veterinary-prescribed treatment.

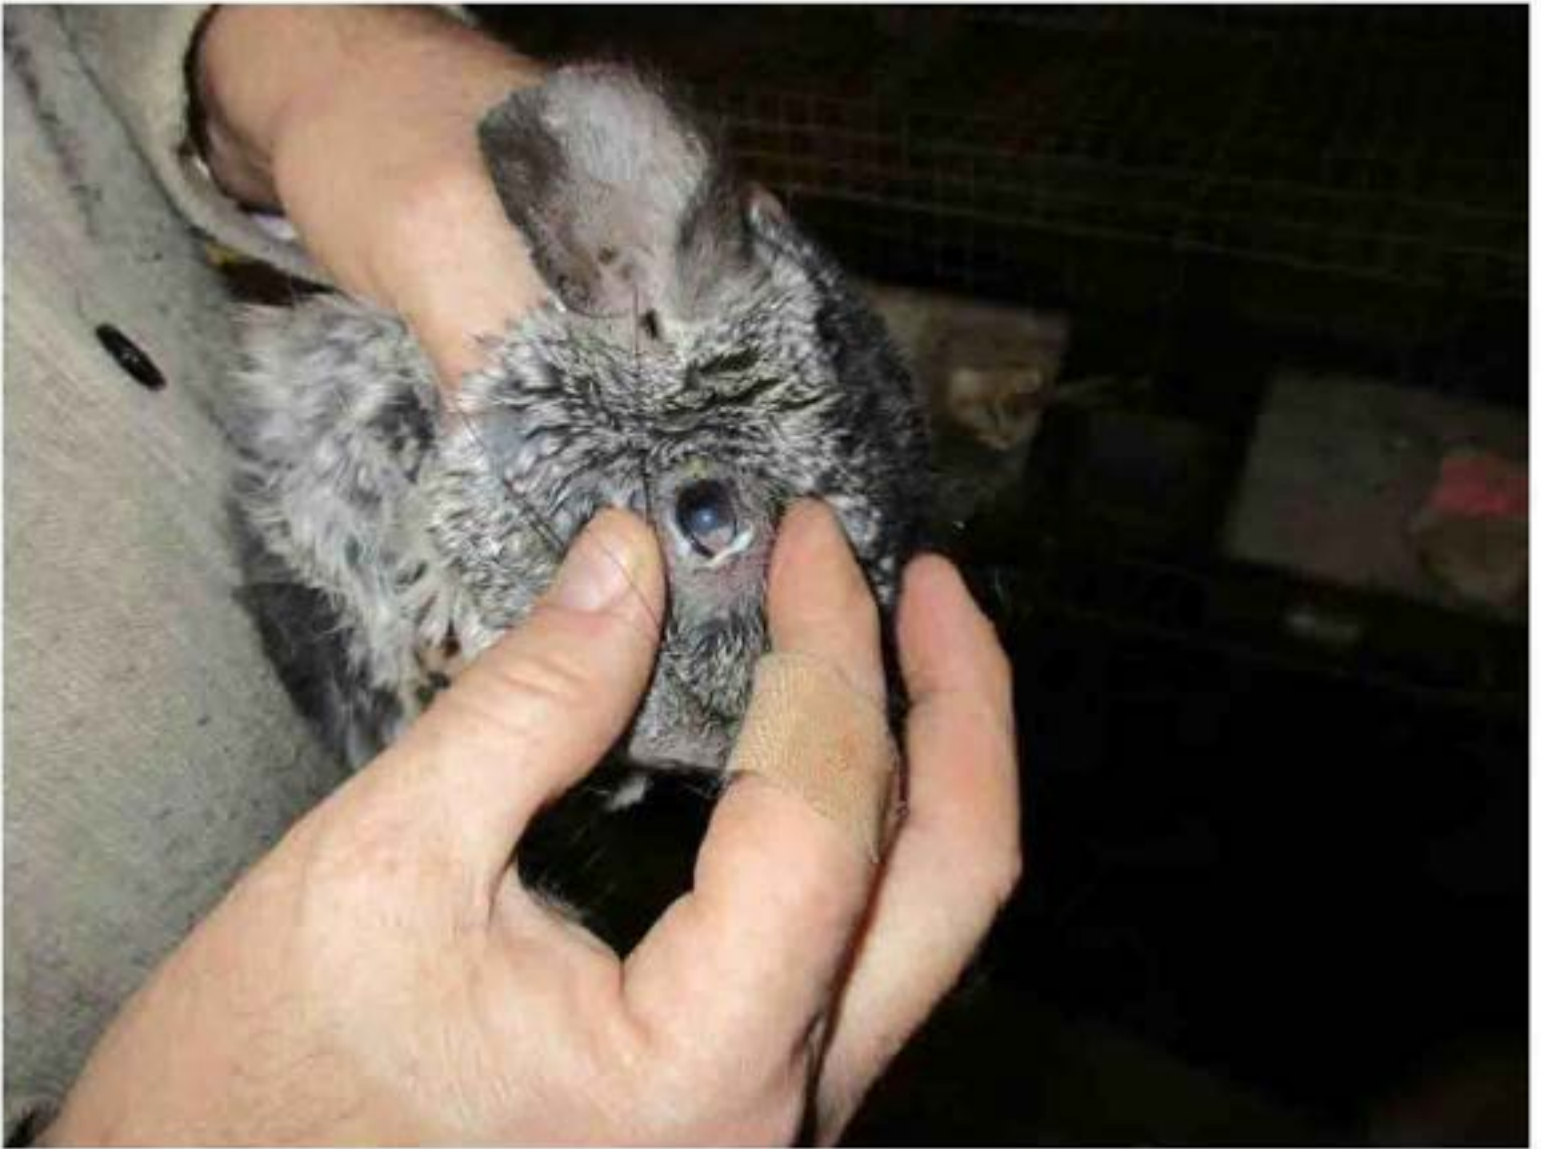
Photographer:	Kevin Wilken	Legal Name:	41-B-0239
Photo Taken:	Mon, Mar 14, '16	DAN MOULTON	
Inspection:	74161711400131		
Description:	Right eye of a black and silver male Chinchilla (eartag VVCR 179). Per records, cage marker; and licensee, animal is receiving veterinary-prescribed treatment.

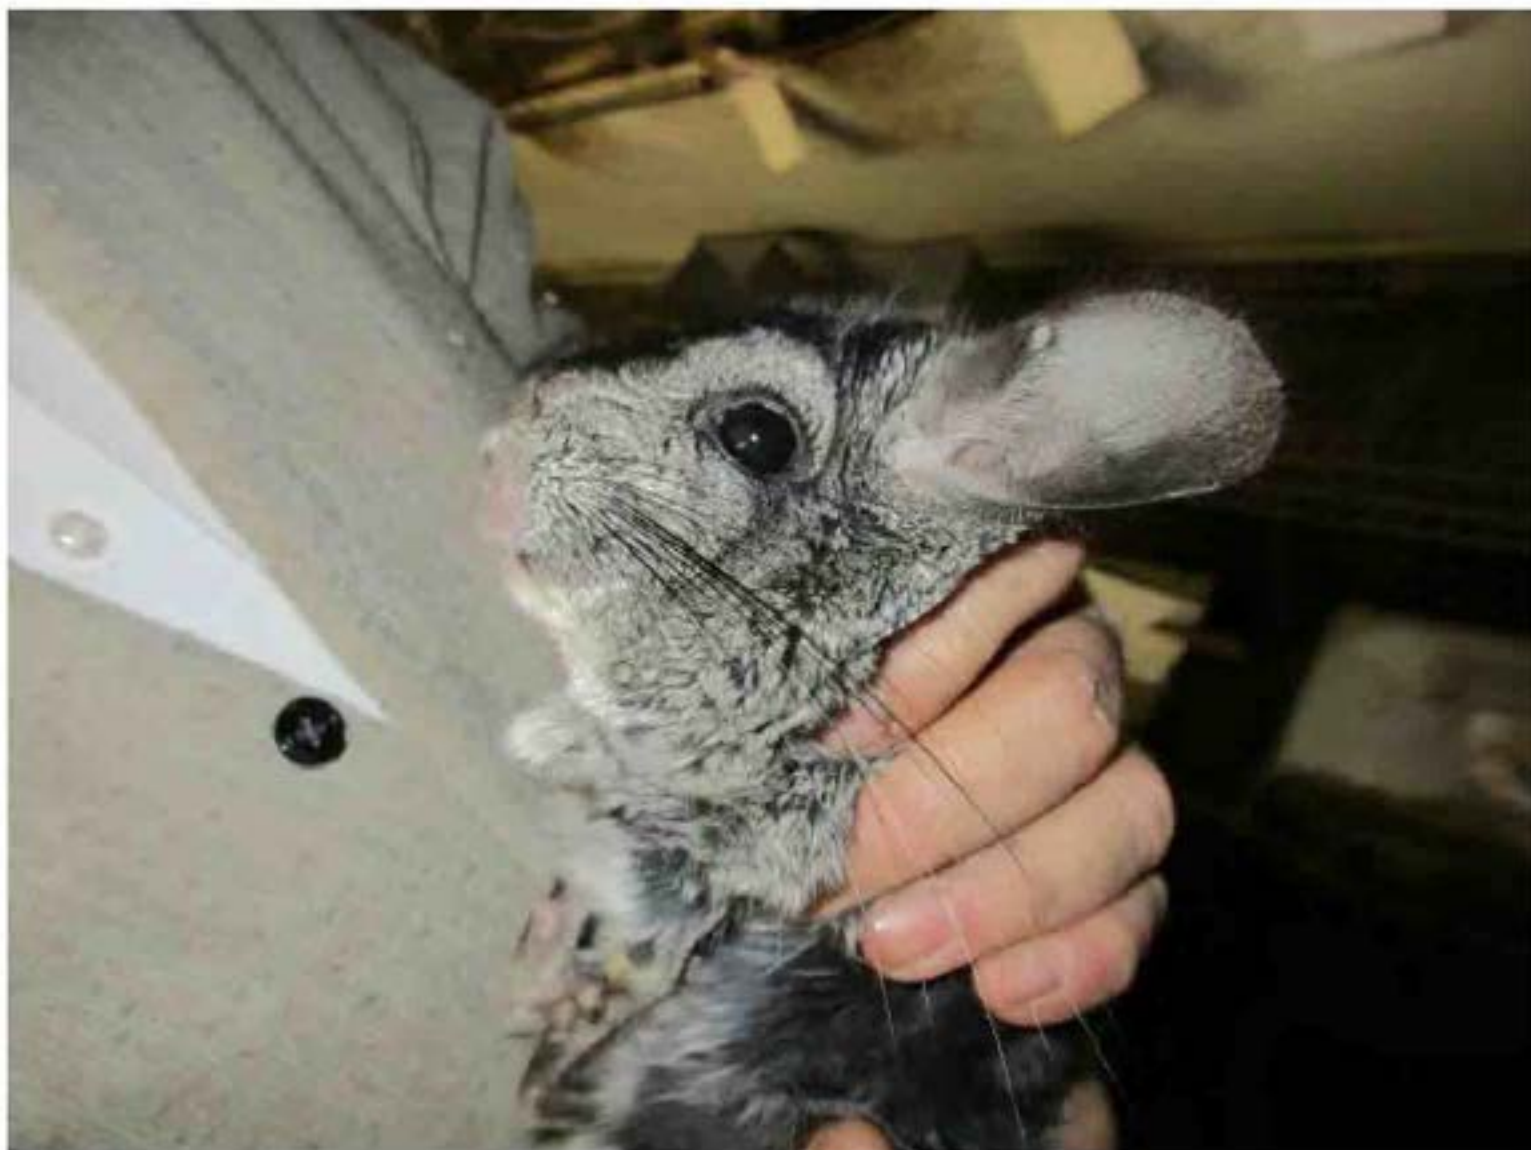
Photographer:	Kevin Wilken	Legal Name:	41-B-0239
Photo Taken:	Mon, Mar 14, '16	DAN MOULTON	
Inspection:	74161711400131		
Description:	Right eye of a black and silver female Chinchilla (eartag GROS 337). Per records, cage marker; and licensee, animal is receiving veterinary-prescribed treatment.

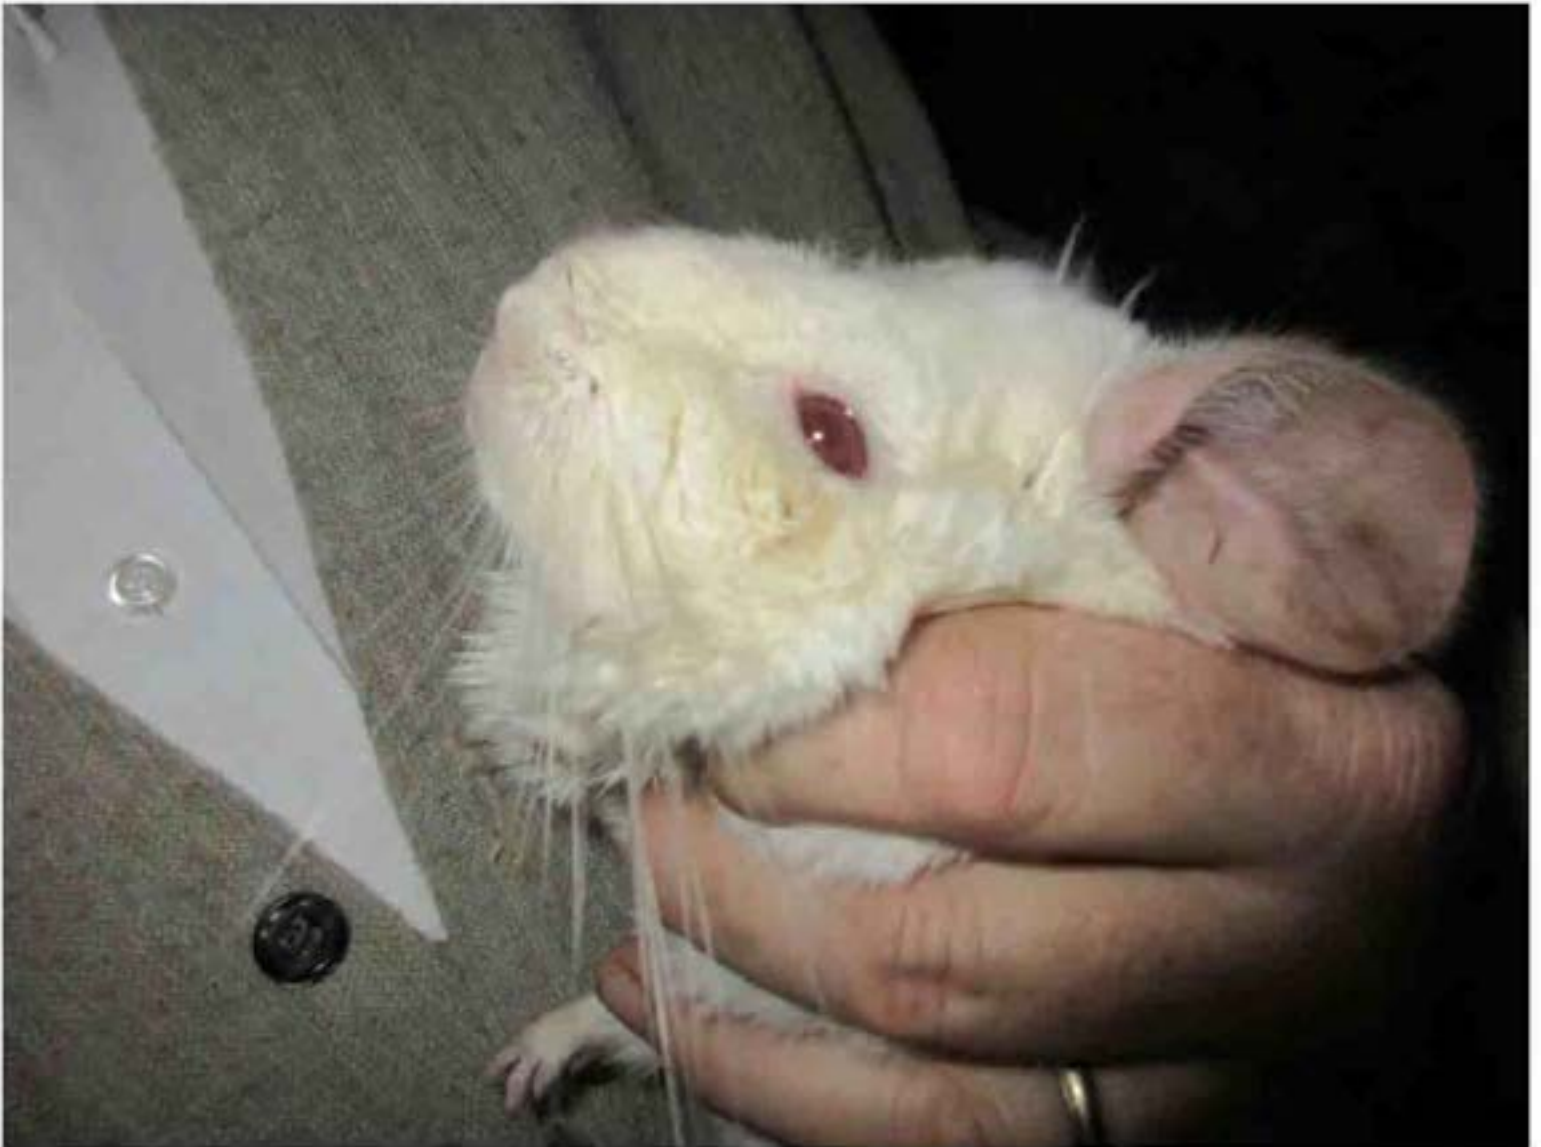
Photographer:	Kevin Wilken	Legal Name:	41-B-0239
Photo Taken:	Mon, Mar 14, '16	DAN MOULTON	
Inspection:	74161711400131		
Description:	Right eye of a white male Chinchilla (no tag). Per records, cage marker; and licensee, animal is receiving veterinary-prescribed treatment.

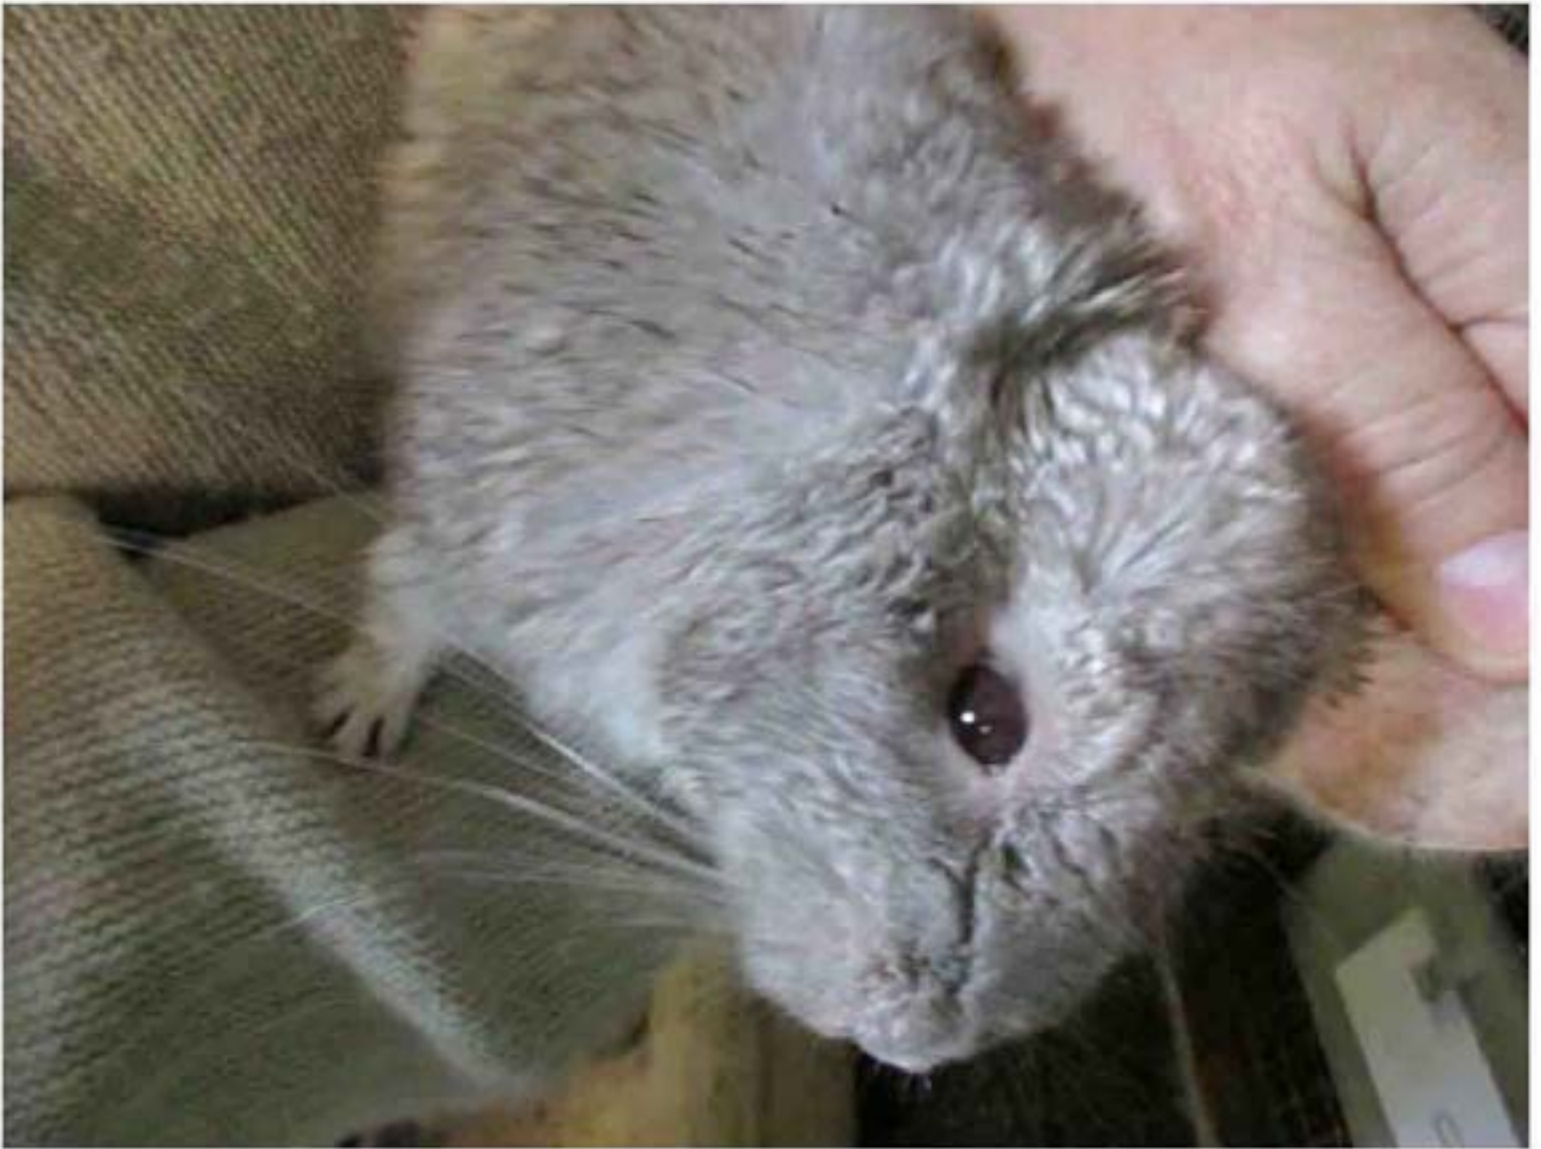
Photographer:	Kevin Wilken	Legal Name:	41-B-0239
Photo Taken:	Mon, Mar 14, '16	DAN MOULTON	
Inspection:	74161711400131		
Description:	Left eye of a beige male Chinchilla (eartag 968). Per records, cage marker; and licensee, animal is receiving veterinary-prescribed treatment.

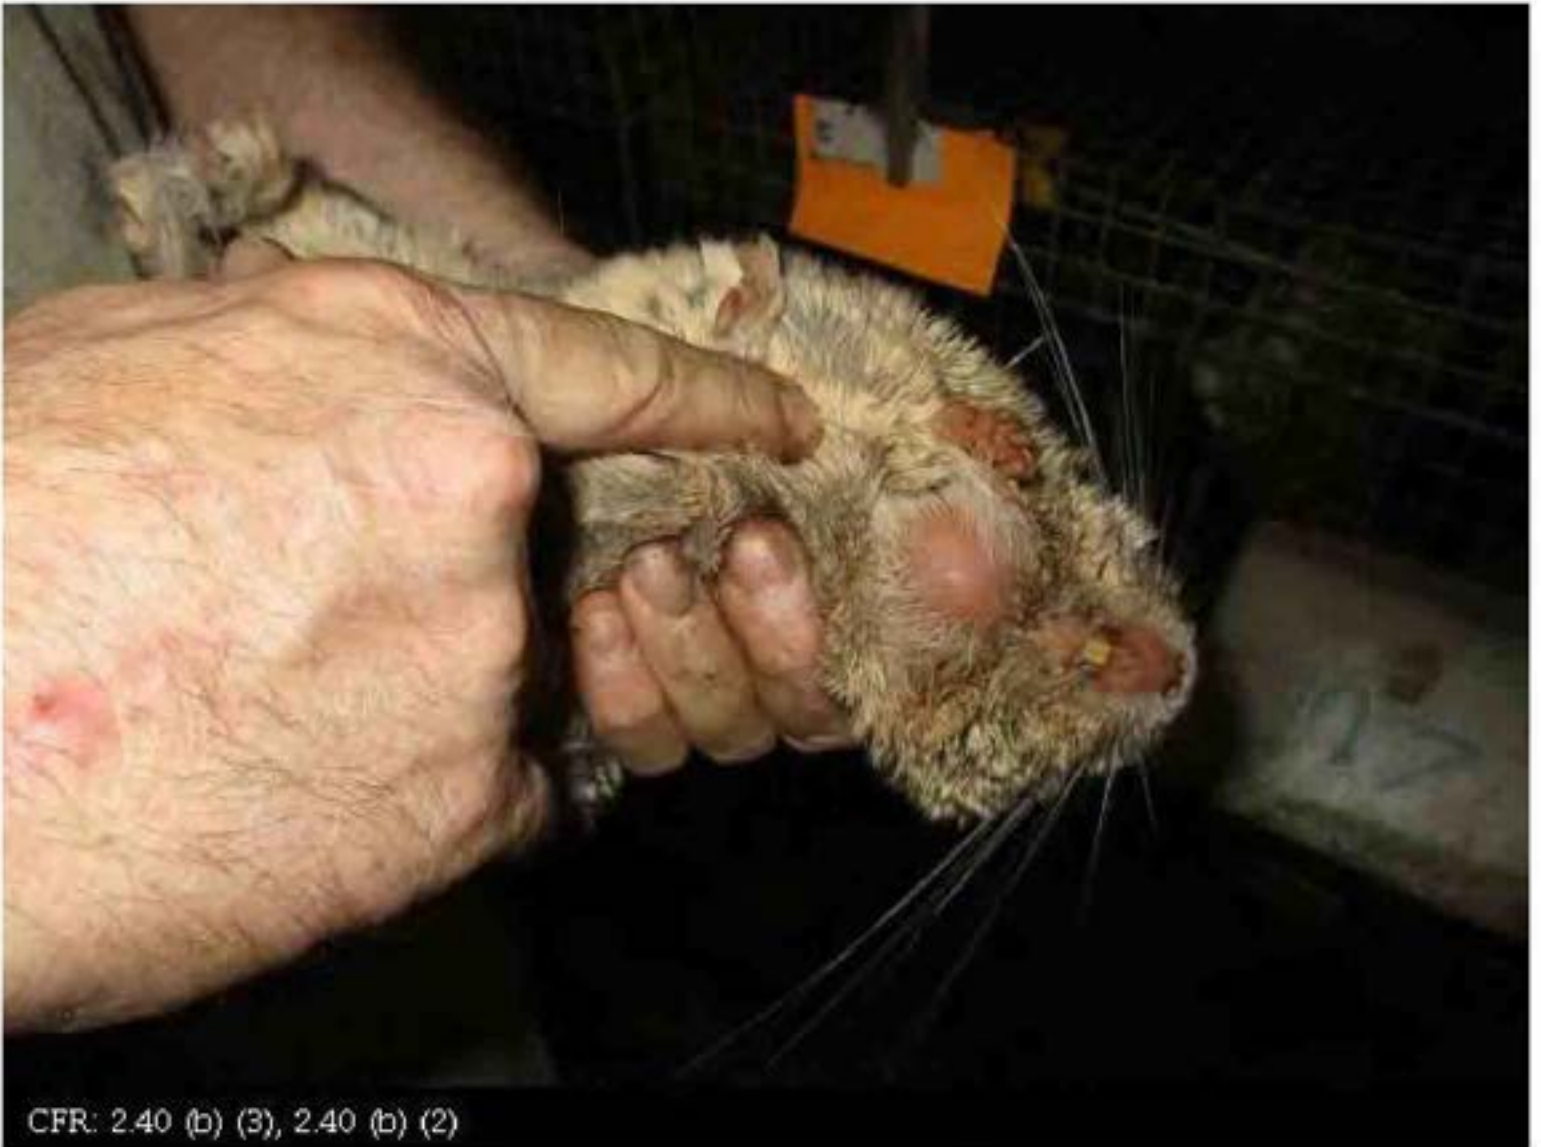
Photographer:	Scott Welch	Legal Name:	41-B-0239
Photo Taken:	Mon, Mar 14, '16	DAN MOULTON	
Inspection:	74161711400131		
Description:	Chinchilla (no id, pen 166); Per records, cage marker; and licensee, animal is receiving veterinary-prescribed treatment.
