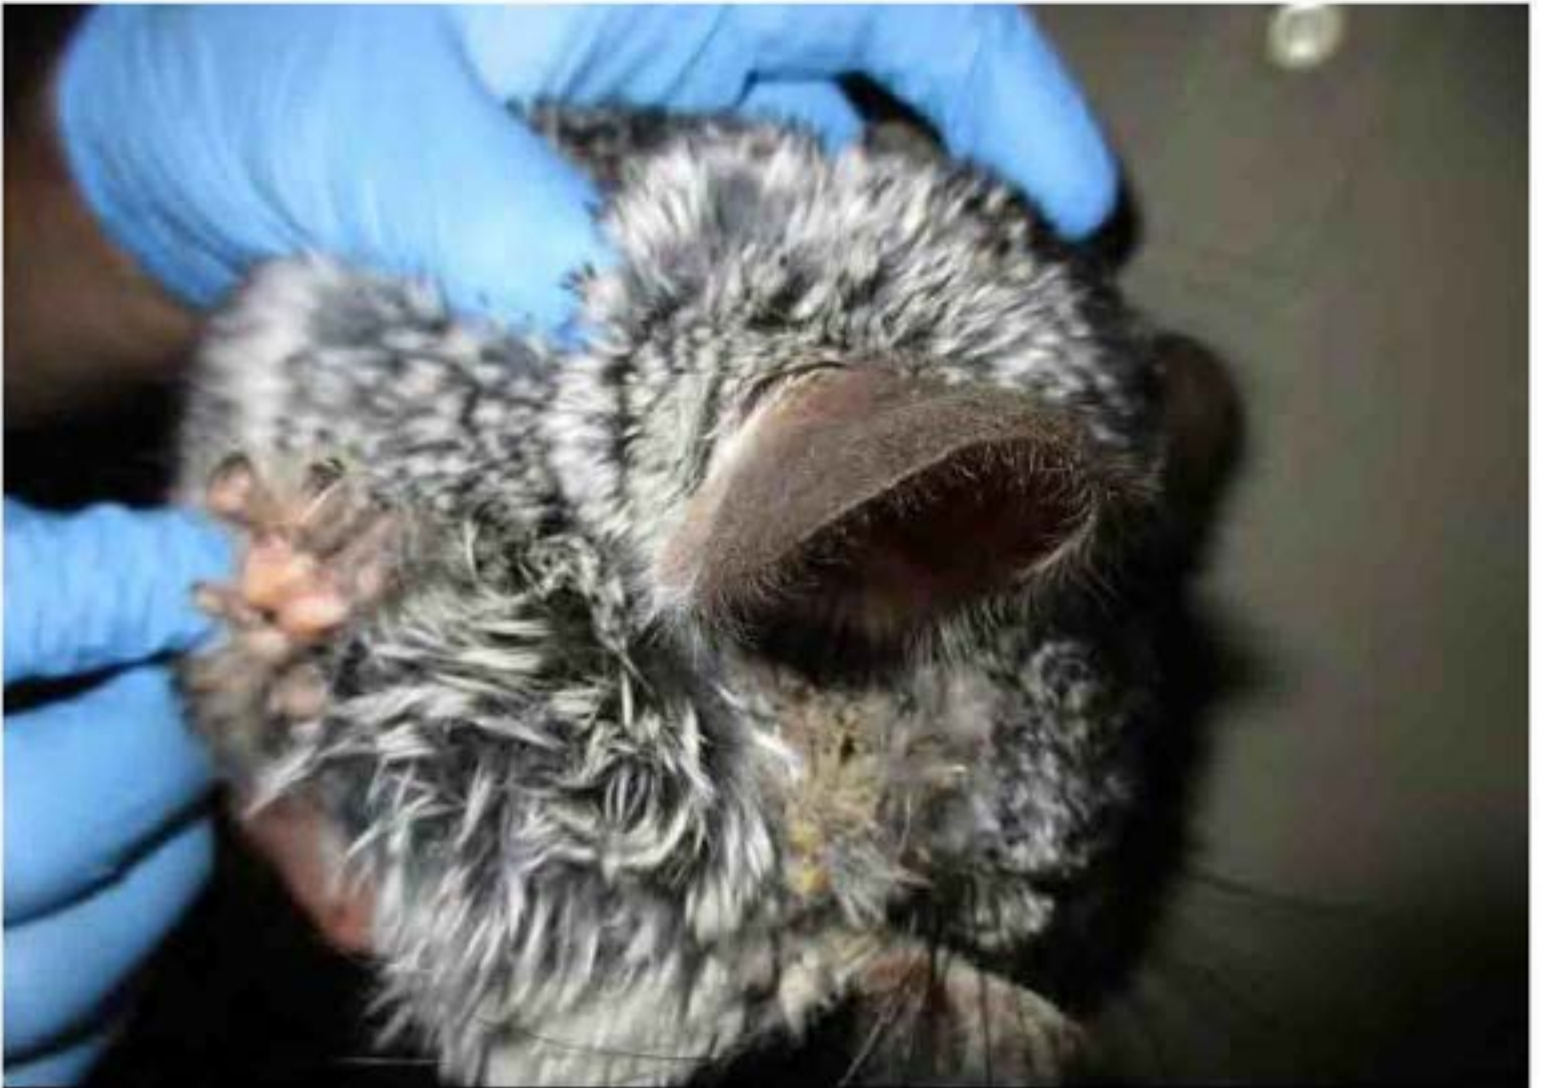
Photographer:	Kevin Wilken	Legal Name:	41-B-0239
Photo Taken:	Wed, Jun 22, '16	DAN MOULTON	
Inspection:	181161057380243		
Description:	Female beige, eartag GROS 352; hairless swelling under chin.

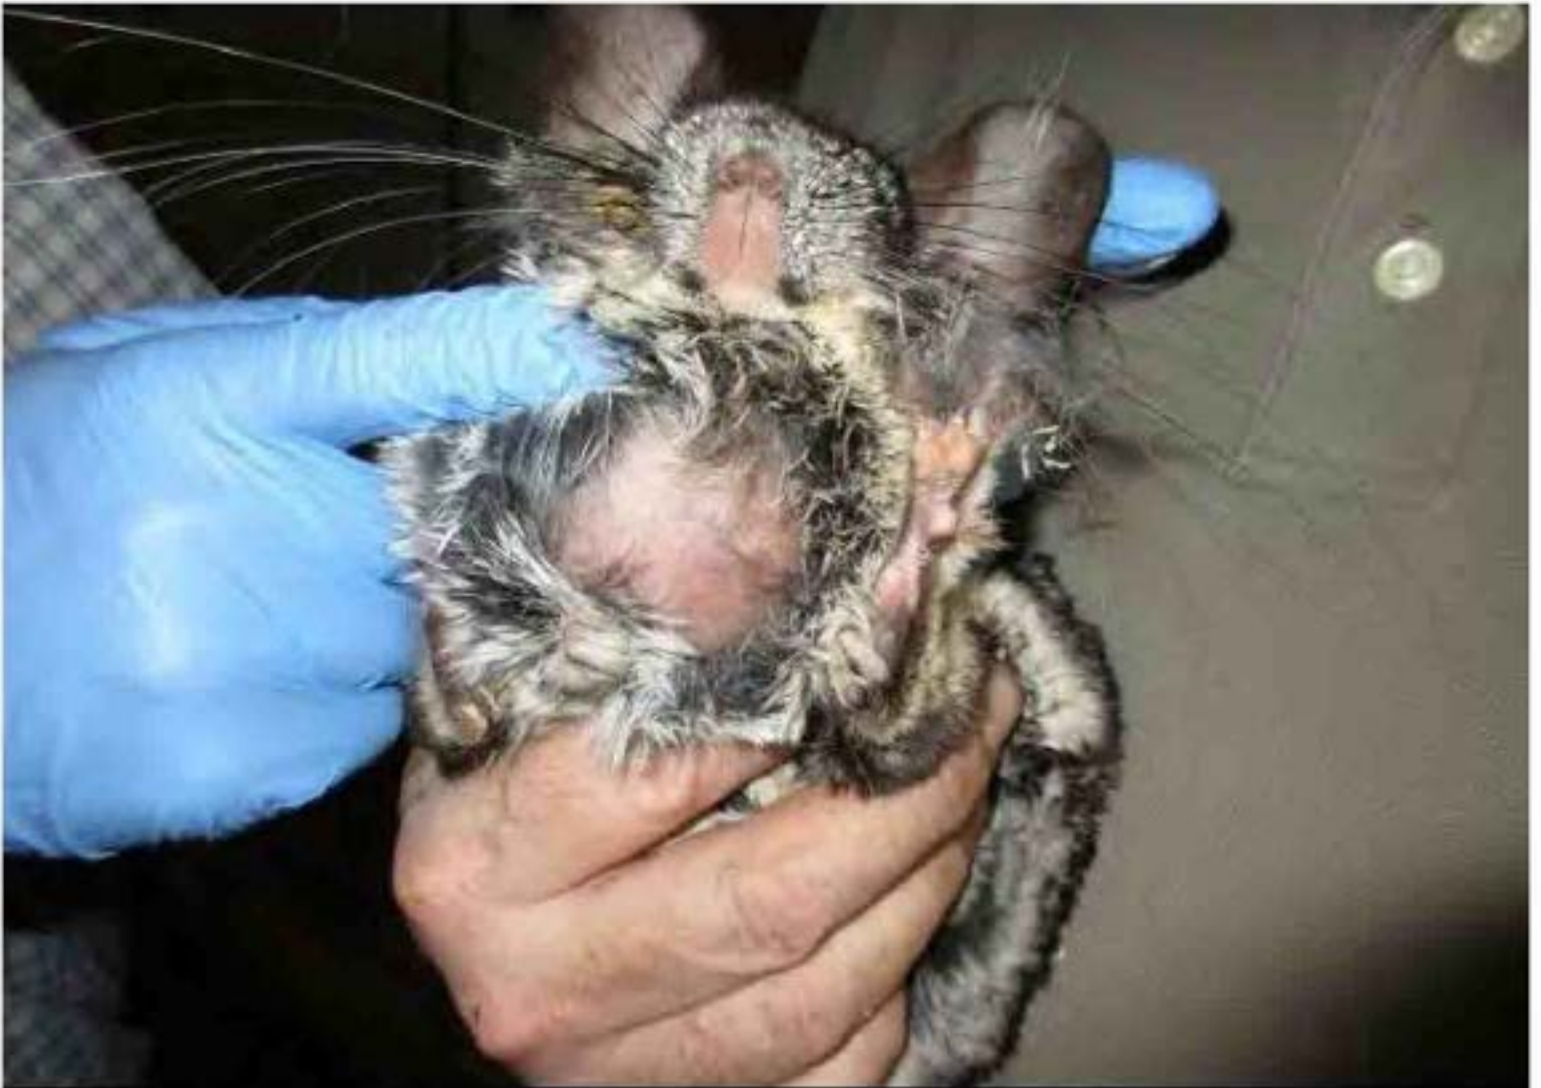
Photographer:	Kevin Wilken	Legal Name:	41-B-0239
Photo Taken:	Wed, Jun 22, '16	DAN MOULTON	
Inspection:	181161057380243		
Description:	Male grey (no id, in south stacked cages, west/front room); its right eye can't be seen because it is crusted shut.

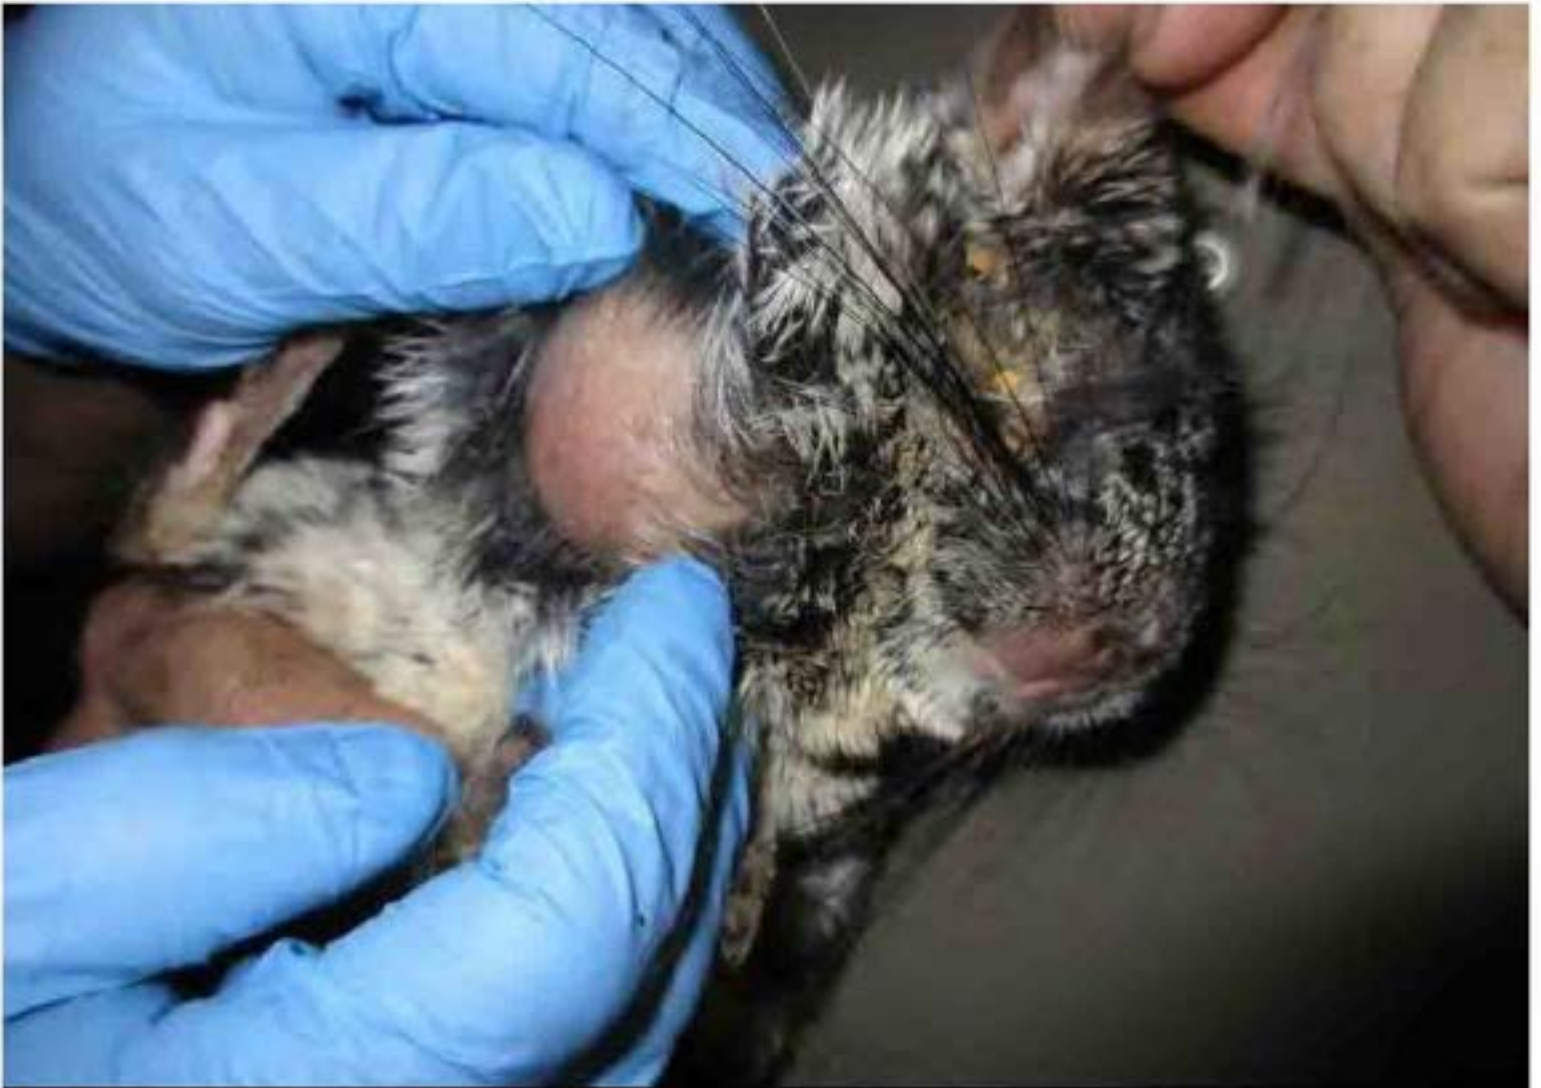
Photographer:	Kevin Wilken	Legal Name:	41-B-0239
Photo Taken:	Wed, Jun 22, '16	DAN MOULTON	
Inspection:	181161057380243		
Description:	Male grey (no id in south stacked cages, west/front room); large hairless swelling under chin and note its right eye crusted over.

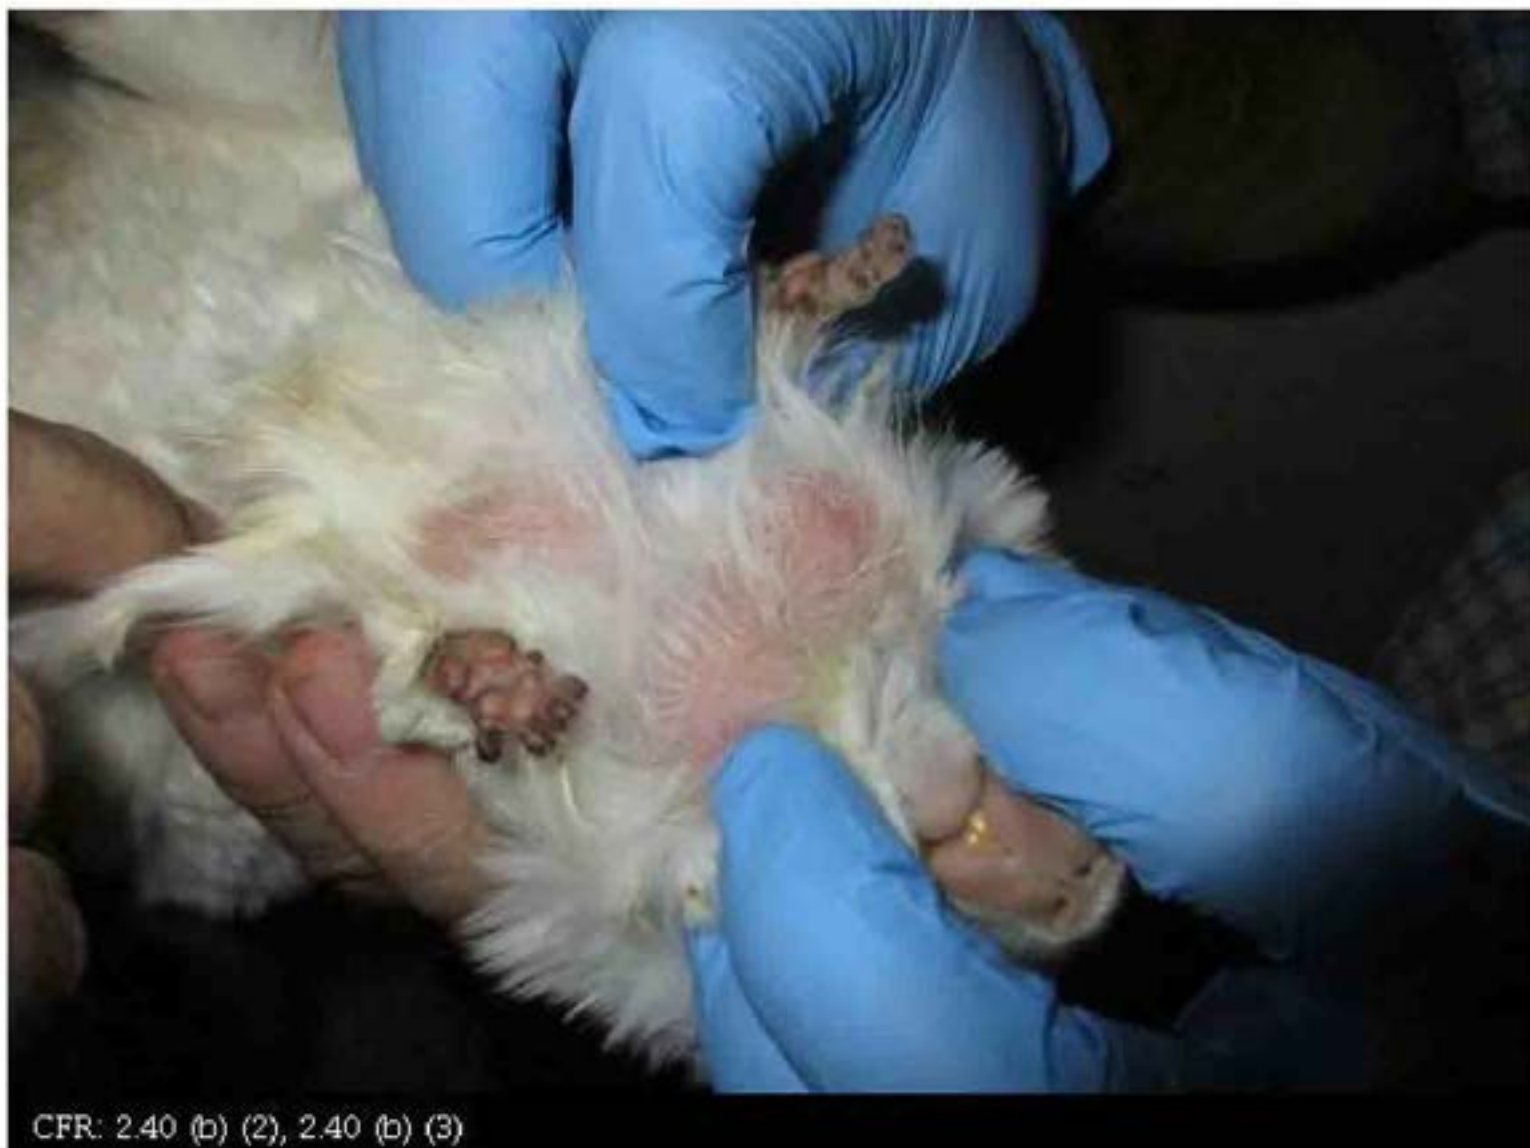
Photographer:	Kevin Wilken	Legal Name:	41-B-0239
Photo Taken:	Wed, Jun 22, '16	DAN MOULTON	
Inspection:	181161057380243		
Description:	White female in cage 168, ear tag 876; swollen area with hair loss under chin. Tissues felt thickened to VMO (gloved hands).

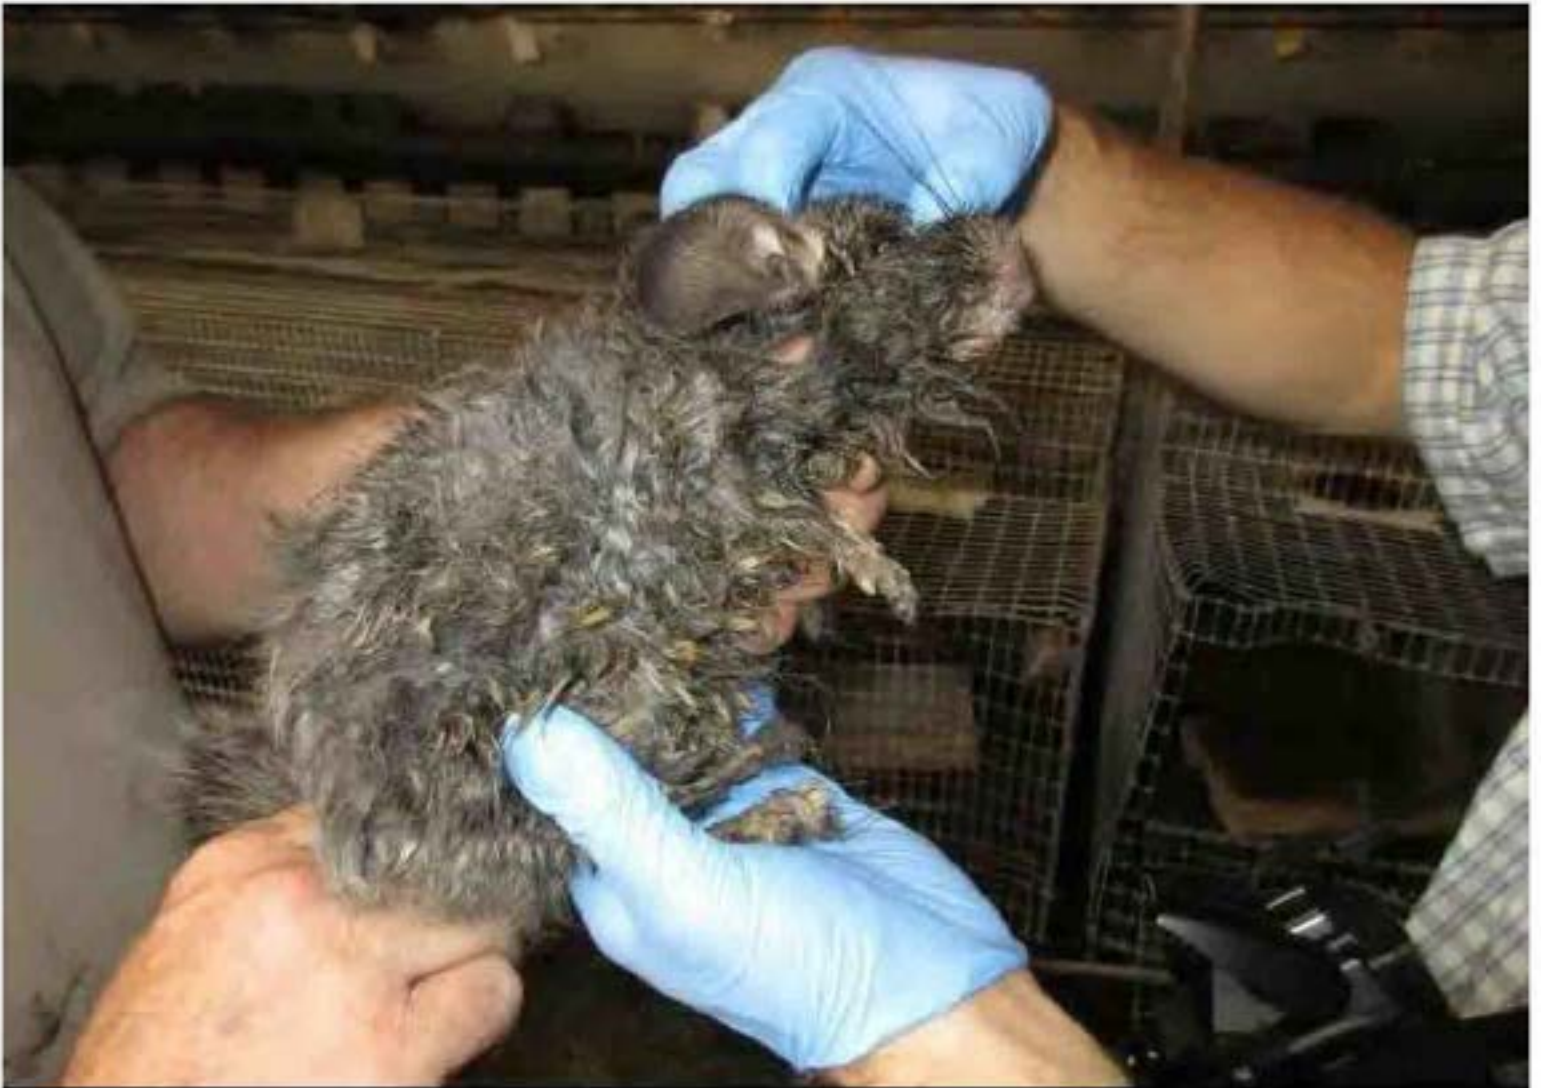
Photographer:	Kevin wilken	Legal Name:	41-B-0239
Photo Taken:	Wed, Jun 22, '16	DAN MOULTON	
Inspection:	181161057380243		
Description:	Female grey-- ear tag 332; its right eye is swollen and had a pale creamy discharge.

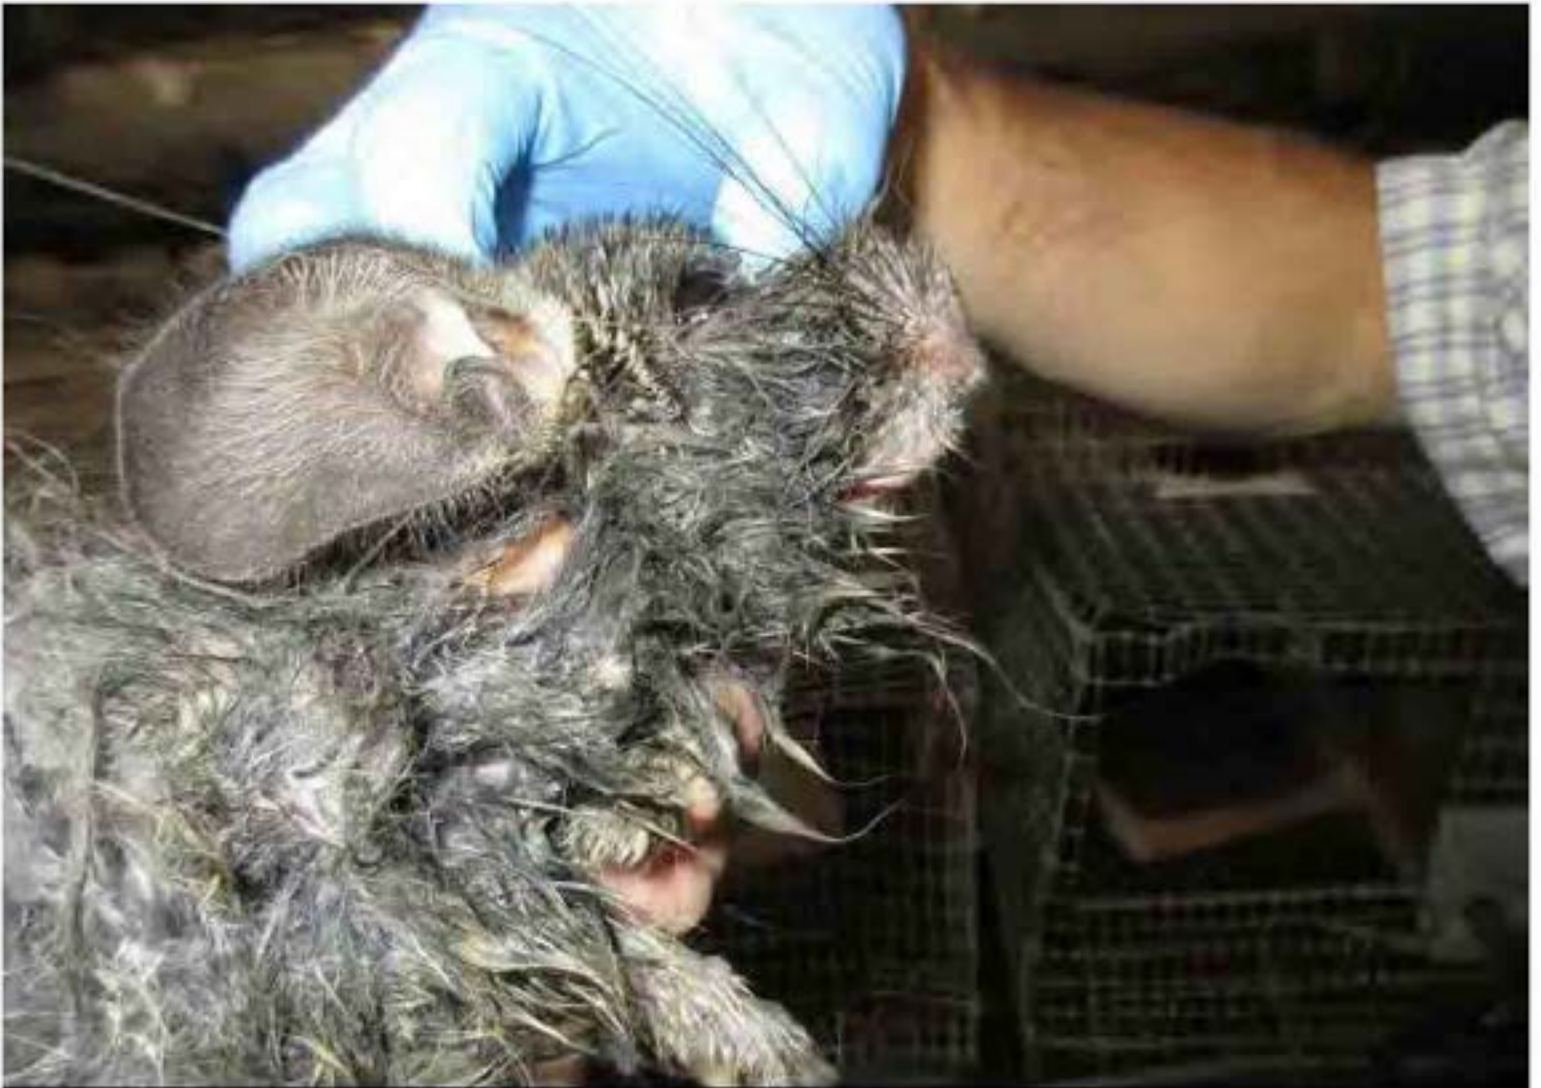
Photographer:	Kevin Wilken	Legal Name:	41-B-0239
Photo Taken:	Wed, Jun 22, '16	DAN MOULTON	
Inspection:	181161057380243		
Description:	Female black; eartag GROS 313; note unkempt hair coat.

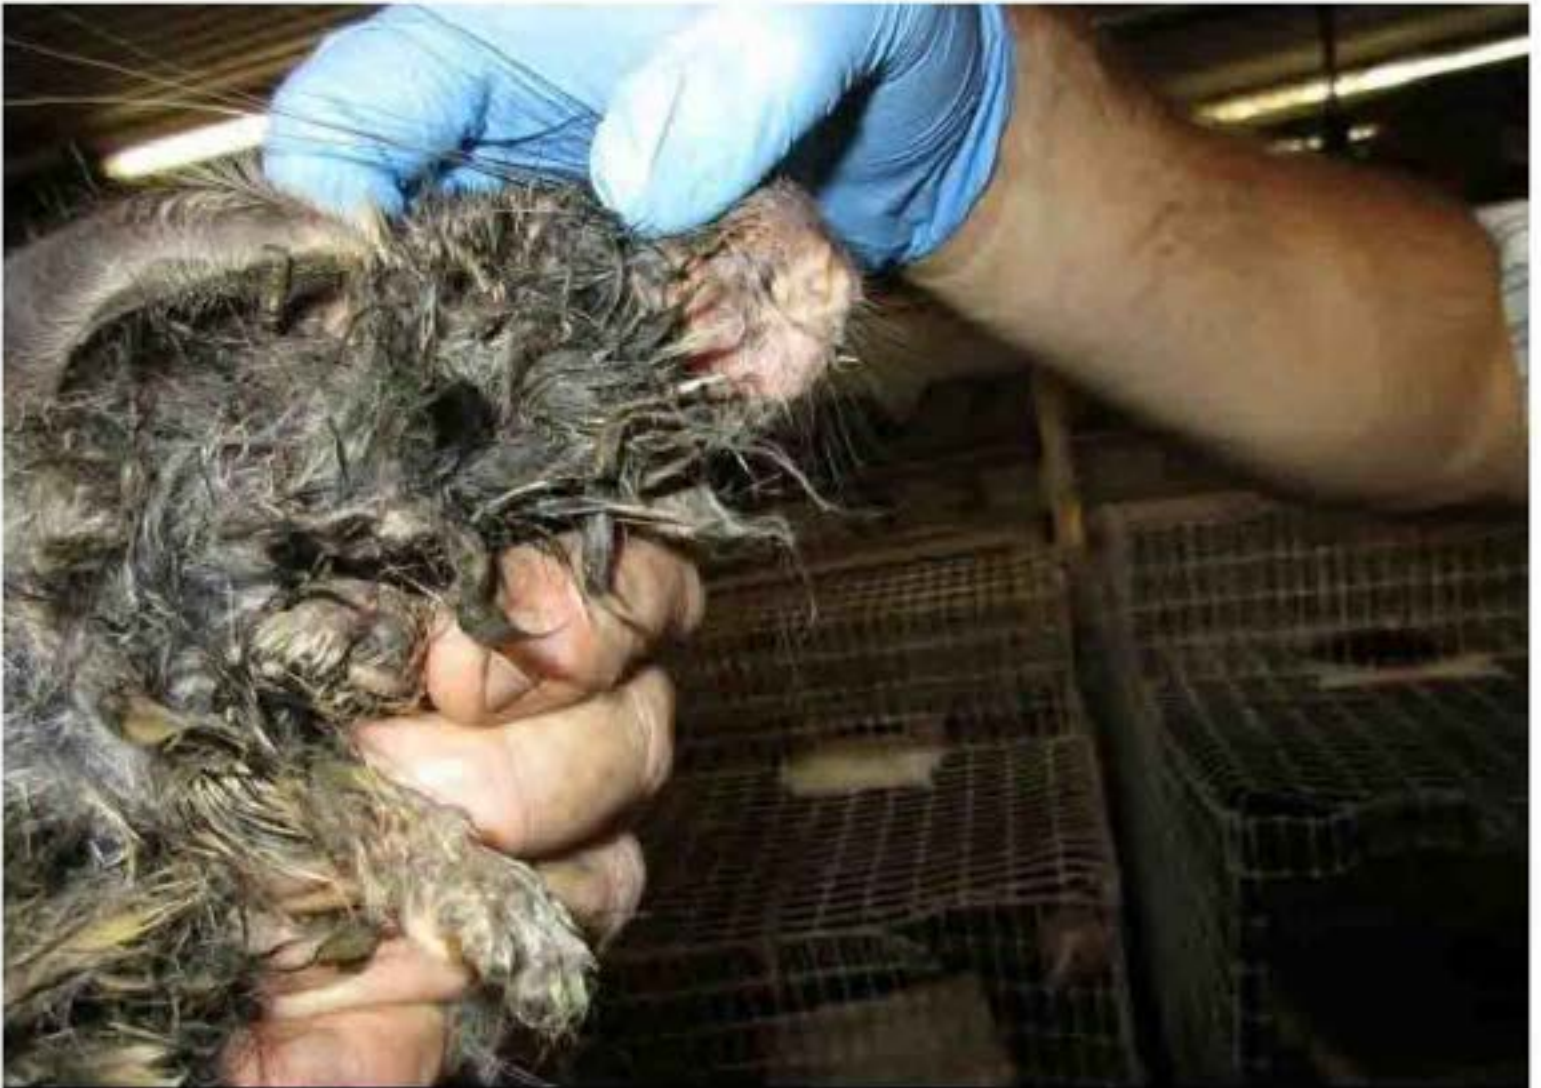
Photographer:	Kevin Wilken	Legal Name:	41-B-0239
Photo Taken:	Wed, Jun 22, '16	DAN MOULTON	
Inspection:	181161057380243		
Description:	Female black; eartag GROS 313; note unkempt hair coat and hair loss around mouth

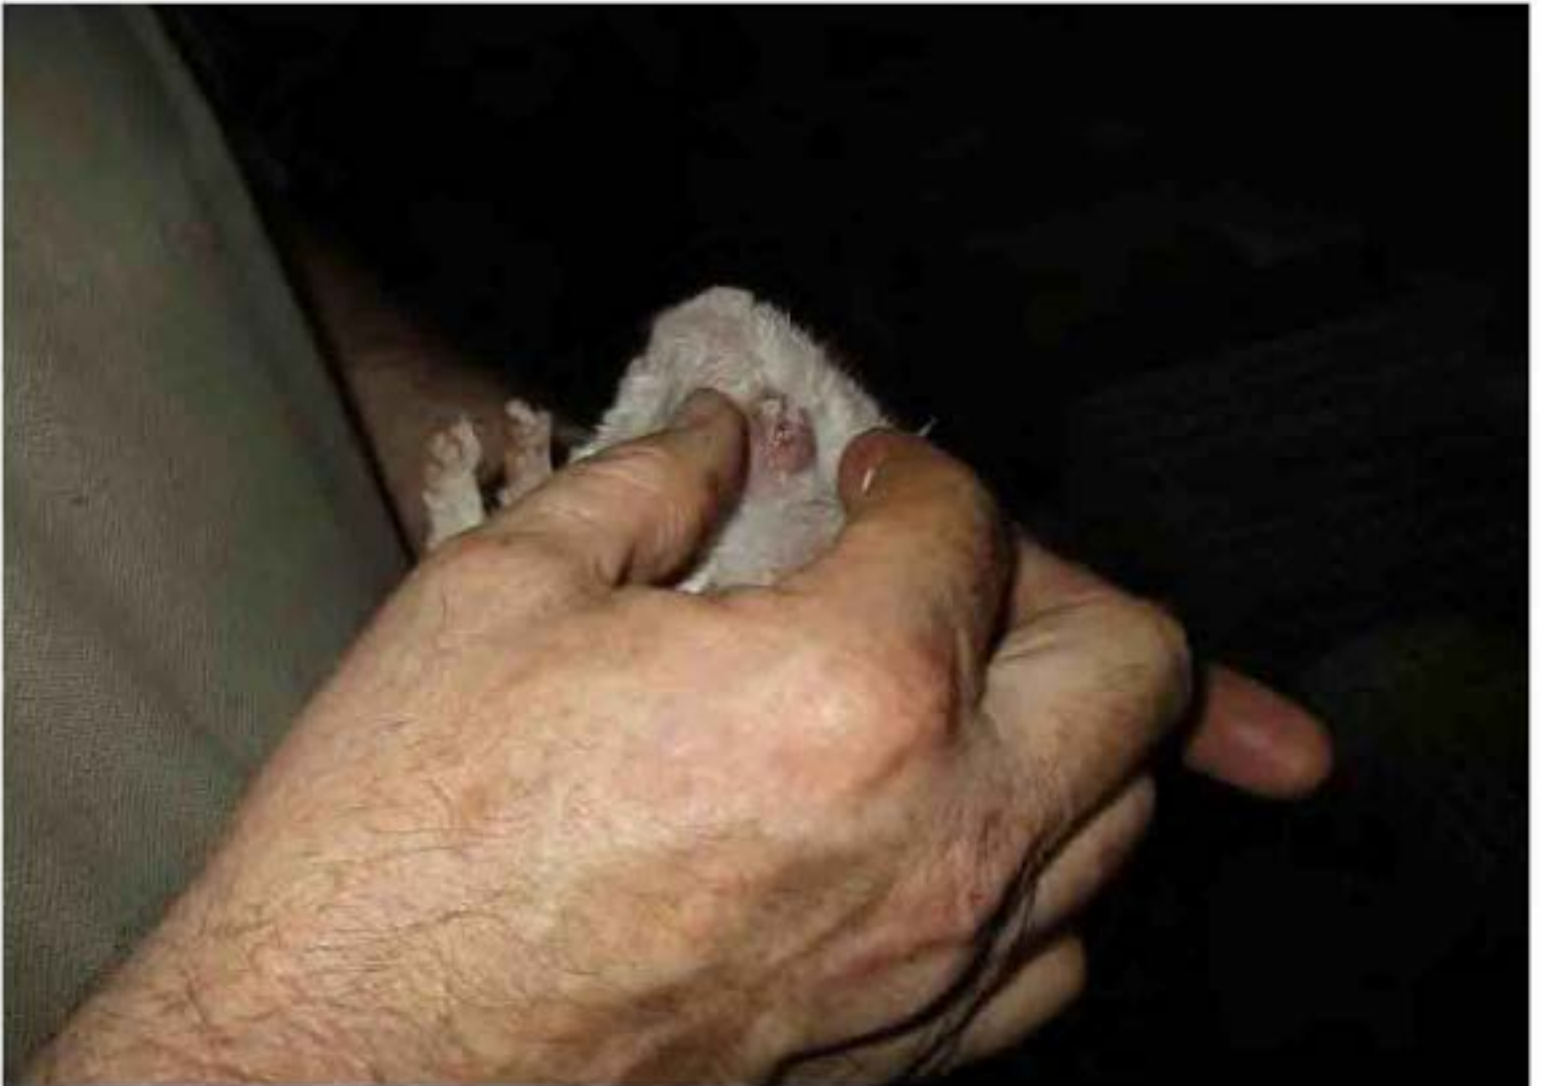
Photographer:	Kevin Wilken	Legal Name:	41-B-0239
Photo Taken:	Wed, Jun 22, '16	DAN MOULTON	
Inspection:	181161057380243		
Description:	Male beige with eartag GROS 329; its left eye was swollen and a pale creamy discharge.

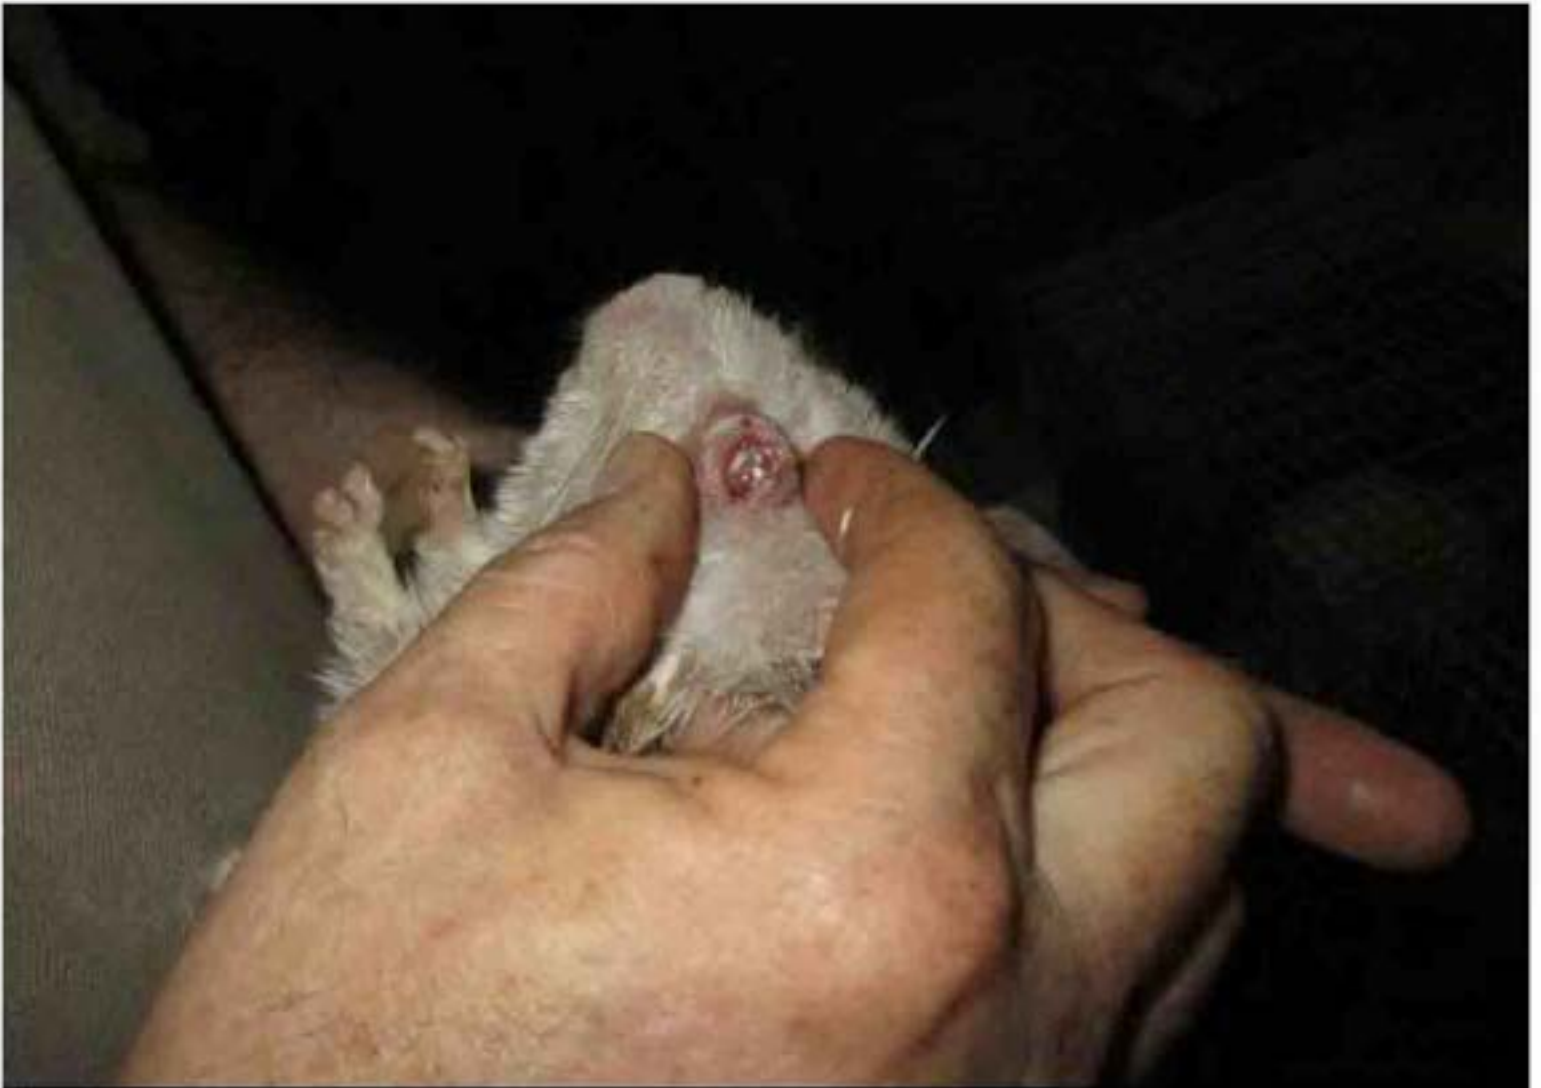
Photographer:	Kevin Wilken	Legal Name:	41-B-0239
Photo Taken:	Wed, Jun 22, '16	DAN MOULTON	
Inspection:	181161057380243		
Description:	Male beige (no ID; cage card AMMC); note left eye swollen with pale creamy discharge.

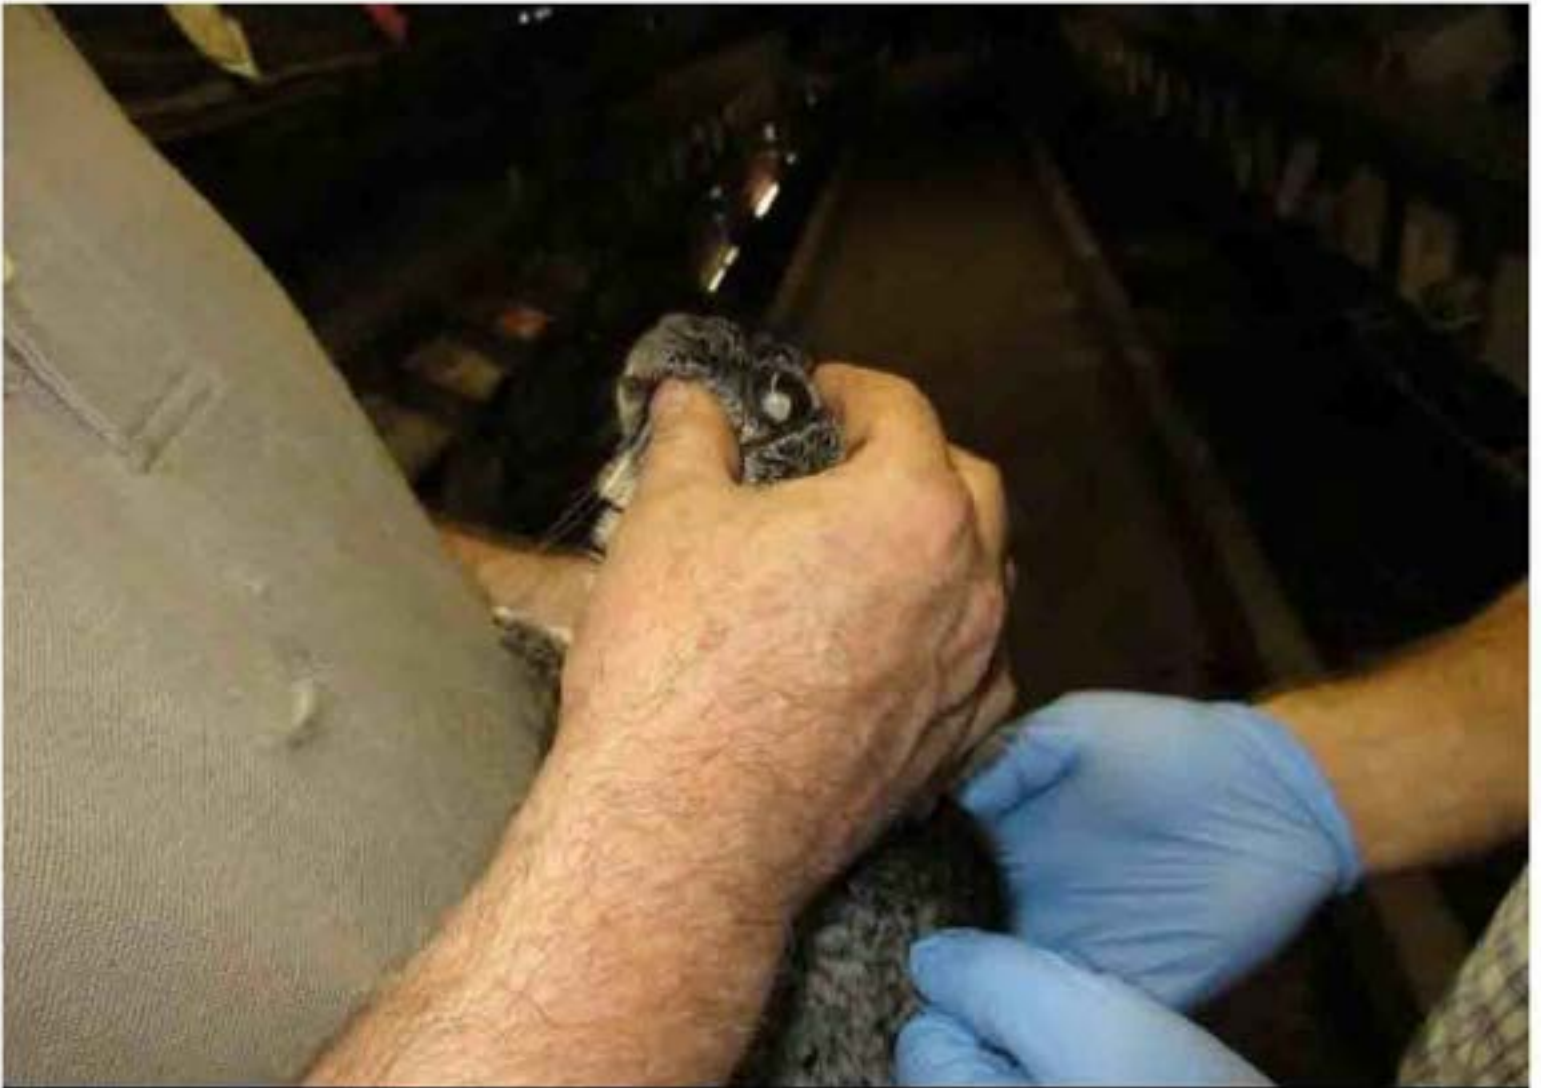
Photographer:	Kevin Wilken	Legal Name:	41-B-0239
Photo Taken:	Wed, Jun 22, '16	DAN MOULTON	
Inspection:	181161057380243		
Description:	Male beige (no ID; cage card AMMC); note left eye swollen with pale creamy discharge.

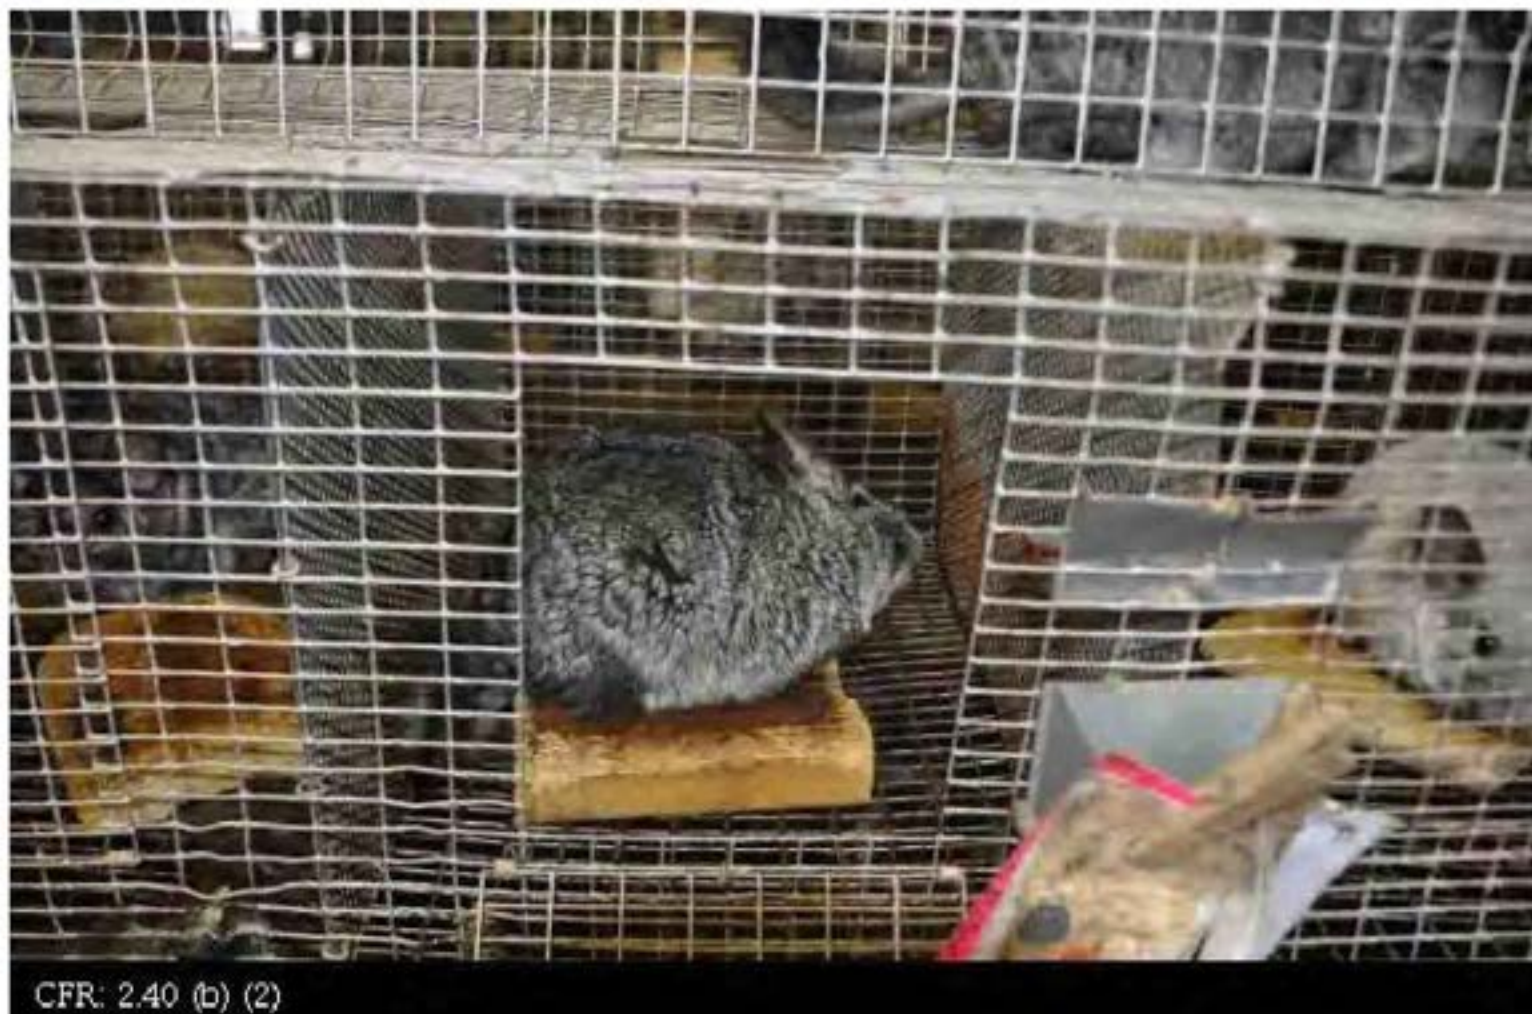
Photographer:	Kevin Wilken	Legal Name:	41-B-0239
Photo Taken:	Wed, Jun 22, '16	DAN MOULTON	
Inspection:	181161057380243		
Description:	Female grey with eartag PMR 233; its left eyeball was noted to have an opaque mass inside it.

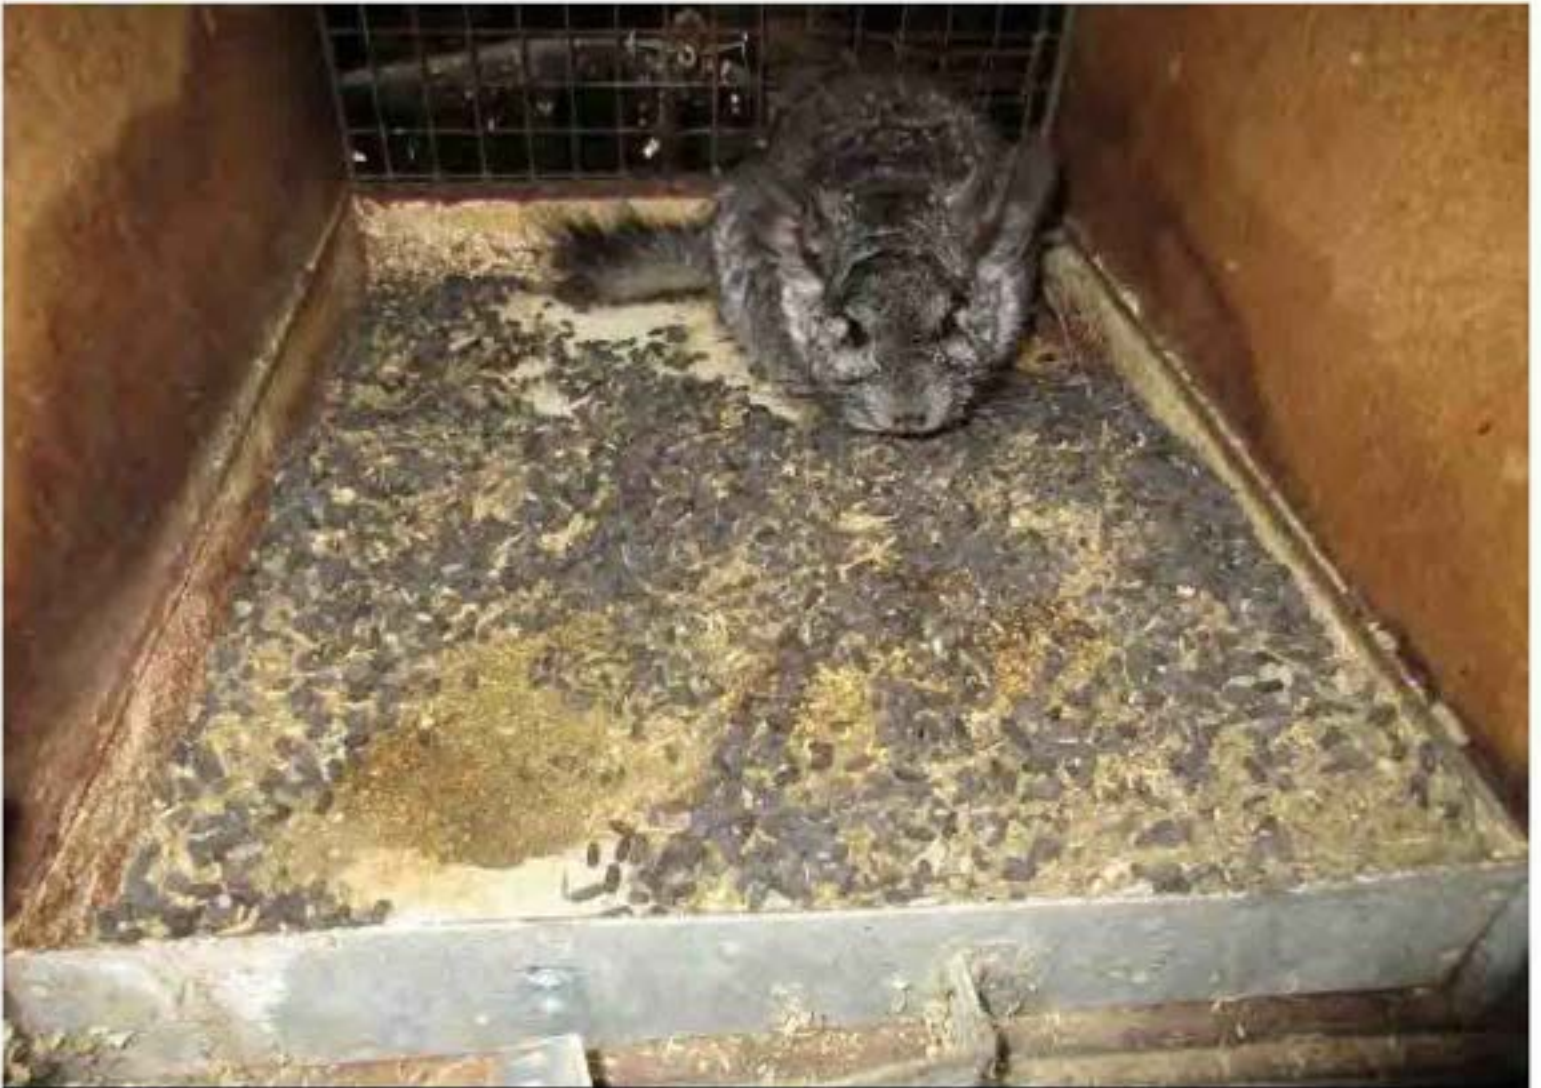
Photographer:	Kevin Wilken	Legal Name:	41-B-0239
Photo Taken:	Wed, Jun 22, '16	DAN MOULTON	
Inspection:	181161057380243		
Description:	Front room middle pen, excessive feces.

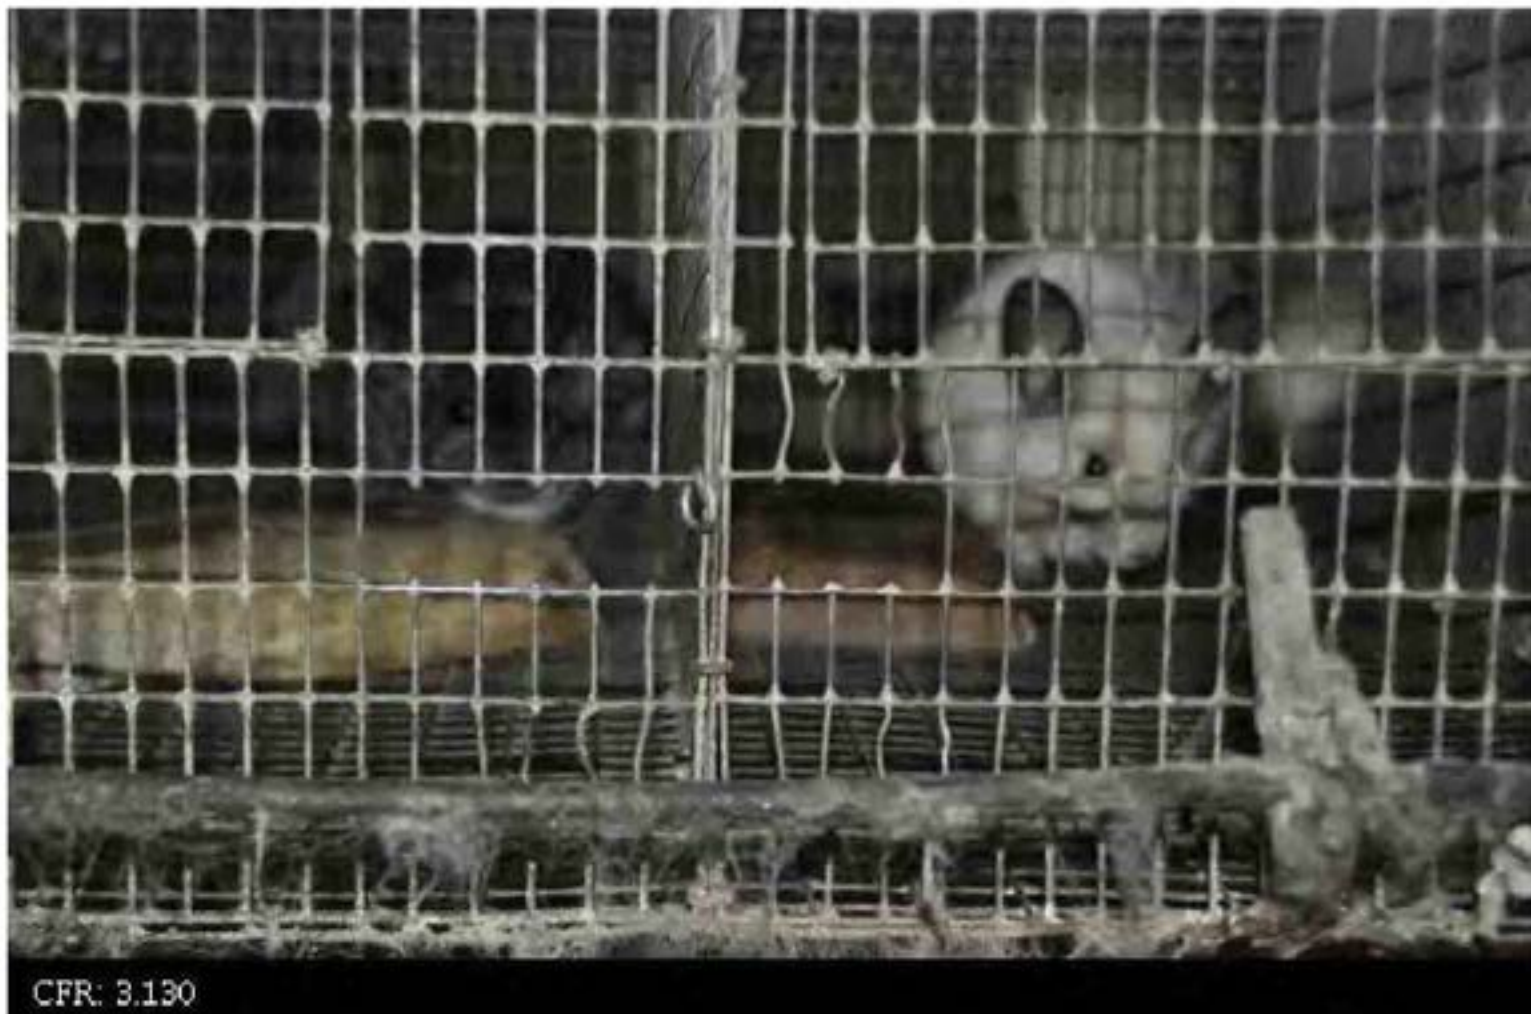
Photographer:	Scott Welch	Legal Name:	41-B-0239
Photo Taken:	Wed, Jun 22, '16	DAN MOULTON	
Inspection:	181161057380243		
Description:	Piece of broken panel with sharp wire points; similar piece is present in enclosure to left white chinchilla and noted in bottom left of photo.
