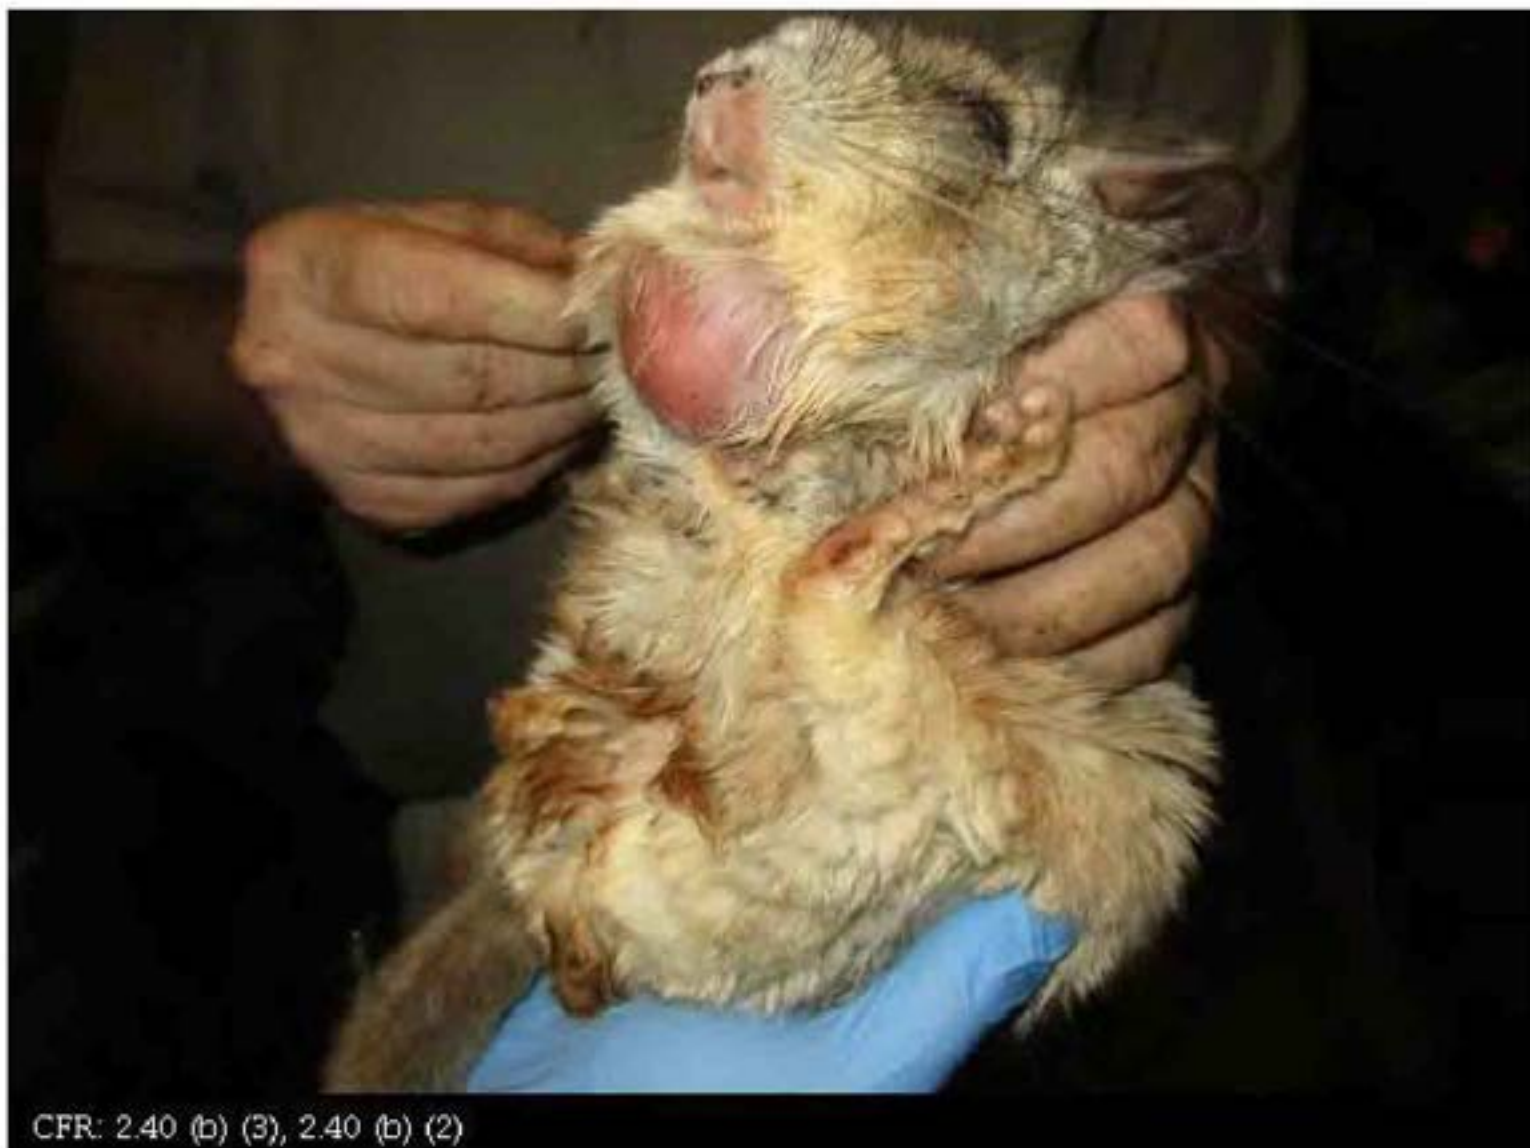
Photographer:	Kevin Wilken	Legal Name:	41-B-0239
Photo Taken:	Wed, Jun 22, '16	DAN MOULTON	
Inspection:	181161057380243		
Description:	Male cream eartag GROS 375; large reddened hairless swelling under chin.
