# Green Space Categorization as a Function of Run off and Infiltration Rates

## **Abstract:**

The University of Vermont campus is subject to high amounts of foot traffic and maintenance vehicle use. The effects of this use cause a drop in infiltration capacity because of green space being used for roads and paths. We defined four categories of green space condition and mapped an area of the campus. In our research, we found that good green space occupied 44% of the test area. Moderate green space occupied 5% of the test area. Poor green space occupied only 1% of the test area. The remaining 50% consisted of impervious surfaces such as paved areas and buildings. We found that although only 1% of the green space in our test area was degraded enough to lower infiltration rates to less than 0.05 cm/hr, the effects of the lowering of infiltration rates had direct effect on the surrounding areas. Impervious ground surfaces made up 50% of the test area, and many of the degraded green spaces were located adjacent to the impervious areas, providing channels through which runoff could be directed. Non-point source pollution and other problems associated with low infiltration areas could be

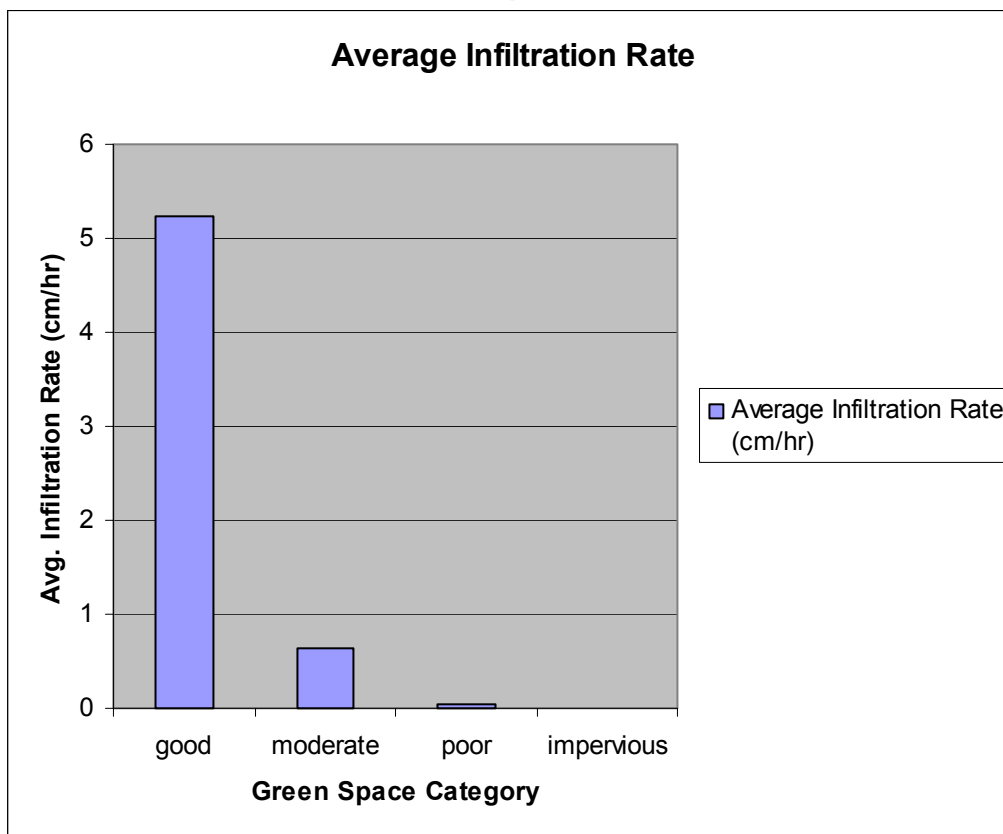
**Graph 1**

Table 3: Shows that good green space has a much higher average infiltration rate than moderate or poor green spaces. It is represented graphically below in Graph 1.

The average infiltration rates for each green space category were computed in table 3 (pg. 9), and visually quantified in graph 1 (pg. 9), with good green space having an average infiltration rate of 5.24cm/hr. Moderate green space had an average infiltration rate of 0.63cm/hr, and poor green space had an average infiltration rate of 0.035cm/hr. In looking at the distribution of green space qualities, the poor, degraded areas make up only a small percentage (1%) of the overall study area. These spaces are critical however in understanding overland flow. With impervious surface areas accounting for 50% of the study area, the runoff from these areas is channeled into either storm drains, or green spaces. The result is channels that allow high volumes of runoff and suspended sediment to flow and erode the surfaces more due to their low infiltration capacities. The moderately degraded areas exhibit an ability to infiltrate water at a reasonable rate, but are not nearly as effective as areas that have 100% vegetation and low foot traffic. Although the percent of degraded green space is less, the impact of these green spaces on runoff and non-point pollution into streams and lakes, is far greater.

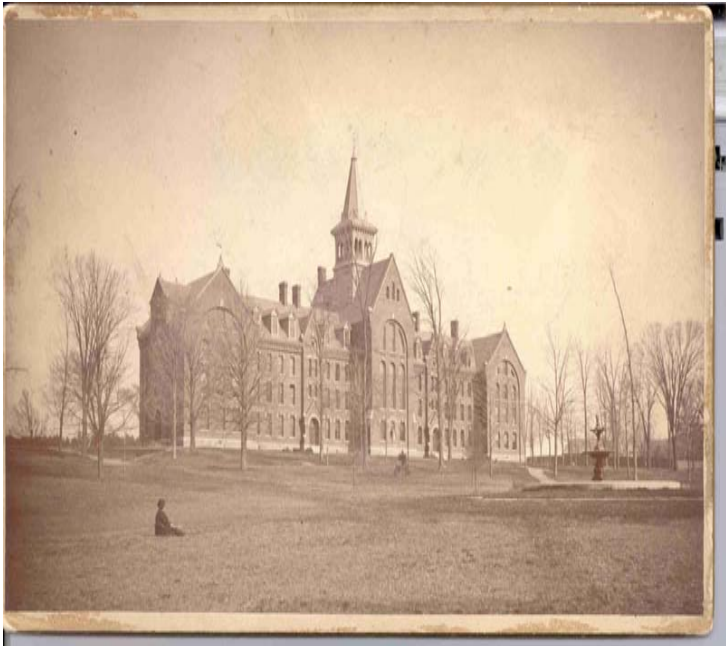
## Figure 8

Old mill historical comparison showing green space areas that have since changed. Notice architecture from before and after fire and subsequent renovation.

The mapping of different green space categories allows a visual representation of the areas that are similar in their infiltration characteristics. There has been a significant change over time in the amount of impervious surfaces within our study area (fig. 7-11, pp.16-20), and this change directly relates to the need for optimal green space health. One problem with the ortho-photographs was with interpolating known green space boundaries that were obscured from view by roof overhangs and elevation features.

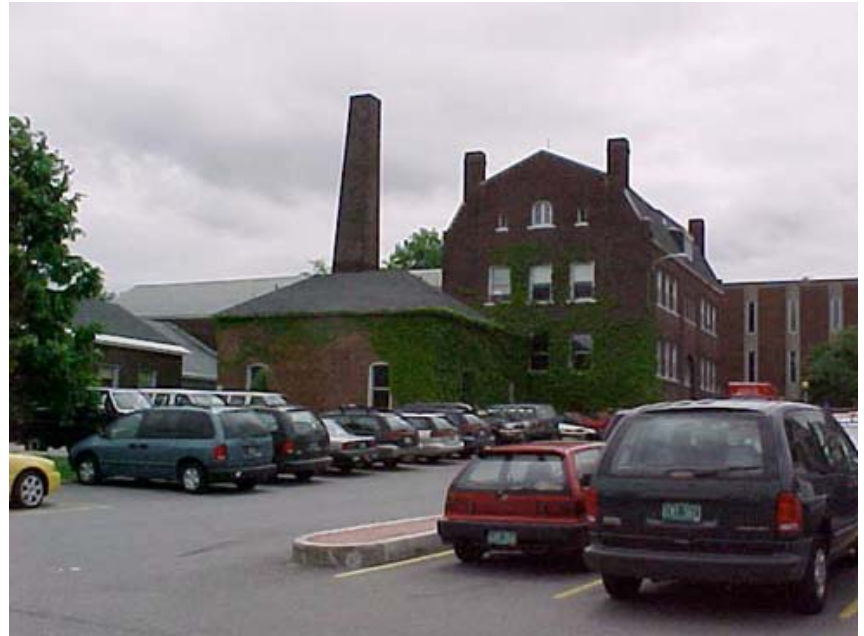
Figure 9

Notice building addition and parking lot.  
Impervious surfaces replace historical  
green space and dirt road.

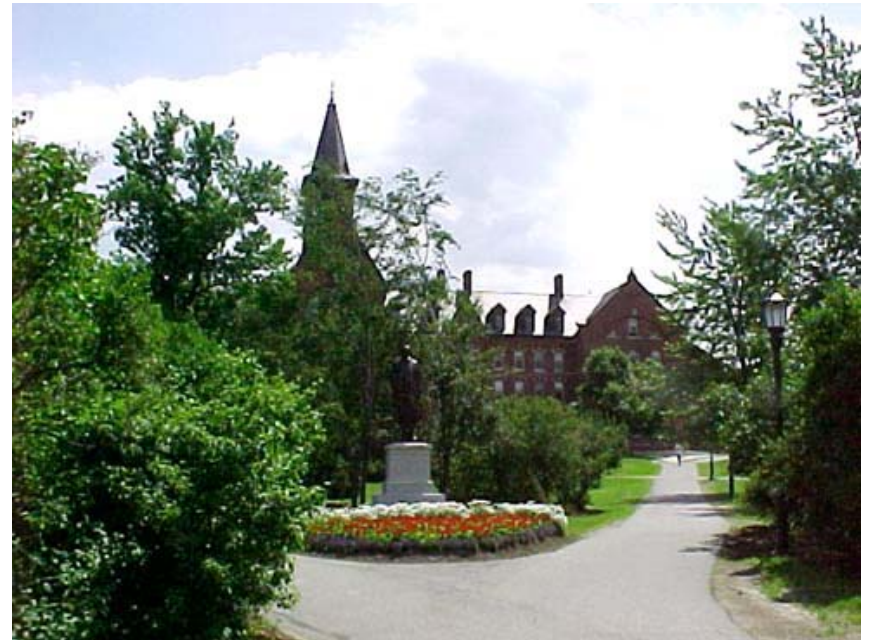
**Figure 10**

Notice change in landscaping composition and density surrounding statue, as well as change from dirt to paved path.

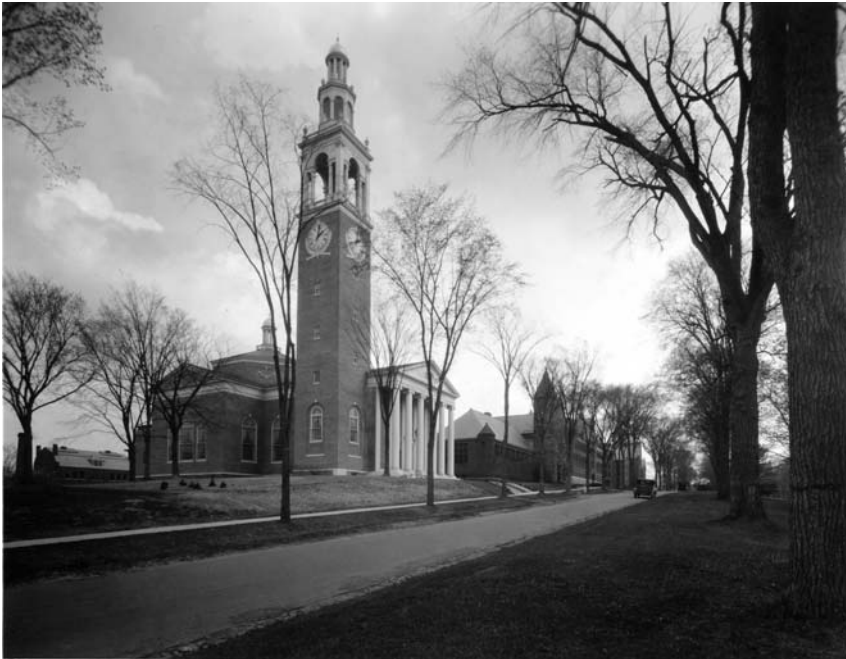
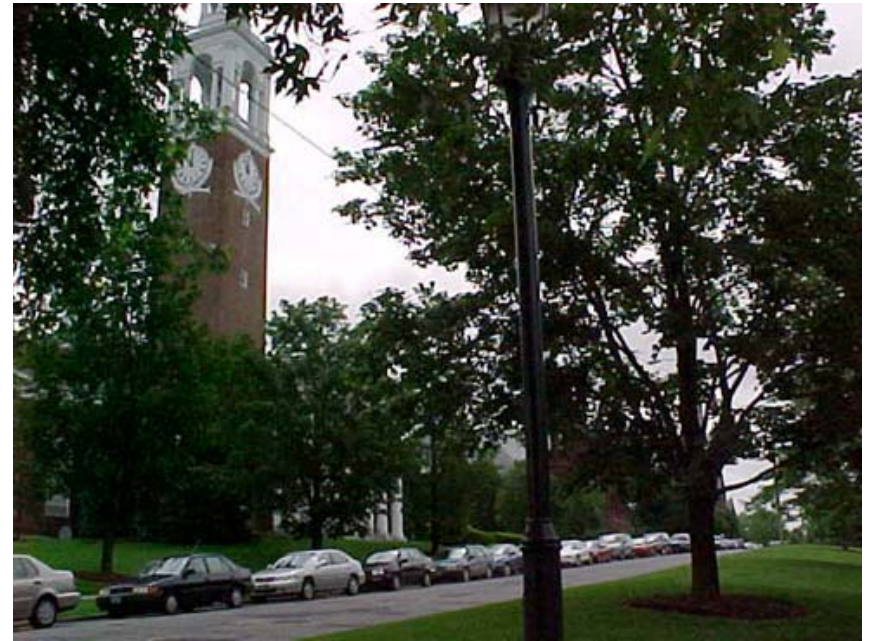
**Figure 11**  
**Ira Allen Chapel**

Notice little change in the northwest corner of campus, except for widening of road.
