# 80<sup>th</sup> Anniversary of the **CASTLEWOOD DAM FAILURE**

Lee Mauney, Hydrologic Engineer, Bureau of Reclamation

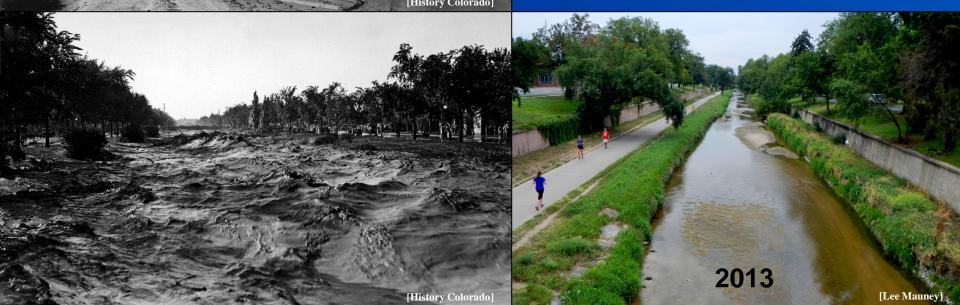
# **Constructed in 1890**

Masonry and Rockfill Structure

Built from local materials

# ← 600 feet long -

70 feet

- Reservoir Capacity = 5,300 acre-feet
- Used for Irrigation

100 x 4 foot notch spillway

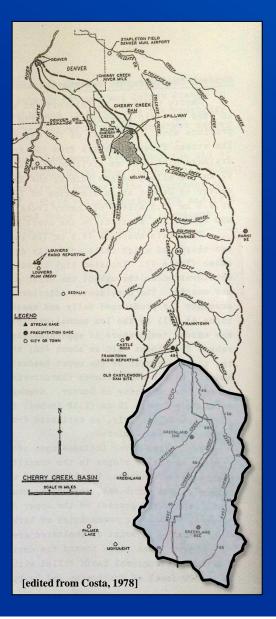
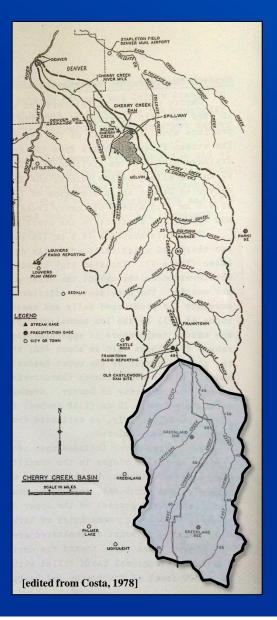
# Basin

- Cherry Creek Basin = 410 mi<sup>2</sup>
- Castlewood Basin = 175 mi<sup>2</sup>
   El. 6500 to 7500 feet

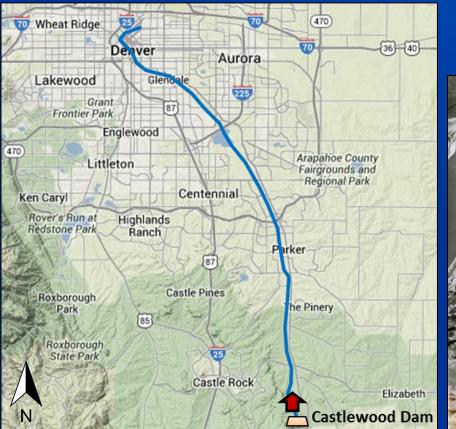
# Immediately downstream ~126,000 ft<sup>3</sup>/s

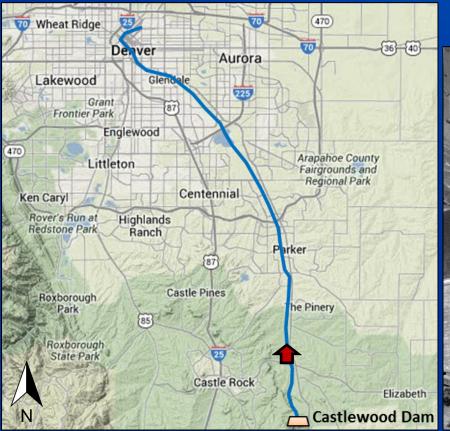
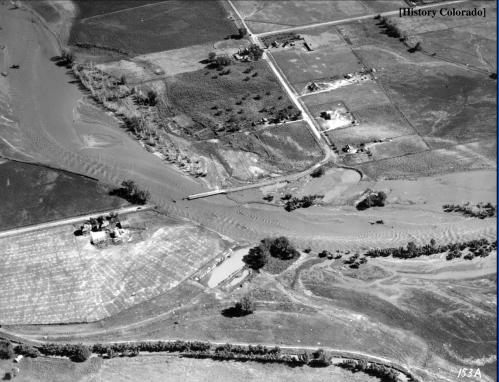
Rural FarmlandWashed out county bridges

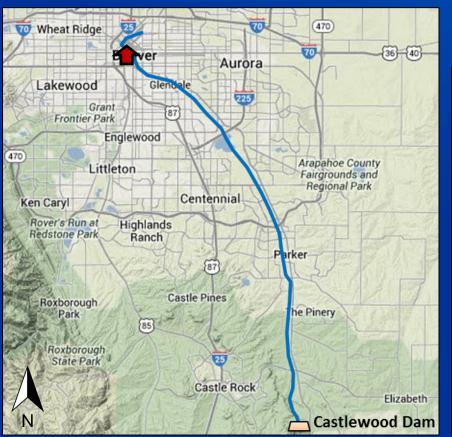
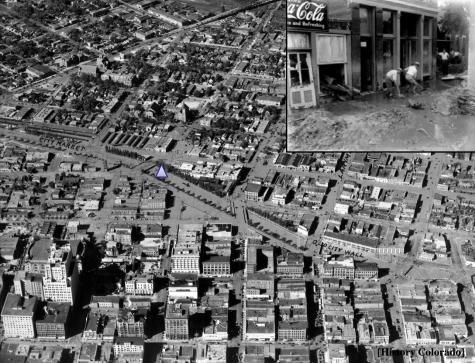
7 am (6 hours after dam breach)
 Discharge = 15,000 ft<sup>3</sup>/s at ▲
 Flooded businesses and homes
