Urban flooding processes in the Nhlamankulu municipal district- Maputo city- Mozambique

Volume 8 Issue 5 - 2024

Rosalina Inácio Fumo Langa

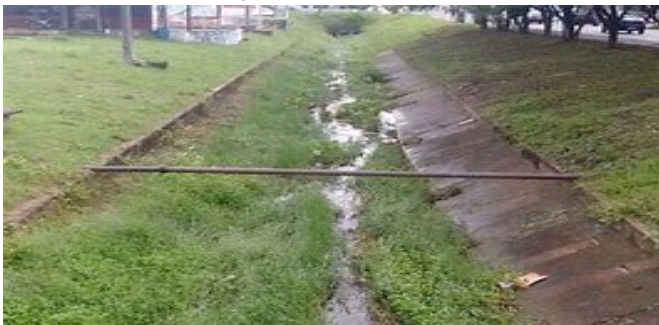
Another no less important situation is the irregular cleaning of drainage ditches and their maintenance by those who are entitled to do so, conditioning the flow of water due to the growth of grass inside them. As illustrated in Figure 1.

Figure 1 Poor drainage system.

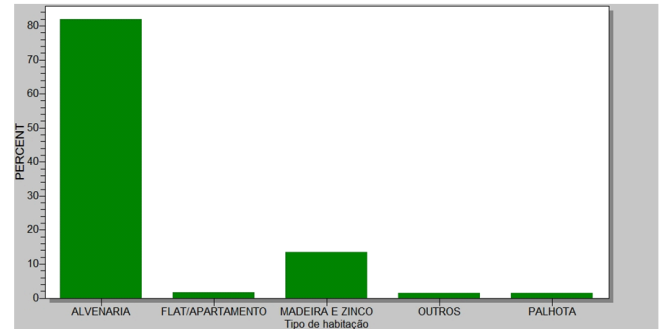
Informal occupation, the accelerated and disorderly process of urbanization that has taken place in recent decades has transformed the DMN into an area with a considerable population density. The type of housing influences sanitation conditions. In general, most of the population, around 80%, live in brick houses with backyards (Graph 1).

Graph 1 Type of housing in the DMN.

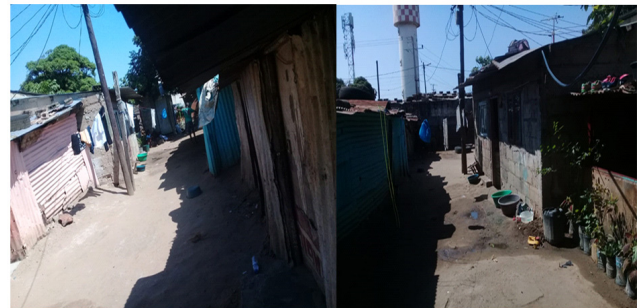
In addition to the above-mentioned factors, the current occupation and layout of homes makes the soil saturated and water runoff poor, influencing the occurrence of flooding by not allowing the construction of rainwater drainage channels (Figure 2).

Figure 2 Layout of the houses.

The disorderly occupation of urban space is evident in this district, where there is not only territorial disorder, but also uncontrolled occupation and overcrowding. In many cases, in a yard that should house a certain number of family members, the head of the household sells or builds small houses for rent in the remaining space.

This factor has been responsible for flooding, as the available space decreases and, with the ground saturated due to land use by occupants, any minimal amount of rain can result in flooding."
