# RECLAMATION

## **Sustainability Success** **at the** **Provo Area Office**

# The Provo Area Office

# Efficiency Upgrades

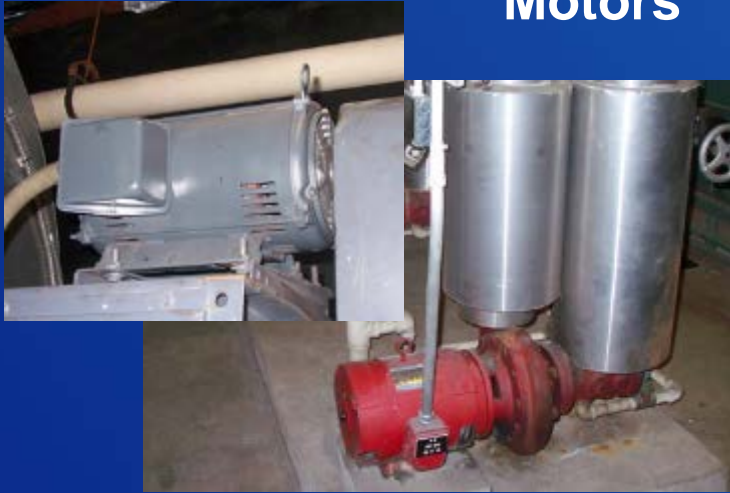
## Single-speed Fan & Pump Motors

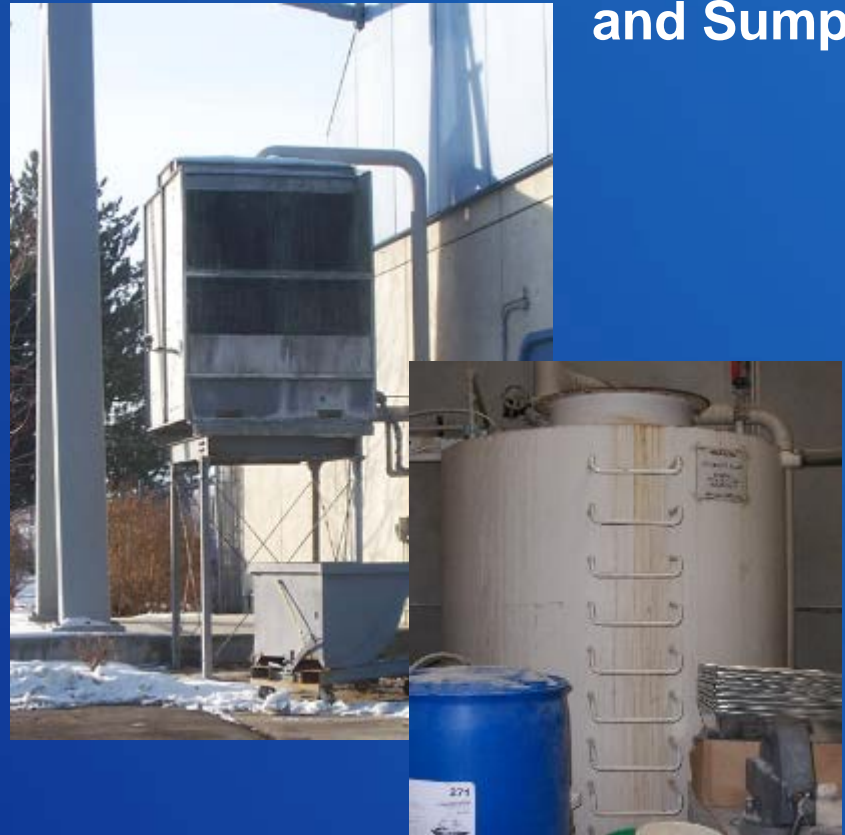
## Evaporative Cooling Tower and Sump

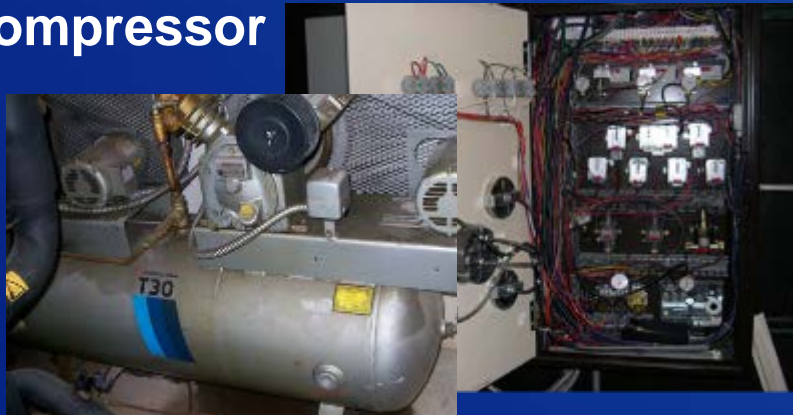
## Pneumatic Controls & Compressor

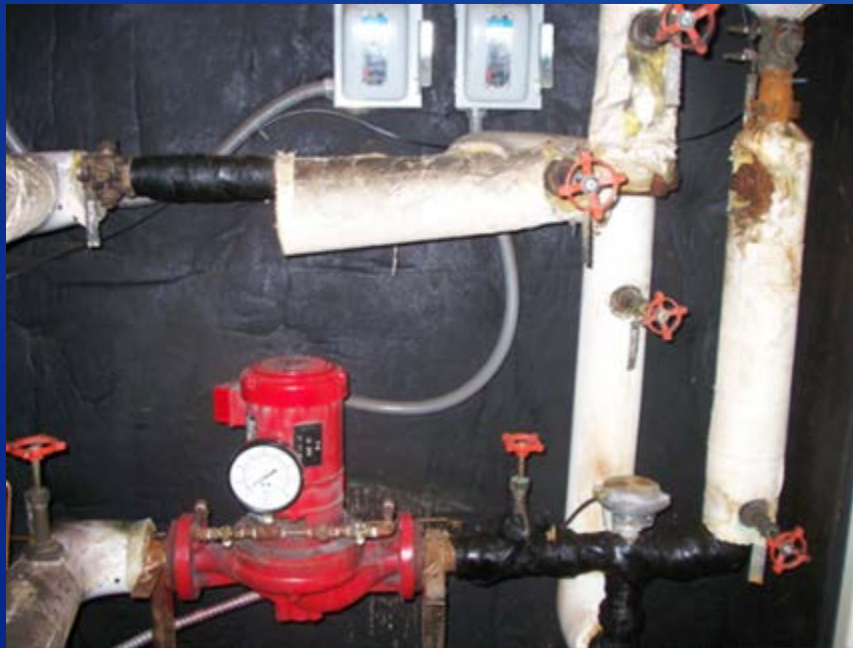
## Deteriorating Valves

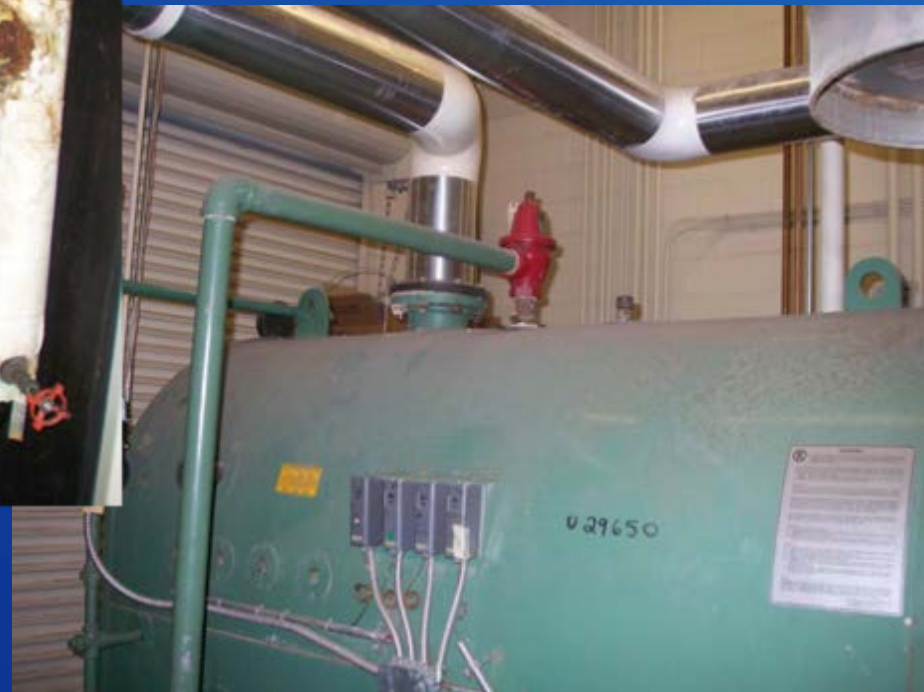
## Inefficient Boiler

## New High Efficiency, Dual Boiler System

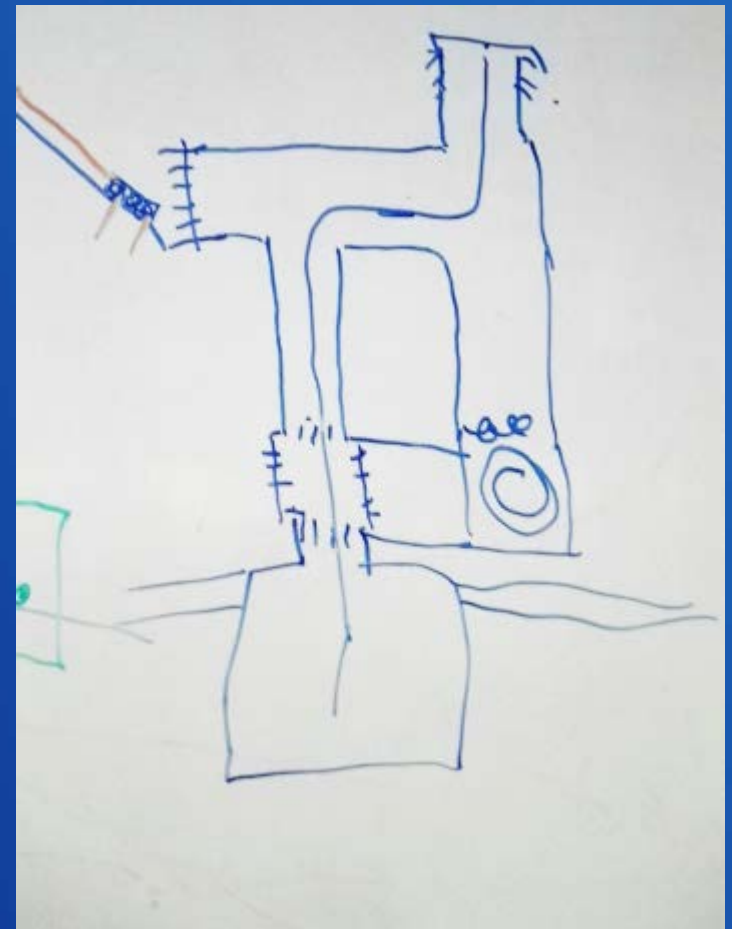
## Air Handler Room Revised Drawing

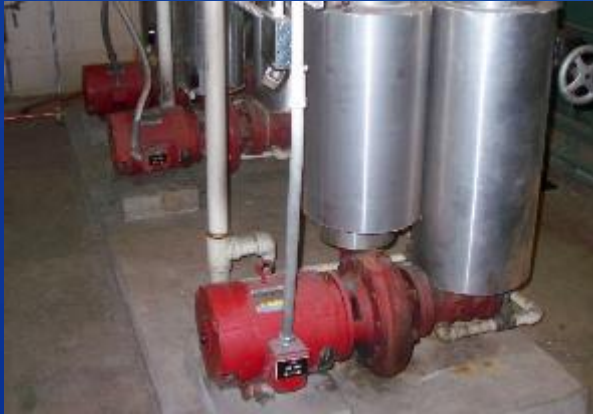
**Old Water Pump Motors**

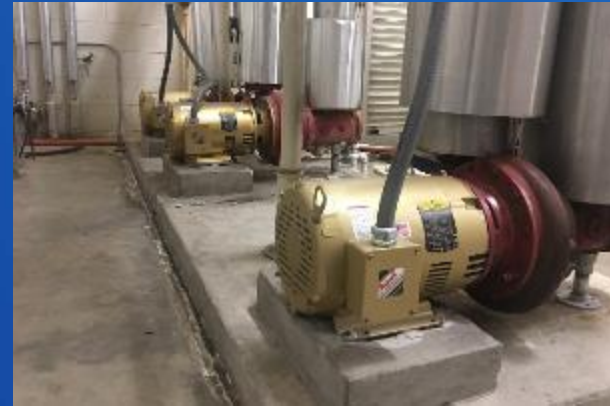
**New Water Pump Motors**

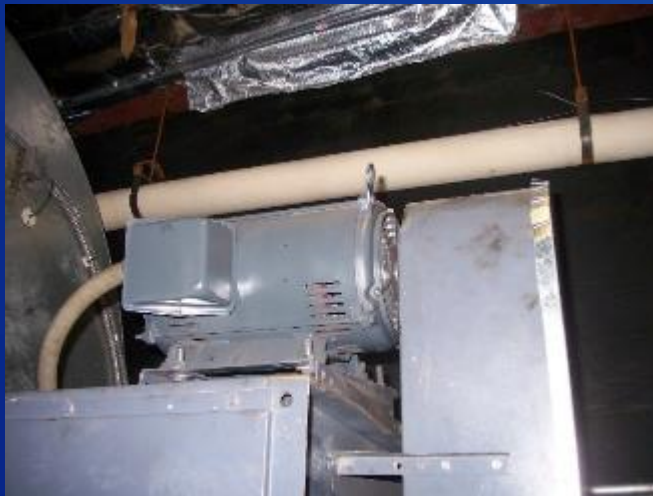
**Old Fan Motor**

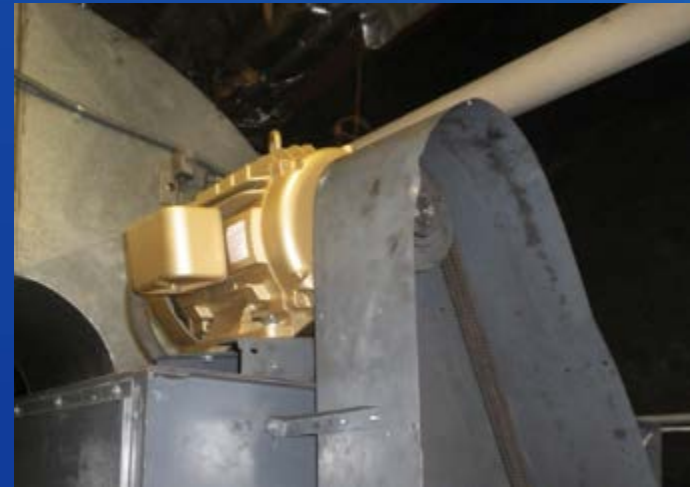
**New Fan Motor**

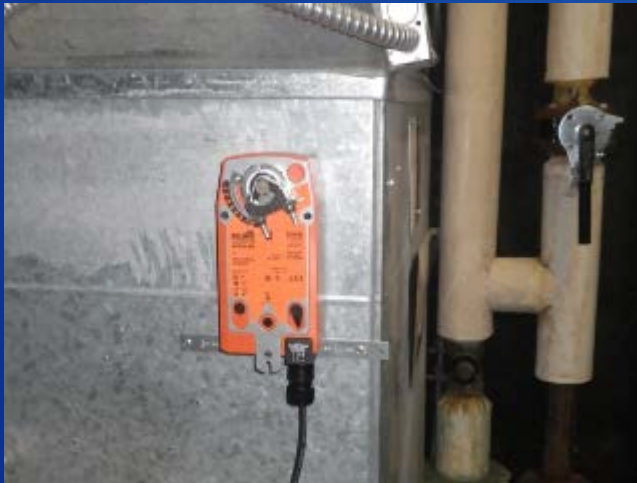
## Electronic Actuators

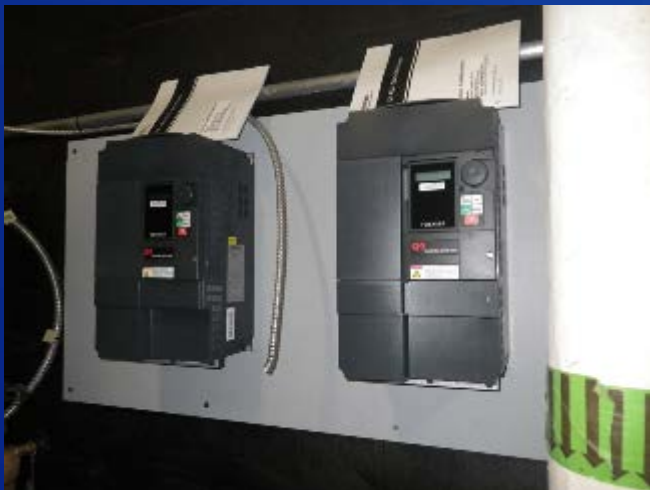
## Variable Frequency Drives

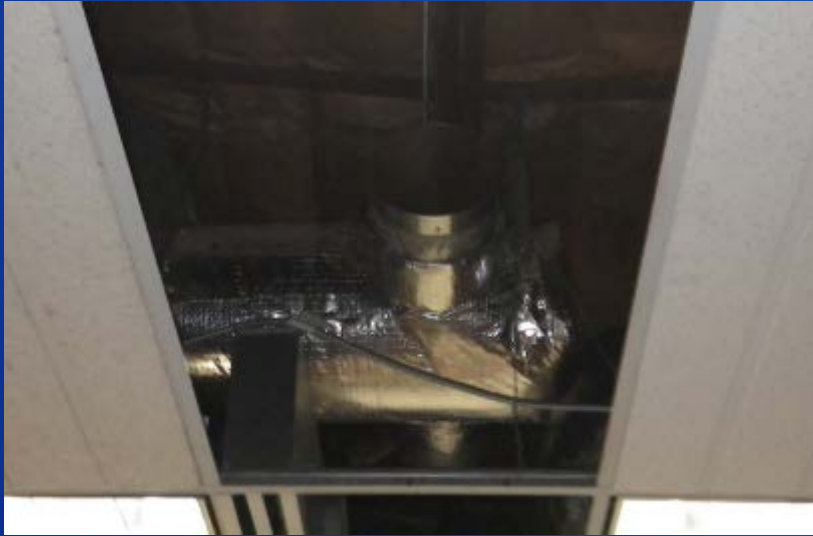
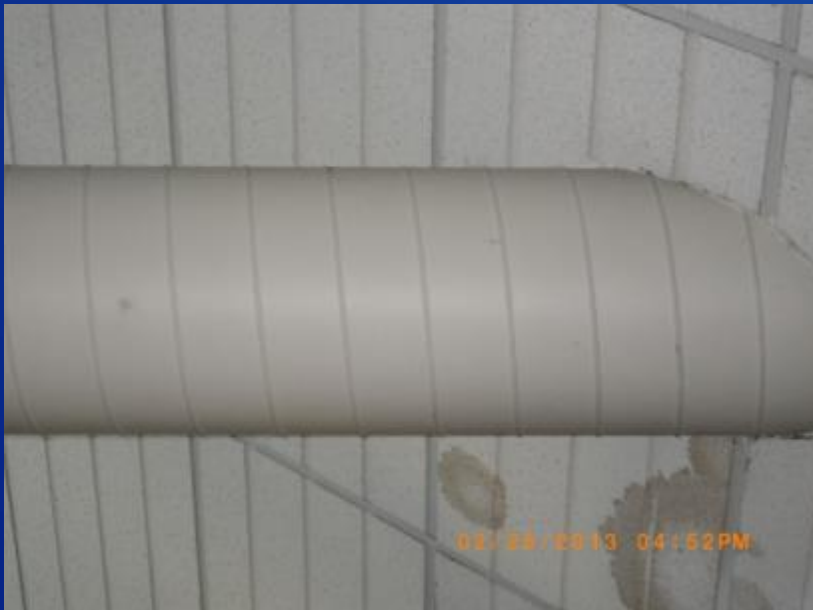
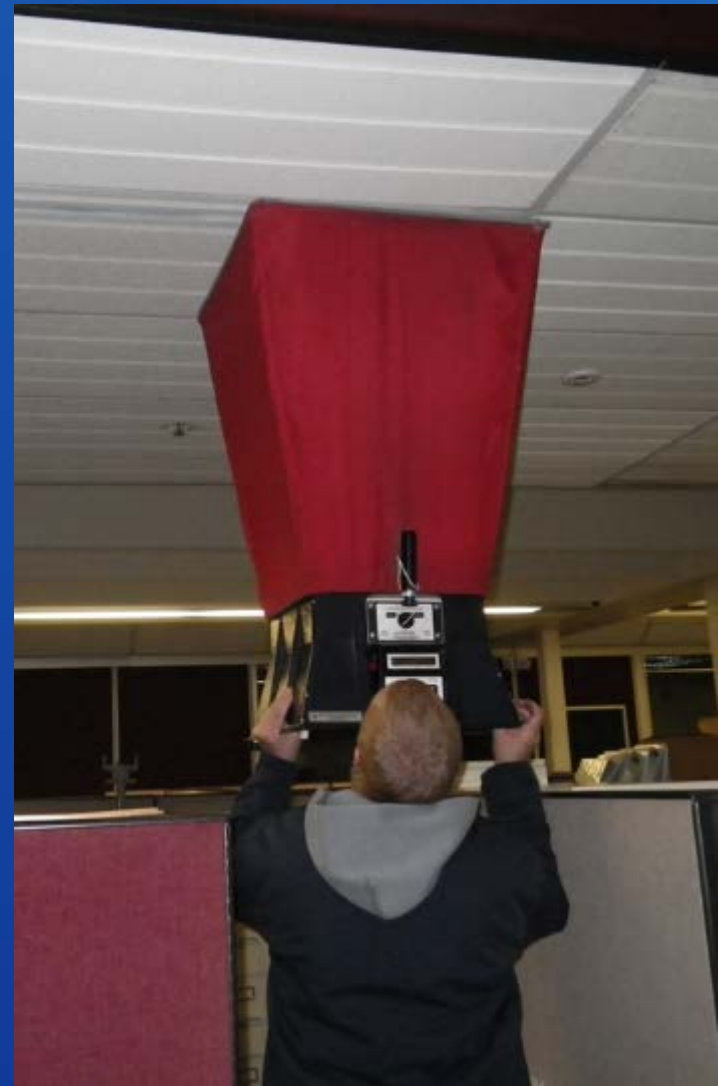
# Duct Repair & Air Balancing

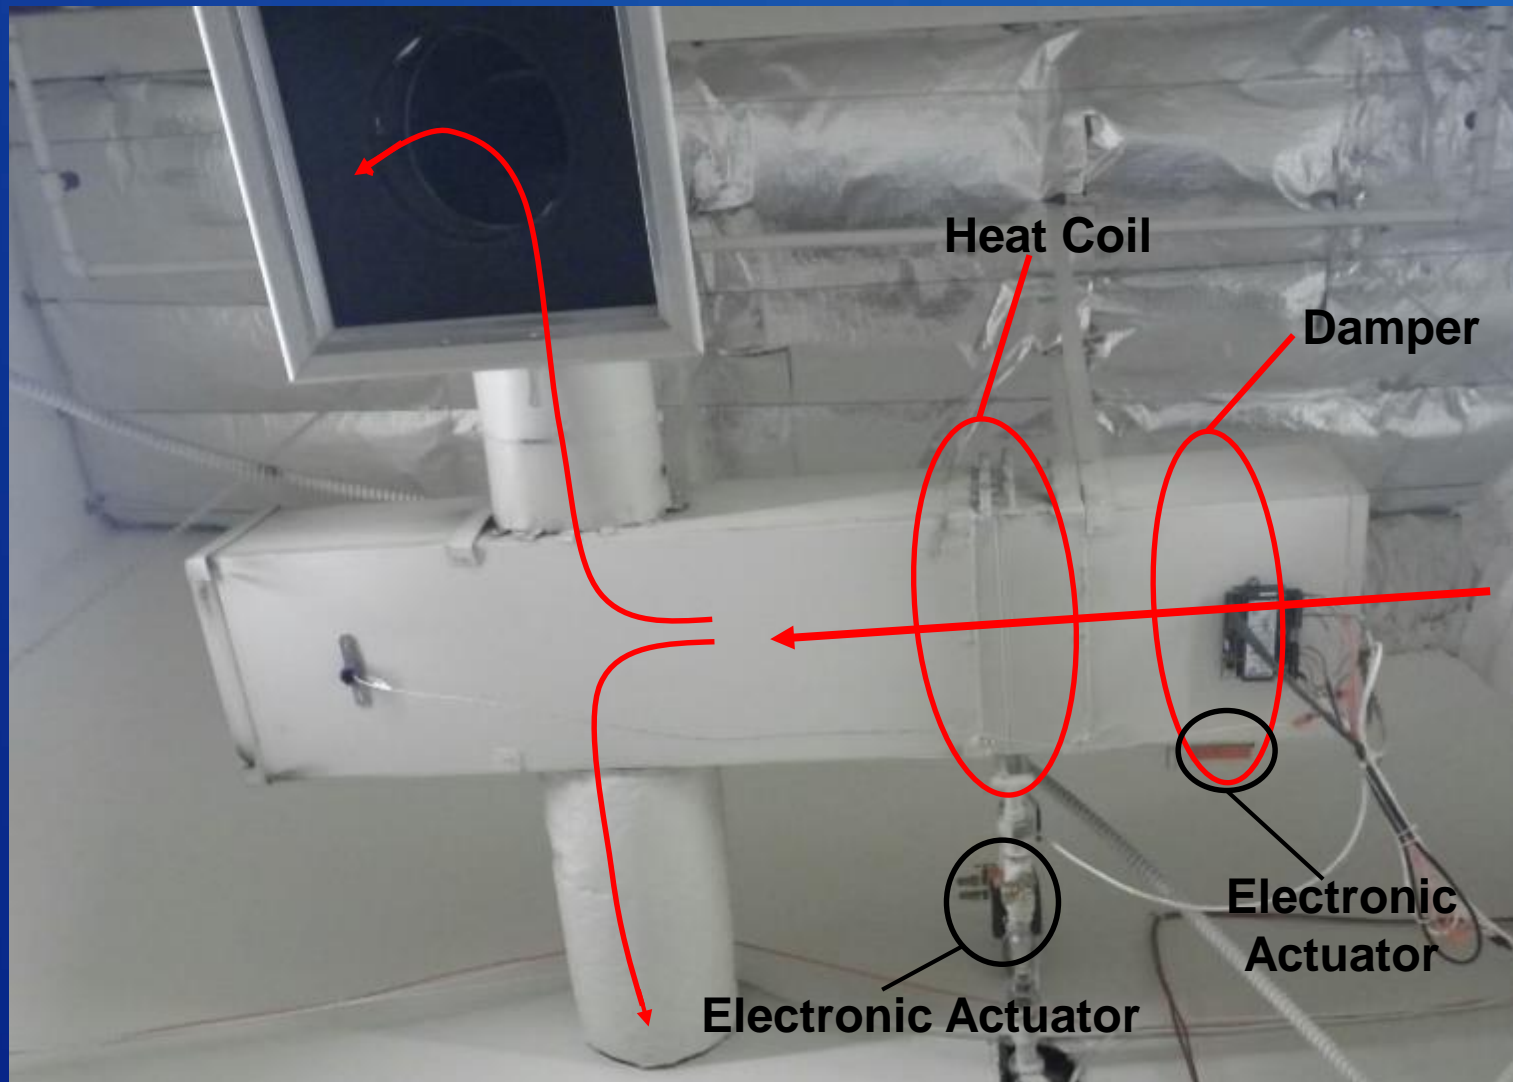
# Variable Air Volume (VAV) Boxes

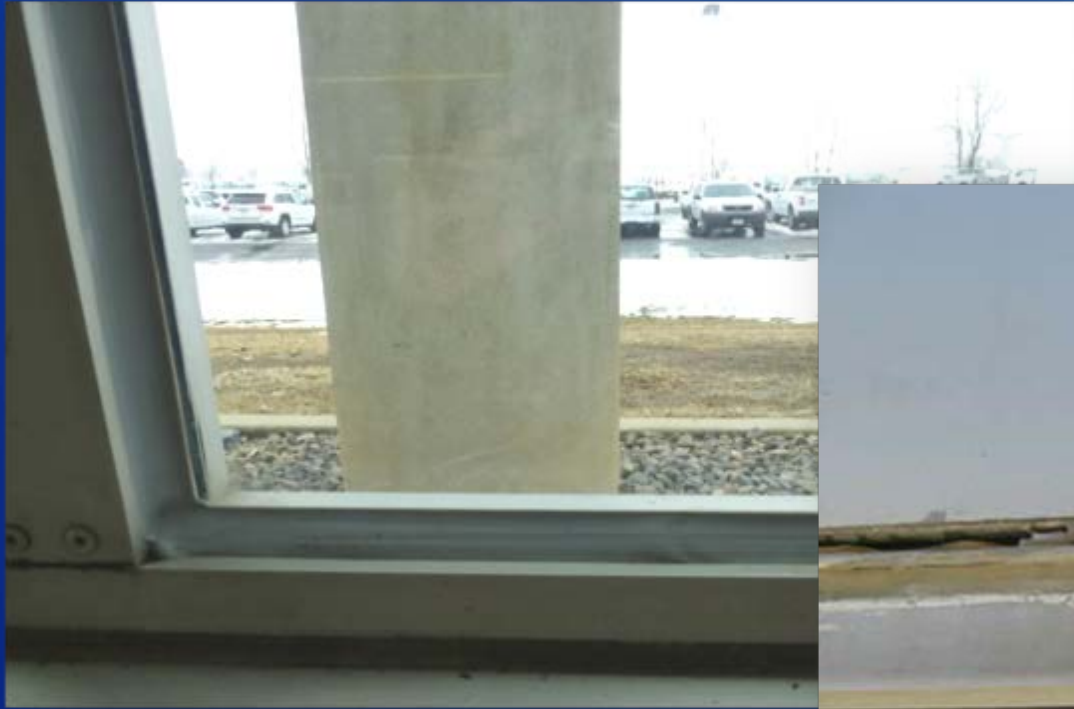
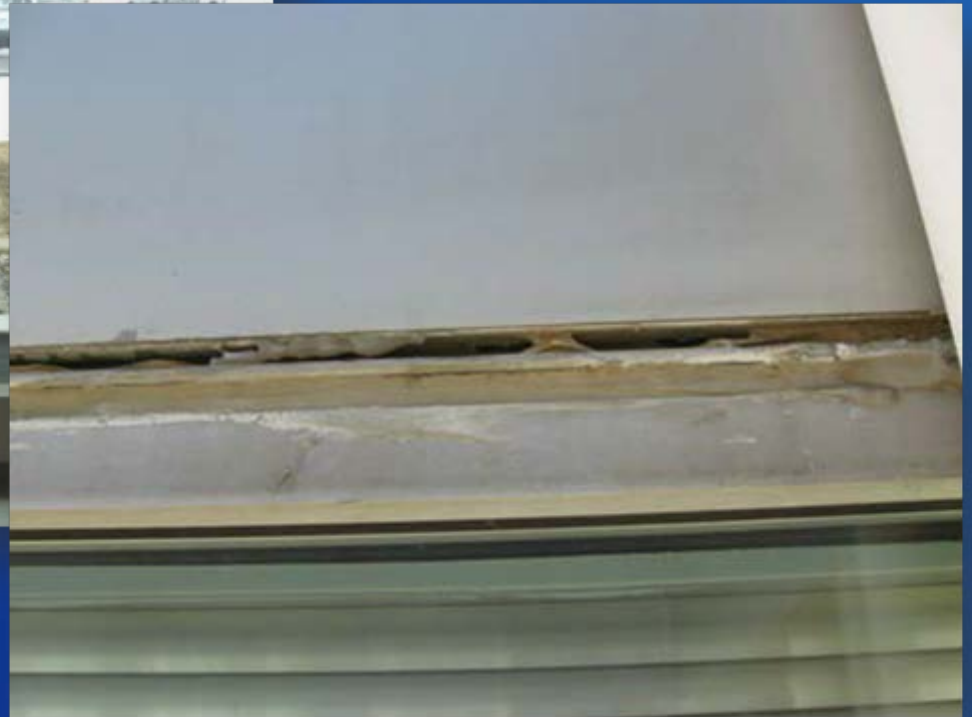
Replaced Deteriorating Window  
Caulk

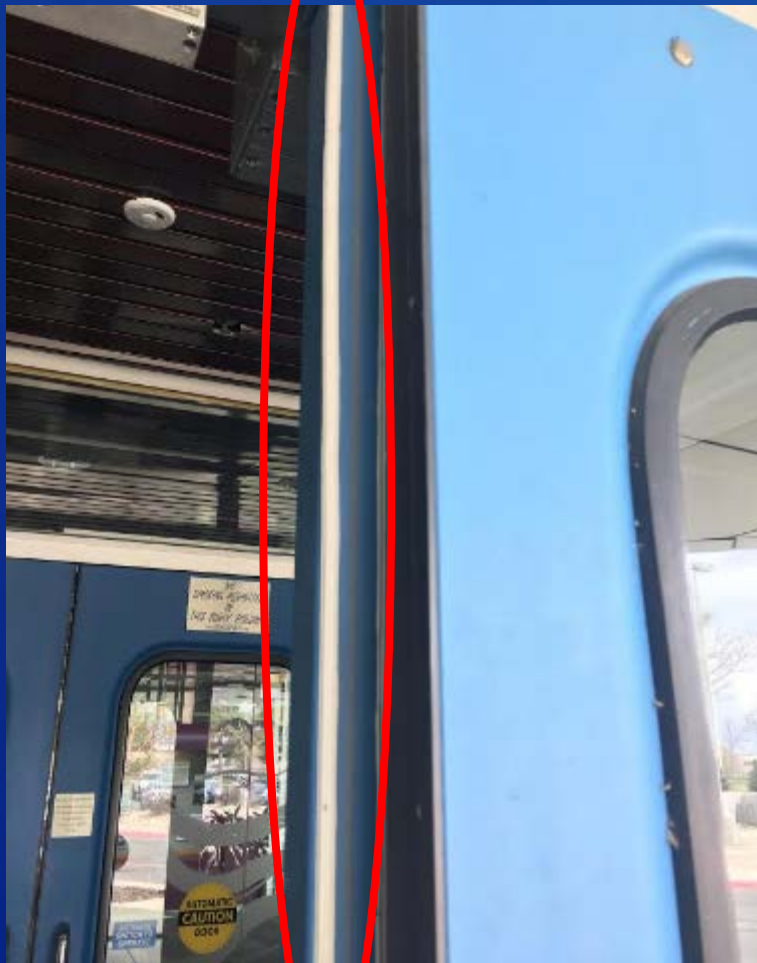
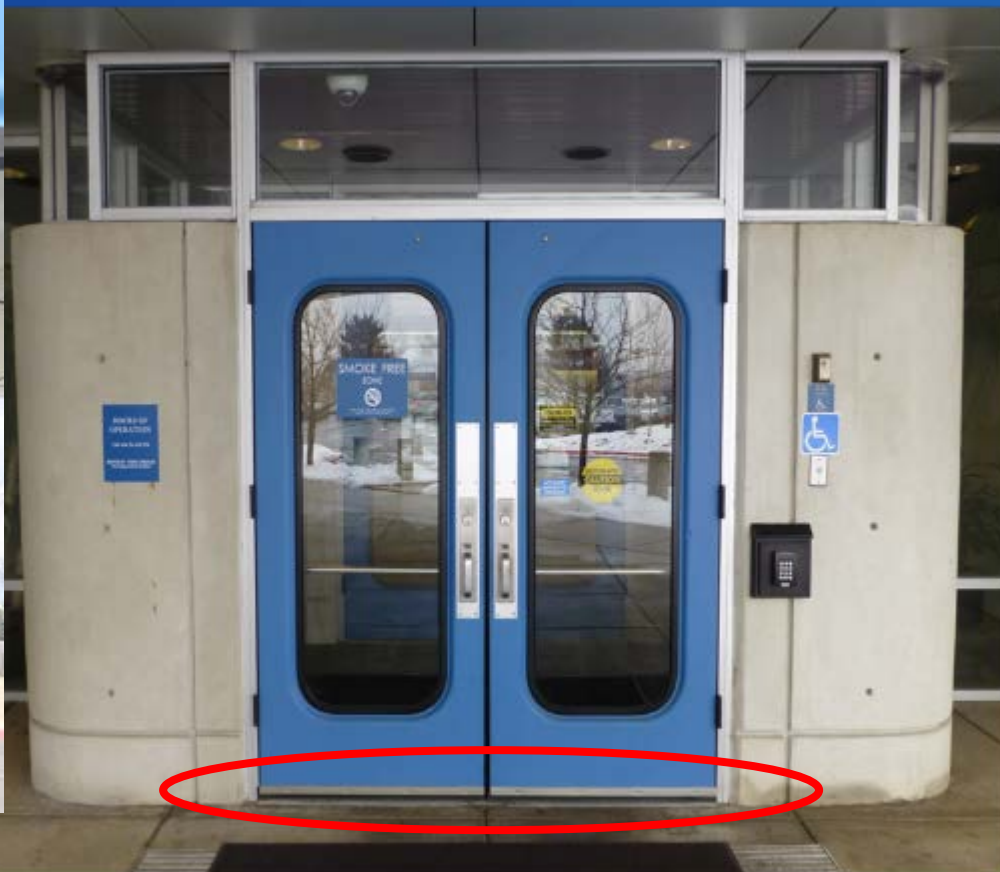
## Replaced Deteriorating Weather Stripping

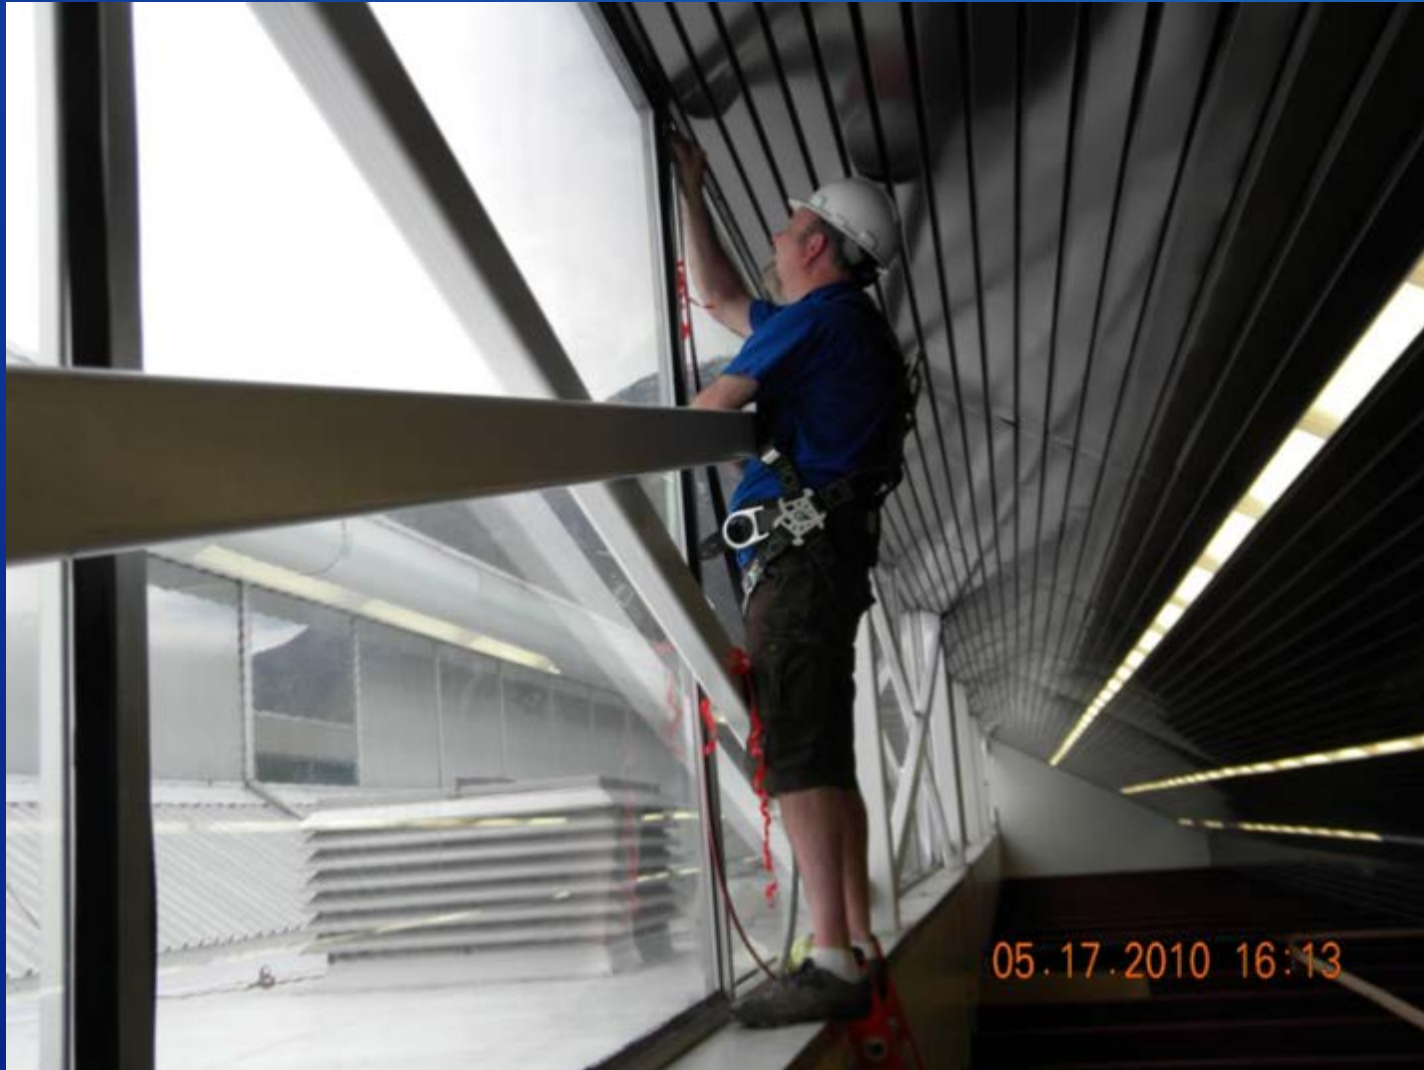
Installed Seismic/Solar Window Film

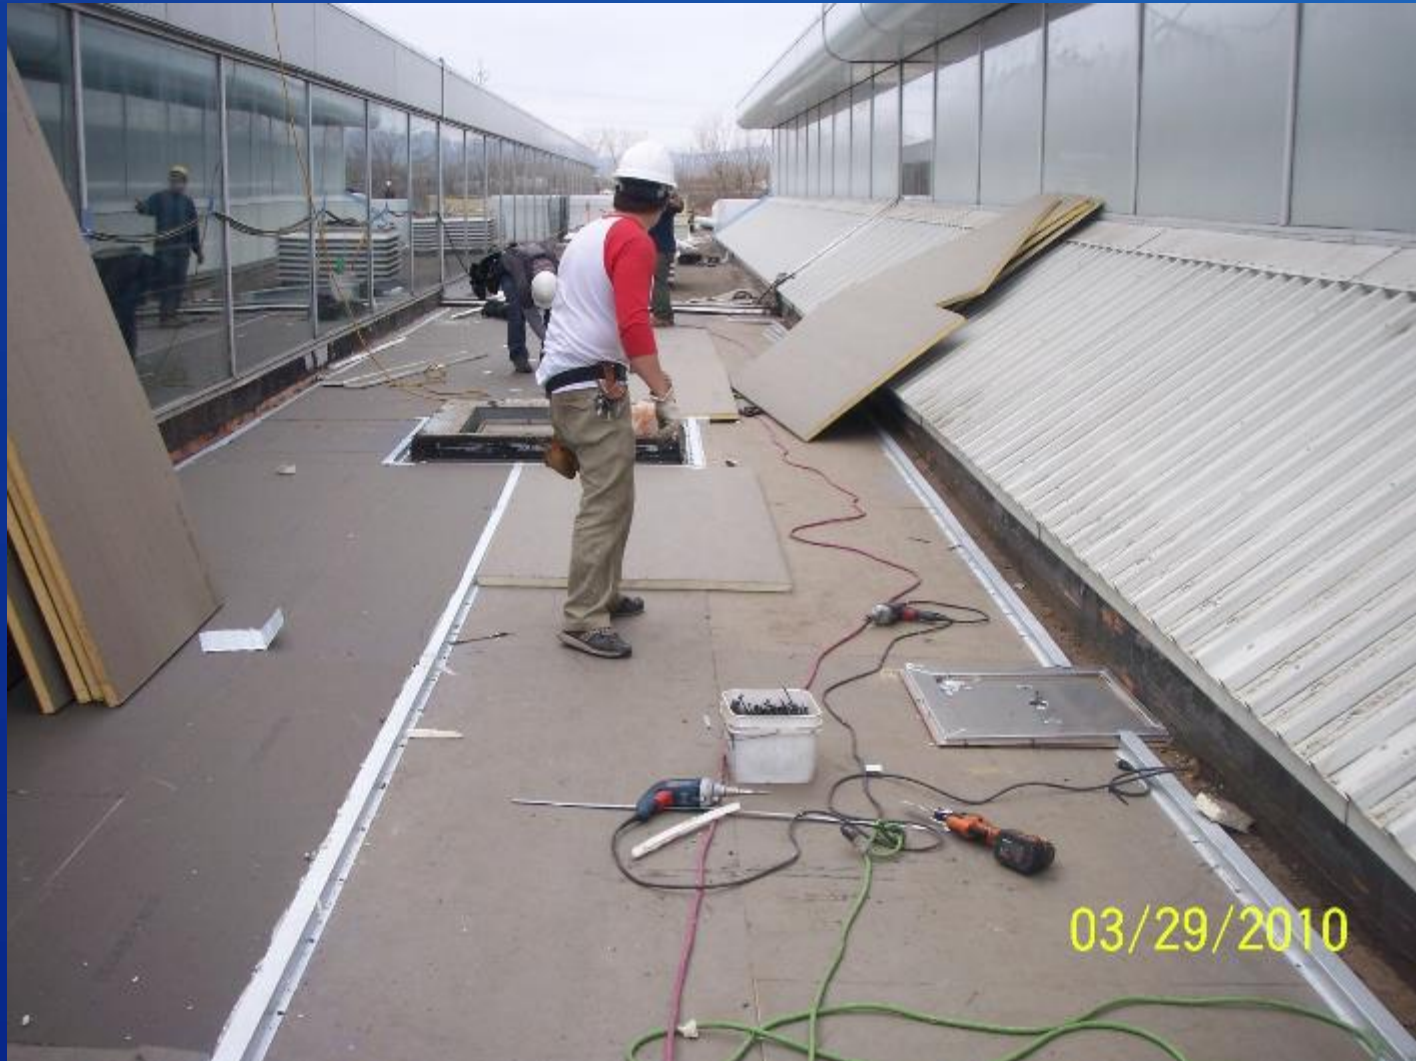
# Building Envelope Installed Roof Insulation

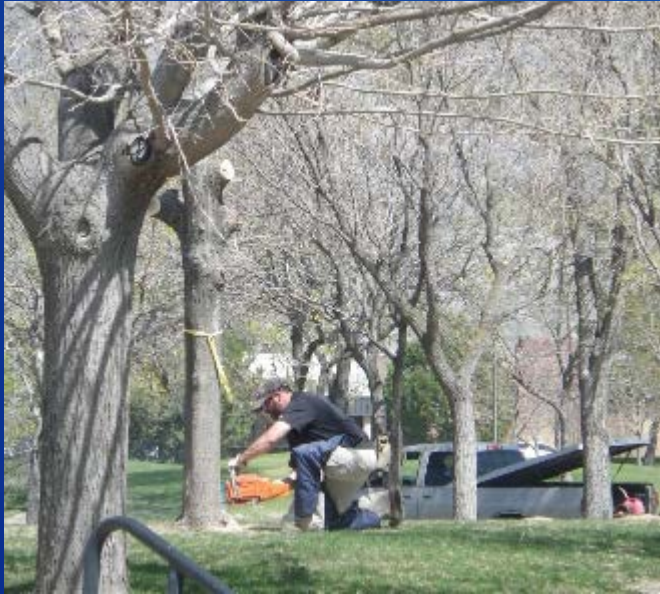
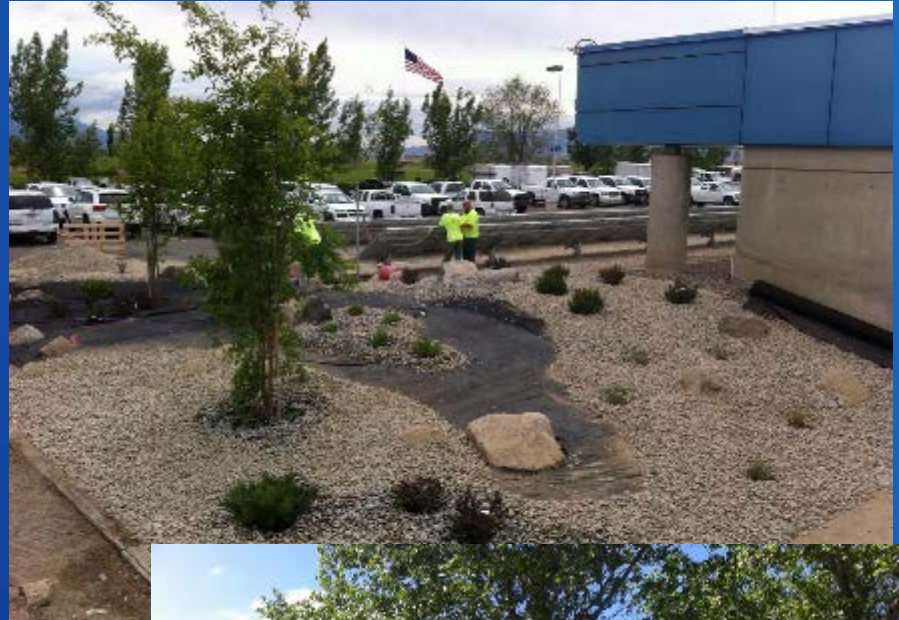
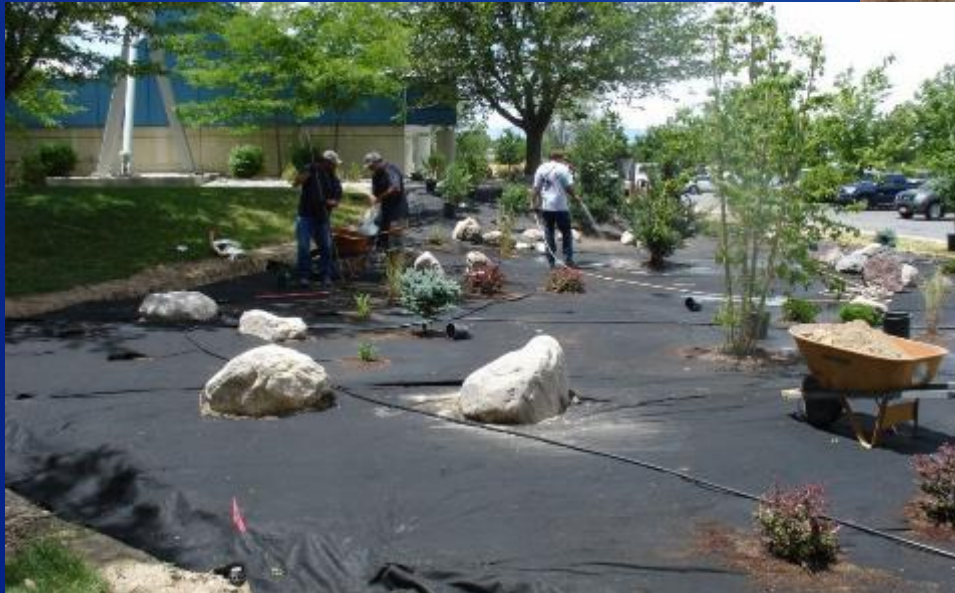
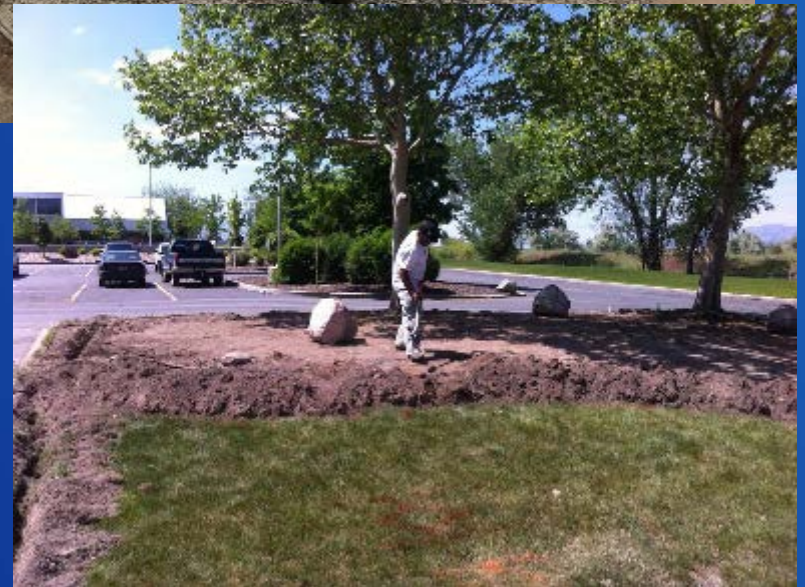
# Removing Grass, Trees, and Installing Xeriscape

- Reduced lawn area by 70%
- Replaced lawn with native, drought-tolerant plants and rock mulch
- Removed overcrowded trees and water-hungry ivy and replaced them with xeriscape
- Installed rainwater harvesting system and drip irrigation system

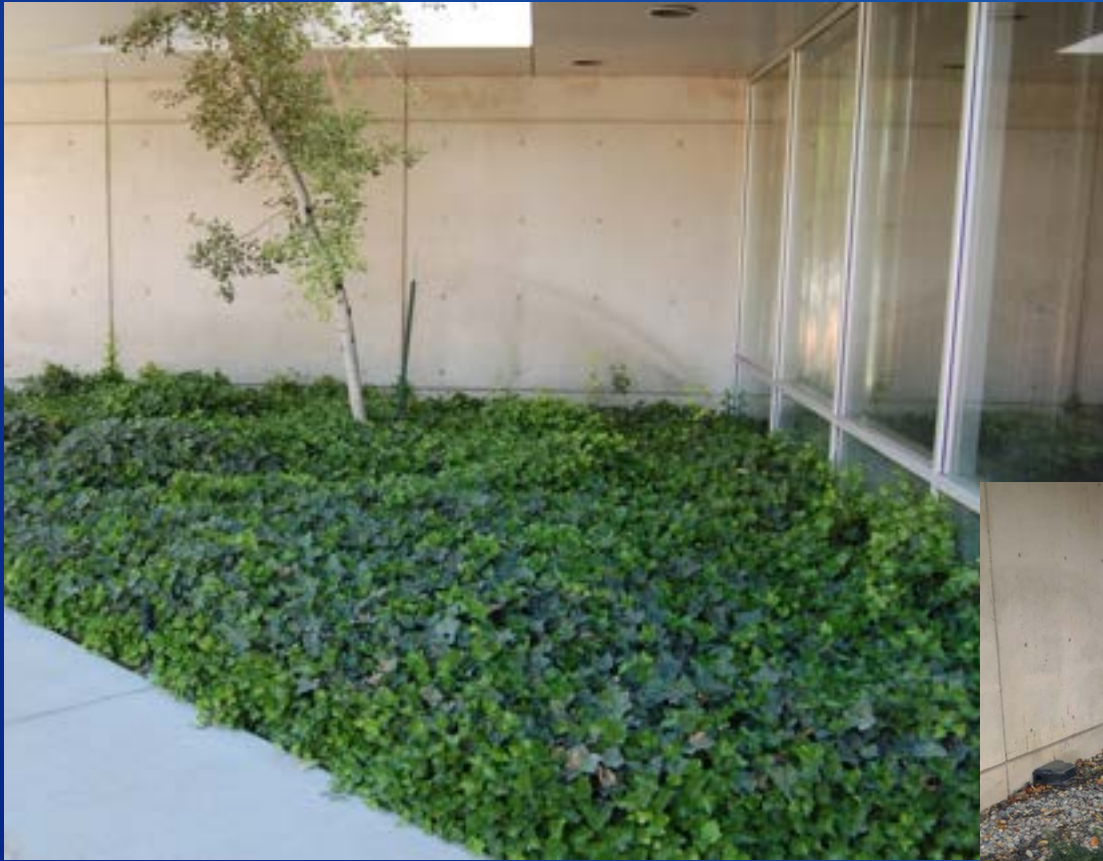
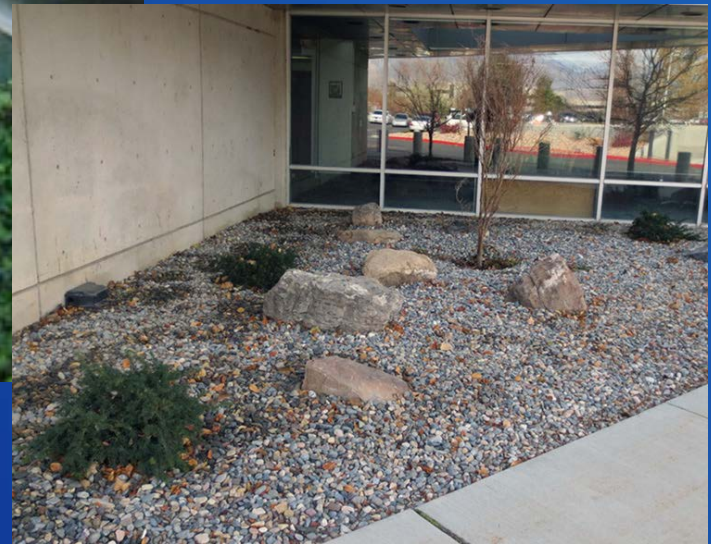
# Xeriscape and Drip Irrigation

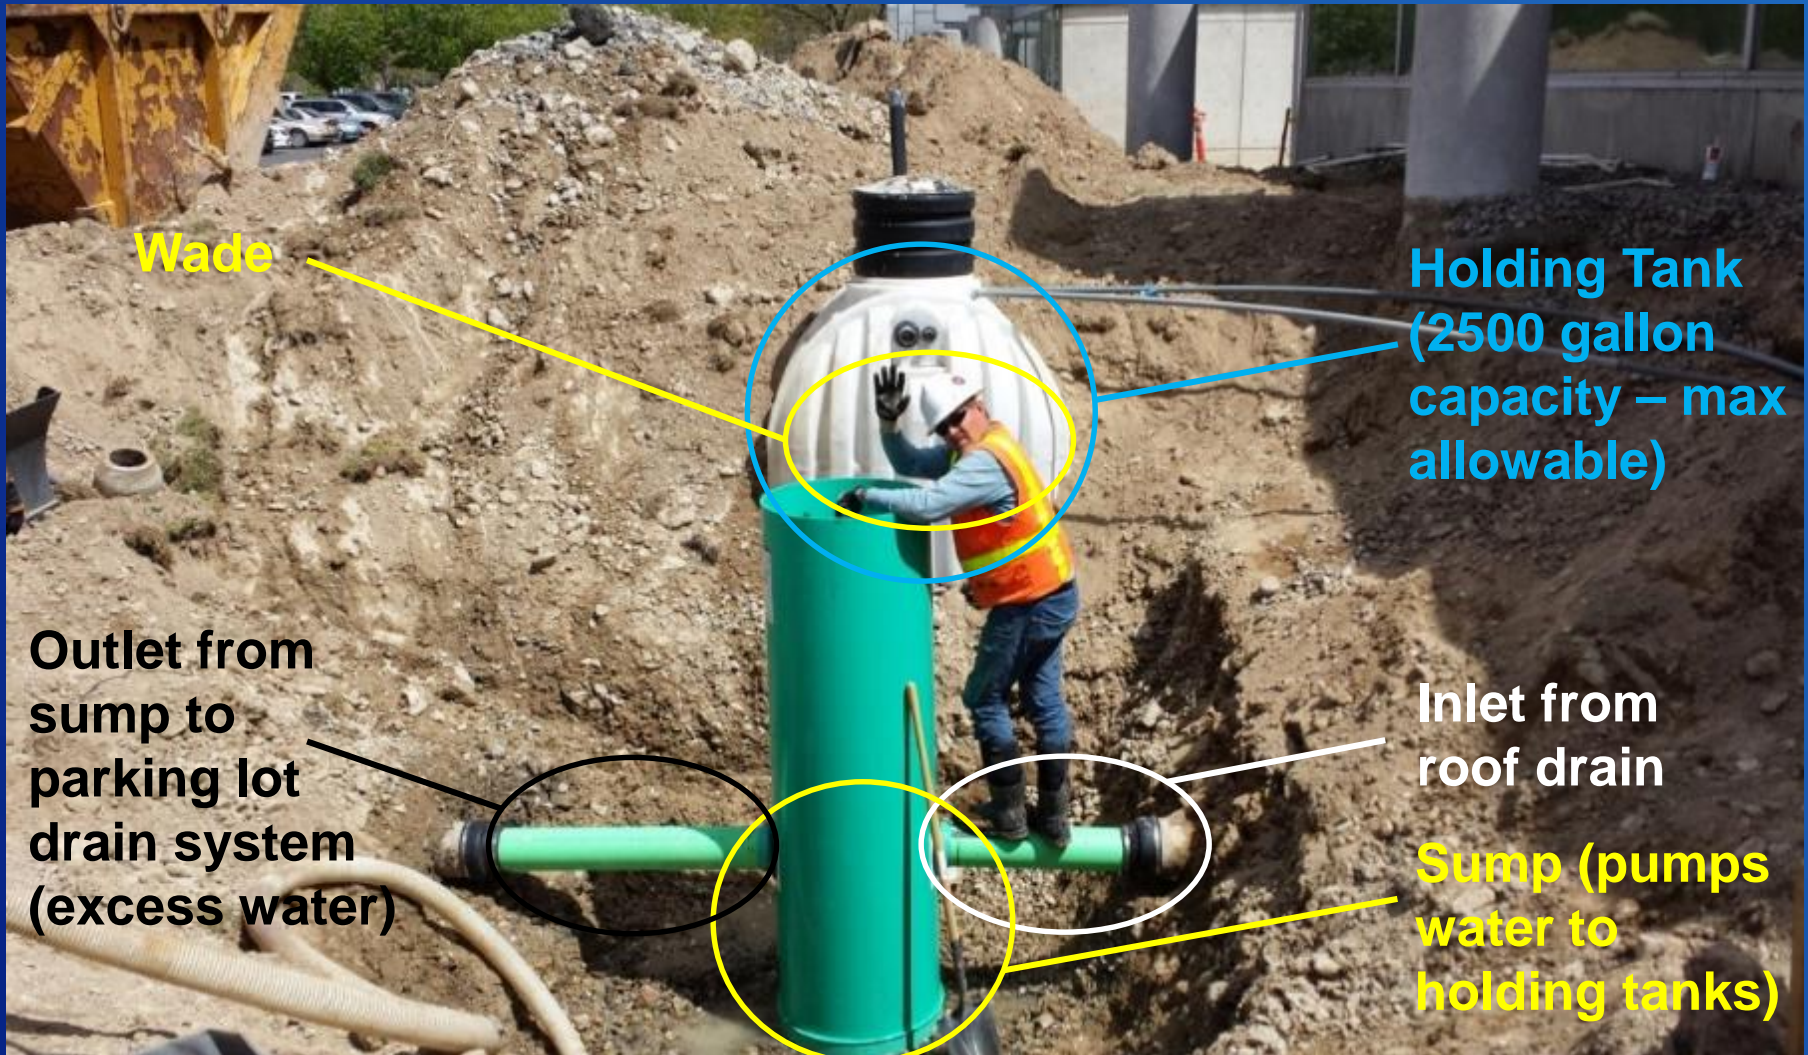
# Rainwater Harvesting System

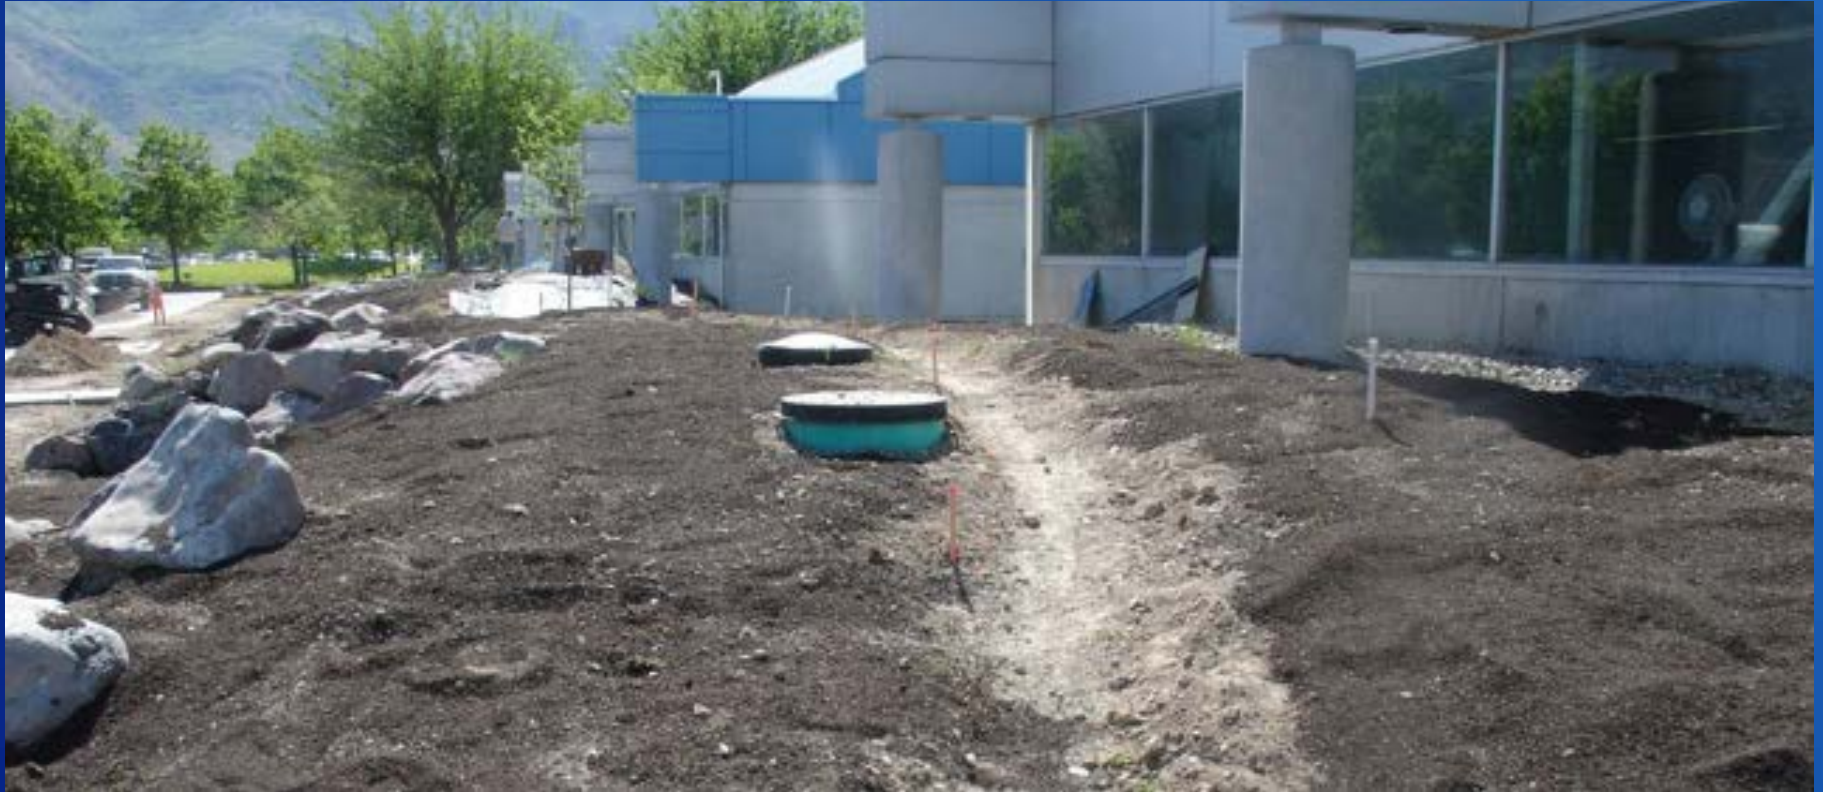
# Rainwater Tanks Buried – Awaiting Xeriscape

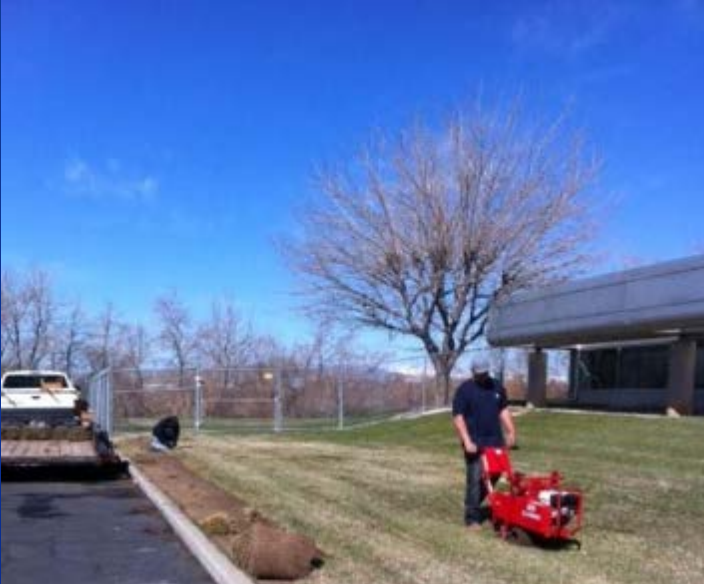
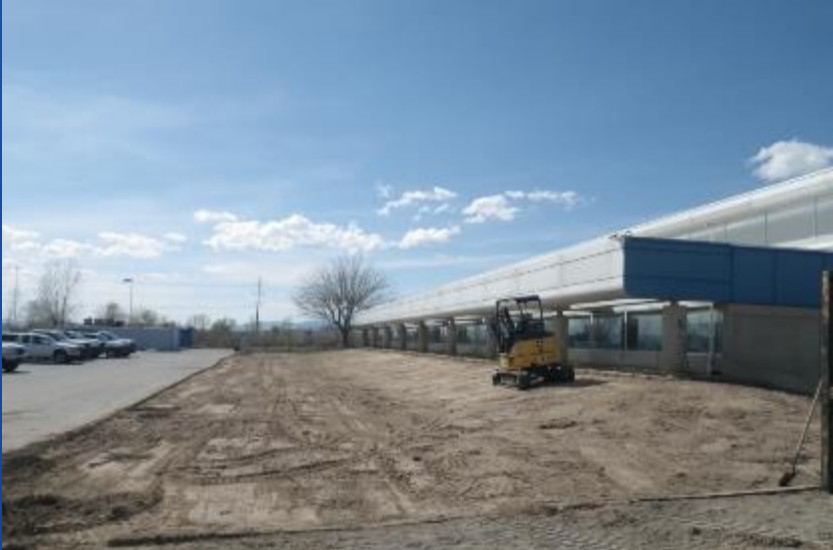
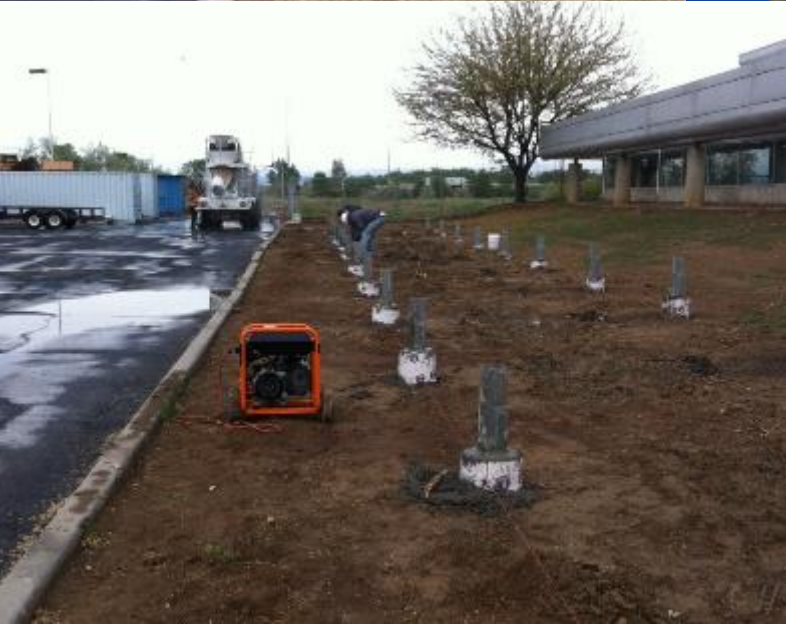
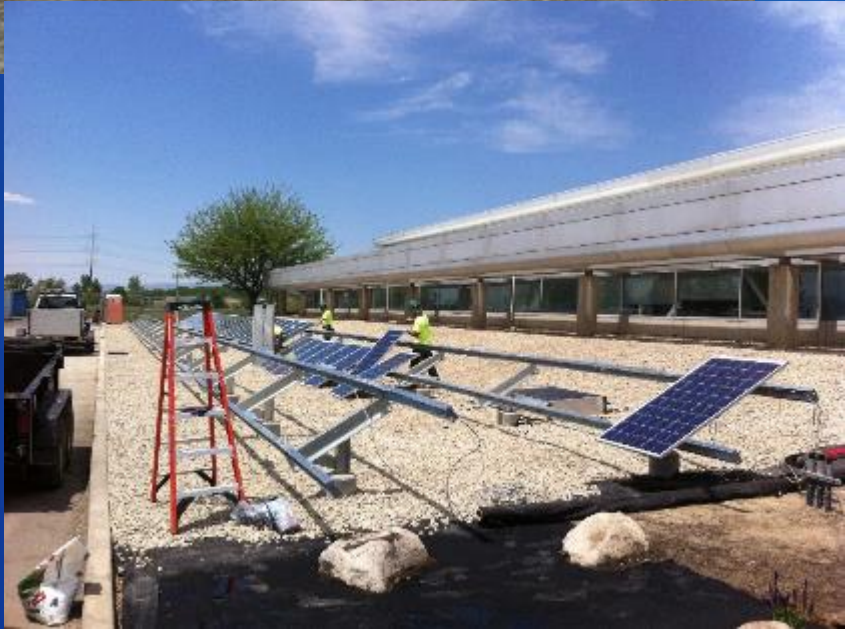
# Goodbye South Lawn – Hello Solar Panels

- Installed a 25 kW system over old south lawn (lawn was removed and replaced with gravel)
- First commercial building in Provo to go solar (quite a learning process for Reclamation and Provo City)
