# RECLAMATION

## **Sustainability Success** **at the** **Provo Area Office**

# The Provo Area Office

# Efficiency Upgrades

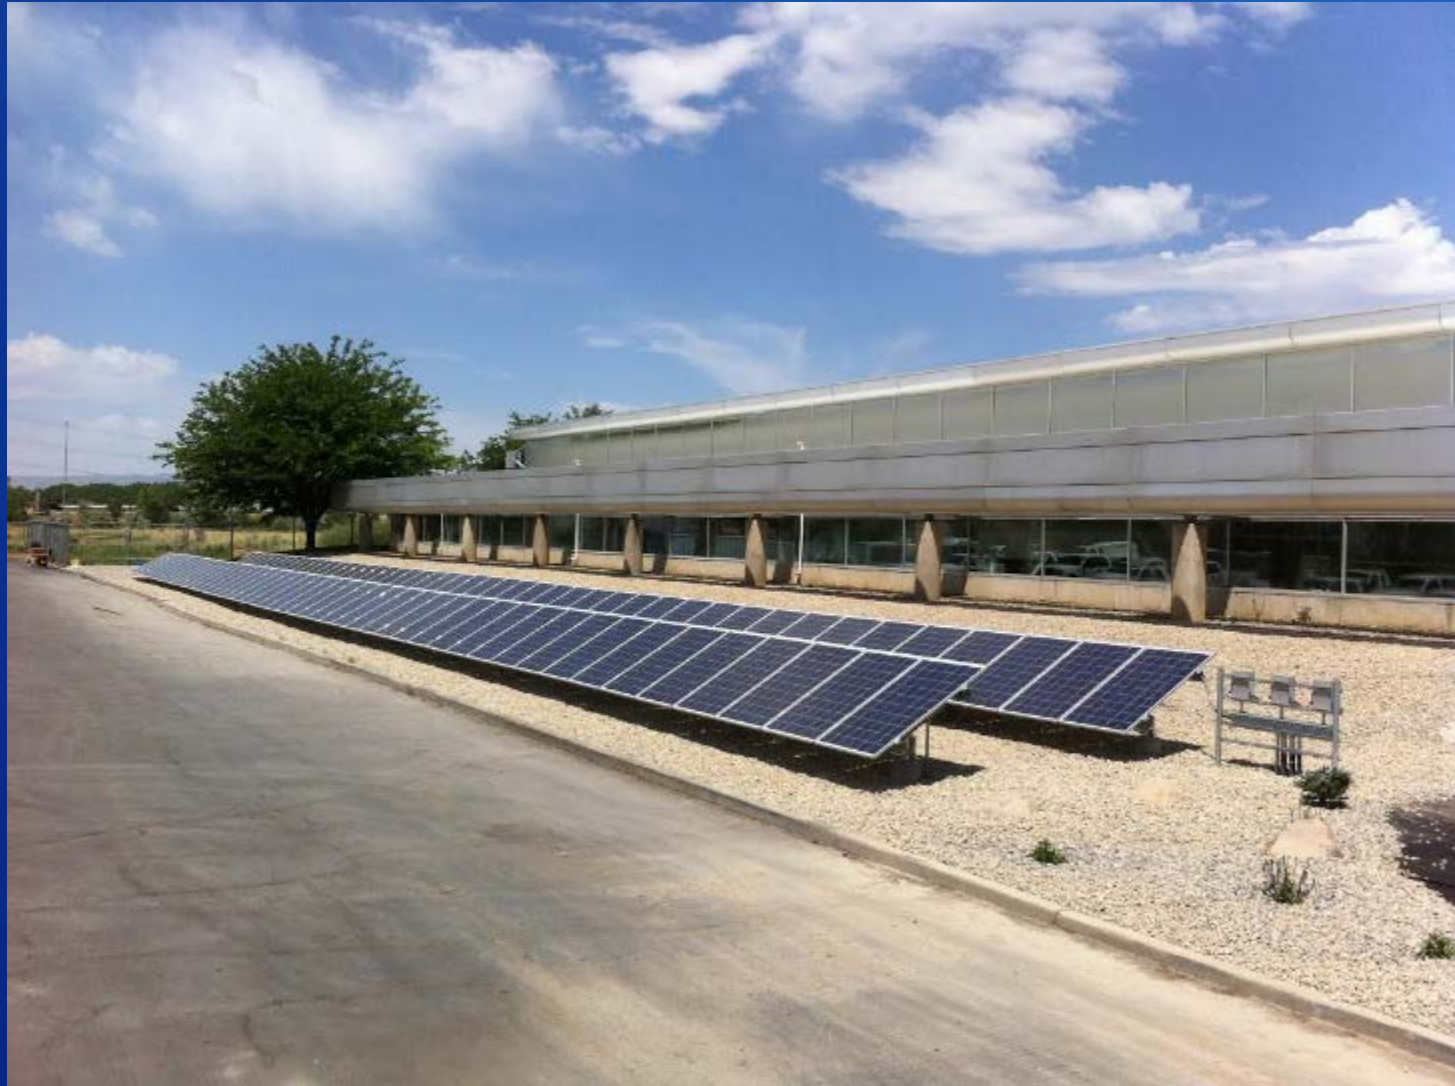
# Goodbye South Lawn – Hello Solar Panels

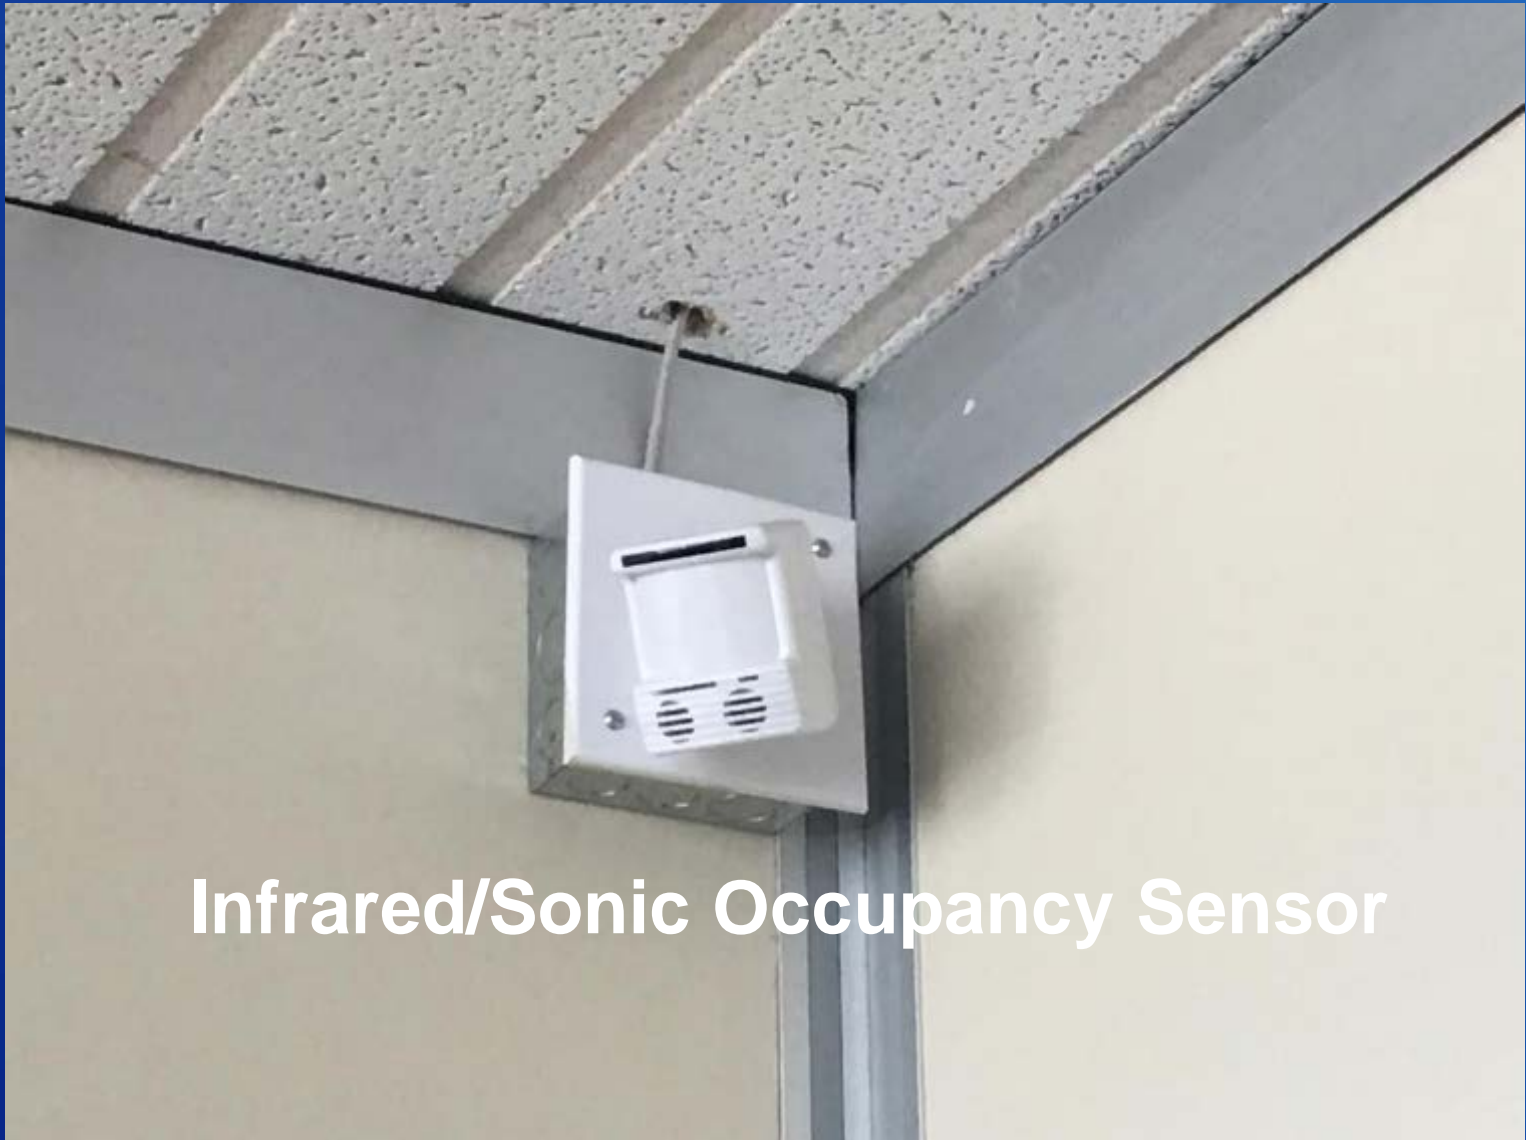
Infrared/Sonic Occupancy Sensor

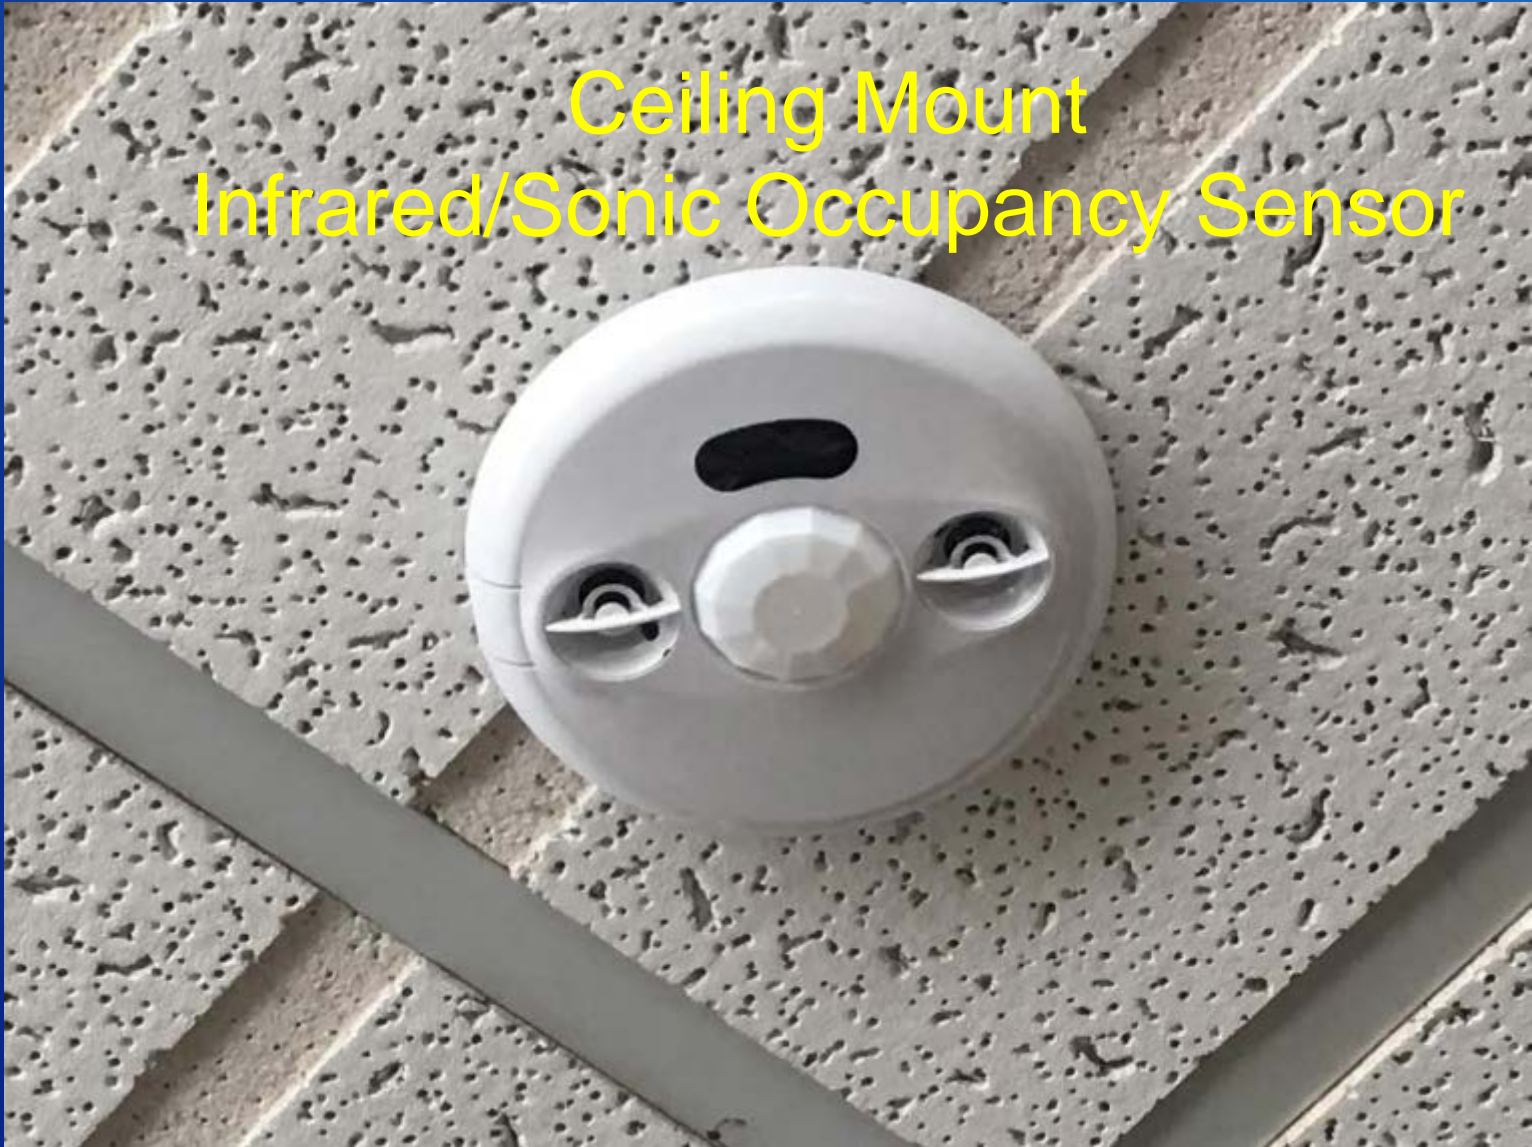
Ceiling Mount  
Infrared/Sonic Occupancy Sensor

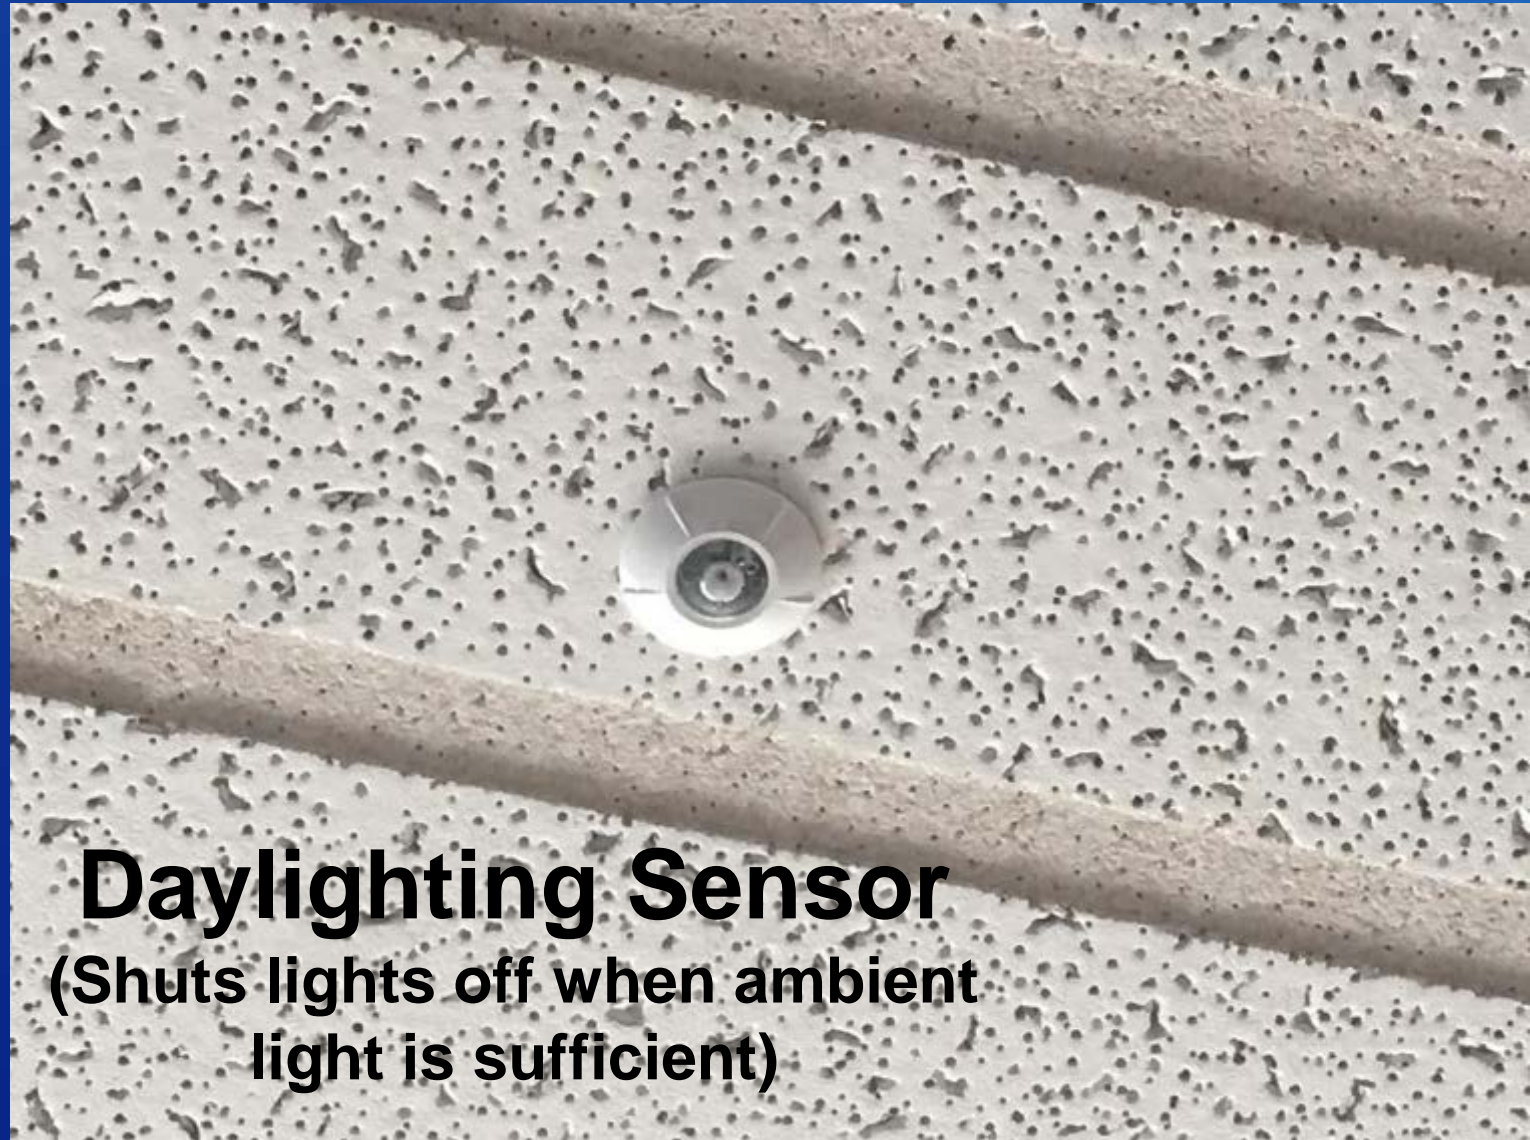
**Daylighting Sensor**  
(Shuts lights off when ambient  
light is sufficient)

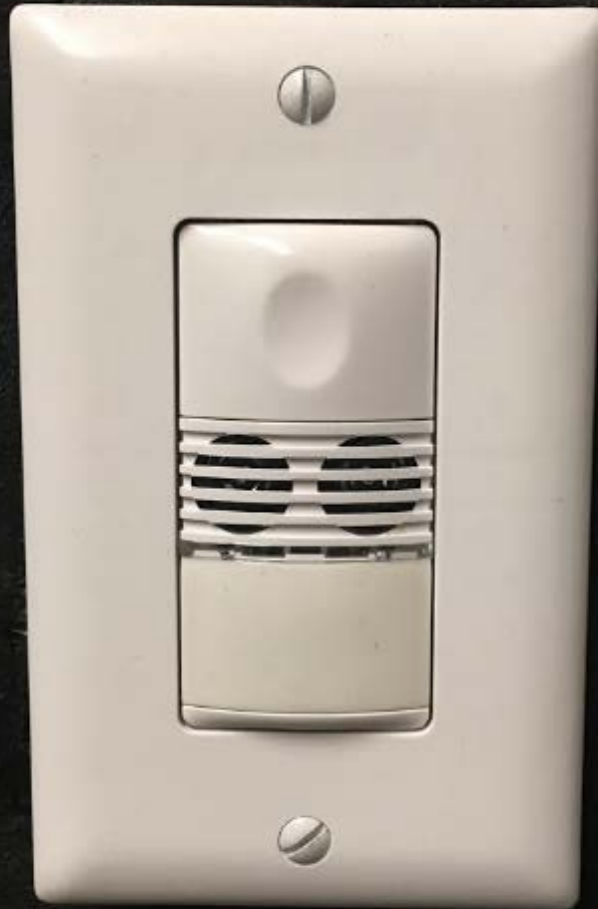
**Sensor/Switch**

**Used in Utility Rooms**

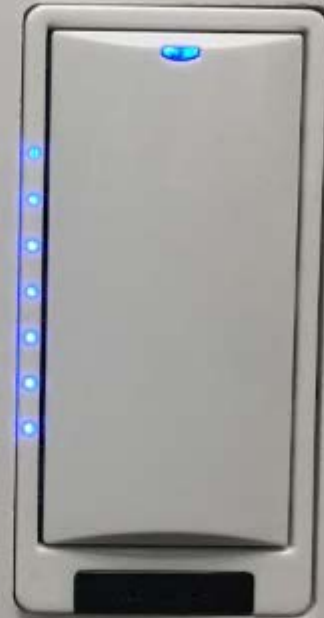
**Dimmer Switch  
(used in rooms  
with projectors  
& screens)**

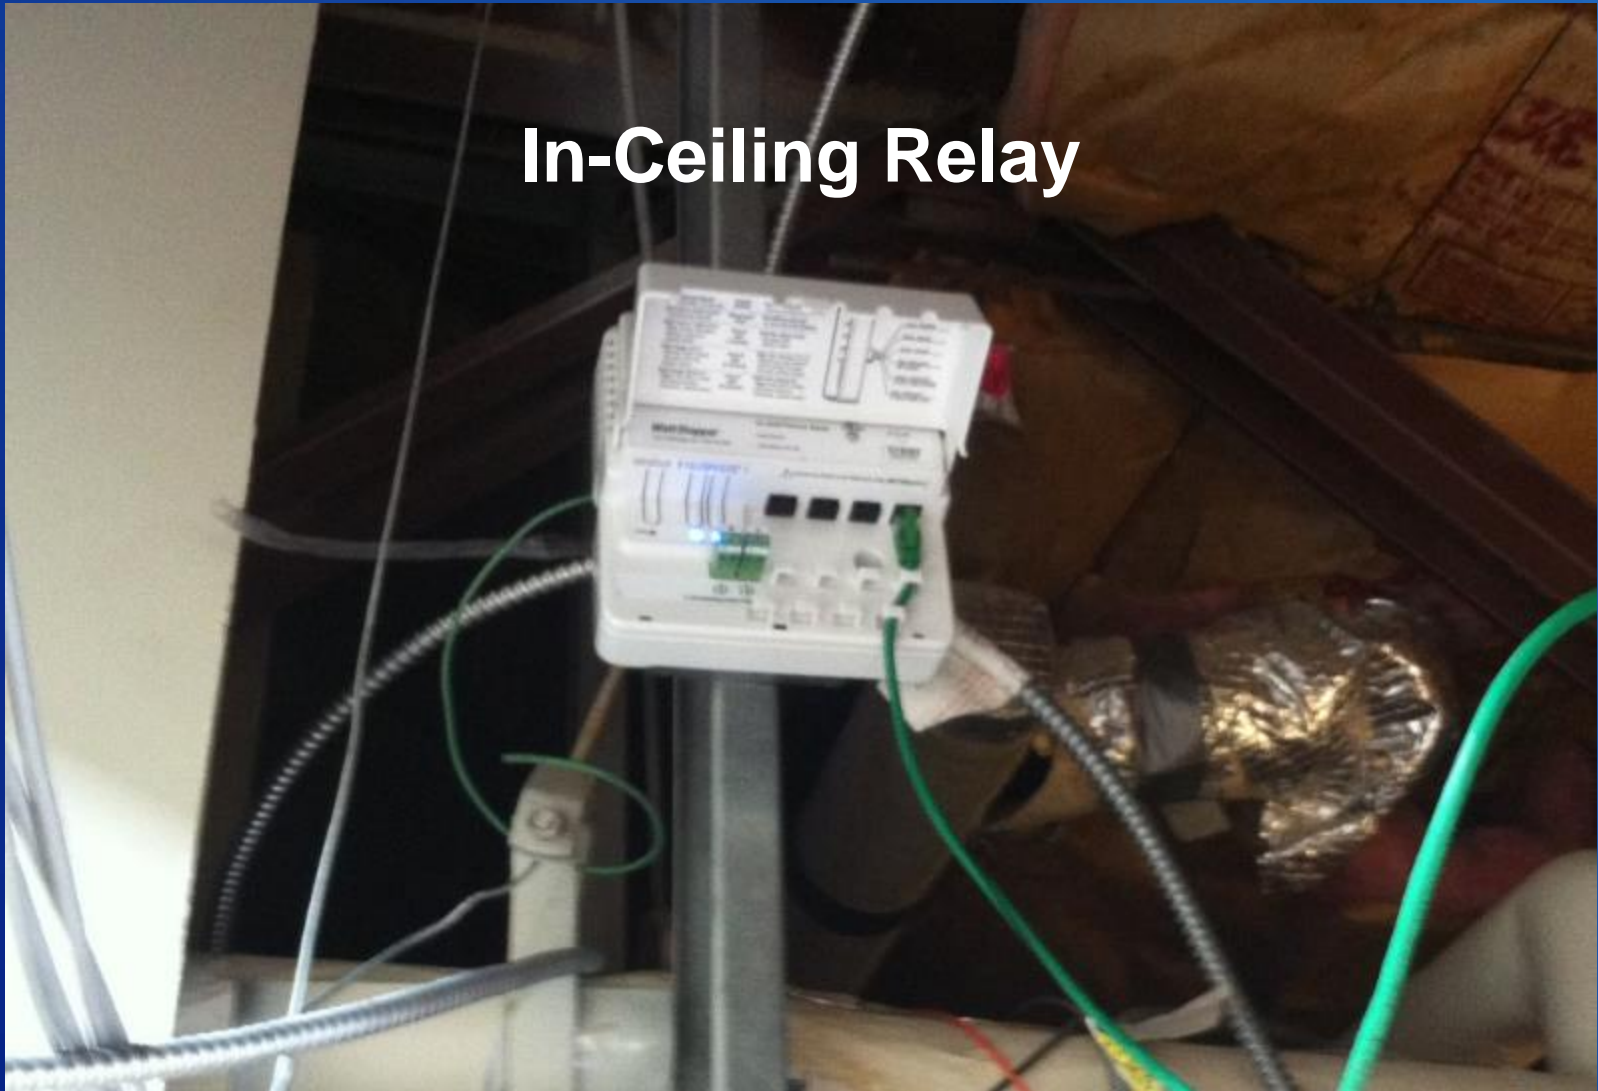
## In-Ceiling Relay

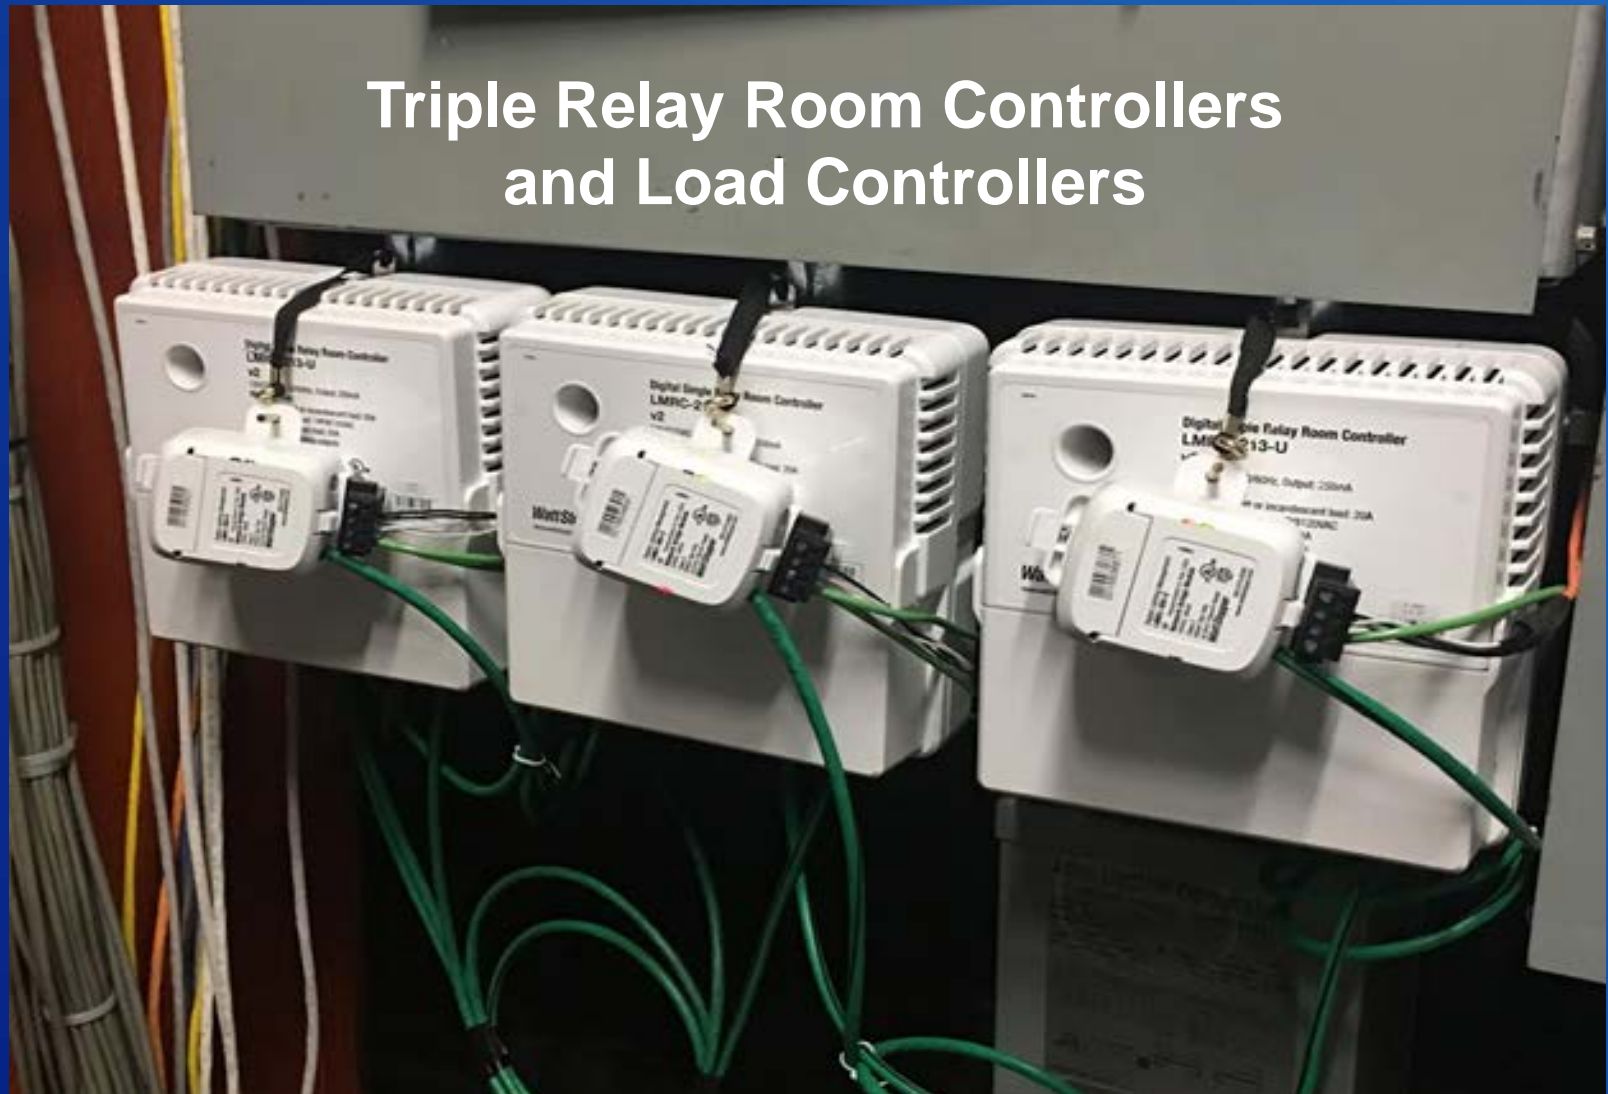
## Triple Relay Room Controllers and Load Controllers

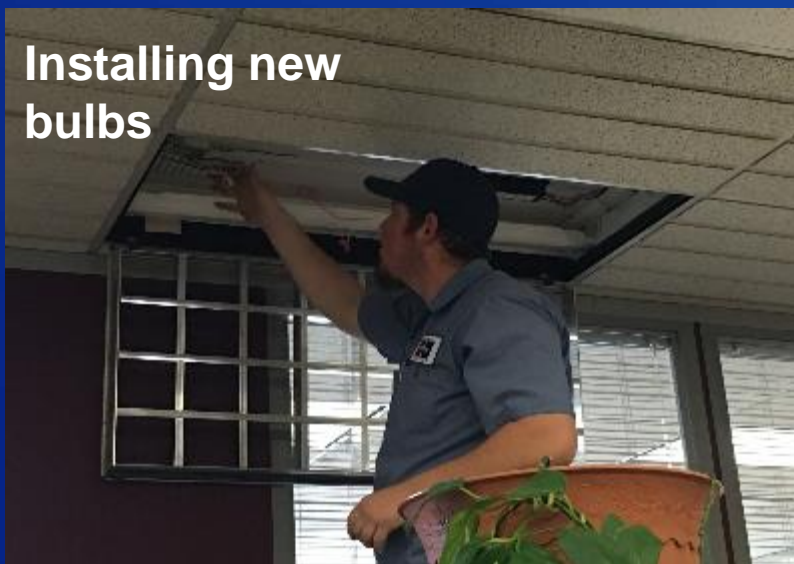
Rewiring  
old fixtures  
for the new  
lights

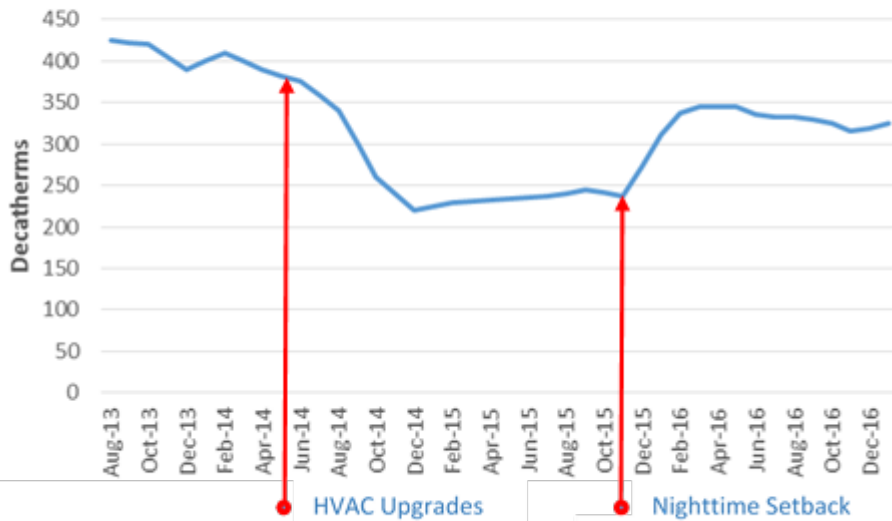
**Natural Gas Consumption**  
12-Month Moving Average  
Provo Area Office

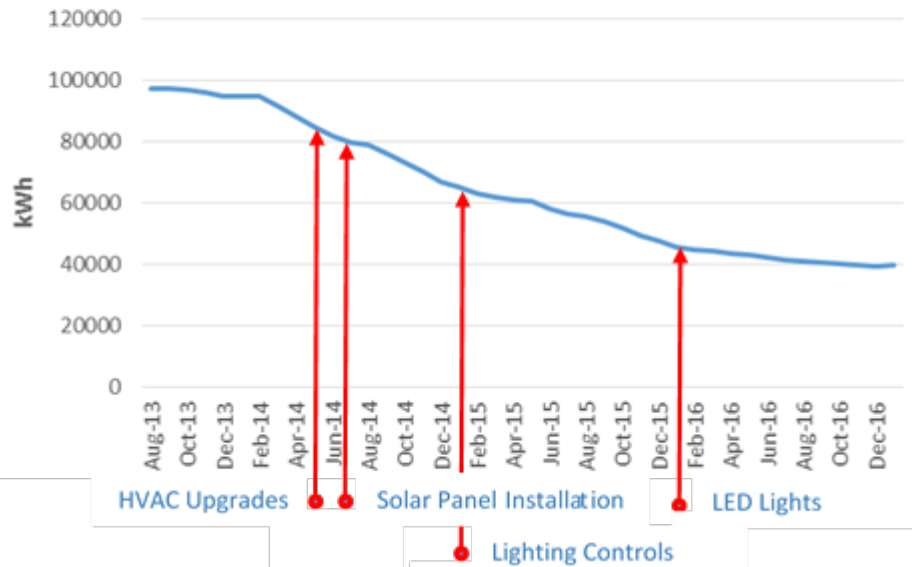
**Electric Consumption**  
12-Month Moving Average  
Provo Area Office
