NWS Damage Surveys

AUSTEN FLANNERY
METEOROLOGIST

**Preliminary**
Damage Survey Results

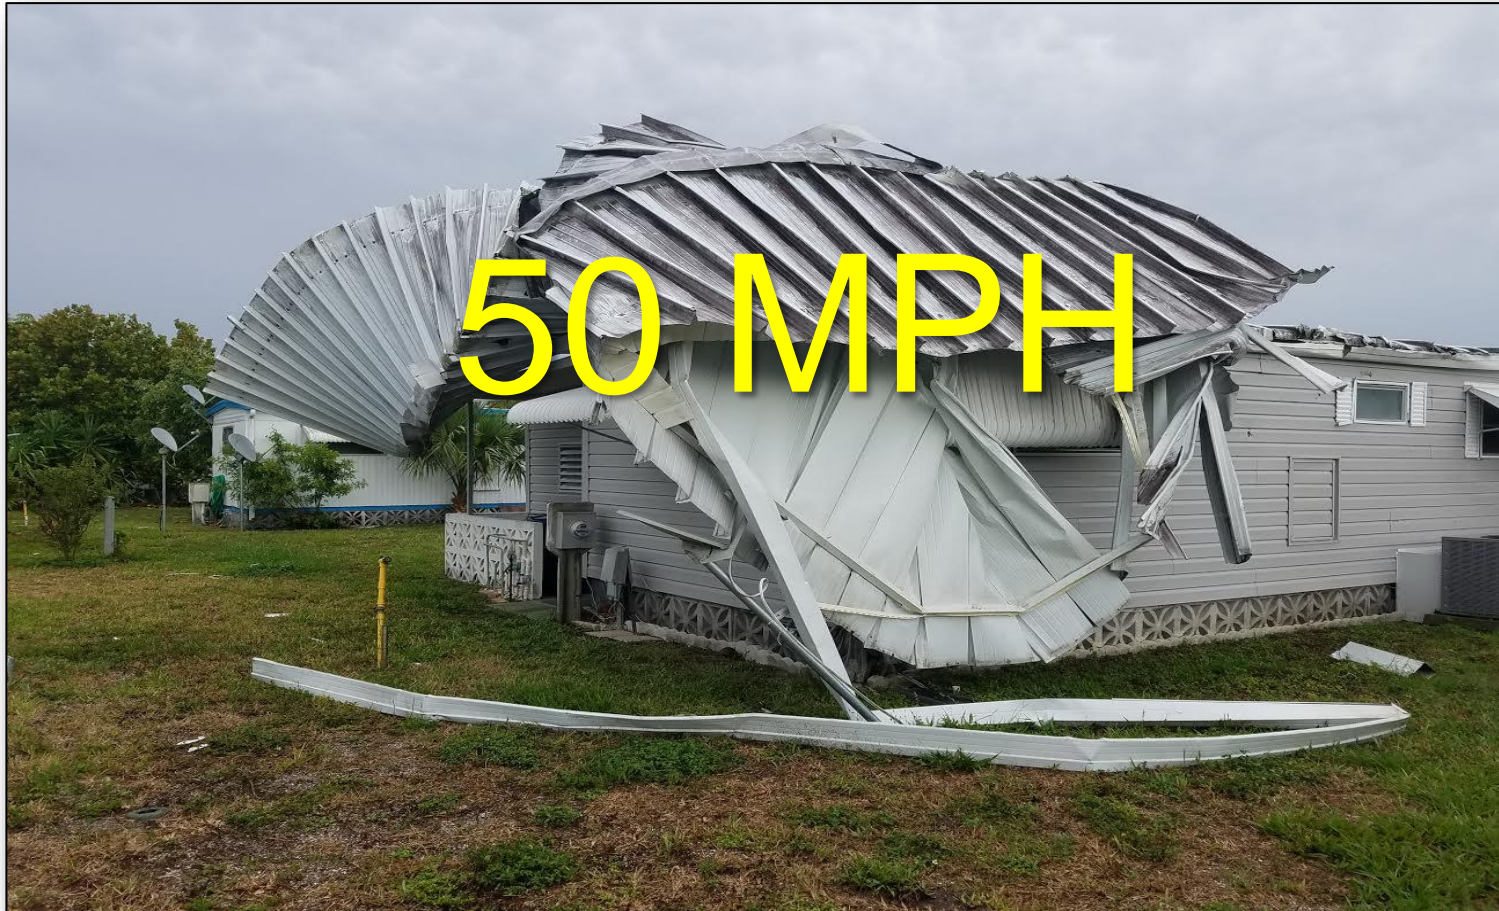
How Strong was the Wind?

- Car ports can act like a parachute to catch the wind

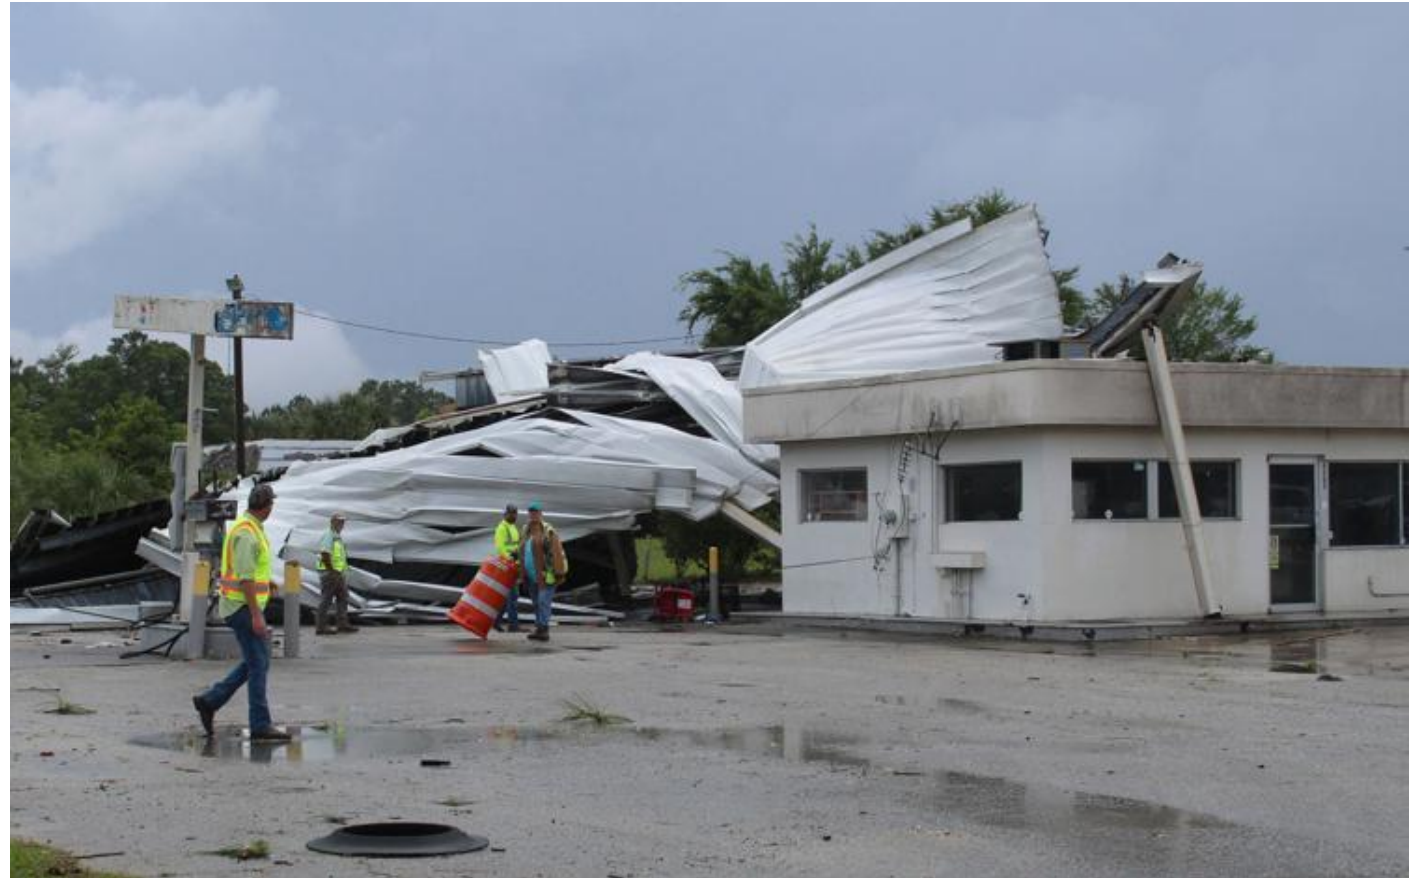
“Metal roof panels stripped from canopy”

“Damage converges towards central point along path”
