# Site Accessibility Evaluation

## Americans with Disabilities Act Title II (Public Services: State and Local Government)

**EPC Public Health South**

**Accessibility Evaluation**

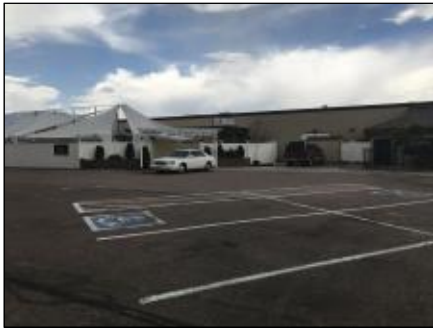
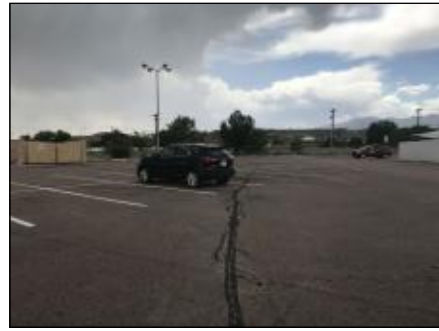
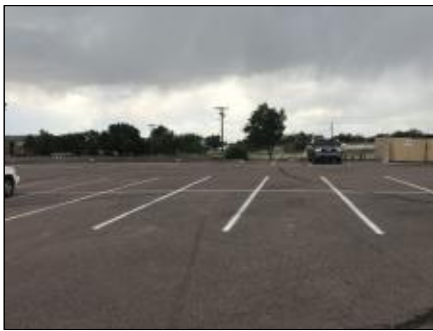
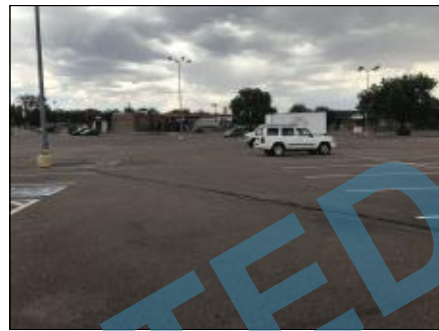
**Finding #1 Additional Finding Photos**

There are not enough accessible stalls.

There are 2 accessible parking stalls including 0 designated for a van.

There should be a minimum of 4 accessible parking stalls including a minimum of 1 van accessible stall.

Not enough accessible parking stalls

Restripe and provide a minimum of 4 accessible parking stalls to include 2 van designated stalls with an 8 foot access aisle.

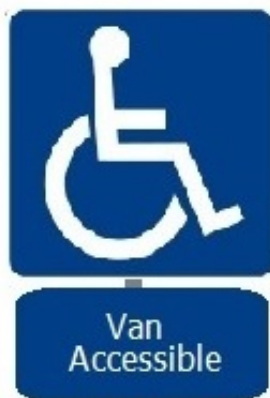
Finding 299328 Main Photo

The van stall is missing a sign identifying it as a van accessible stall.

ADA parking signage missing

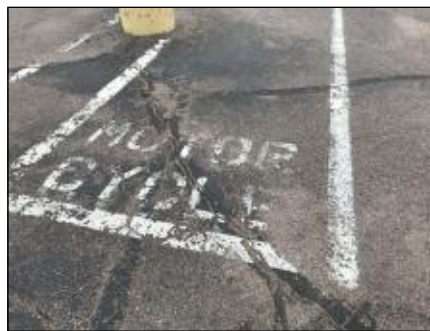
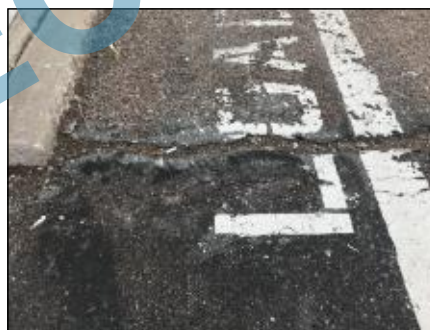
Finding 299332 Additional Photo

Parking lot needs crack fill and sealant throughout

Parking lot needs to be asphalt patched, crack filled, sealed and re striped. Also, the accessible parking stalls need to be located as close as possible to the front entrance and ensure a designated path of travel from the access aisle to the front entrance is well defined.

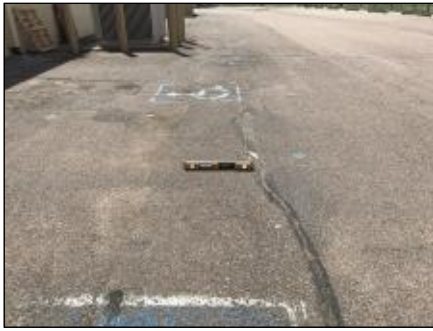
Finding 299372 Additional Photo

The required parking signage is missing.

Accessible parking  
signage missing  
and/or non-compliant

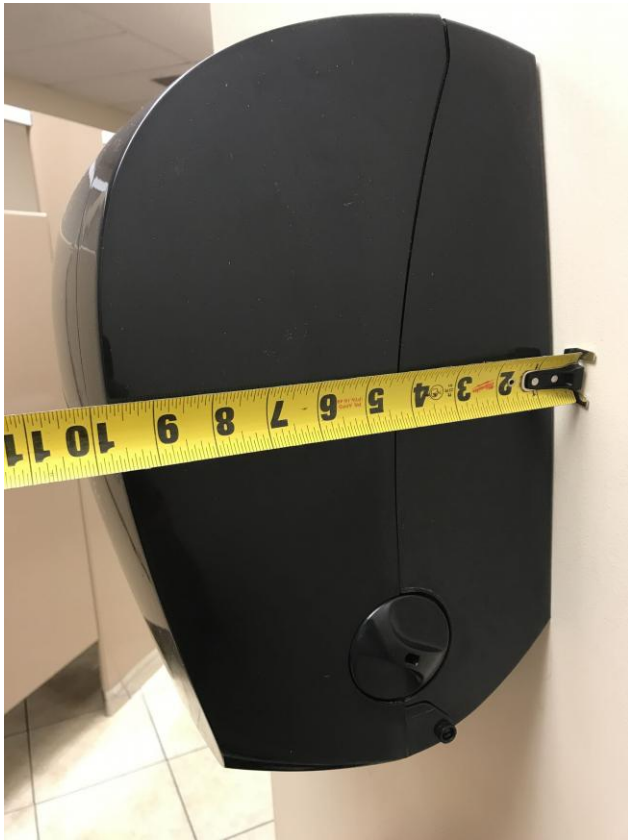
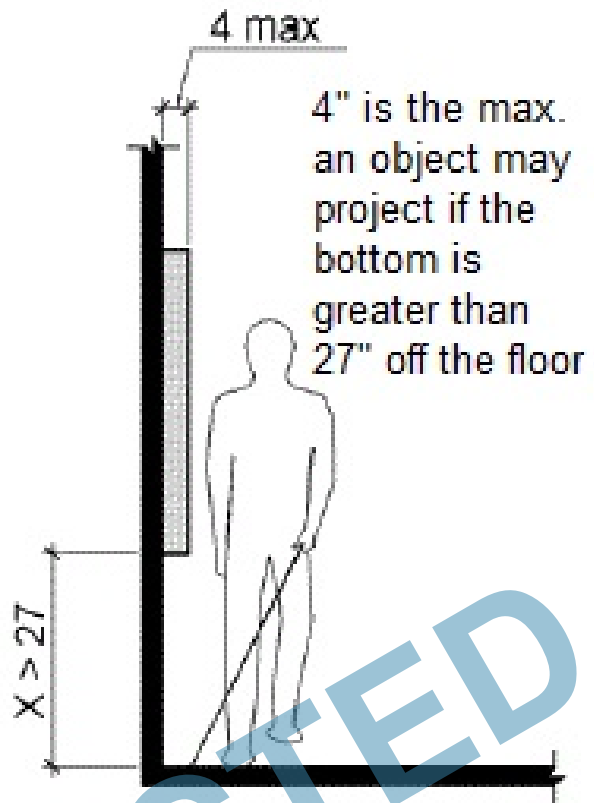
Finding 299337 Main Photo

Wall-mounted objects that have leading edges between 27 inches and 80 inches from the floor must not project more than 4 inches into the circulation path. Protruding objects that extend to the floor or within 27 inches of the floor are cane detectable and are therefore not hazardous. Where it is necessary or desirable to have objects protrude from the wall, a manner of cane detection must be provided.

Reposition paper towel dispenser adjacent to lavatory. Recommend replacing existing dispenser with low profile dispenser. 48 inches maximum height above finished floor for operable parts (knob/sensor).

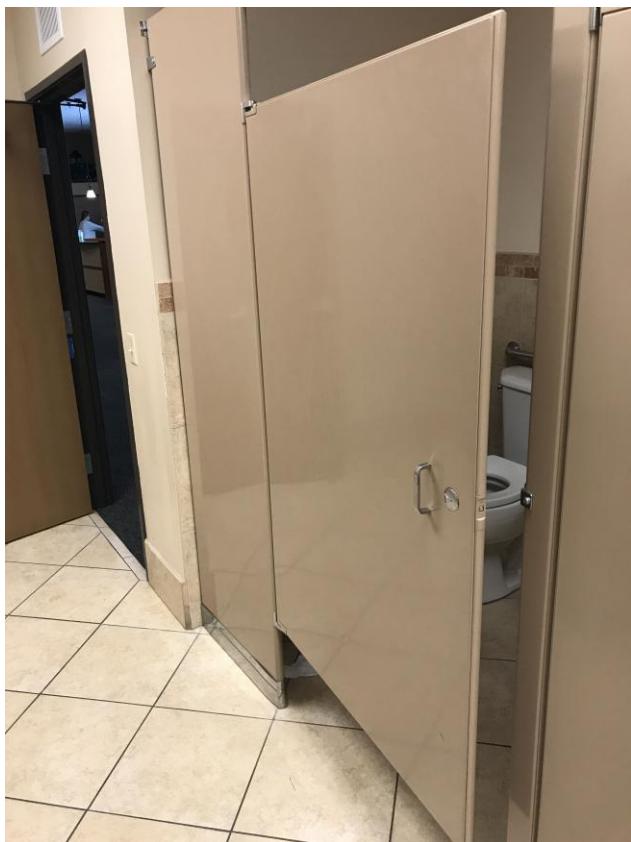
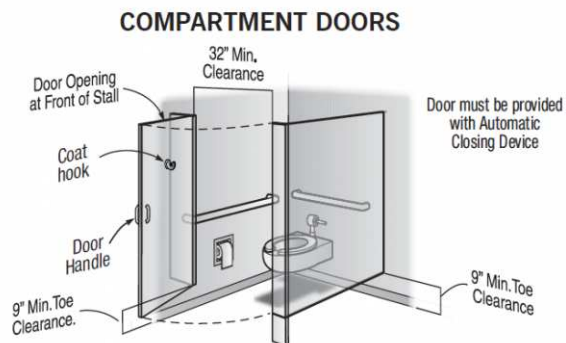
Finding 299338 Main Photo

The water closet compartment door is missing a loop handle on the inside.

Missing inside loop handle

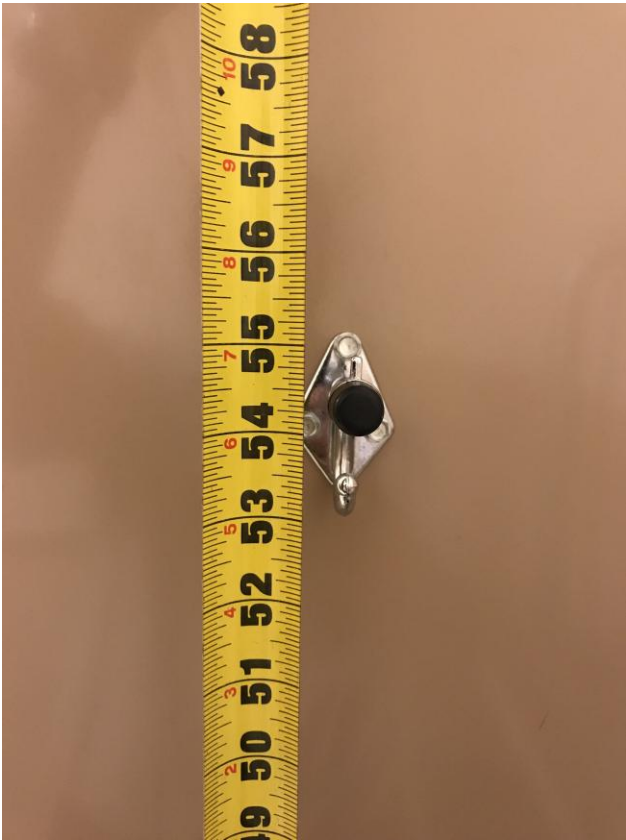
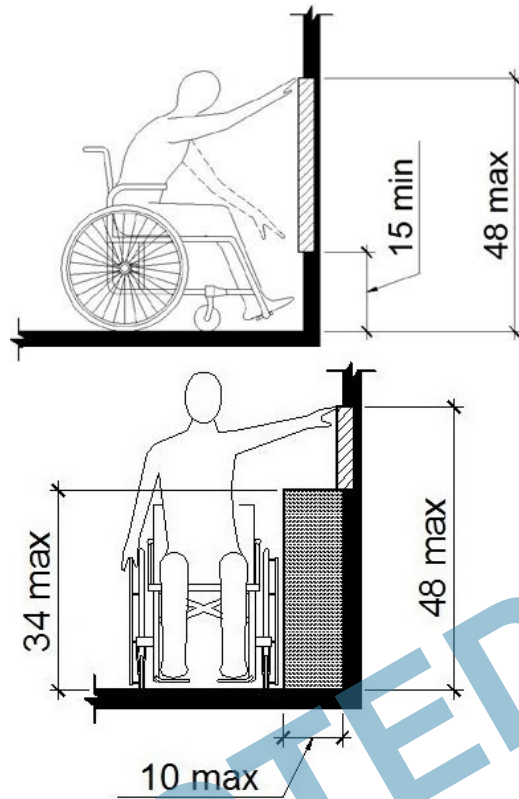
Finding 299341 Main Photo

Considered  
Unobstructed

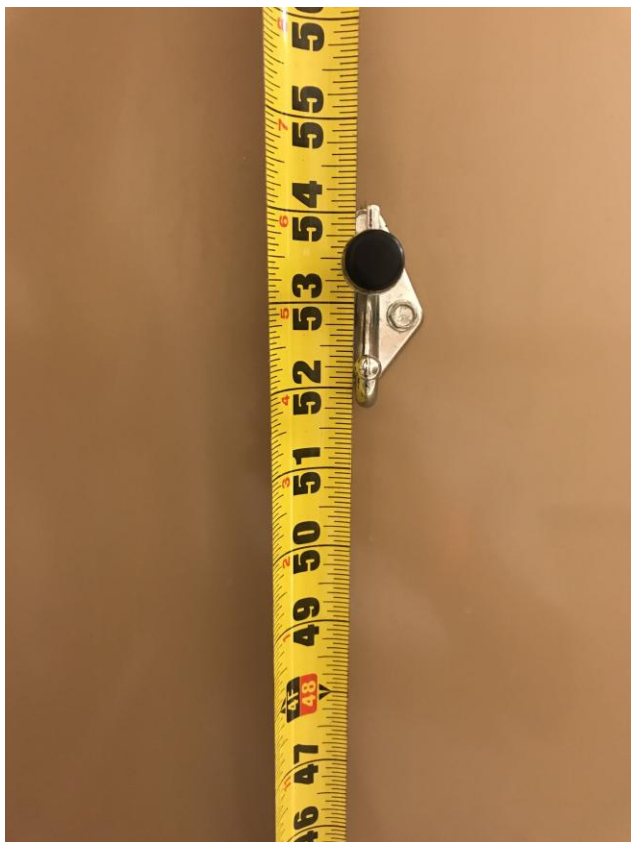
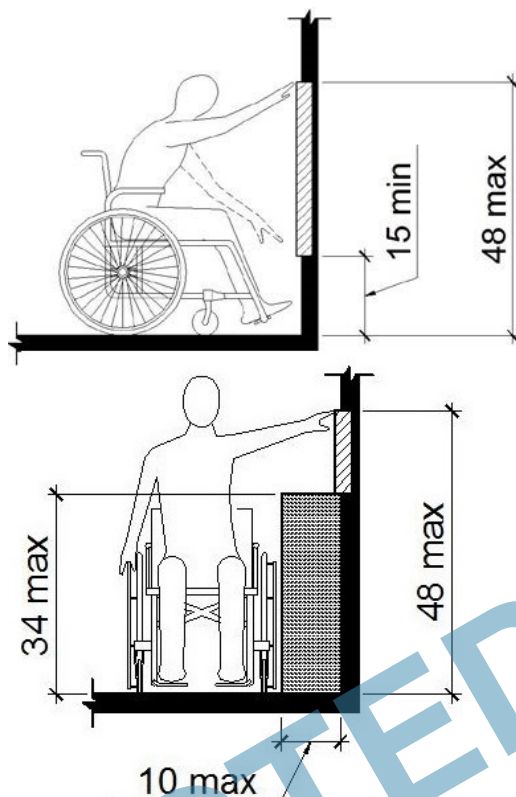
Finding 299352 Main Photo

Considered  
Unobstructed

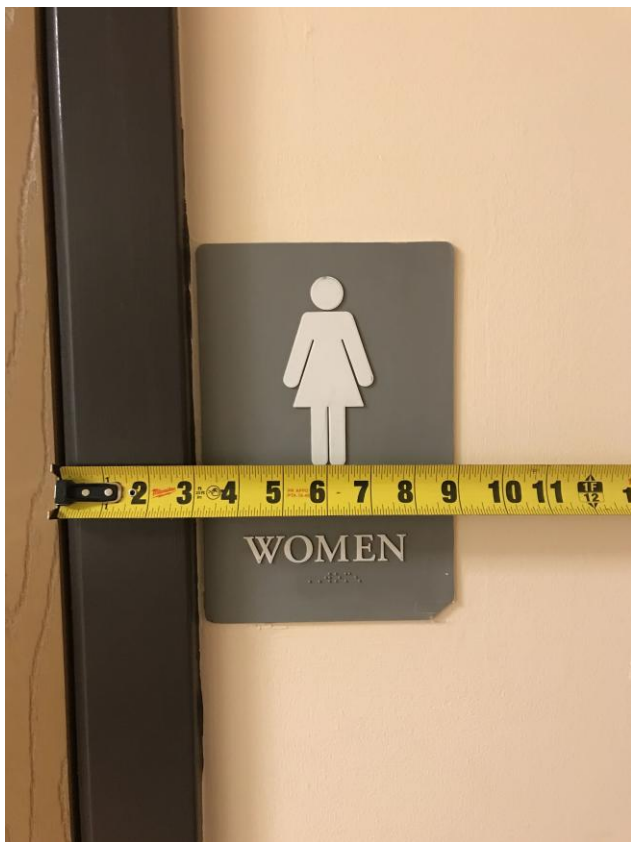
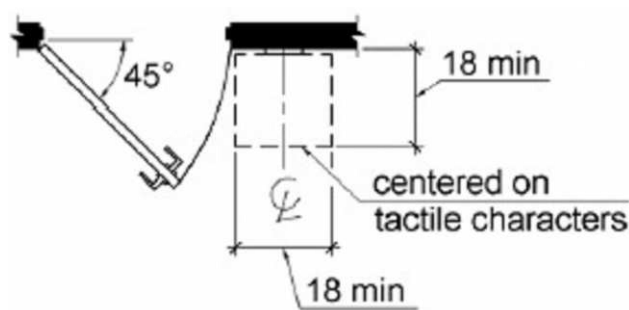
Finding 299356 Main Photo

Inadequate clear floor space provided beyond door swing arc

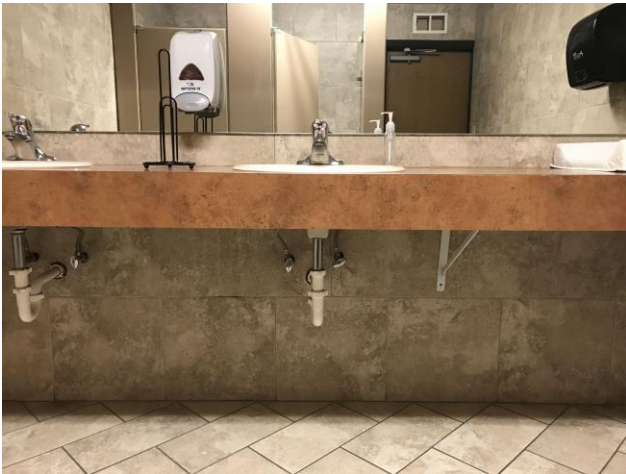
Finding 299361 Main Photo

Pipe insulation  
missing underneath  
laboratory

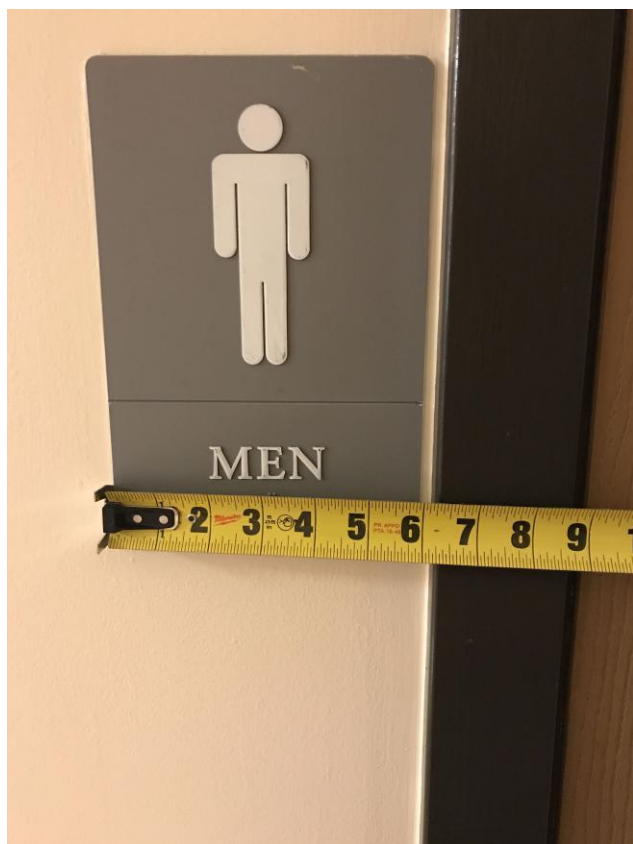
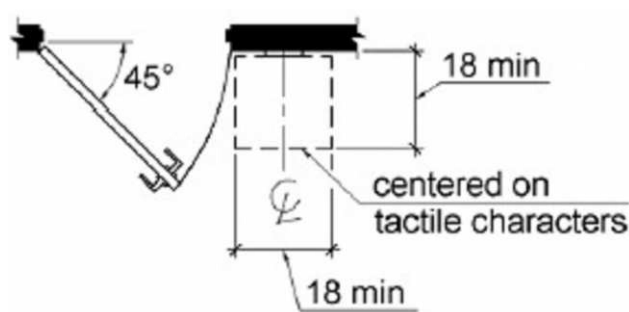
Finding 299357 Main Photo

Inadequate clear floor space provided beyond door swing arc

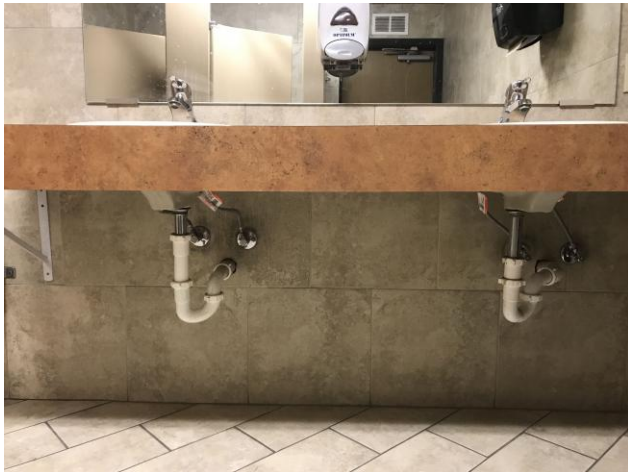
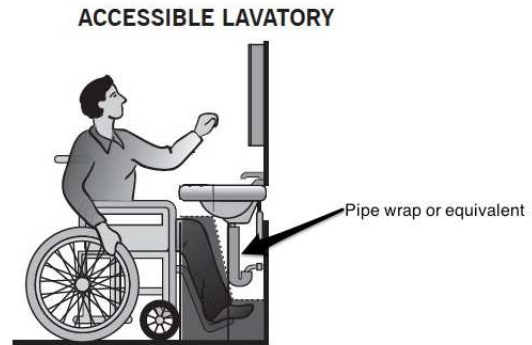
Finding 299366 Main Photo

Pipe insulation  
missing underneath  
laboratory
