Site Accessibility Evaluation

Environmental Building

**3255 Akers Dr
Colorado Springs, CO
80922**

***Inspection Date: 02/21/2018
Inspector: David Mejia***

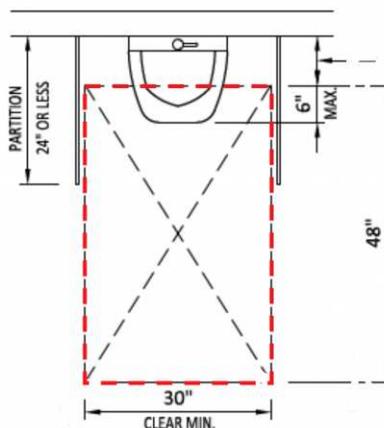
Space extending greater than 6 inches beyond the available knee clearance at 9 inches above the finished floor or ground surface shall not be considered to clearance.

URINAL CLEAR SPACE
PARTITION 24" OR LESS
