Site Accessibility Evaluation

Sahwatch Parking Garage

**255 Sahwatch St
Colorado Springs, CO
80903**

Accessibility Evaluation

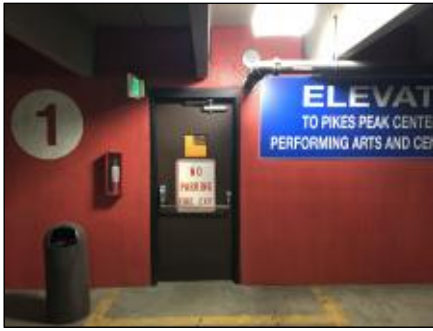
Finding 297982 Additional Photo

The door is equipped with a door closer and returns to a closed position too quickly.

2.5 seconds to closed position

Adjust door closer to allow a minimum of 5 seconds before returning to a position of 12 degrees from the latch/locking mechanism.

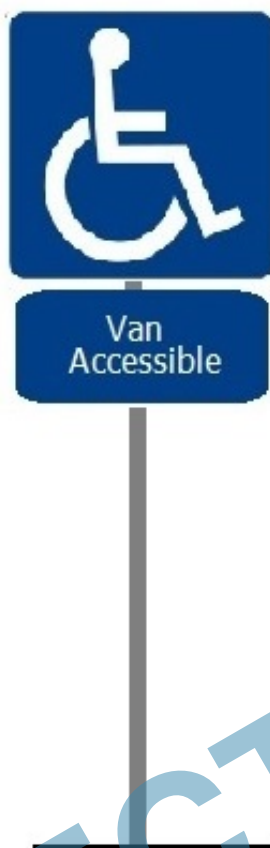
Finding 297983 Main Photo

The van stall is missing a sign identifying it as a van accessible stall.

Van accessible sign missing

Replace existing sign with ISA sign that also includes "Van Accessible" verbiage.

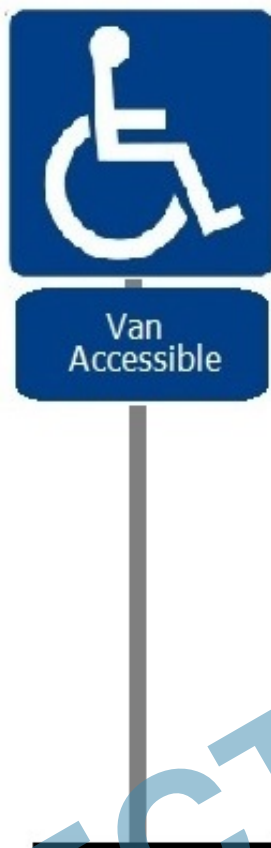
Finding 297989 Main Photo

The van stall is missing a sign identifying it as a van accessible stall.

Van accessible sign missing

Replace existing sign with ISA sign that also includes "Van Accessible" verbiage.

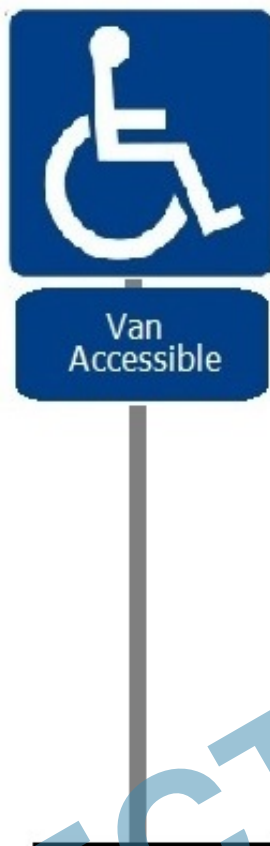
Finding 298022 Main Photo

The van stall is missing a sign identifying it as a van accessible stall.

Van accessible sign missing

Replace existing sign with ISA sign that also includes "Van Accessible" verbiage.

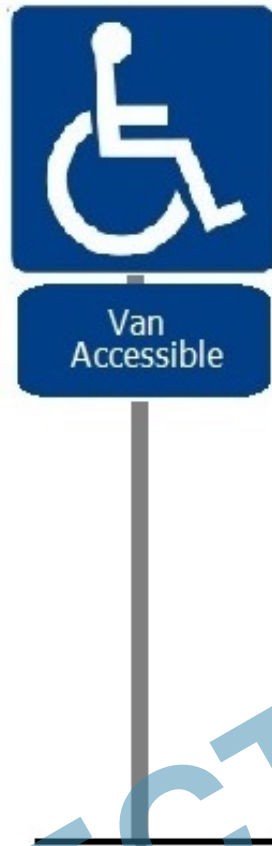
Finding 298032 Main Photo

The van stall is missing a sign identifying it as a van accessible stall.

Van accessible sign missing

Replace existing sign with ISA sign that also includes "Van Accessible" verbiage.
