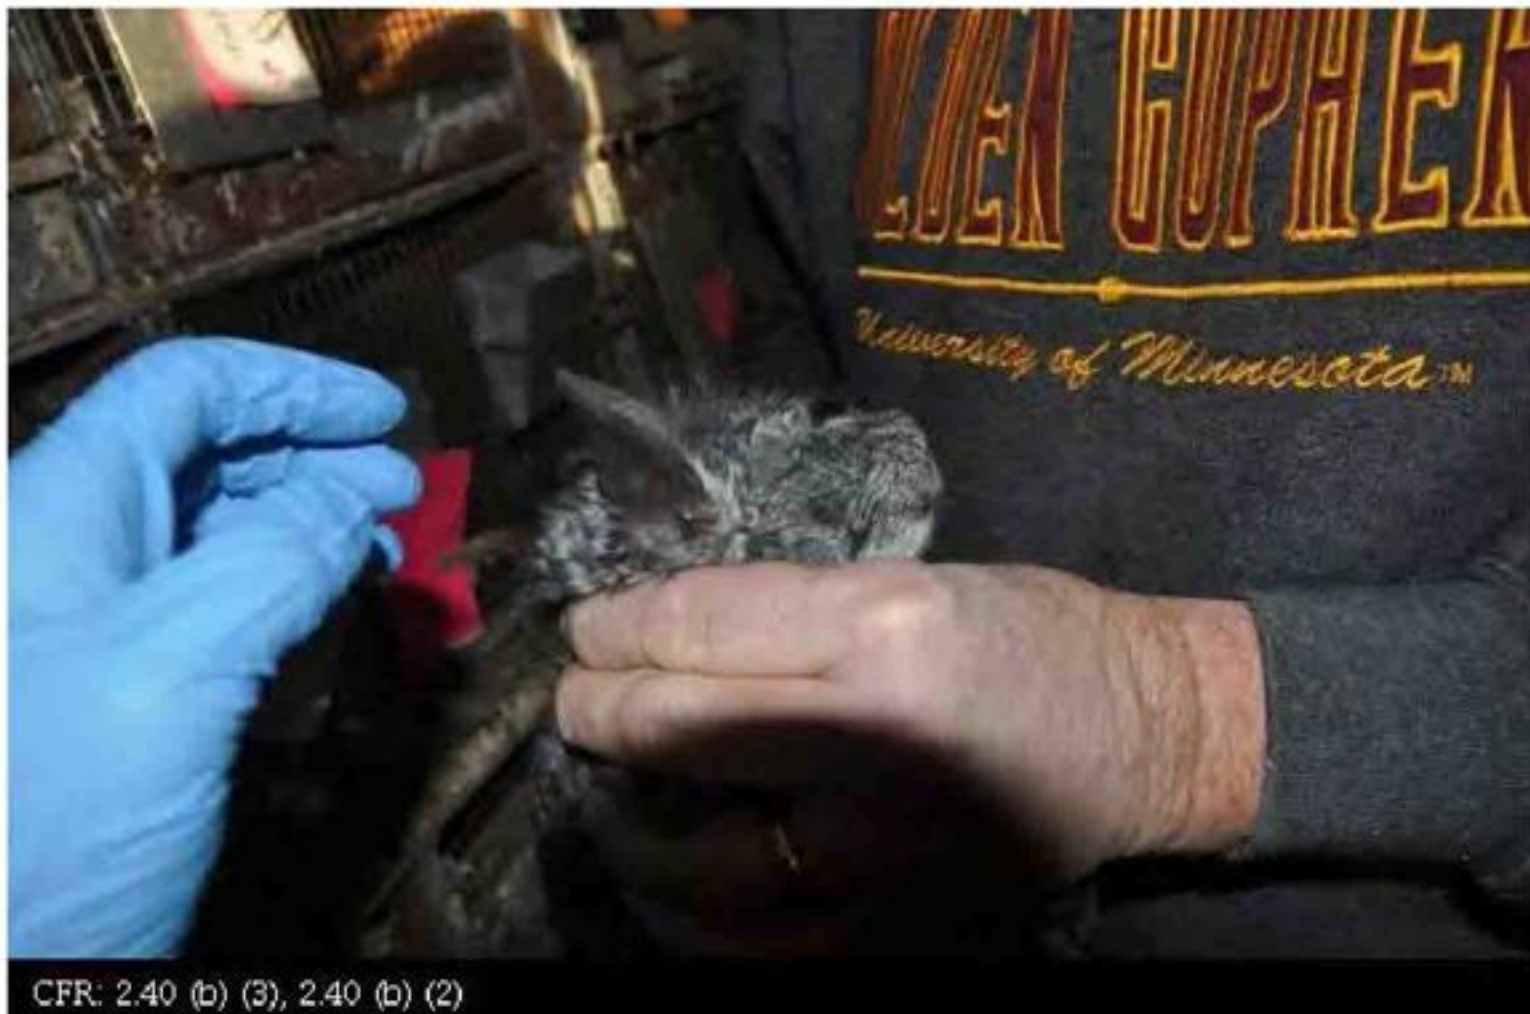
CFR: 2.40 (b) (3), 2.40 (b) (2)

Photographer:	Scott Welch	Legal Name:	41-B-0239
Photo Taken:	Wed, Feb 3, '16	DAN MOULTON	
Inspection:	40161623280694		
Description:	Female (eartag "DJM 131"); right eye sealed shut.

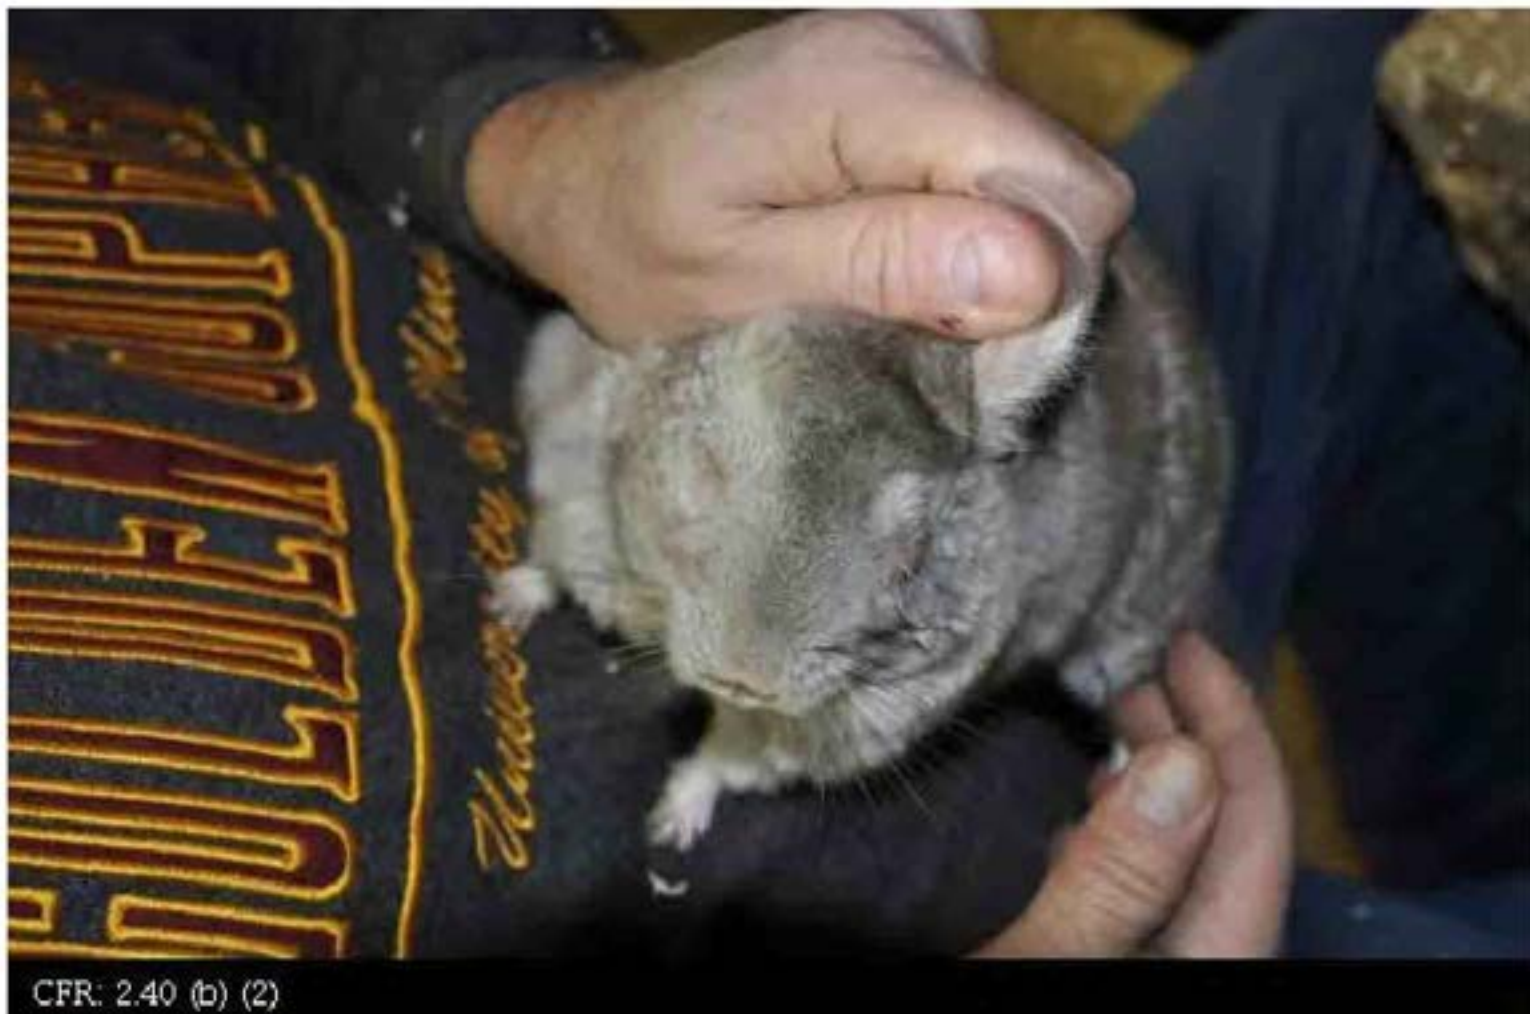
CFR: 2.40 (b) (2)

Photographer:	Scott Welch	Legal Name:	41-B-0239
Photo Taken:	Wed, Feb 3, '16	DAN MOULTON	
Inspection:	40161623280694		
Description:	Beige color female (no ID; pen 166 on south wall stacked cages); right eye sealed shut with crusted material. Licensee had cage marked and said he was watching this one, but not giving medicine.

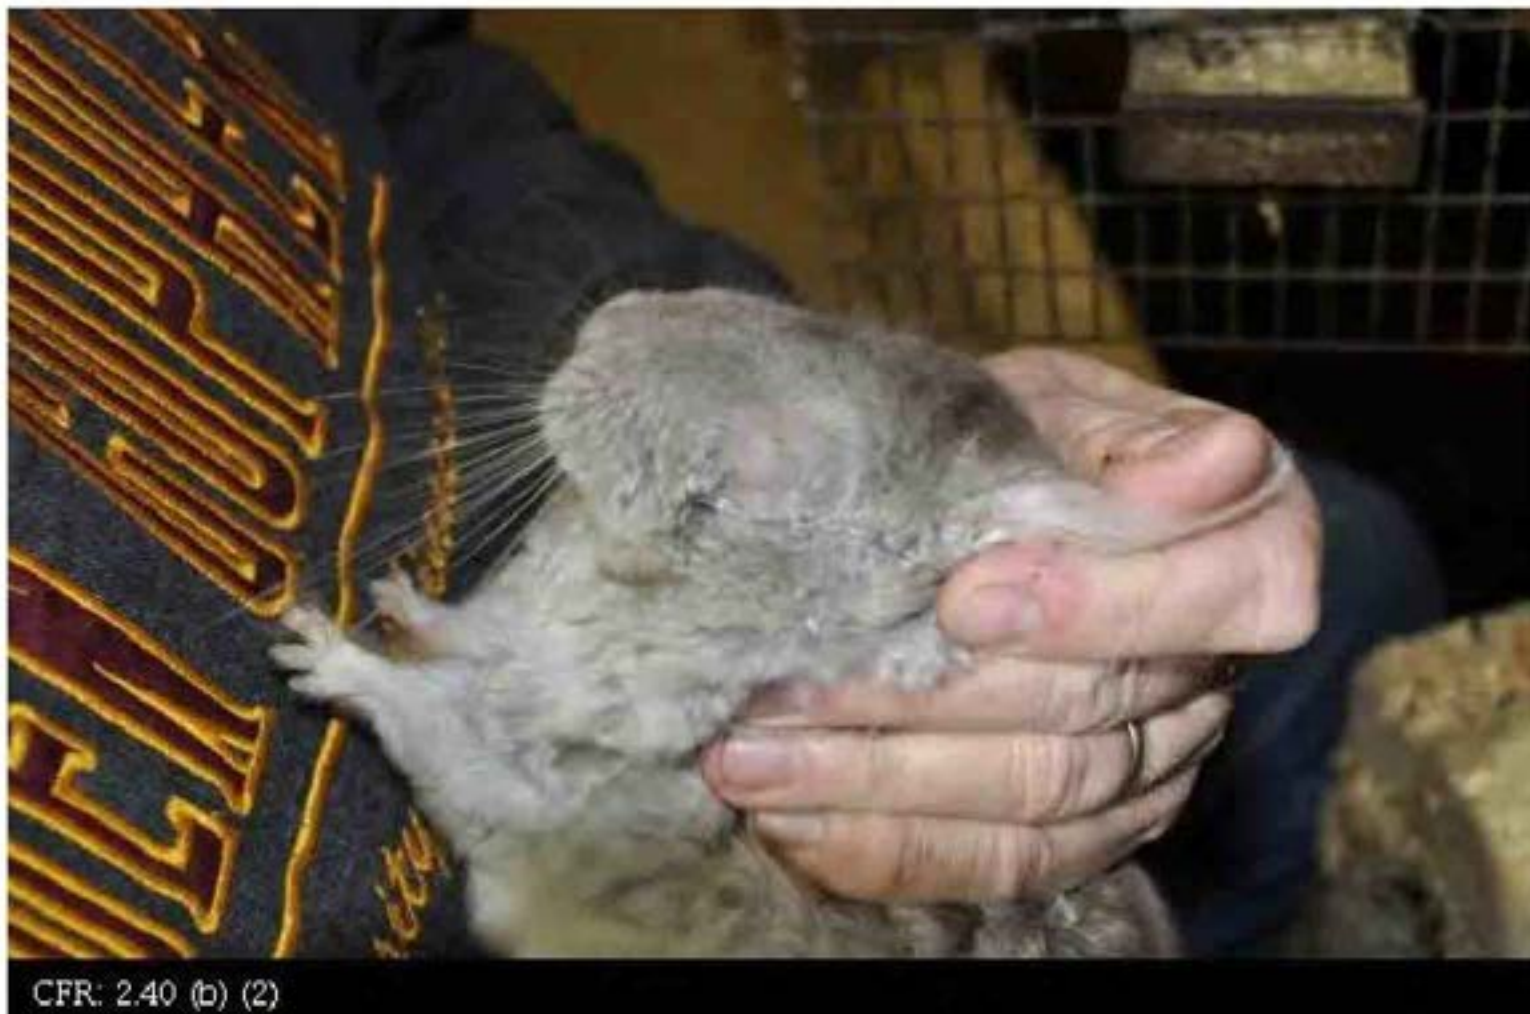
CFR: 2.40 (b) (2)

Photographer:	Scott Welch	Legal Name:	41-B-0239
Photo Taken:	Wed, Feb 3, '16	DAN MOULTON	
Inspection:	40161623280694		
Description:	Beige color female (no ID; pen 166 on south wall stacked cages); left eye sealed shut with crusted material, eyelids swollen with hair-loss. Licensee reported watching this one but not giving medicine

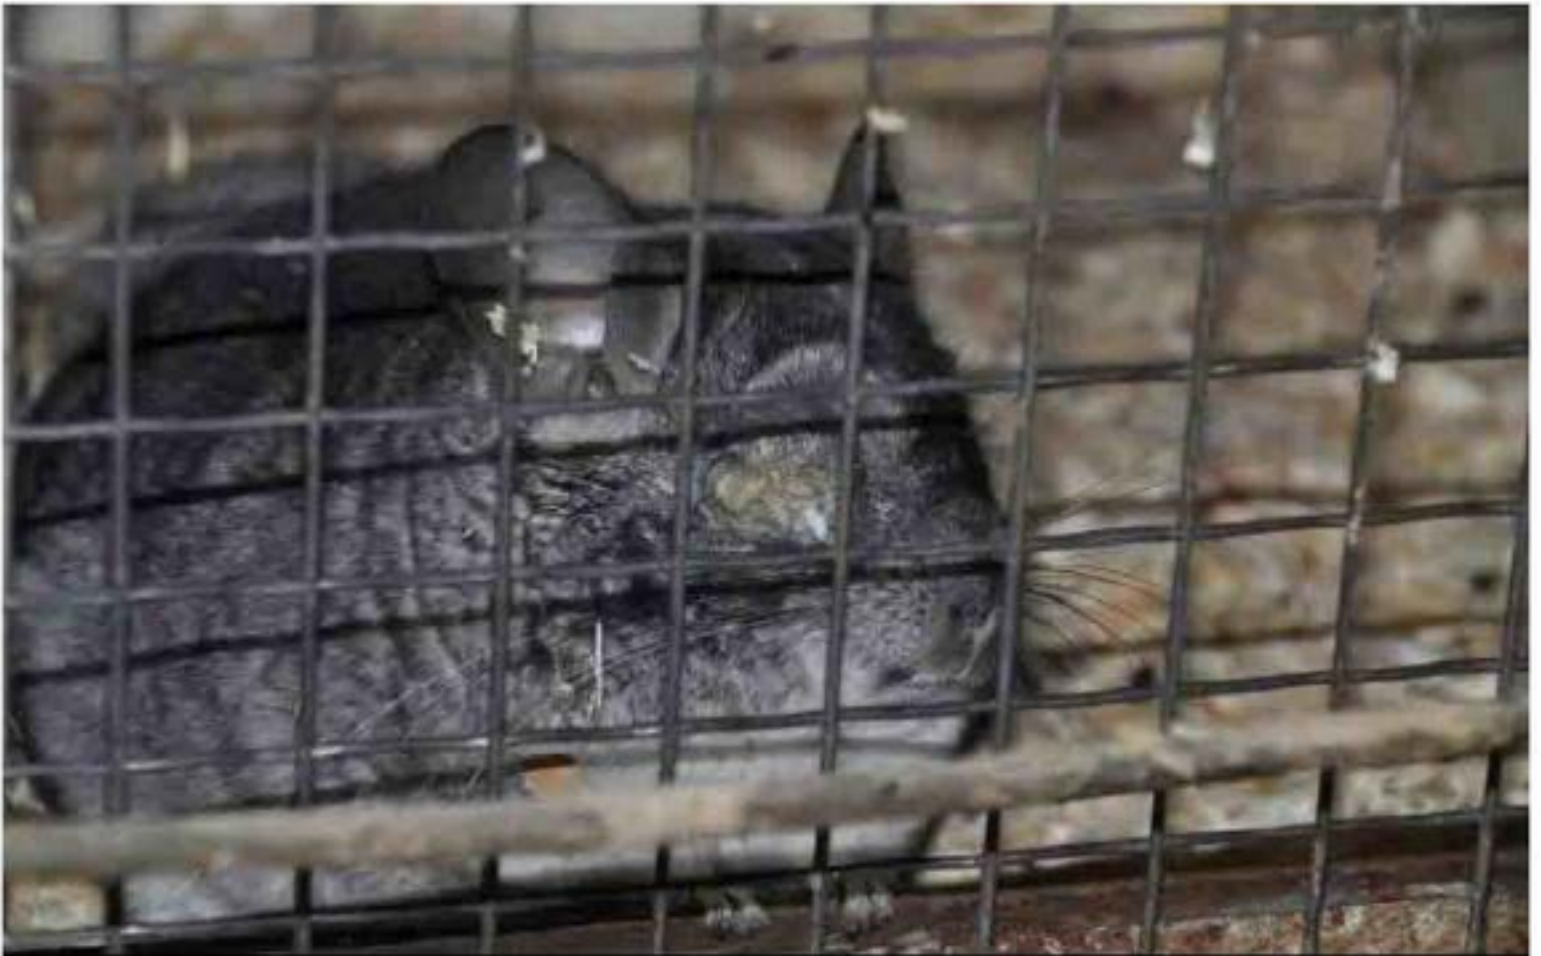
CFR: 2.40 (b) (2), 2.40 (b) (3)

Photographer:	Scott Welch	Legal Name:	41-B-0239
Photo Taken:	Wed, Feb 3, '16	DAN MOULTON	
Inspection:	40161623280694		
Description:	Silver-colored female with card #580 housed on south wall; prior to owner handling; its right eye crusted shut and pale creamy discharge (pus).

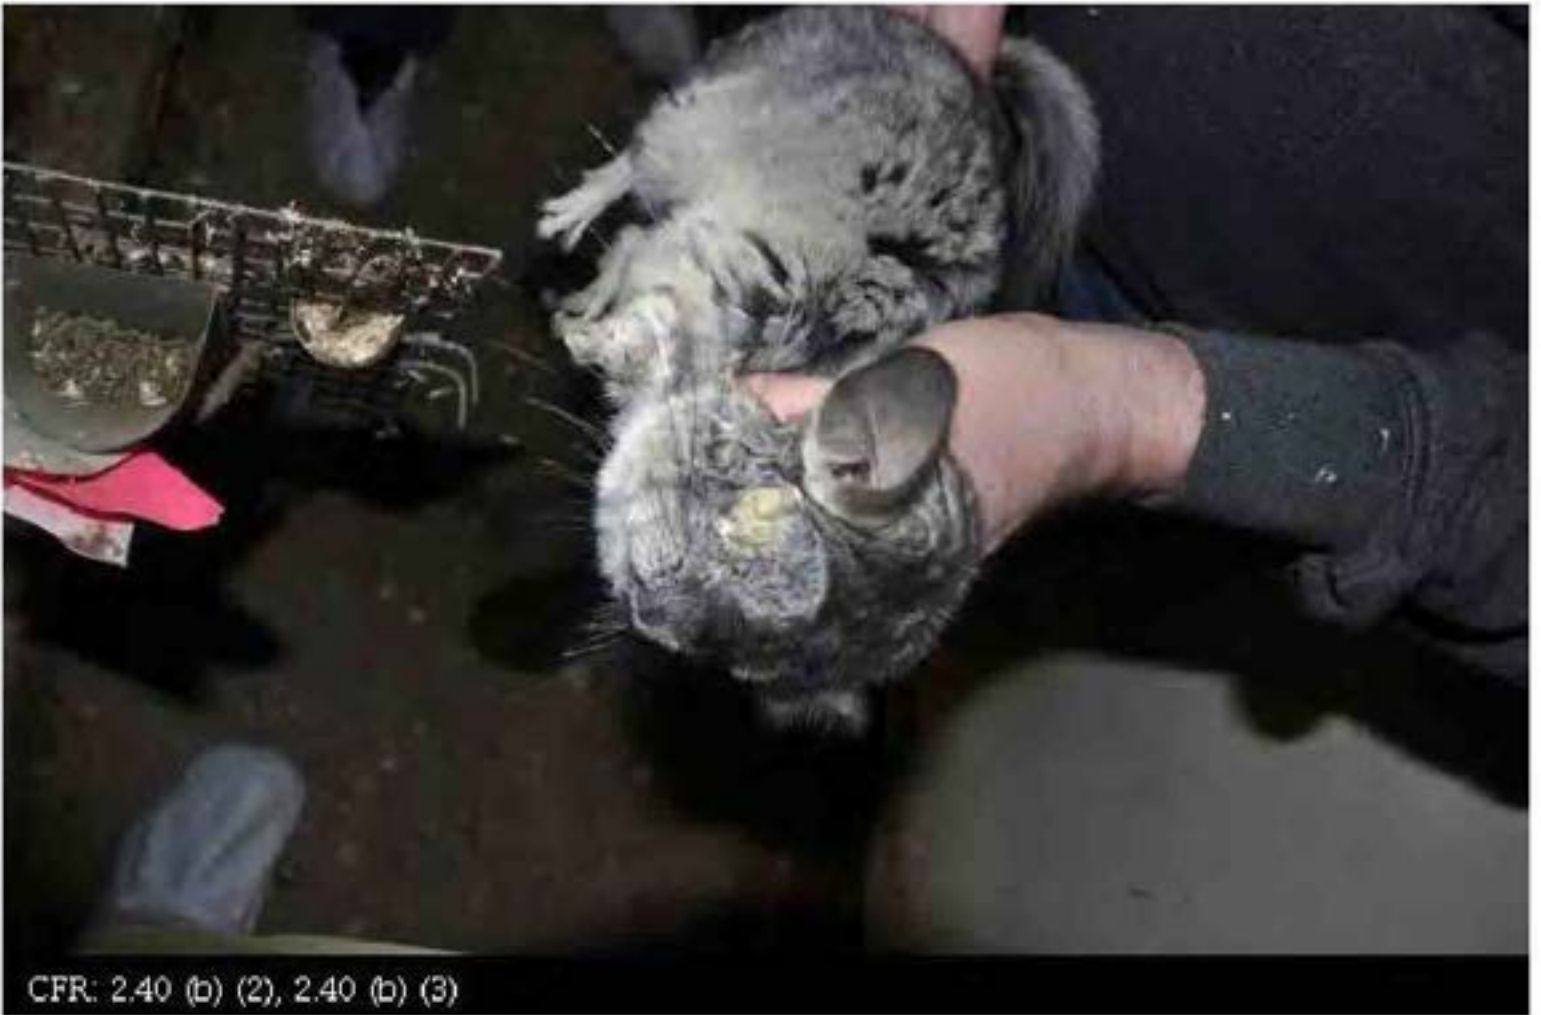
Photographer:	Scott Welch	Legal Name:	41-B-0239
Photo Taken:	Wed, Feb 3, '16	DAN MOULTON	
Inspection:	40161623280694		
Description:	Silver-colored female with card #580 housed on south wall; its right eye crusted shut and pale creamy discharge (pus).

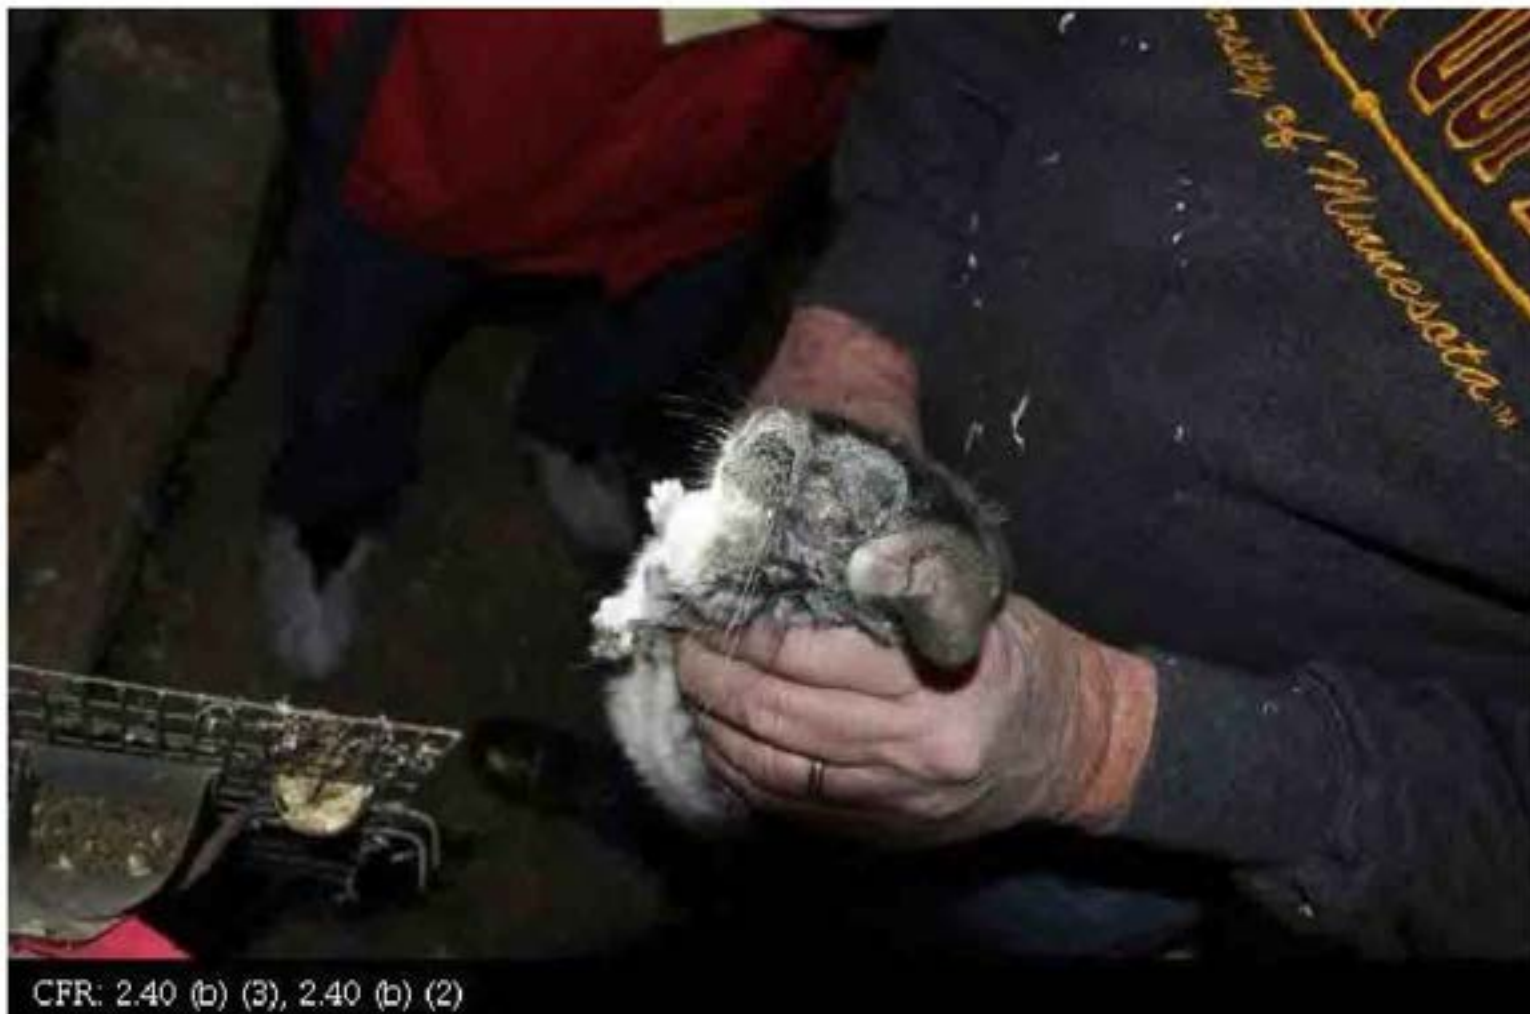
Photographer:	Scott Welch	Legal Name:	41-B-0239
Photo Taken:	Wed, Feb 3, '16	DAN MOULTON	
Inspection:	40161623280694		
Description:	Silver-colored female with card #580 housed on south wall; left eye sealed shut with crusted material.

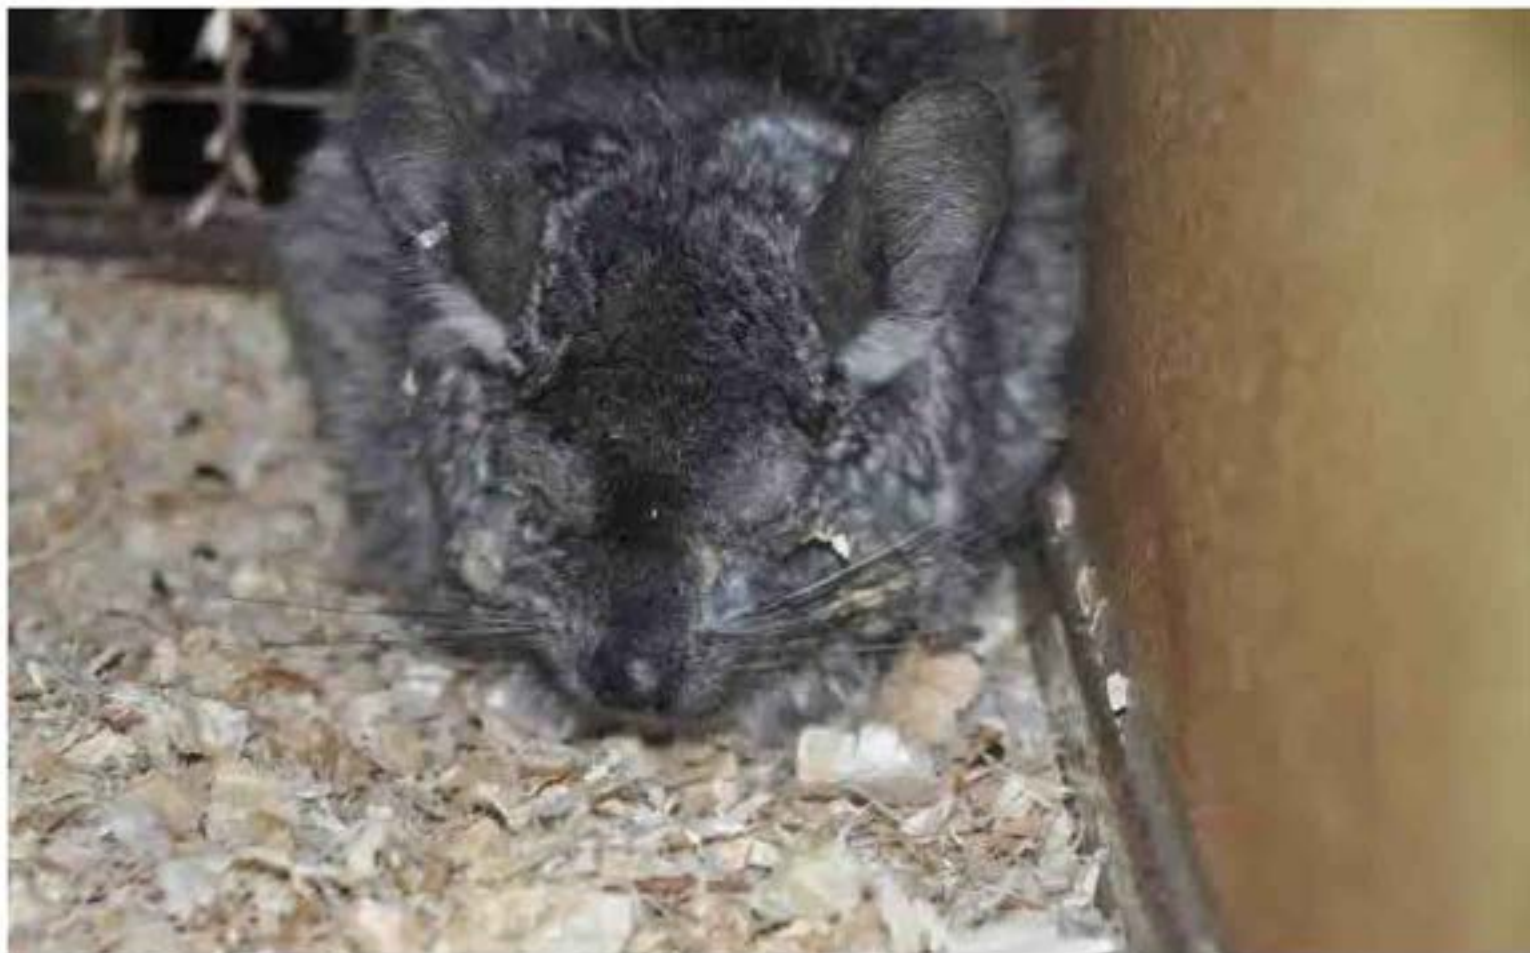
CFR: 2.40 (b) (2), 2.40 (b) (3)

Photographer:	Scott Welch	Legal Name:	41-B-0239
Photo Taken:	Wed, Feb 3, '16	DAN MOULTON	
Inspection:	40161623280694		
Description:	Female with eartag "DJM 145"; both eyes seen crusted shut. Note its left eyelids are swollen and with hair loss.

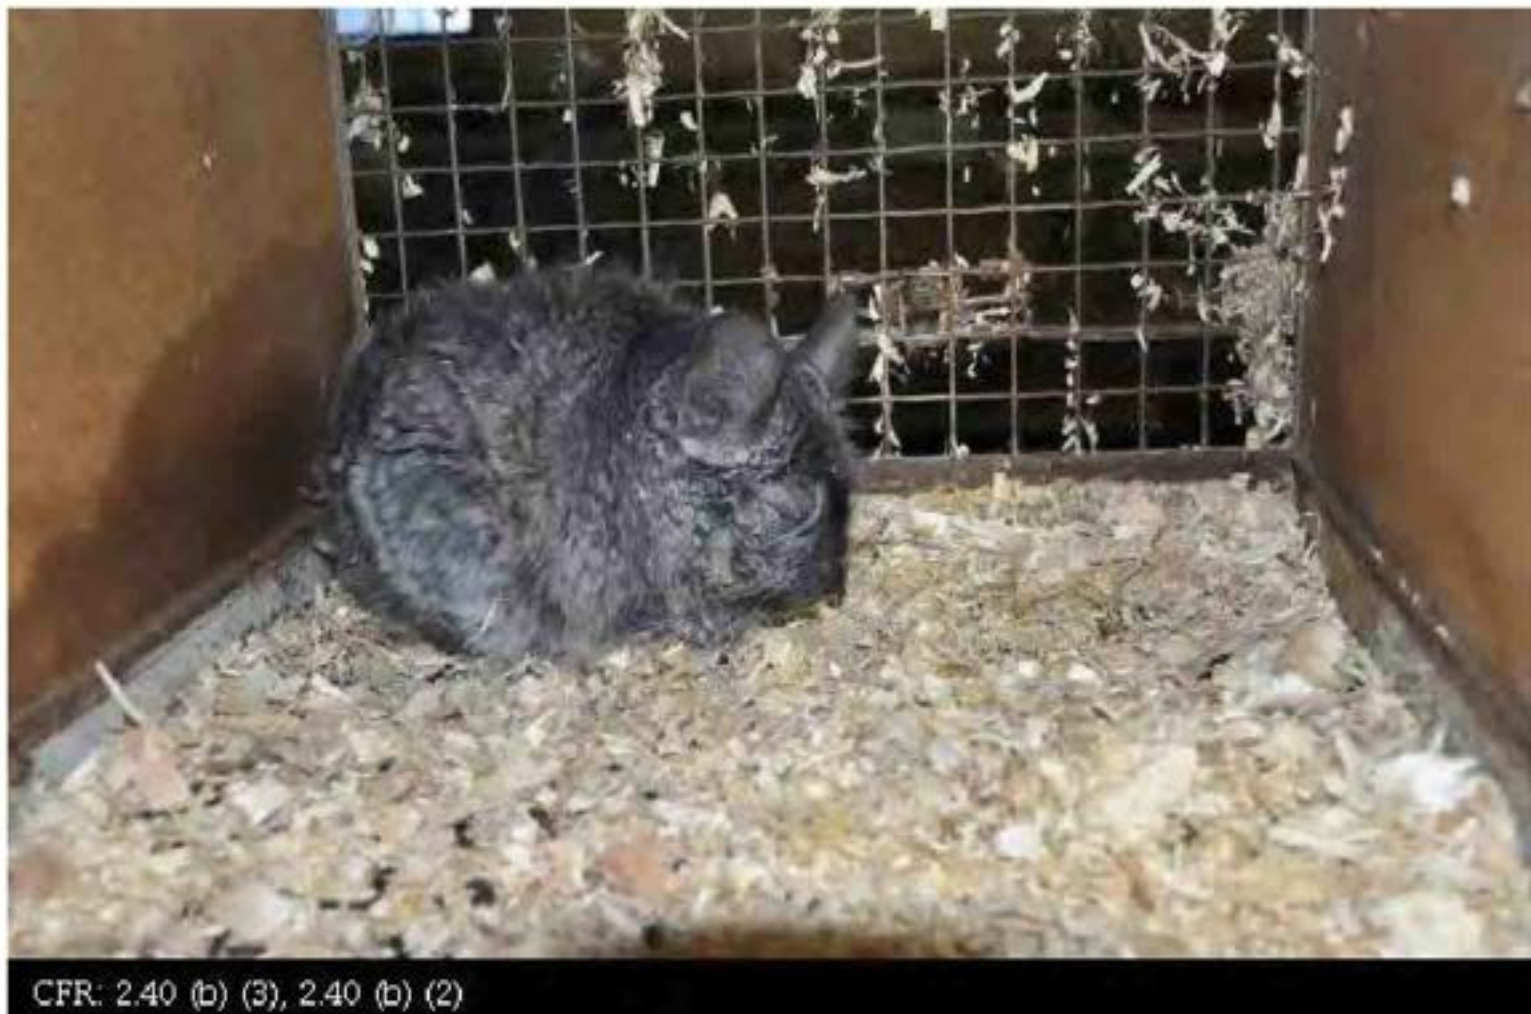
CFR: 2.40 (b) (3), 2.40 (b) (2)

Photographer:	Scott Welch	Legal Name:	41-B-0239
Photo Taken:	Wed, Feb 3, '16	DAN MOULTON	
Inspection:	40161623280694		
Description:	Female with eartag "DJM 145"; right eye seen crusted shut.

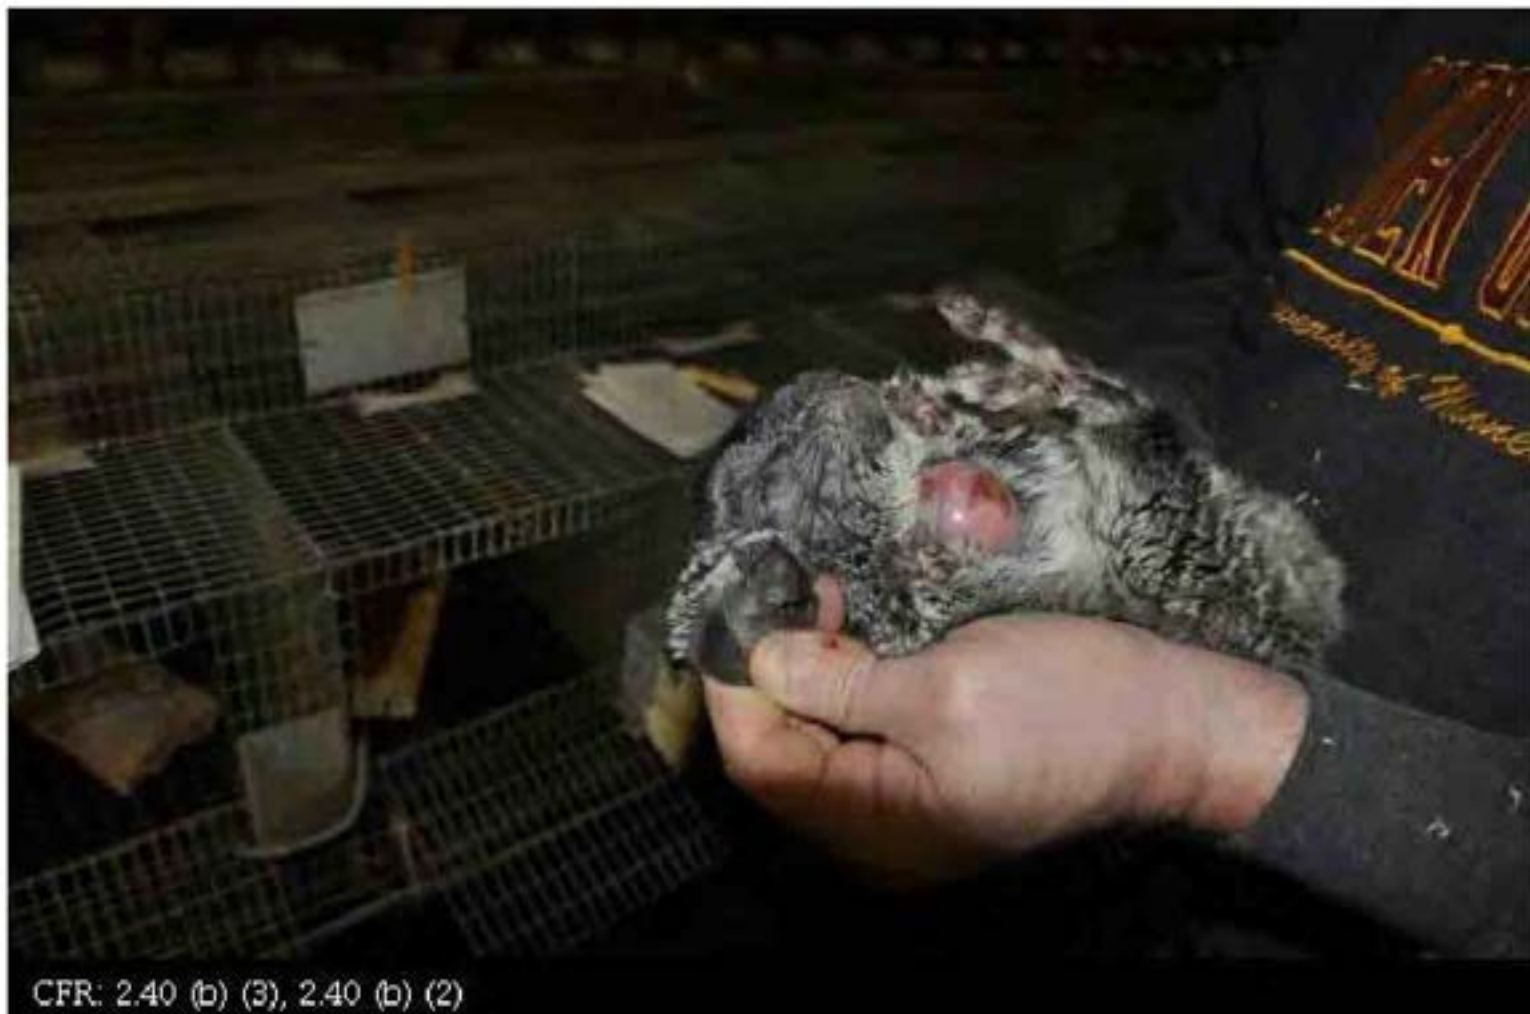
Photographer:	Scott Welch	Legal Name:	41-B-0239
Photo Taken:	Wed, Feb 3, '16	DAN MOULTON	
Inspection:	40161623280694		
Description:	Female with eartag "OKES 108" (or "801"). Note large, scabbed swelling under chin and right eyelids that are swollen with hair loss and discharge in eye.

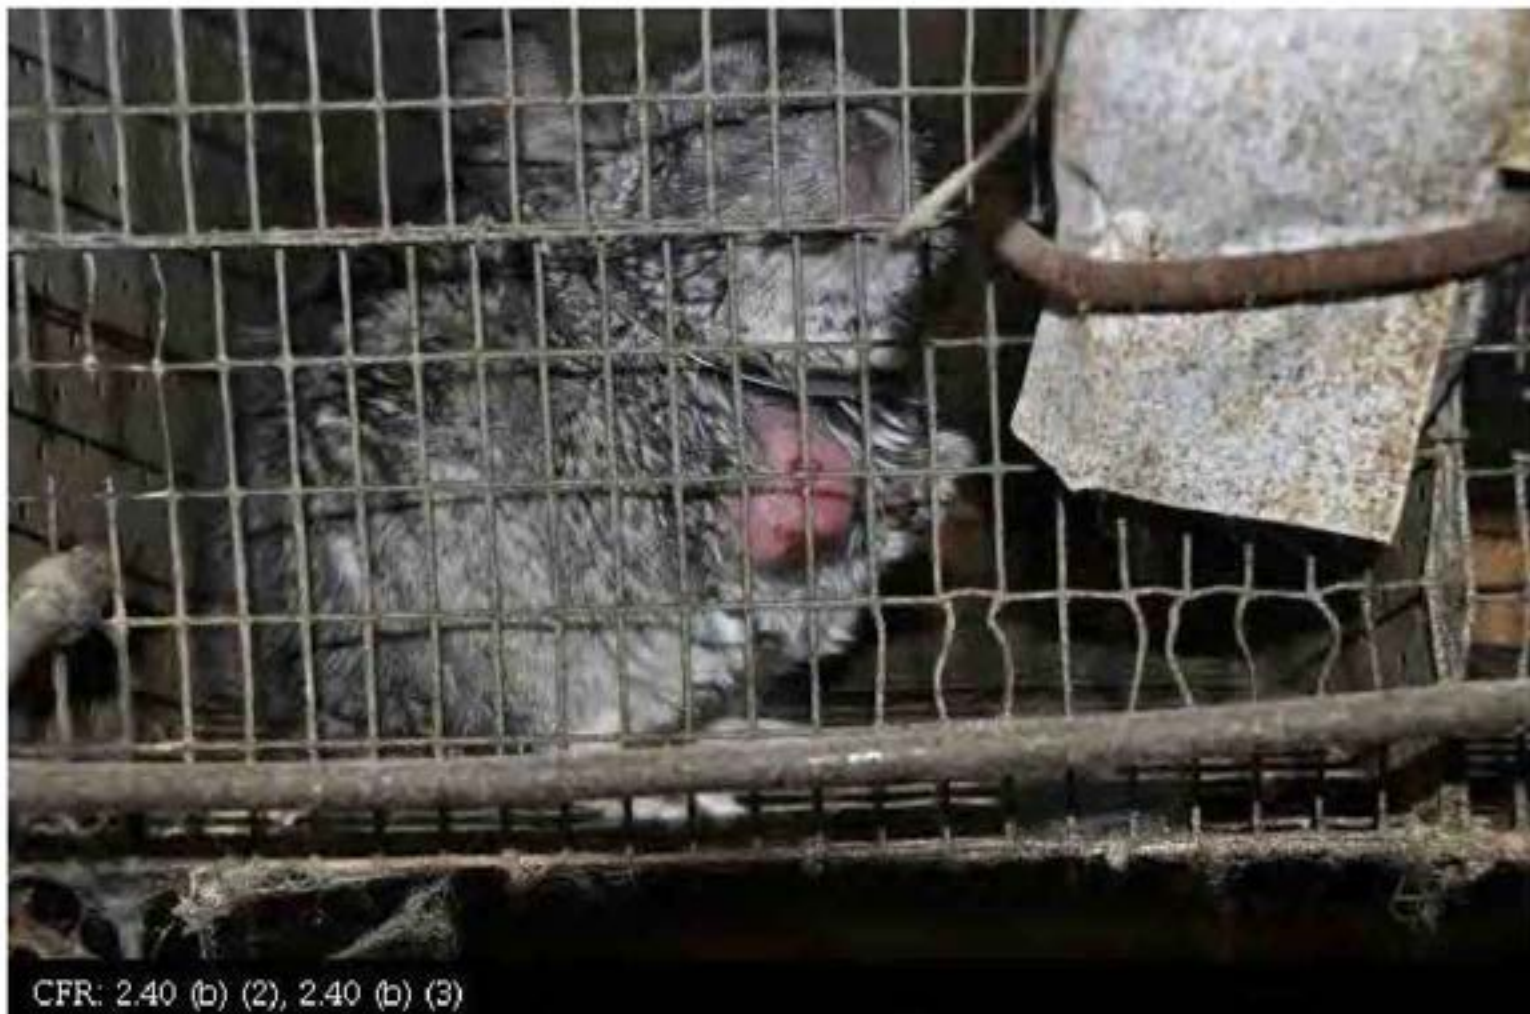
Description: Female with eartag "OKES 108" (or "801") in cage.

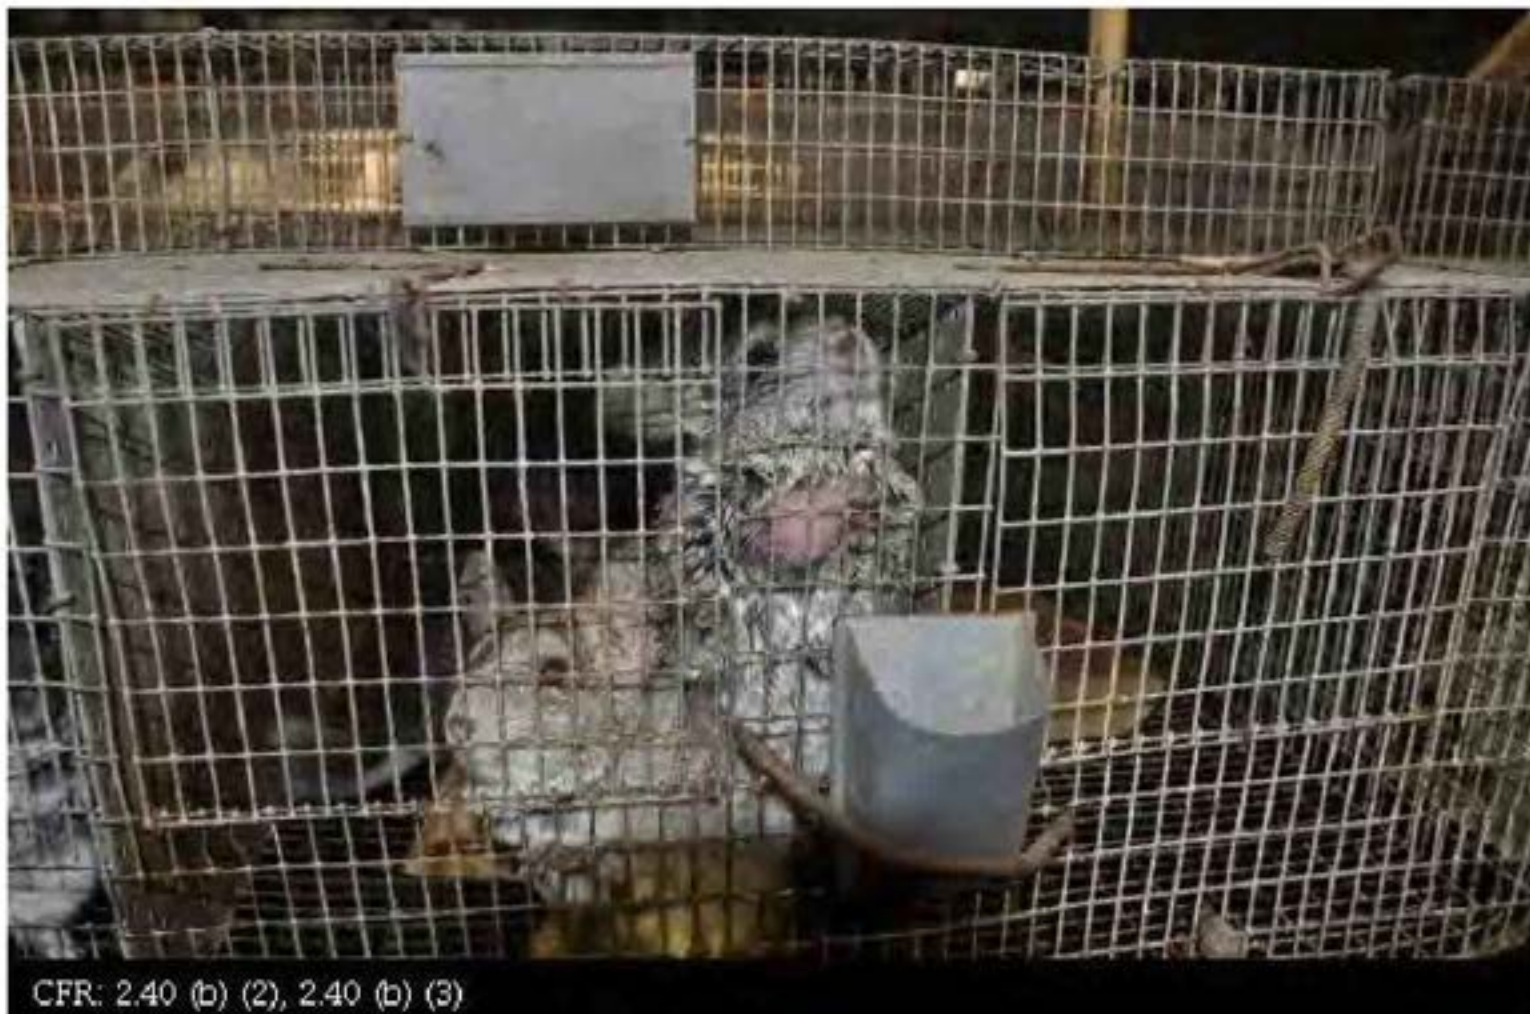
CFR: 2.40 (b) (2), 2.40 (b) (3)

Photographer:	Scott Welch	Legal Name:	41-B-0239
Photo Taken:	Wed, Feb 3, '16	DAN MOULTON	
Inspection:	40161623280694		
Description:	Male with eartag 147; large swelling under its chin with reddened skin and hair loss.

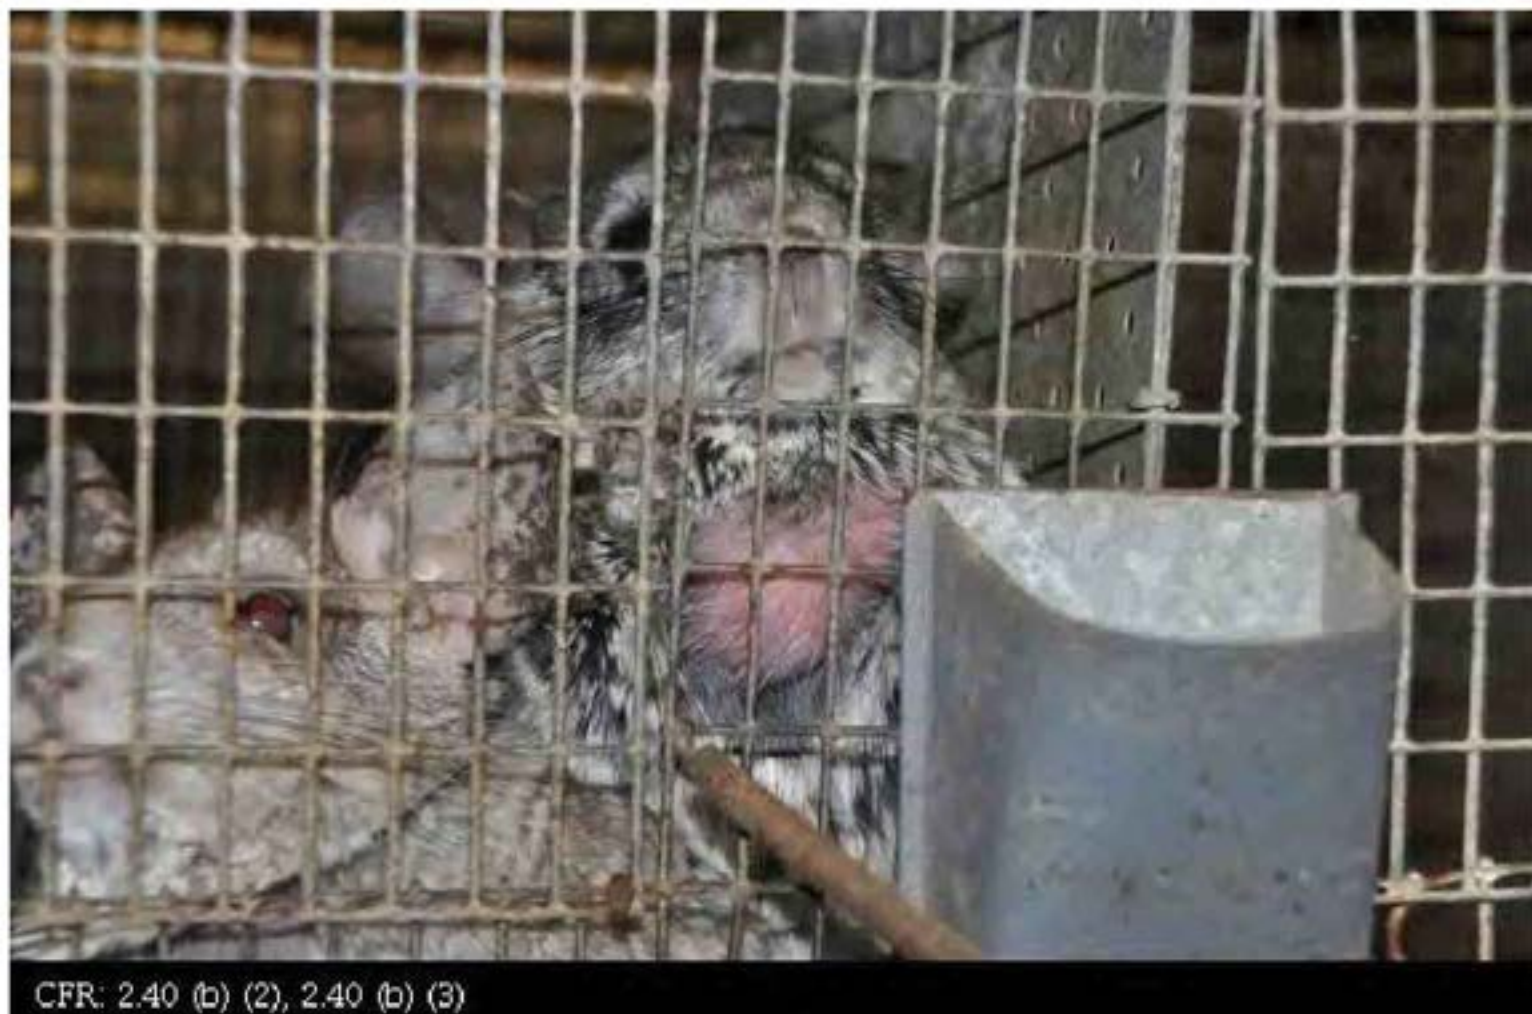
CFR: 2.40 (b) (2), 2.40 (b) (3)

Description: Male with eartag 147; large swelling under its chin with reddened skin and hair loss.

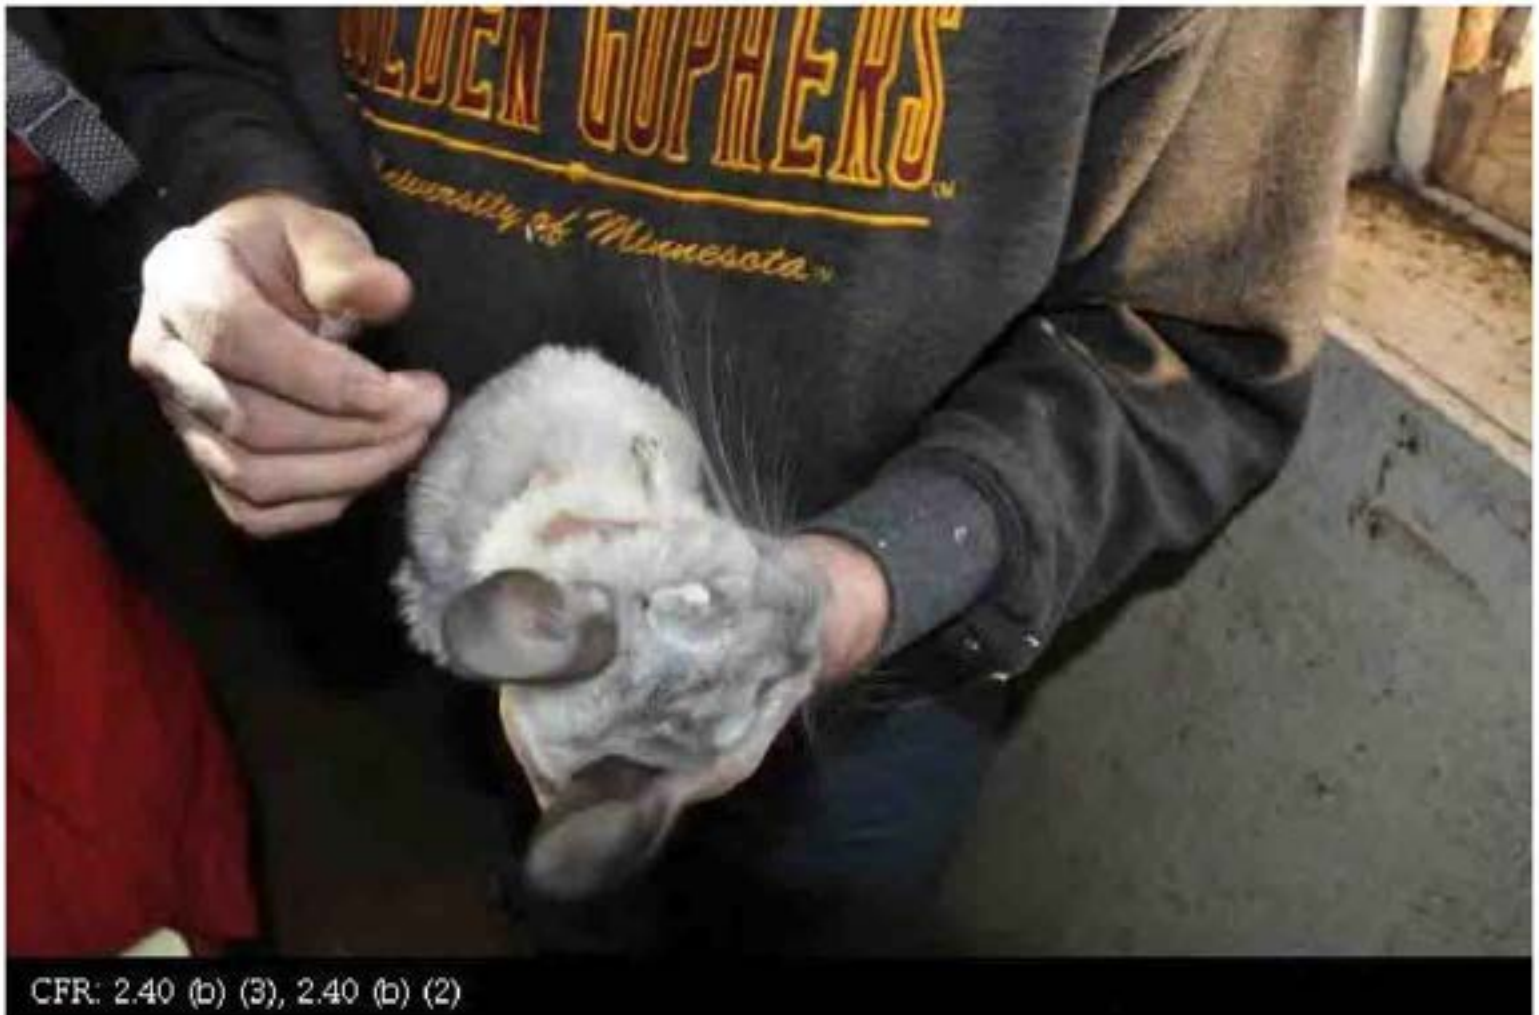
CFR: 2.40 (b) (3), 2.40 (b) (2)

Photographer:	Scott Welch	Legal Name:	41-B-0239
Photo Taken:	Wed, Feb 3, '16	DAN MOULTON	
Inspection:	40161623280694		
Description:	Beige male (no ID; cage card AM-F-8; housed on south wall stacked cages). Its left eyelids swollen and pale creamy discharge from the eye.

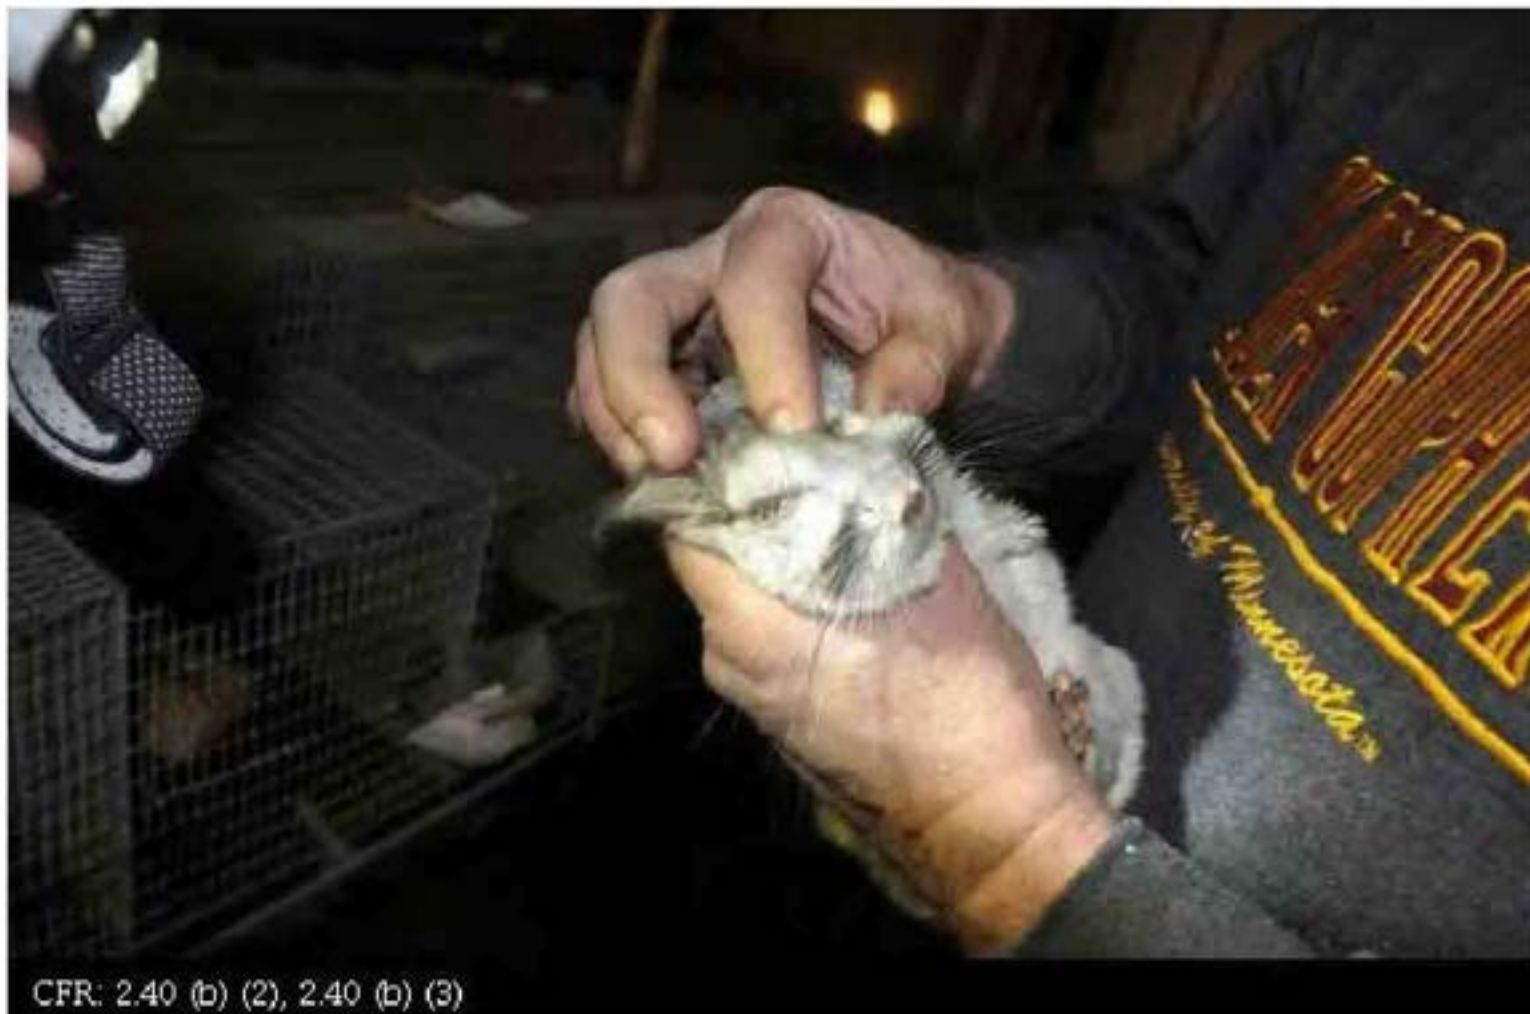
Photographer:	Scott Welch	Legal Name:	41-B-0239
Photo Taken:	Wed, Feb 3, '16	DAN MOULTON	
Inspection:	40161623280694		
Description:	Beige male (no ID; cage card AM-F-8; housed on south wall stacked cages). Its right eye crusted shut.
