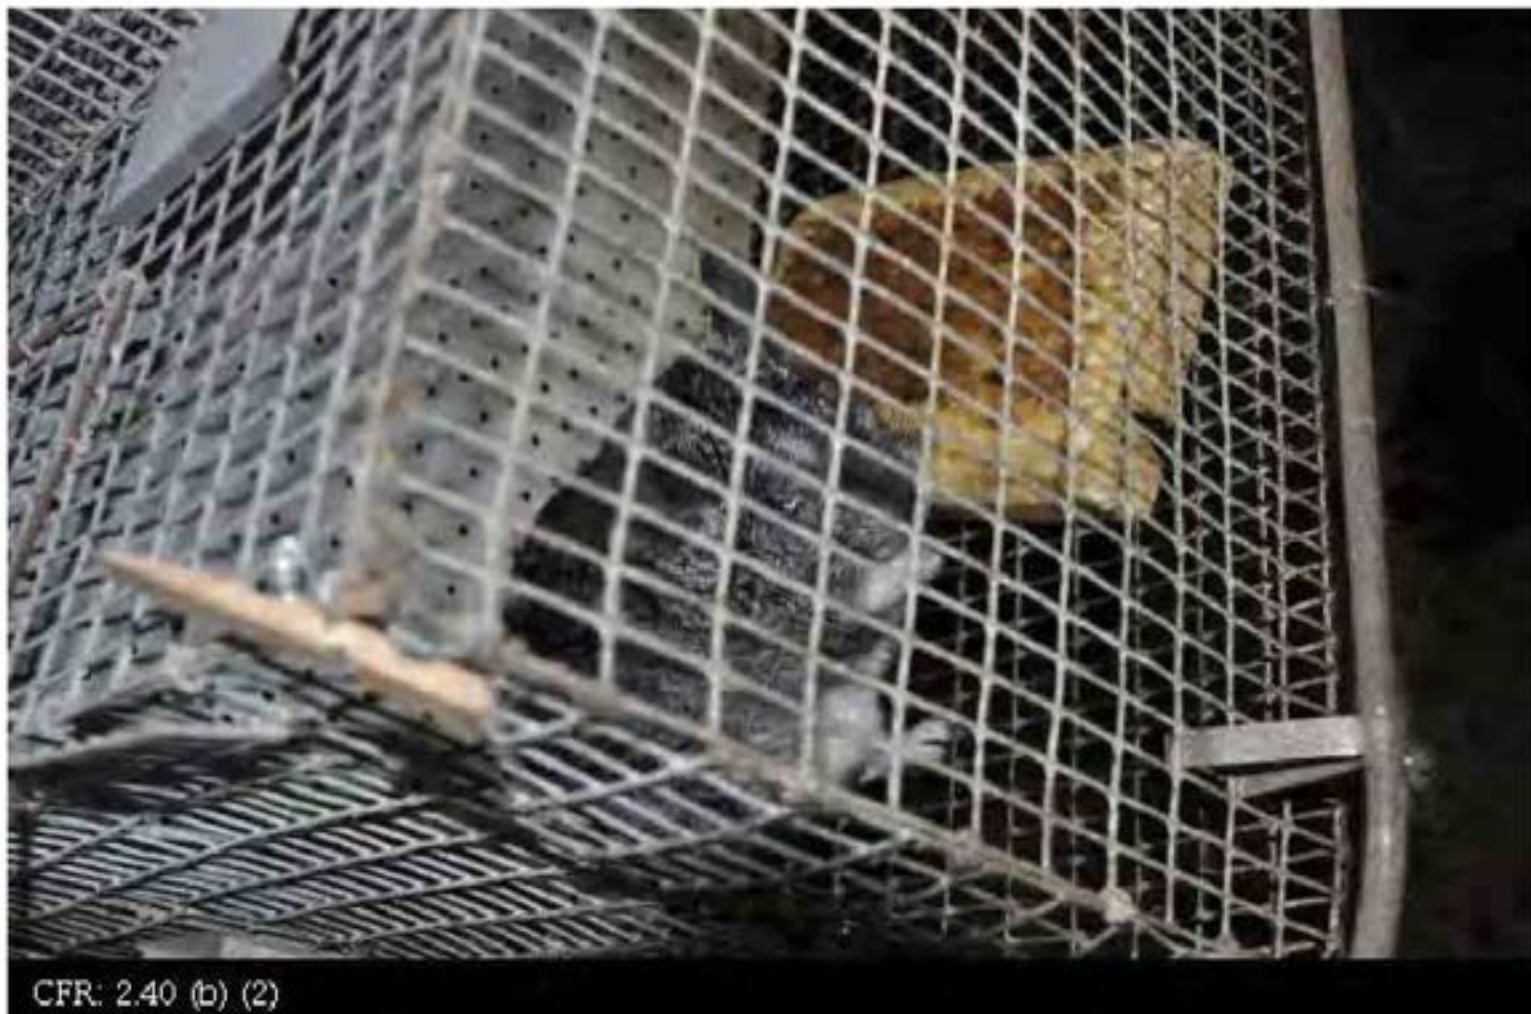
Photographer:	Scott Welch	Legal Name:	41-B-0239
Photo Taken:	Wed, Feb 3, '16	DAN MOULTON	
Inspection:	40161623280694		
Description:	Male with eartag "VVCR 179". Its right eyelids are swollen and crusted shut. Licensee had cage marked and said he was watching this one, but not giving medicine.

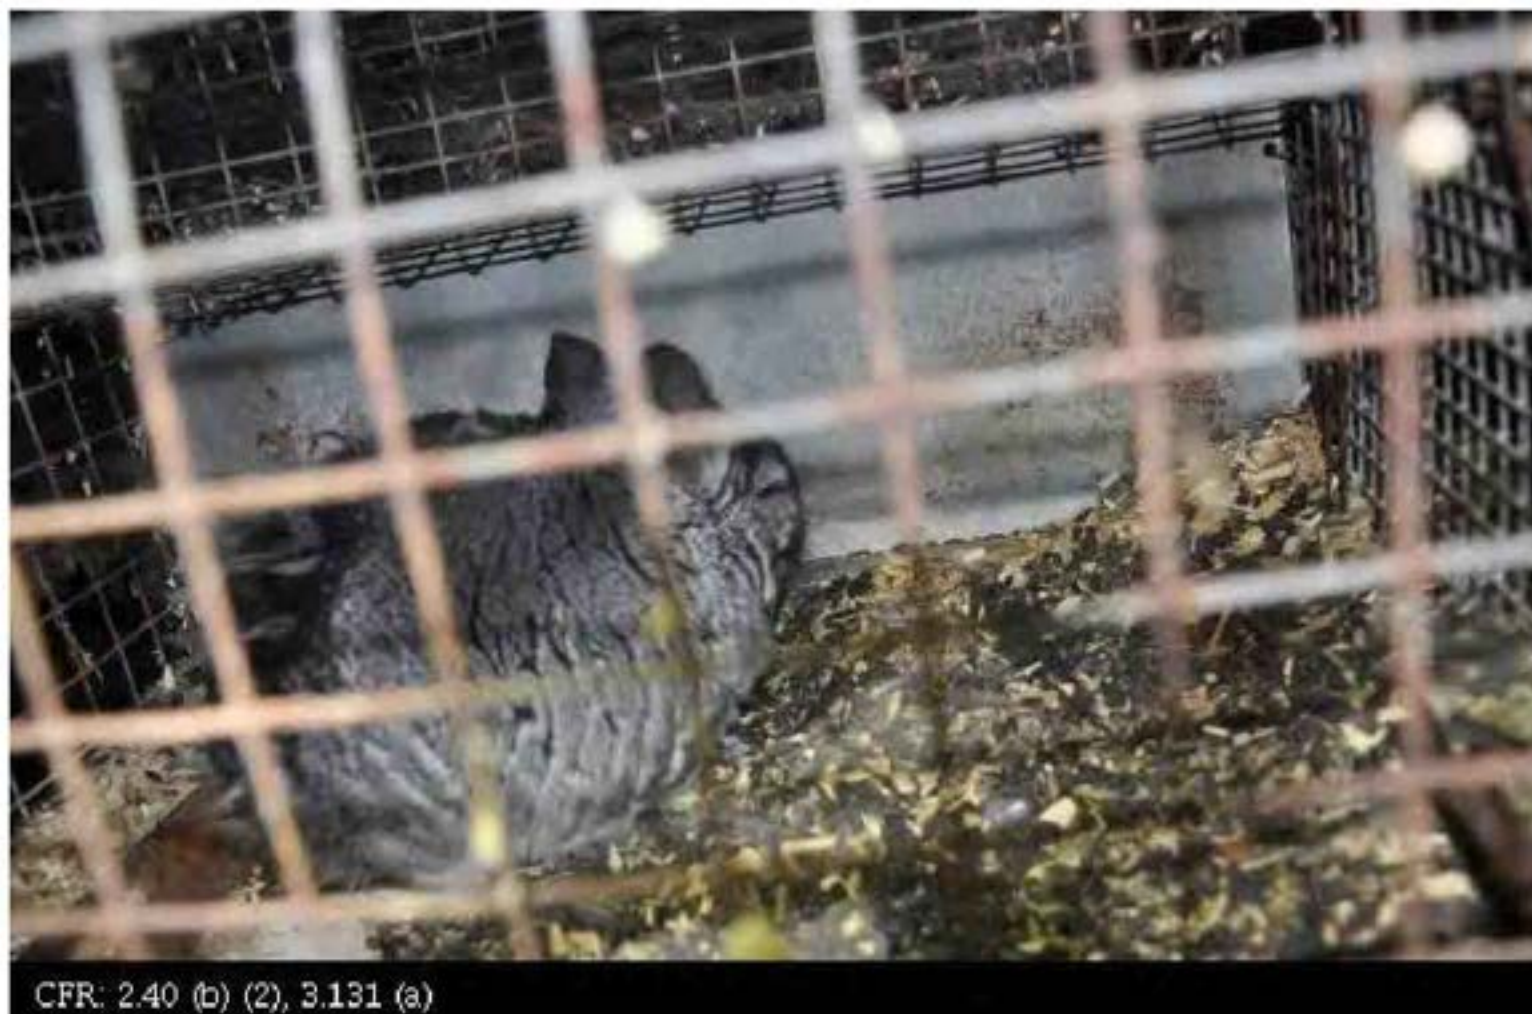
CFR: 2.40 (b) (2), 3.131 (a)

Photographer:	Scott Welch	Legal Name:	41-B-0239
Photo Taken:	Wed, Feb 3, '16	DAN MOULTON	
Inspection:	40161623280694		
Description:	Chinchilla in backroom; three (no id's) had unresolved eye problems. Note right eye is difficult to visualize; Representative of other 2 in backroom with un-resolved eye problems. Note excessive feces

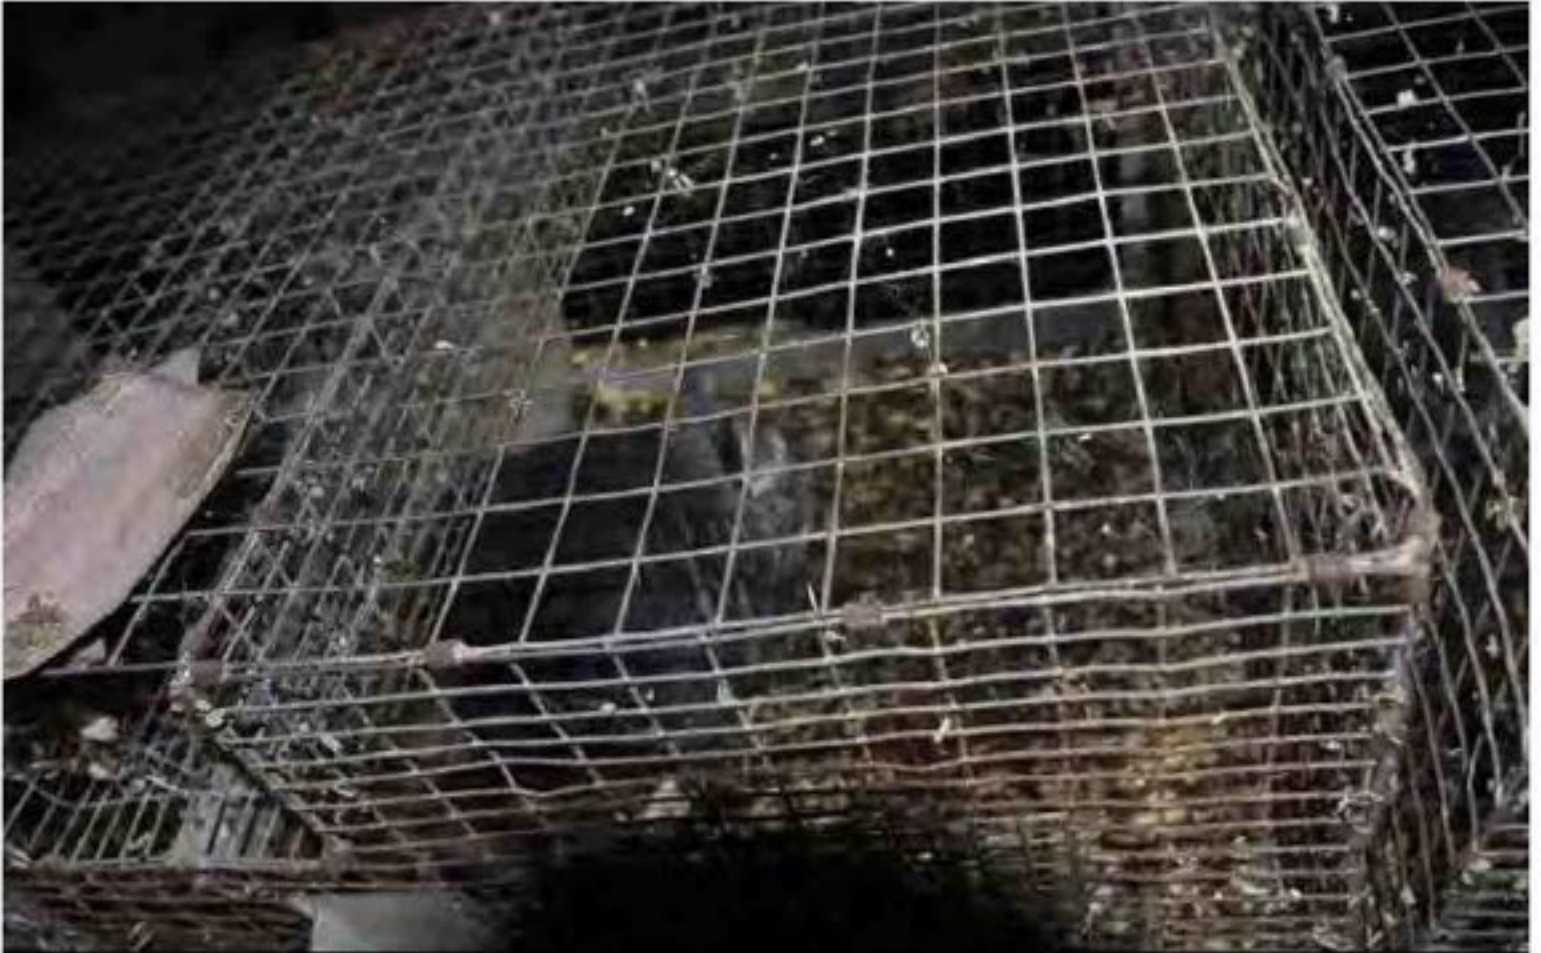
CFR: 2.40 (b) (2)

Photographer:	Scott Welch	Legal Name:	41-B-0239
Photo Taken:	Wed, Feb 3, '16	DAN MOULTON	
Inspection:	40161623280694		
Description:	Chinchilla in backroom; three (no id's) had unresolved eye problems; right eye was not well visualized as in normal chinchillas.

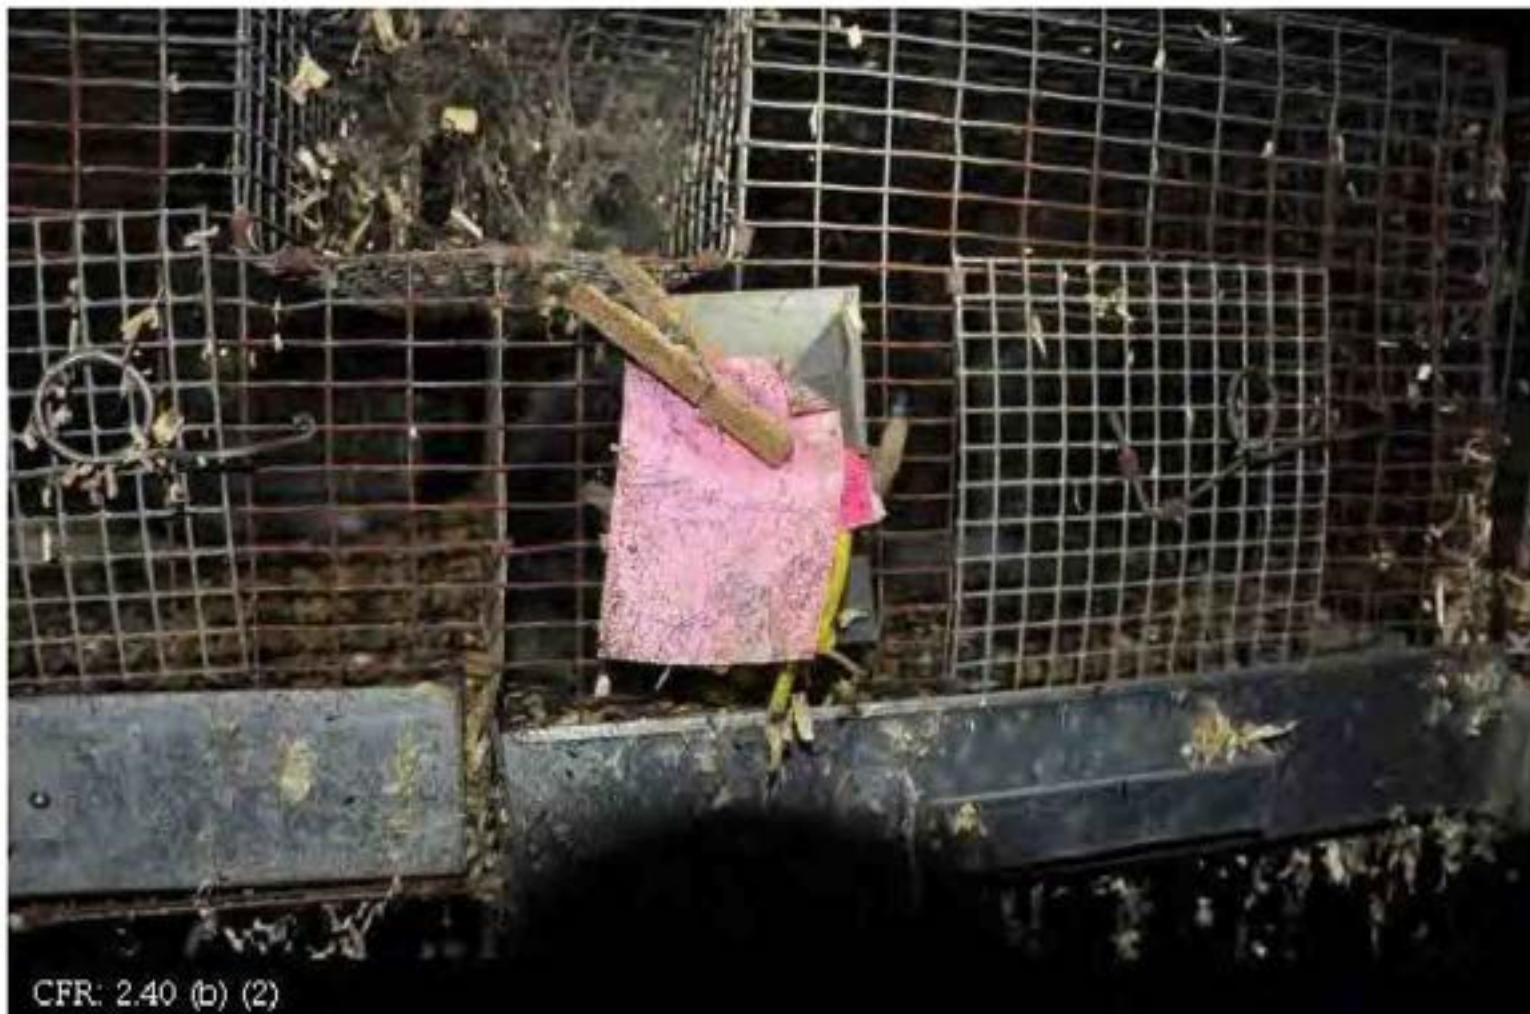
Photographer:	Scott Welch	Legal Name:	41-B-0239
Photo Taken:	Wed, Feb 3, '16	DAN MOULTON	
Inspection:	40161623280694		
Description:	Chinchilla in backroom; three (no id's) had unresolved eye problems. Treatment card on cage upper left has 7/3 for date and lower right has 9/4.

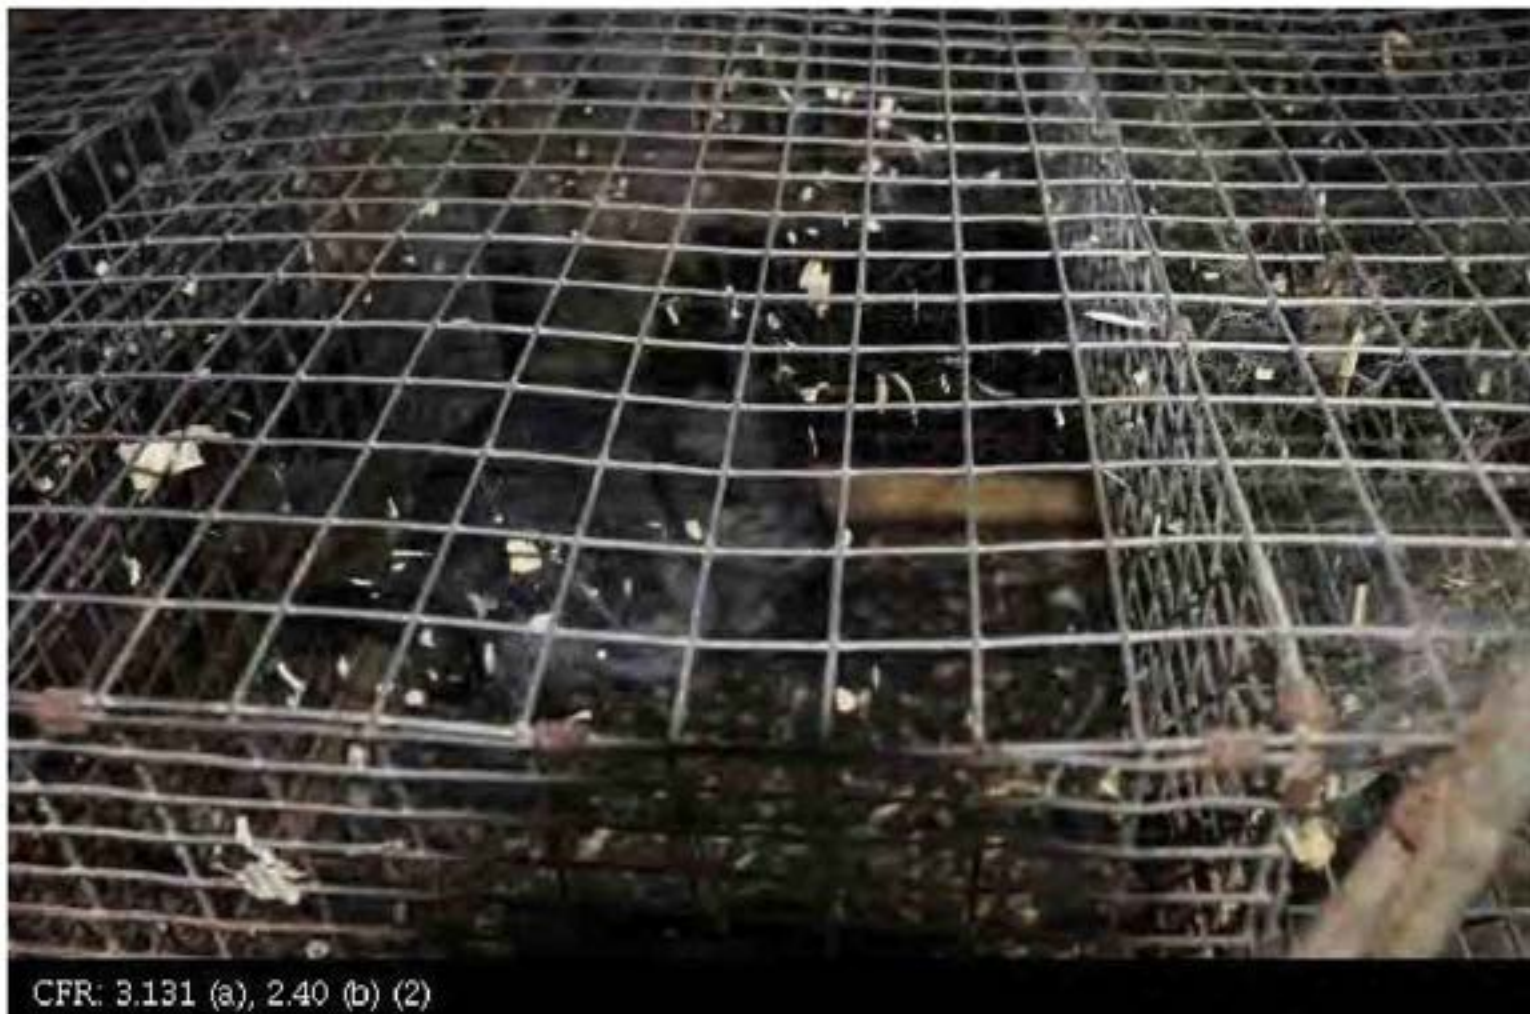
Photographer:	Scott Welch	Legal Name:	41-B-0239
Photo Taken:	Wed, Feb 3, '16	DAN MOULTON	
Inspection:	40161623280694		
Description:	Chinchillas in backroom; three (no id's) had unresolved eye problems. Note excessive feces in enclosure.

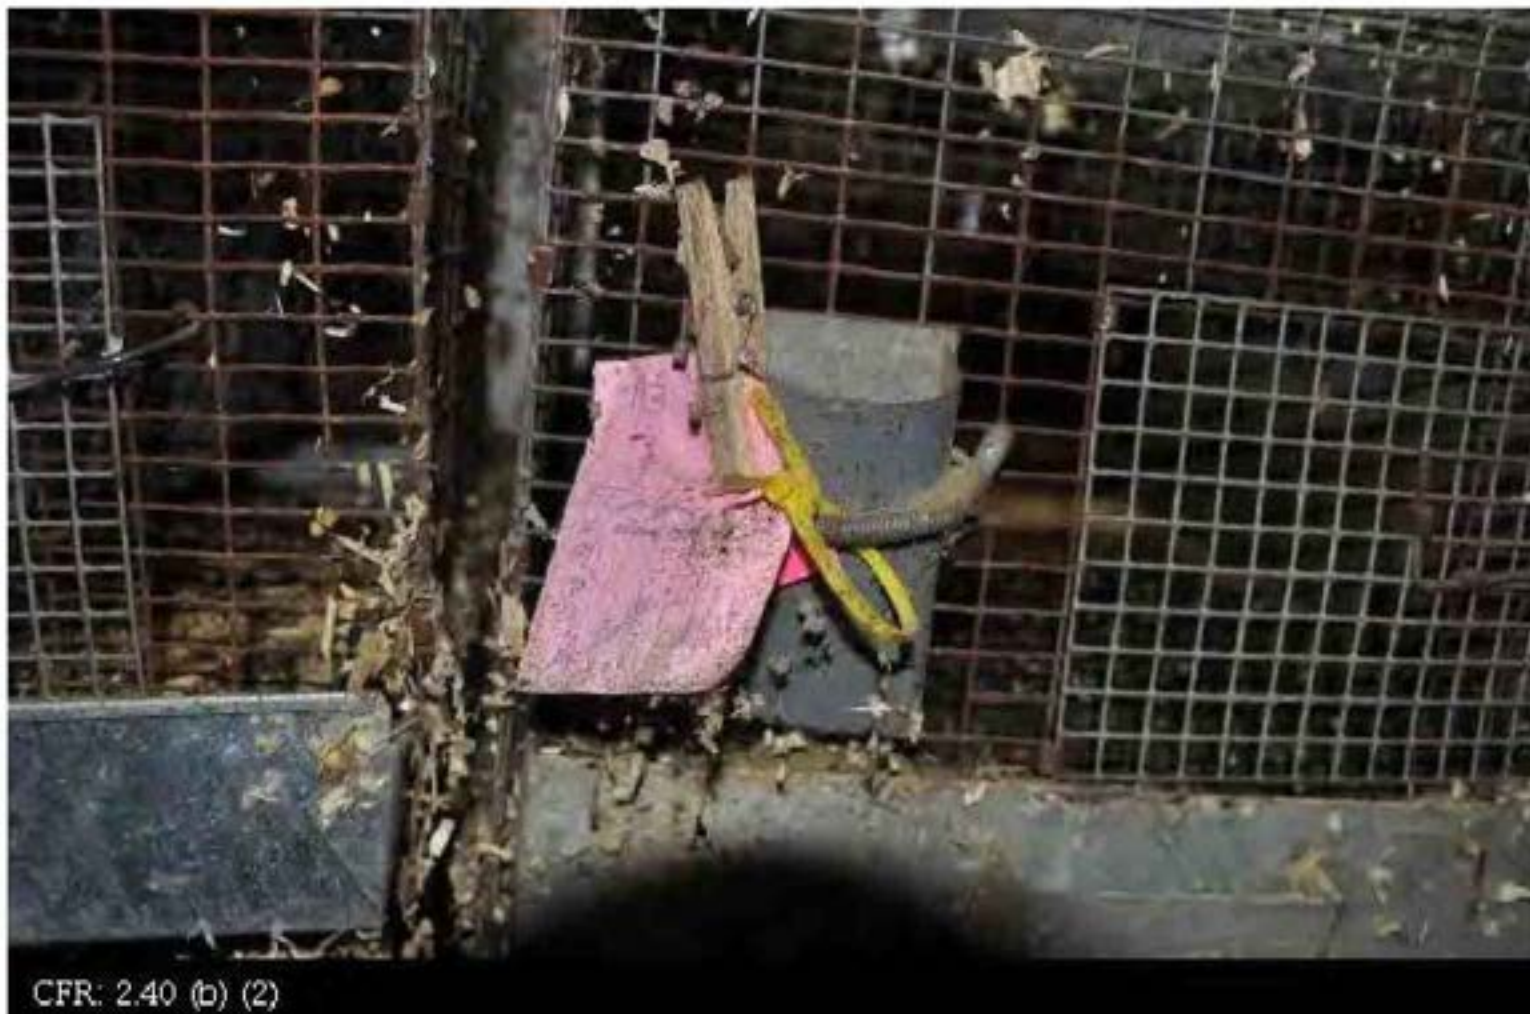
CFR: 2.40 (b) (2)

Photographer:	Scott Welch	Legal Name:	41-B-0239
Photo Taken:	Wed, Feb 3, '16	DAN MOULTON	
Inspection:	40161623280694		
Description:	Chinchillas in backroom; three (no id's) had unresolved eye problems. Treatment card on cage upper left has 7/3 for date and lower right has 9/7.

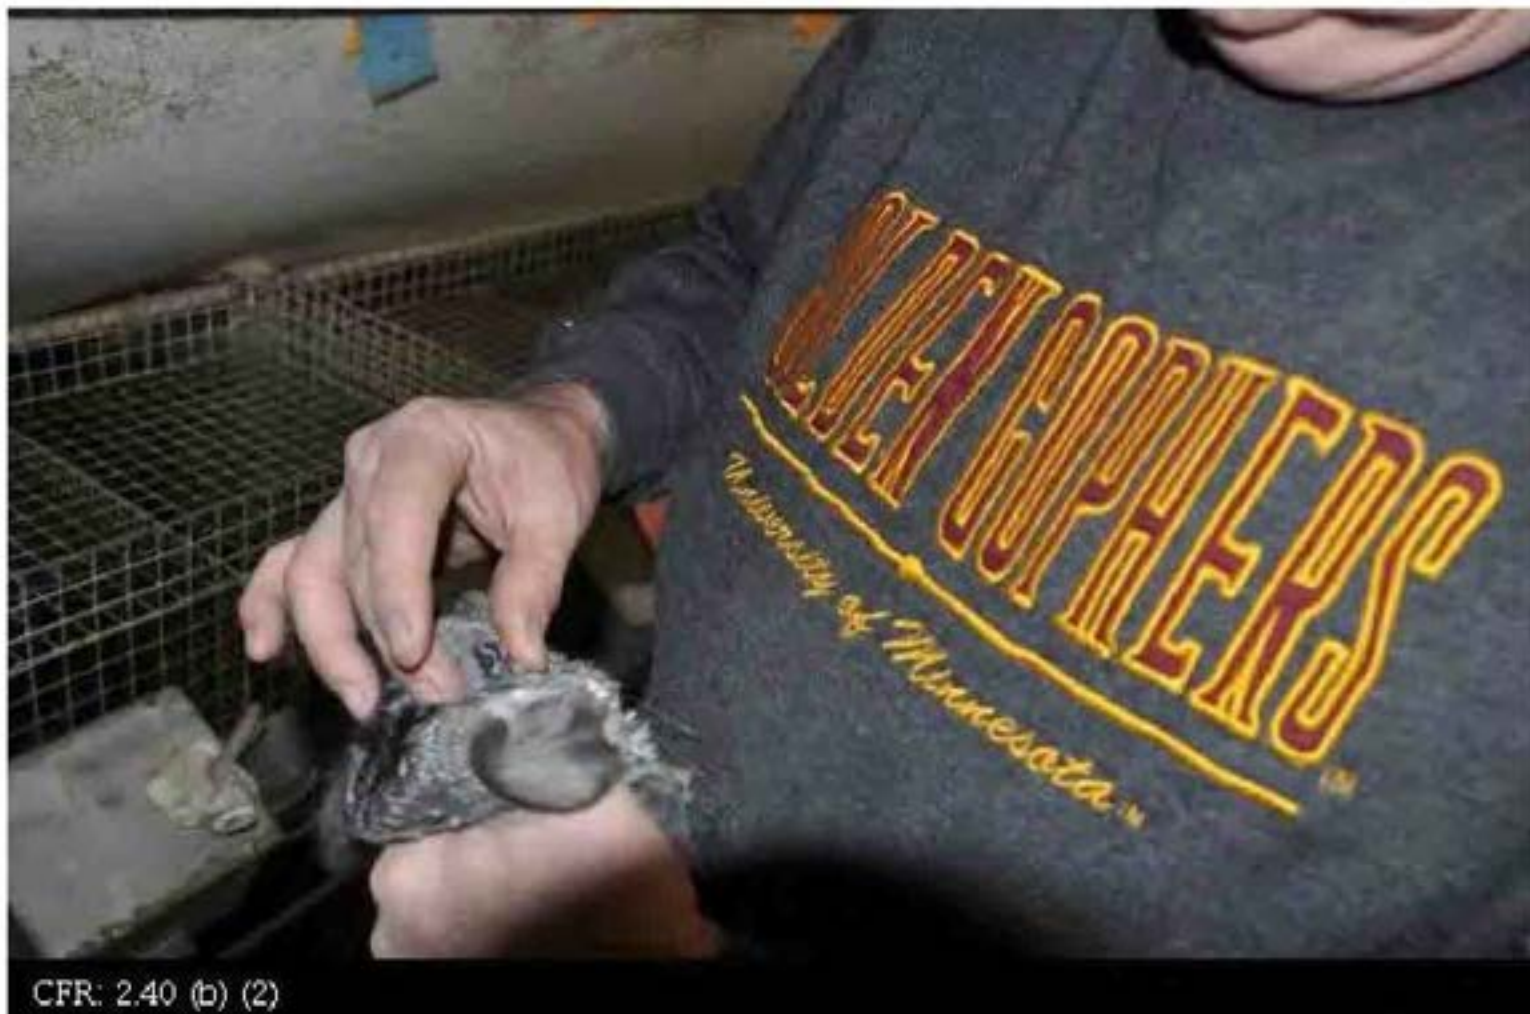
Photographer:	Scott Welch	Legal Name:	41-B-0239
Photo Taken:	Wed, Feb 3, '16	DAN MOULTON	
Inspection:	40161623280694		
Description:	Female with eartag "337". Right eyelids swollen with crusty material and creamy pale discharge from eye. Licensee had cage marked and said he was watching this one, but not giving medicine.

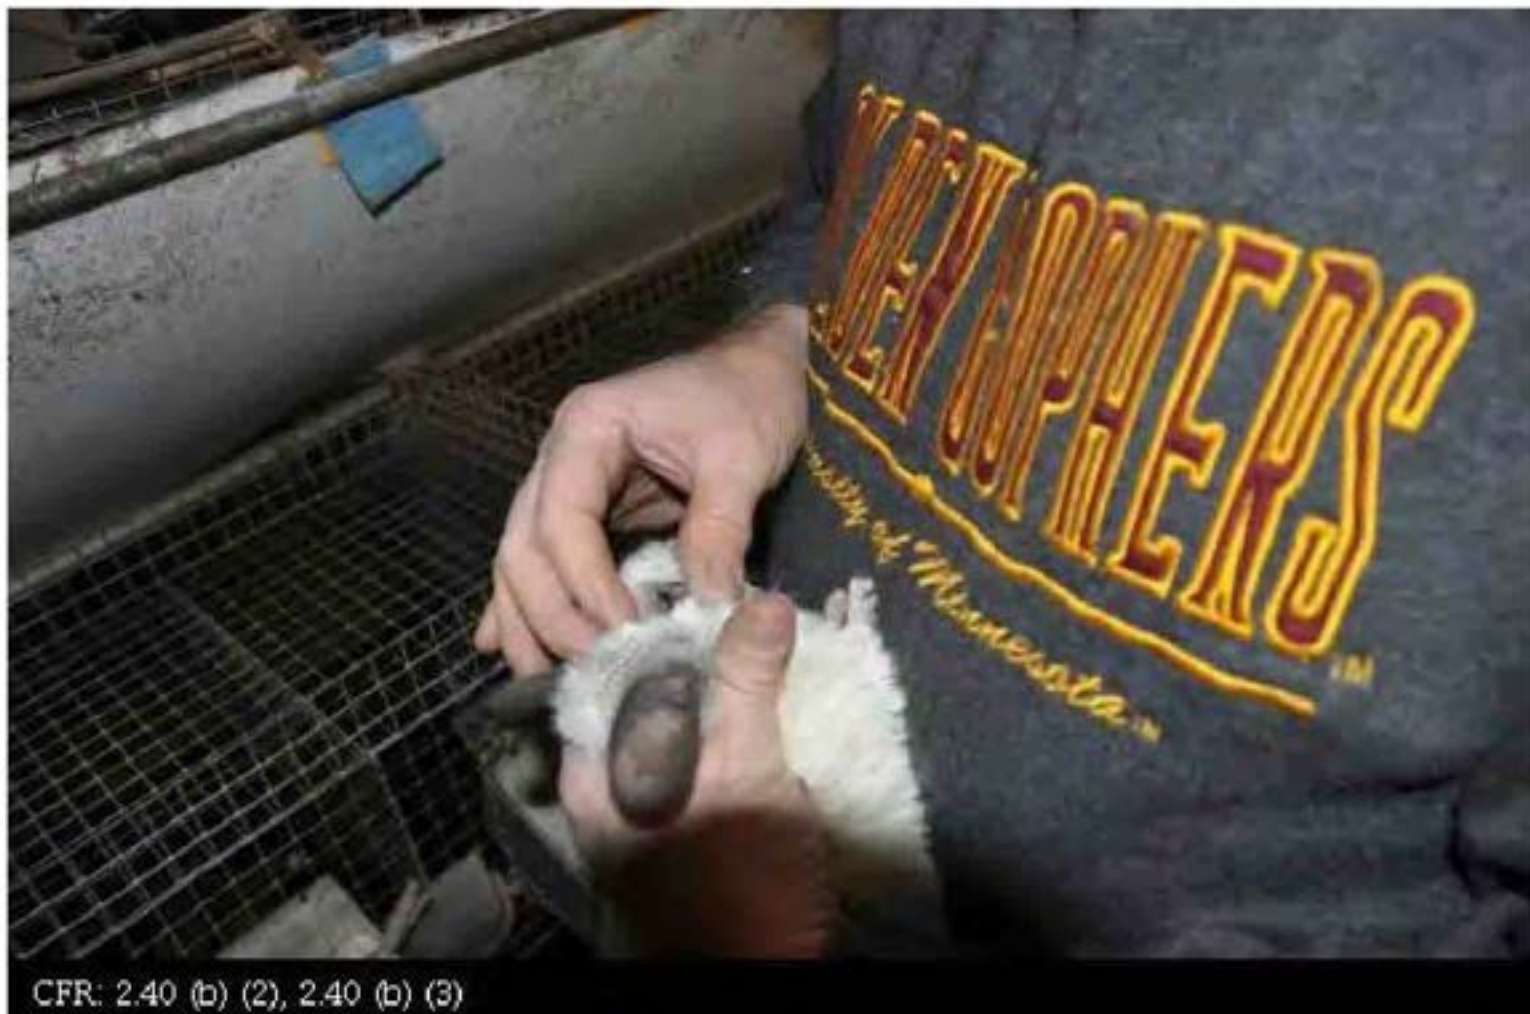
CFR: 2.40 (b) (2), 2.40 (b) (3)

Photographer:	Scott Welch	Legal Name:	41-B-0239
Photo Taken:	Wed, Feb 3, '16	DAN MOULTON	
Inspection:	40161623280694		
Description:	Male with cage card R242; its right eyelids were swollen and had a pale creamy discharge.

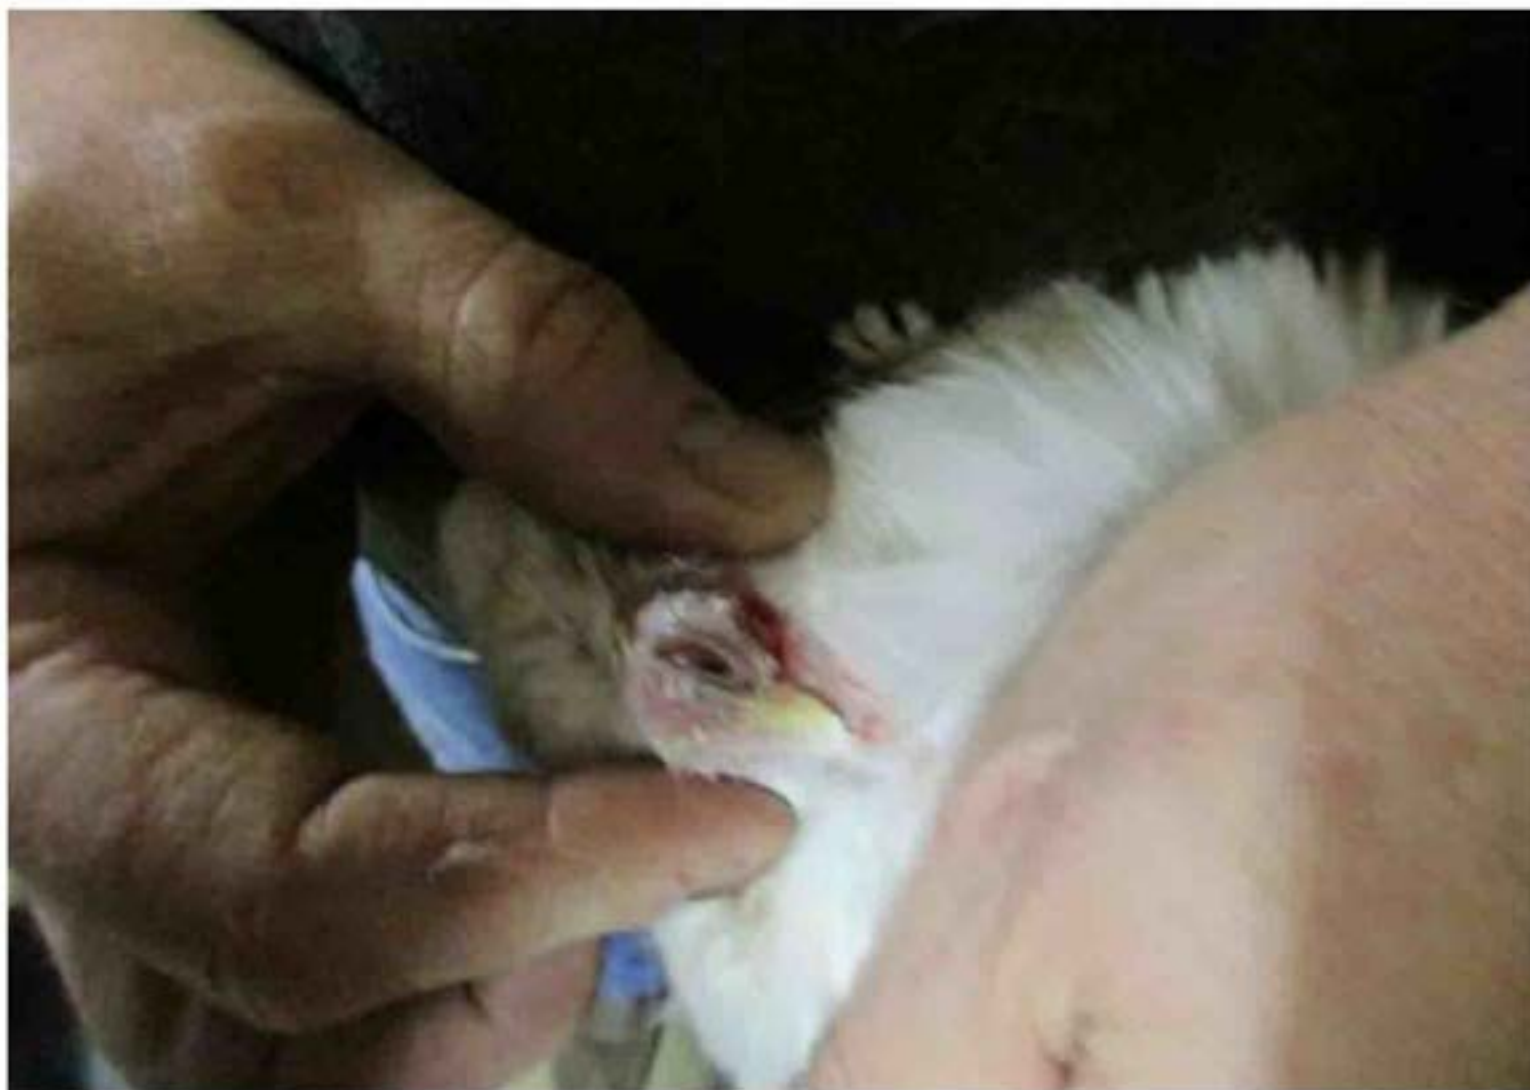
CFR: 2.40 (b) (2), 2.40 (b) (3)

Photographer:	Kevin Wilken	Legal Name:	41-B-0239
Photo Taken:	Wed, Feb 3, '16	DAN MOULTON	
Inspection:	40161623280694		
Description:	Male (no id; '3-5' on cage card); its right eyelids crusted, swollen with pale creamy discharge in eye, its right lower eyelid also bled after licensee touched it.

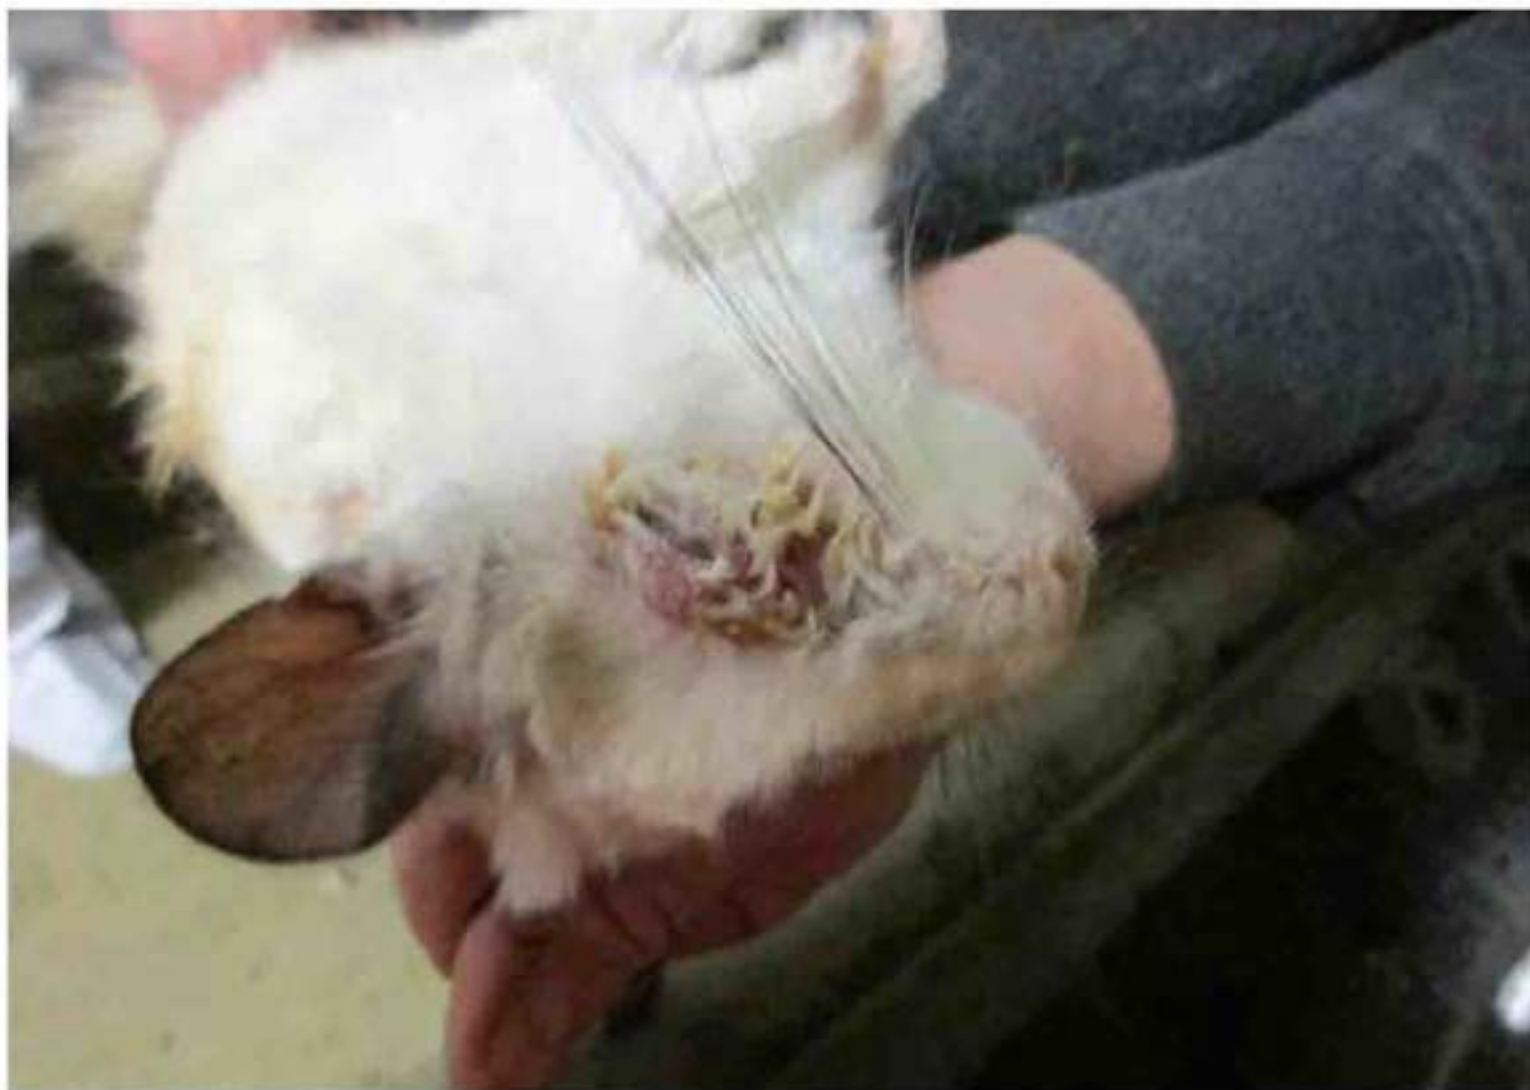
CFR: 2.40 (b) (2), 2.40 (b) (3)

Photographer:	Kevin Wilken	Legal Name:	41-B-0239
Photo Taken:	Wed, Feb 3, '16	DAN MOULTON	
Inspection:	40161623280694		
Description:	Male (no id; '3-5' on cage card); its left eyelids were crusted, swollen, and had a creamy pale discharge from the eye.

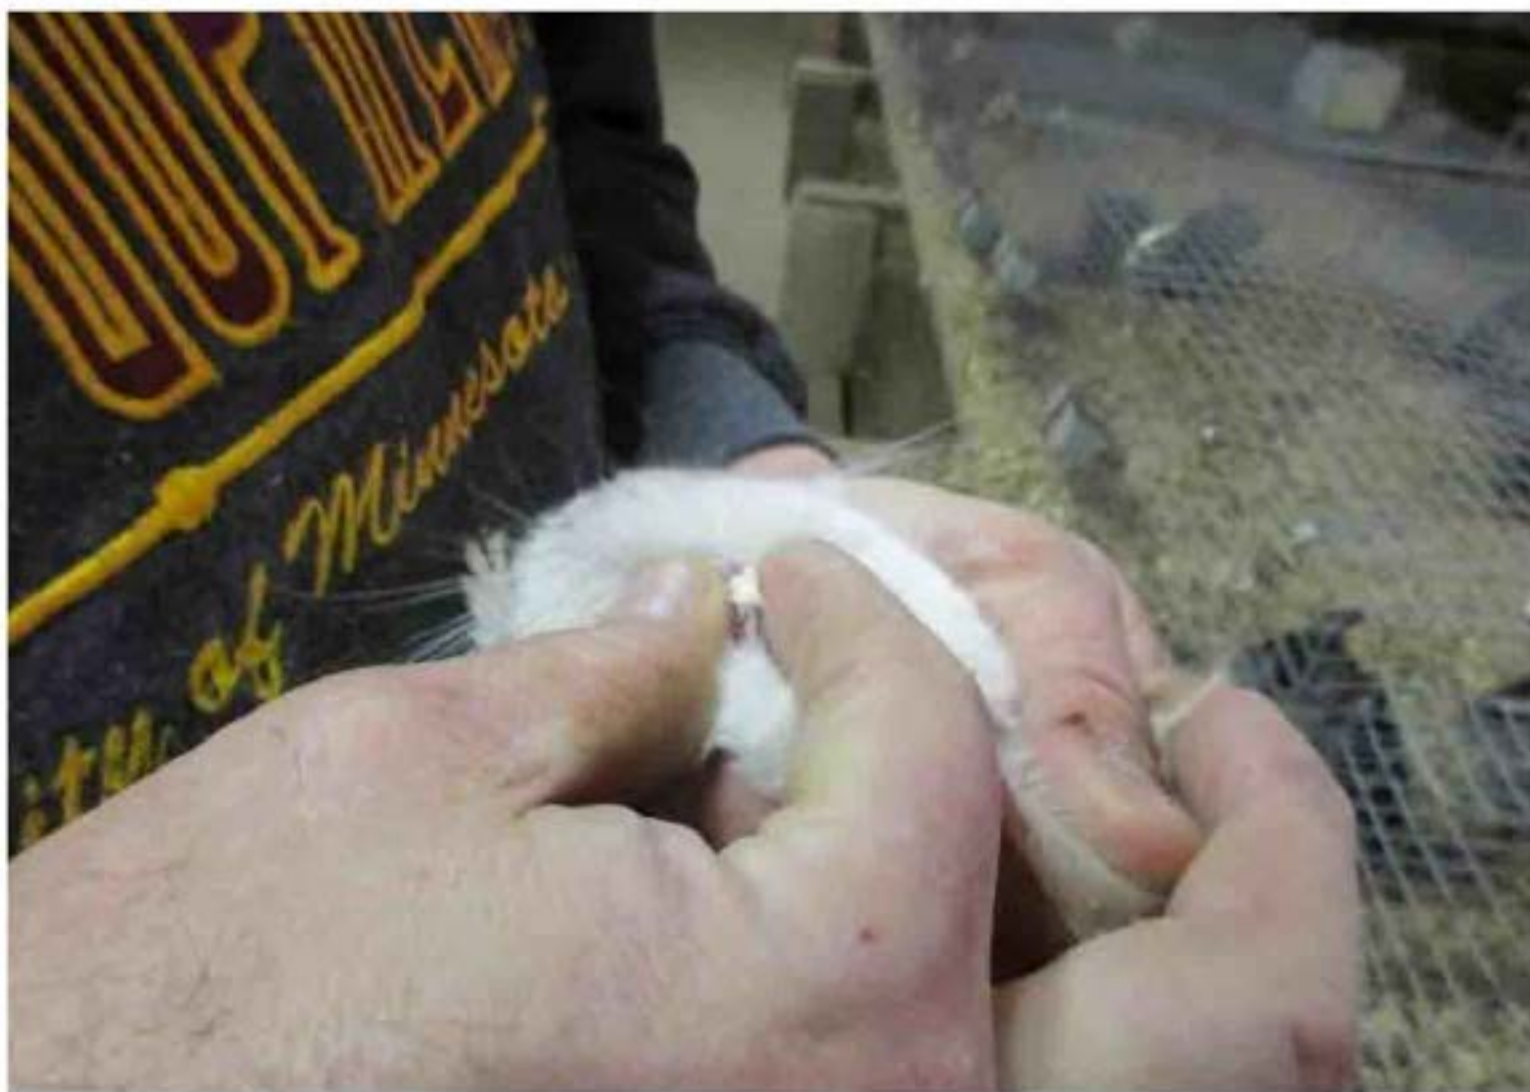
CFR: 2.40 (b) (3), 2.40 (b) (2)

Photographer:	Kevin Wilken	Legal Name:	41-B-0239
Photo Taken:	Wed, Feb 3, '16	DAN MOULTON	
Inspection:	40161623280694		
Description:	Female with eartag 'DJM 196'; swollen left eyelids and a thick pale creamy discharge that came out from underneath them as licensee handled the eyelids.

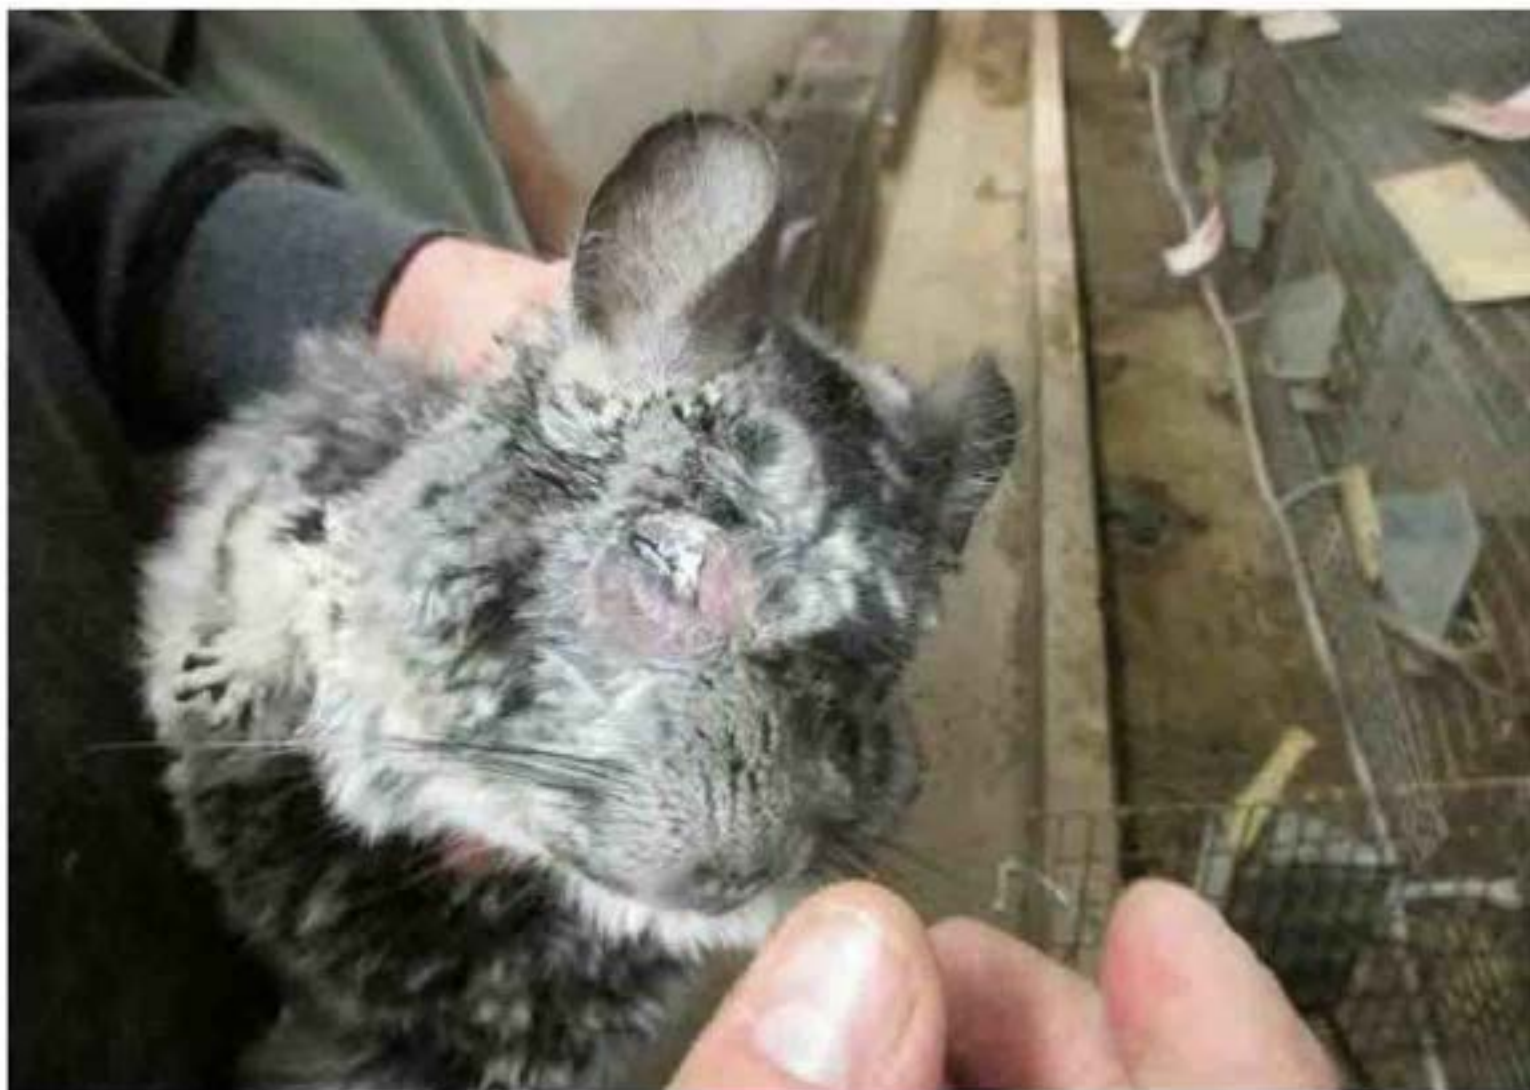
CFR: 2.40 (b) (2), 2.40 (b) (3)

Photographer:	Kevin Wilken	Legal Name:	41-B-0239
Photo Taken:	Wed, Feb 3, '16	DAN MOULTON	
Inspection:	40161623280694		
Description:	Female with eartag "505"; its right eyelids sealed shut with crusty material with hair loss, reddened skin, and a pale creamy discharge from eye.

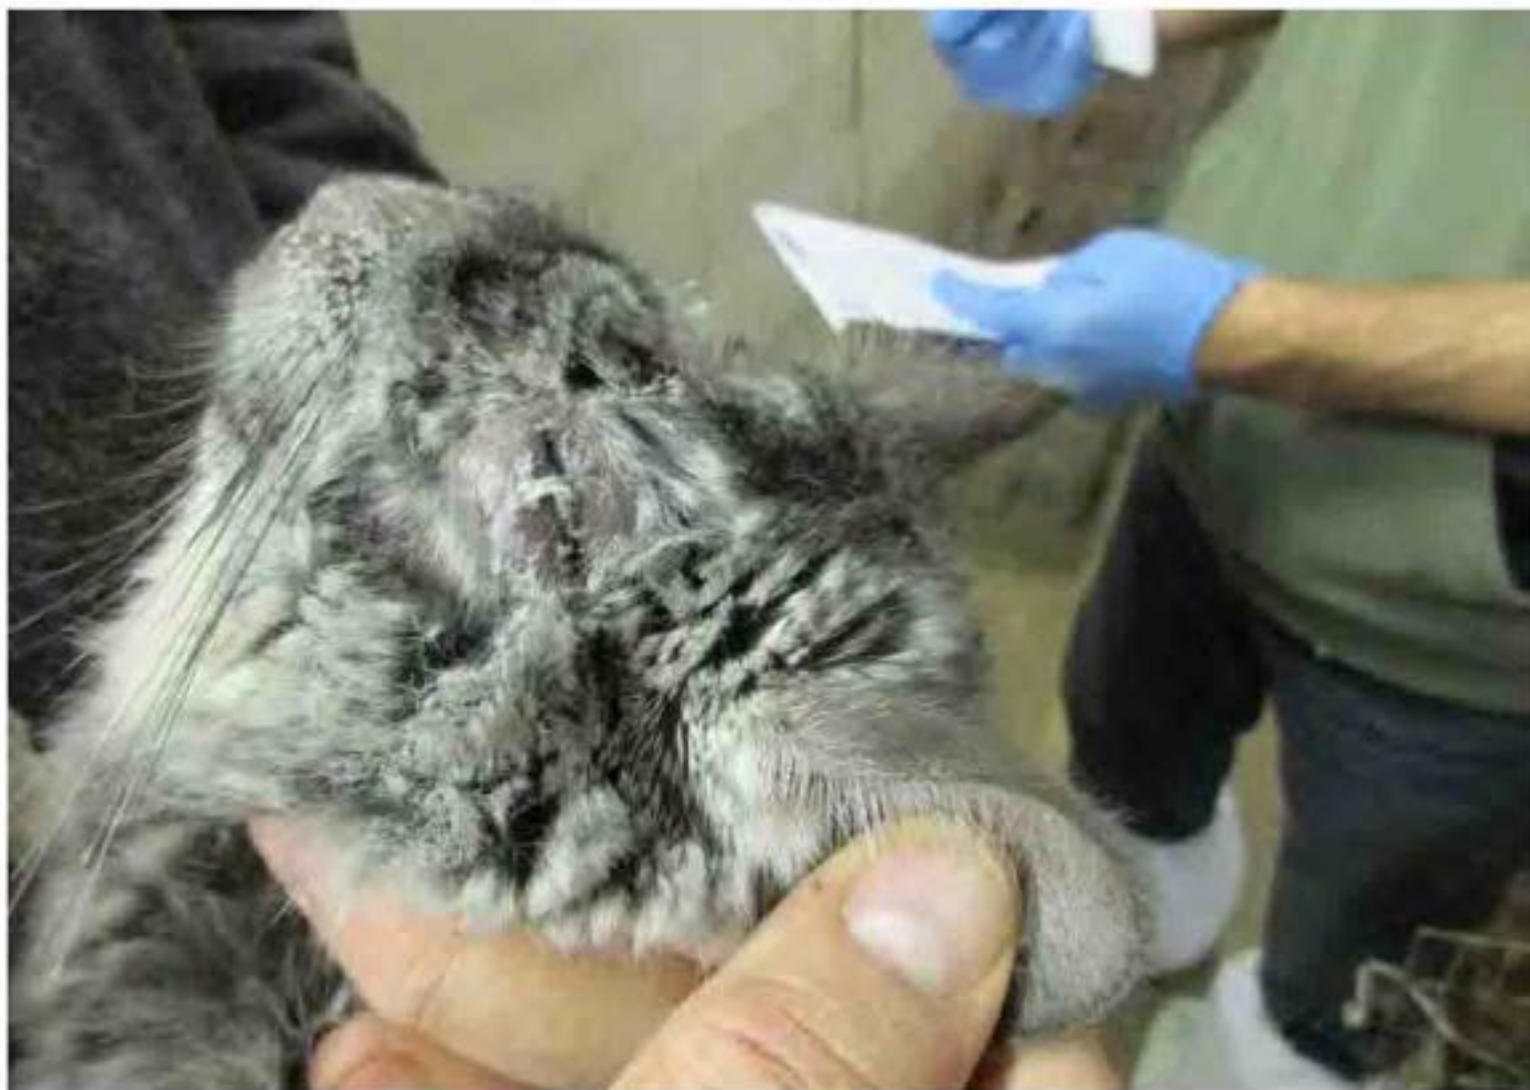
CFR: 2.40 (b) (2), 2.40 (b) (3)

Photographer:	Kevin Wilken	Legal Name:	41-B-0239
Photo Taken:	Wed, Feb 3, '16	DAN MOULTON	
Inspection:	40161623280694		
Description:	Female with eartag "505" its left eyelids sealed shut with crusty material with hair loss, reddened skin, and a pale creamy discharge from eye.
