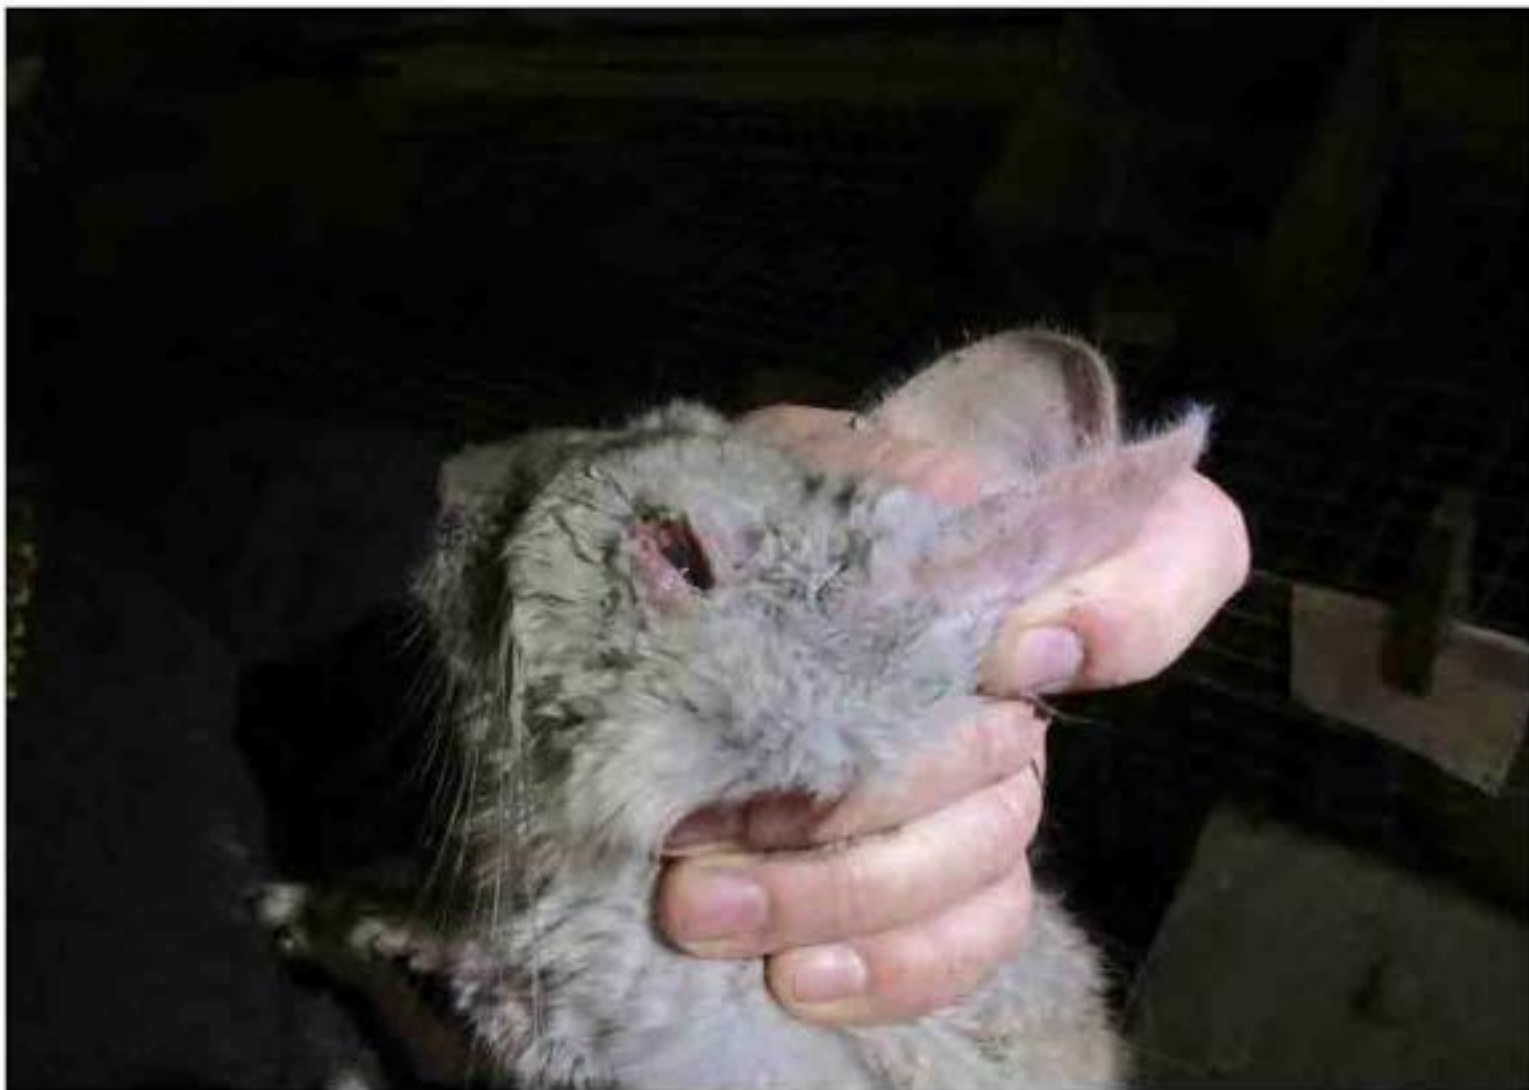
CFR: 2.40 (b) (2), 2.40 (b) (3)

Photographer:	Kevin Wilken	Legal Name:	41-B-0239
Photo Taken:	Wed, Feb 3, '16	DAN MOULTON	
Inspection:	40161623280694		
Description:	Male with eartag "CRO 968"; its left eyelids were crusted shut, they are swollen with hair loss and reddened skin. Note pale creamy discharge.

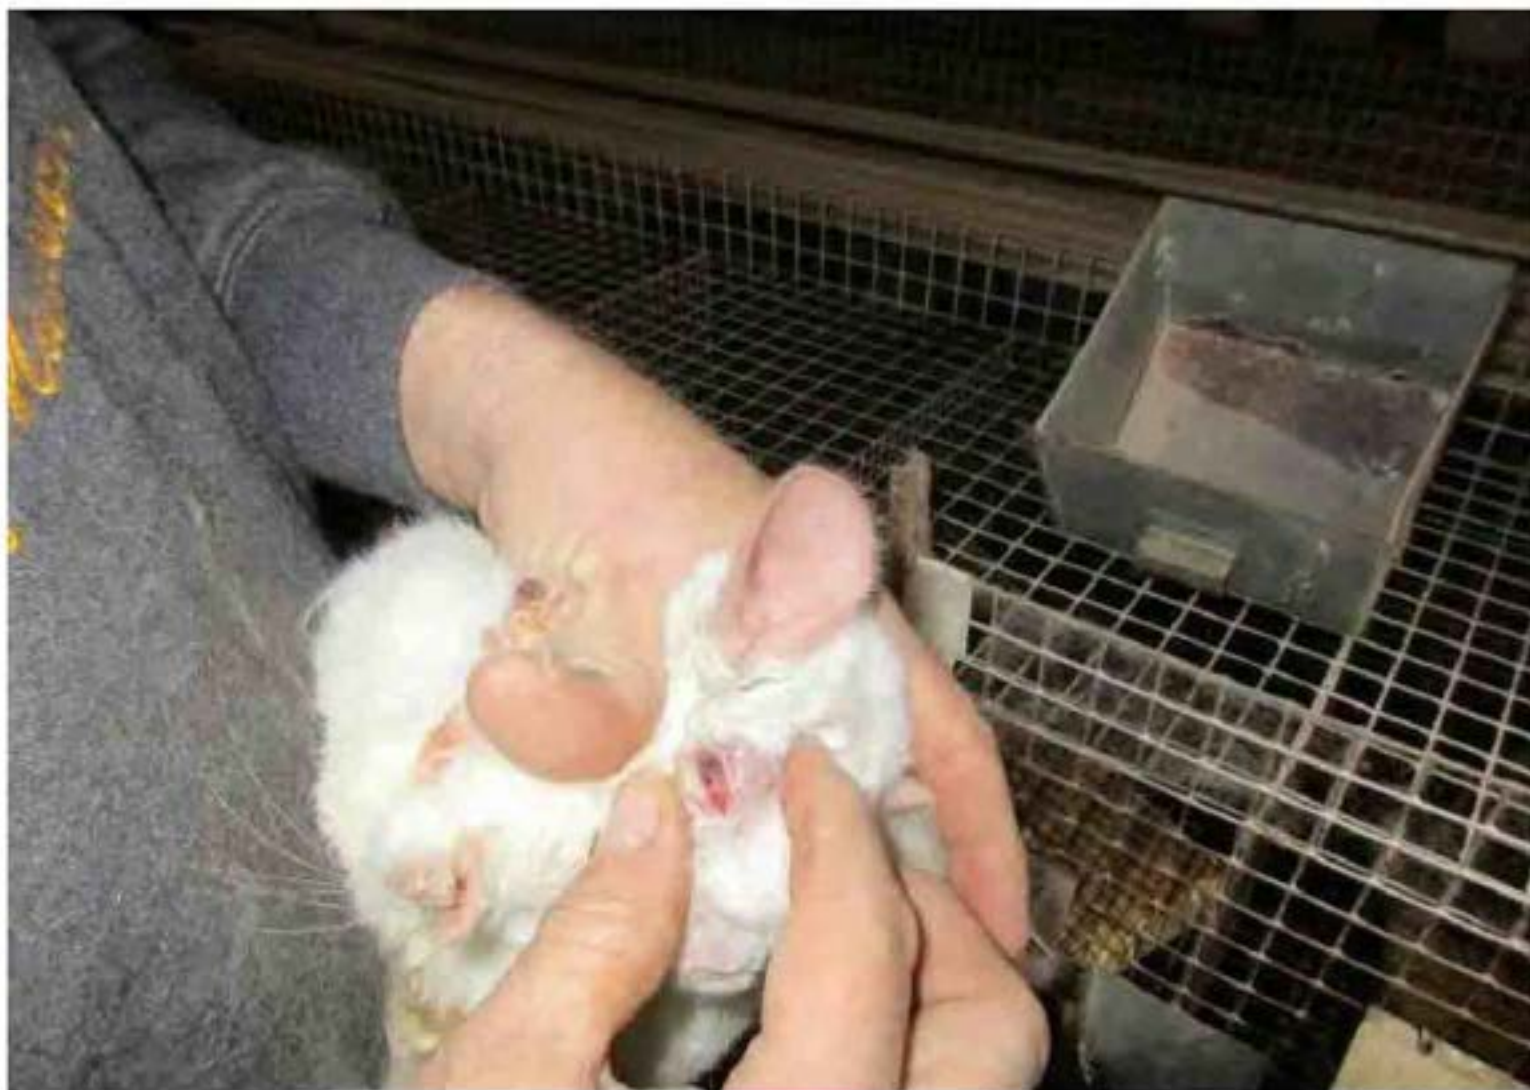
CFR: 2.40 (b) (3), 2.40 (b) (2)

Photographer:	Kevin Wilken	Legal Name:	41-B-0239
Photo Taken:	Wed, Feb 3, '16	DAN MOULTON	
Inspection:	40161623280694		
Description:	Male (no id; cage card "4-8"); its right eye was crusted shut; eyelids swollen with hair loss and surrounding tissues under eyelids bright red.

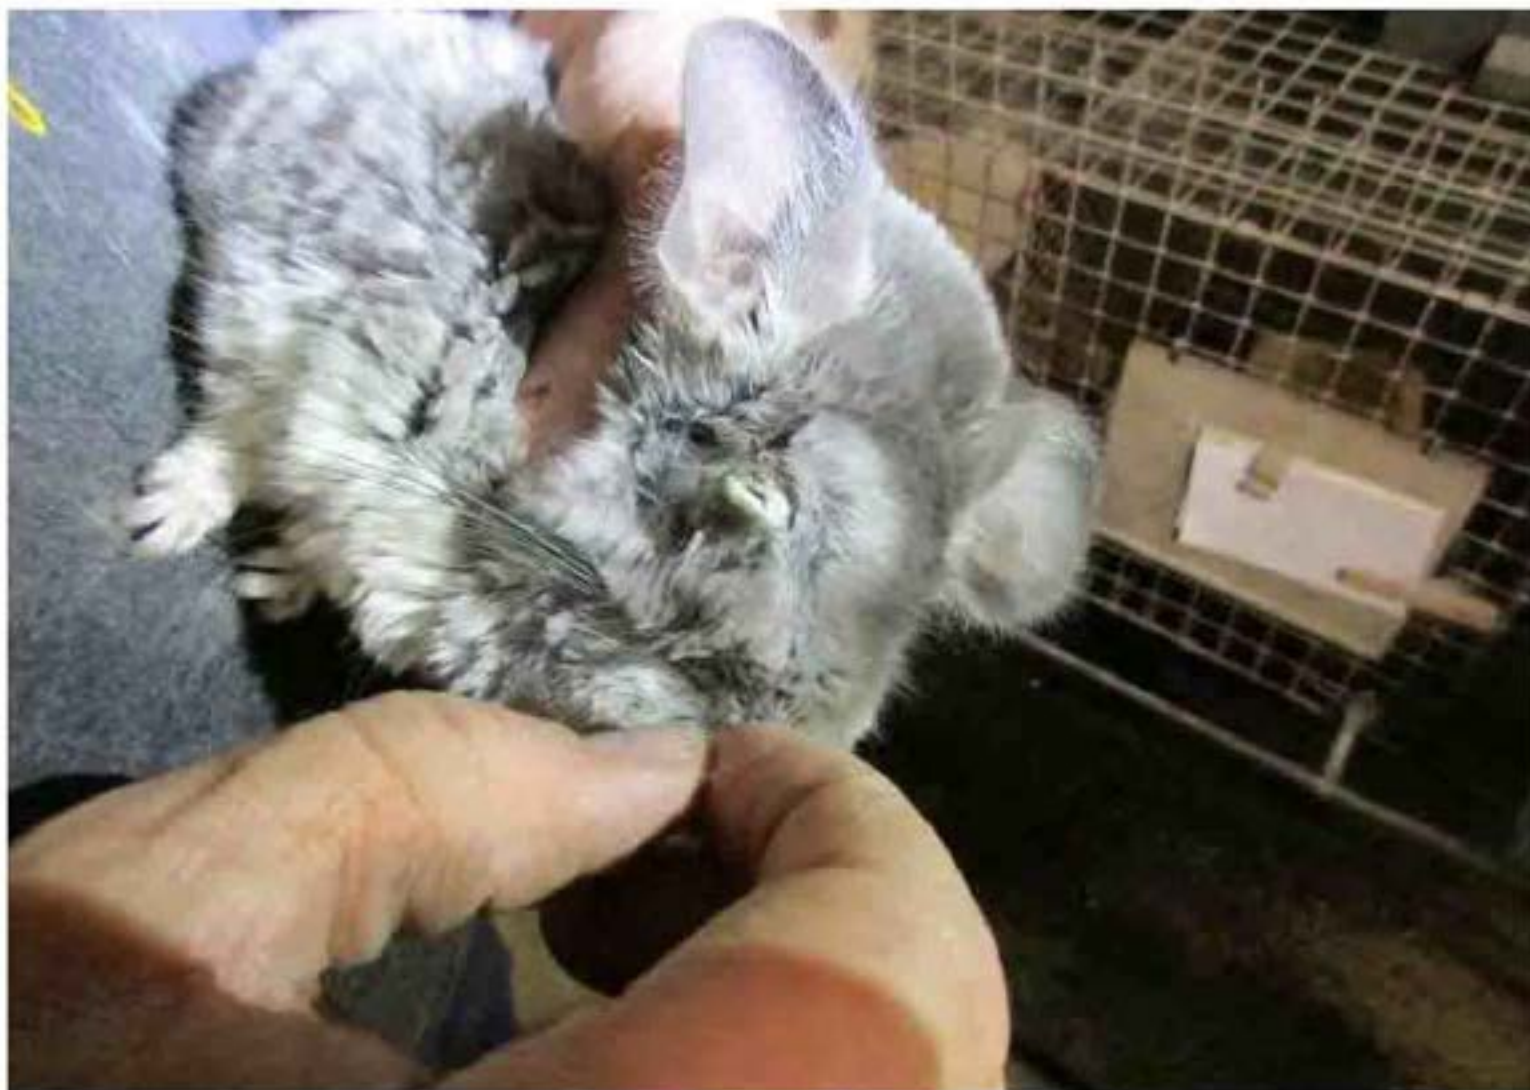
CFR: 2.40 (b) (2), 2.40 (b) (3)

Photographer:	Kevin Wilken	Legal Name:	41-B-0239
Photo Taken:	Wed, Feb 3, '16	DAN MOULTON	
Inspection:	40161623280694		
Description:	Male (no id; cage card "9-13-11"); right eye was sealed shut with crusted material and had some pale creamy discharge.

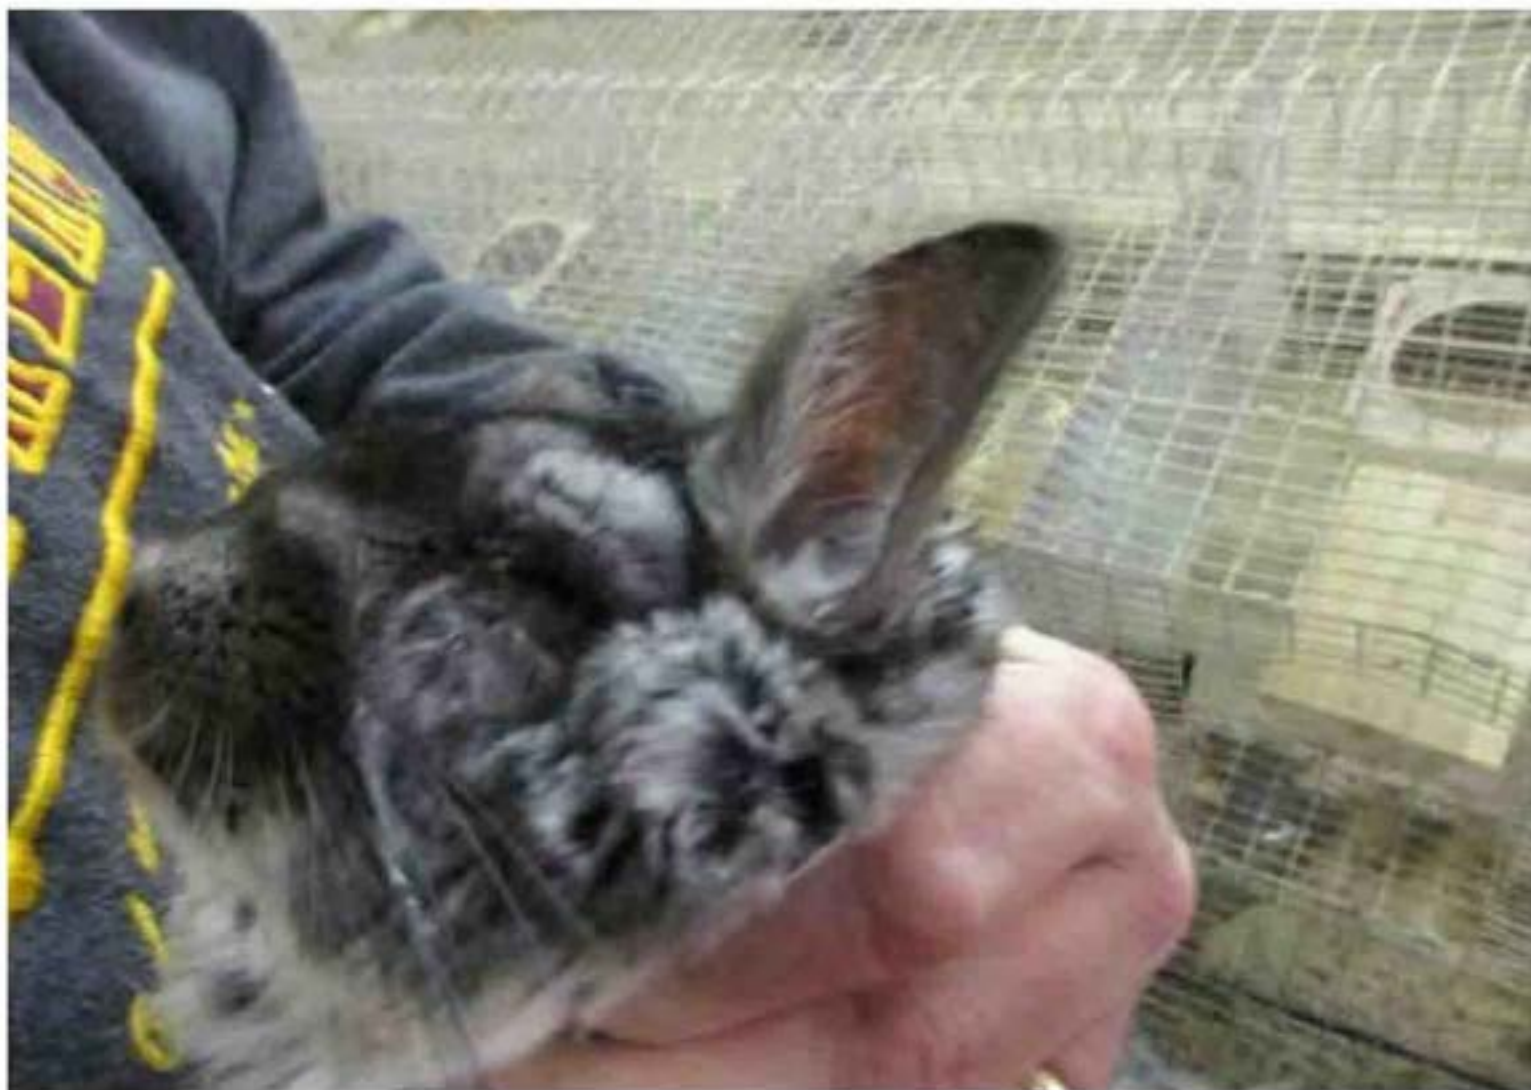
CFR: 2.40 (b) (2)

Photographer:	Kevin Wilken	Legal Name:	41-B-0239
Photo Taken:	Wed, Feb 3, '16	DAN MOULTON	
Inspection:	40161623280694		
Description:	BDX-531's left eye with some crusting and partly sealed shut.

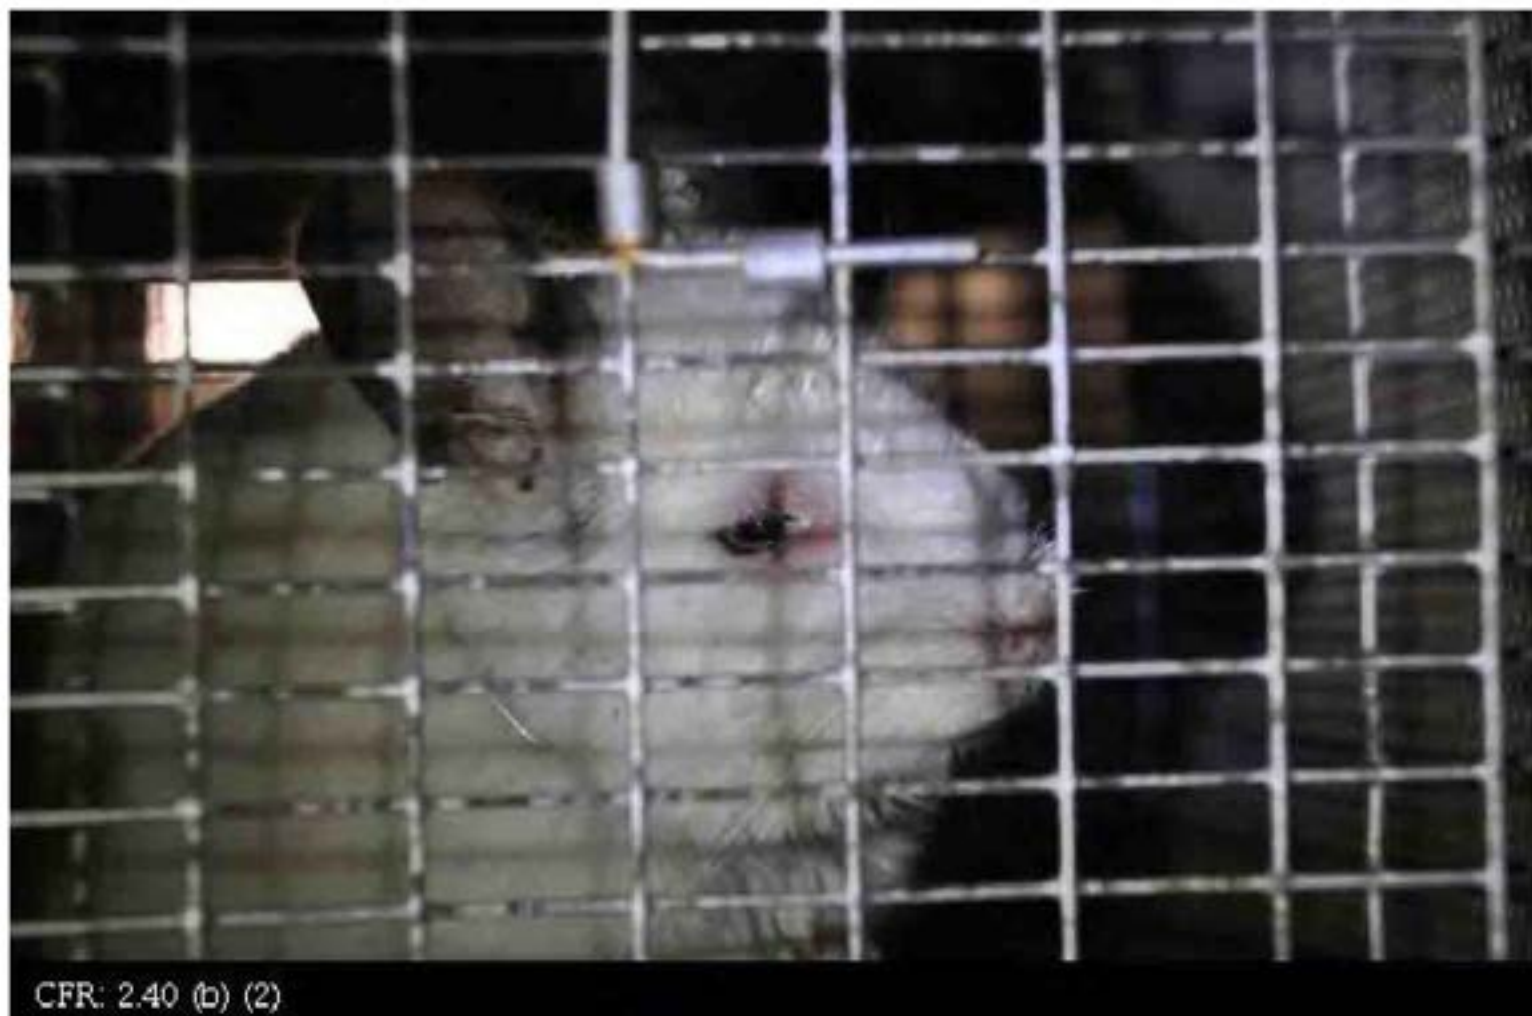
CFR: 2.40 (b) (2)

Photographer:	Scott Welch	Legal Name:	41-B-0239
Photo Taken:	Wed, Feb 3, '16	DAN MOULTON	
Inspection:	40161623280694		
Description:	White colored with cage card 2113; had a small amount of pale creamy discharge in right eye.

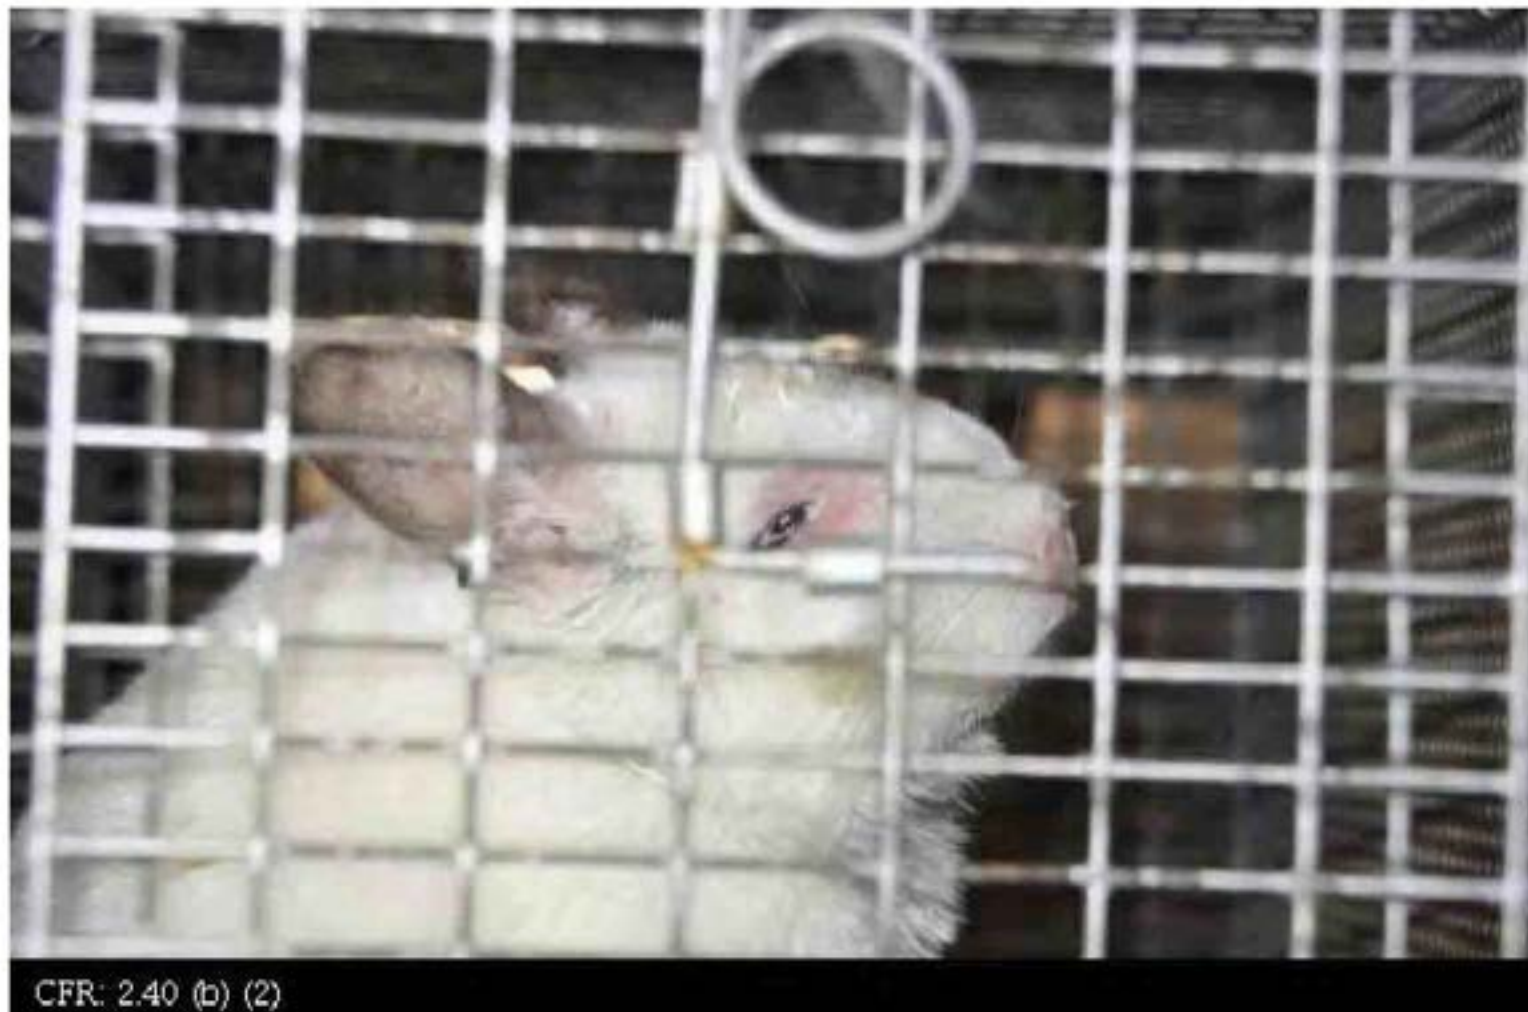
Description: White colored with cage card 2113; had a small amount of pale creamy discharge in right eye.

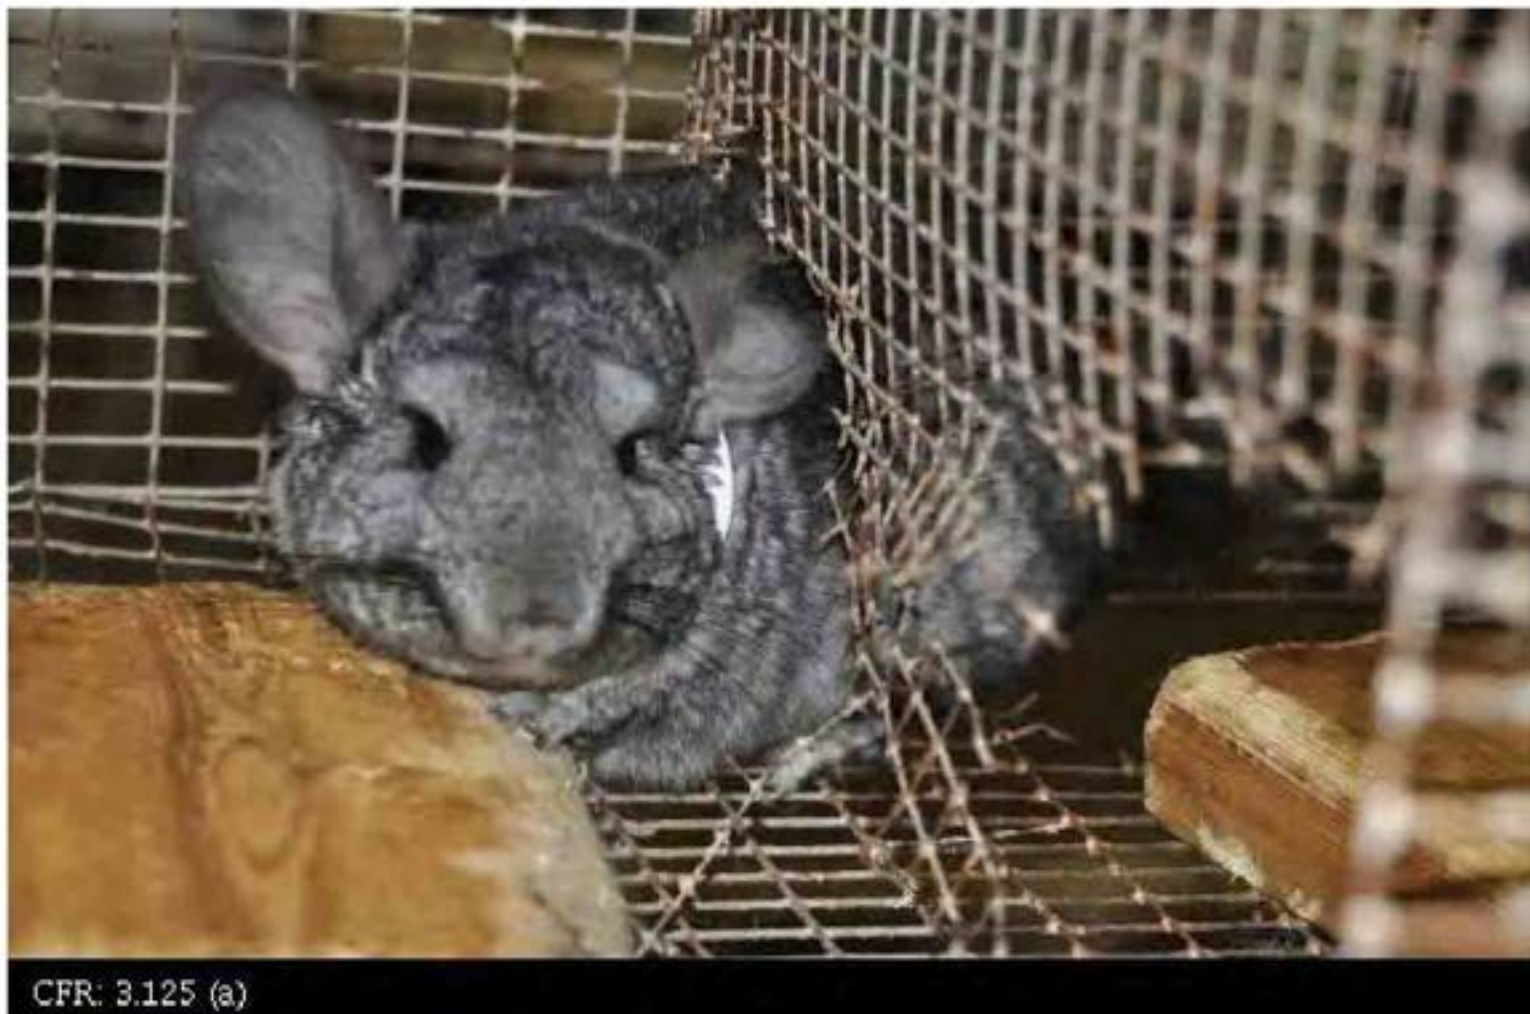
CFR: 3.125 (a)

Photographer:	Scott Welch	Legal Name:	41-B-0239
Photo Taken:	Wed, Feb 3, '16	DAN MOULTON	
Inspection:	40161623280694		
Description:	Wire points and holes in enclosure; note behind the chinchilla behind the wood block on the right there is a large hole with points in the enclosure floor.

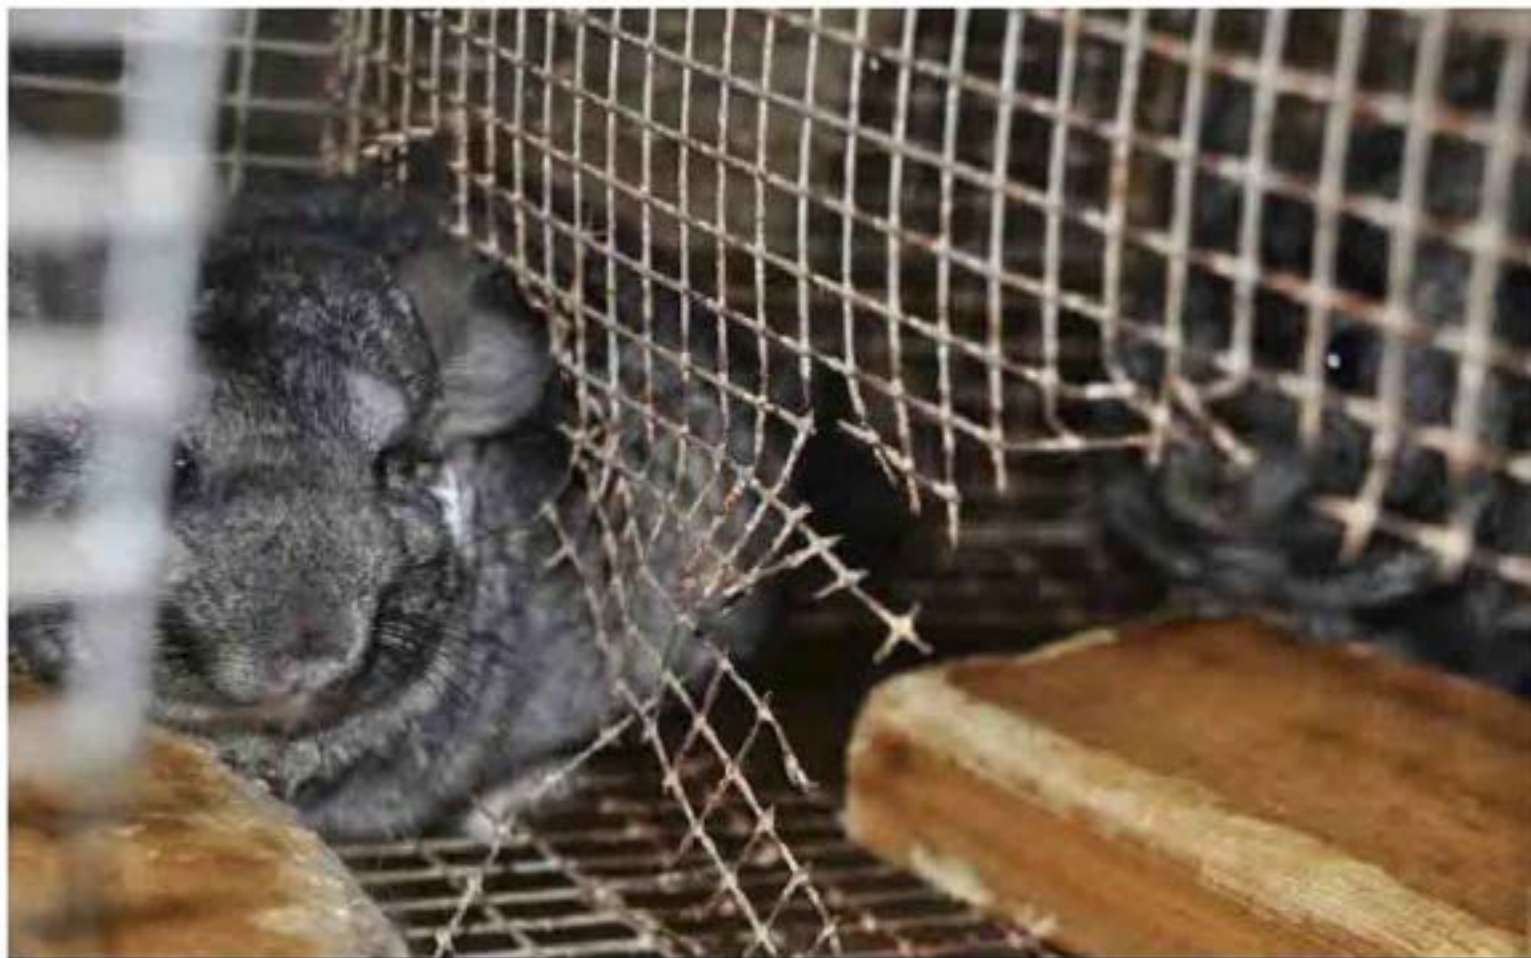
CFR: 3.125 (a)

Description: Close up of wire points in enclosure.

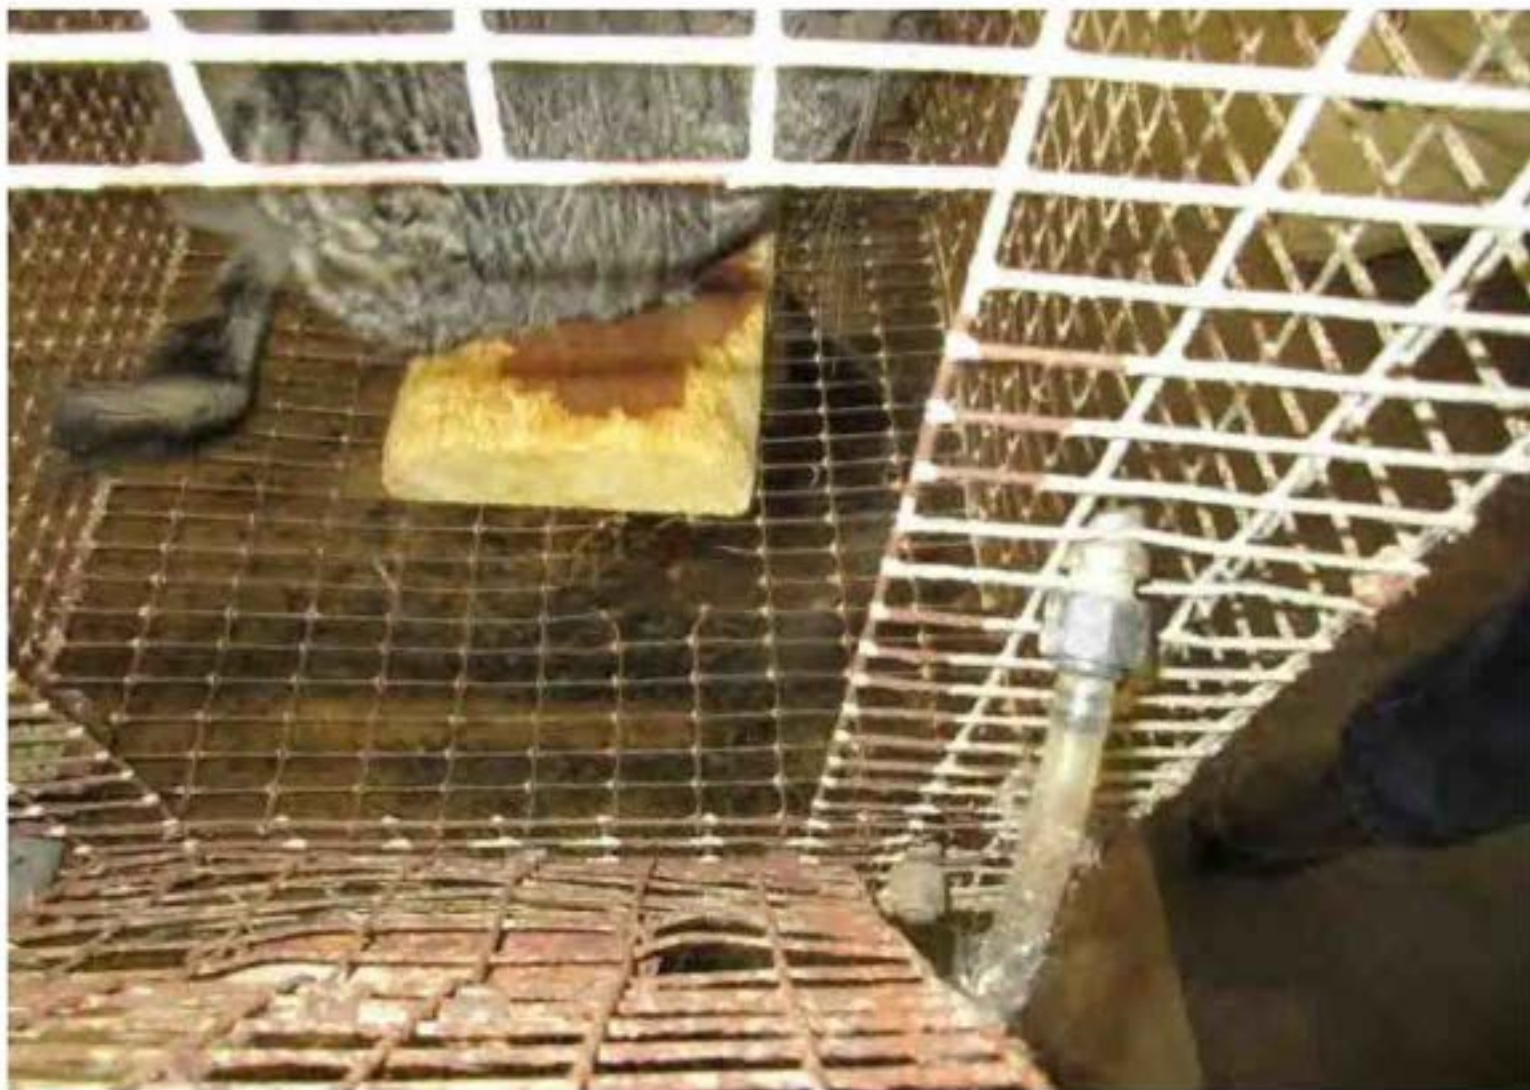
CFR: 3.125 (a)

Photographer:	Kevin Wilken	Legal Name:	41-B-0239
Photo Taken:	Wed, Feb 3, '16	DAN MOULTON	
Inspection:	40161623280694		
Description:	Another enclosure with hole and wire points in flooring that was housing chinchilla with cage card BD-Z-46.

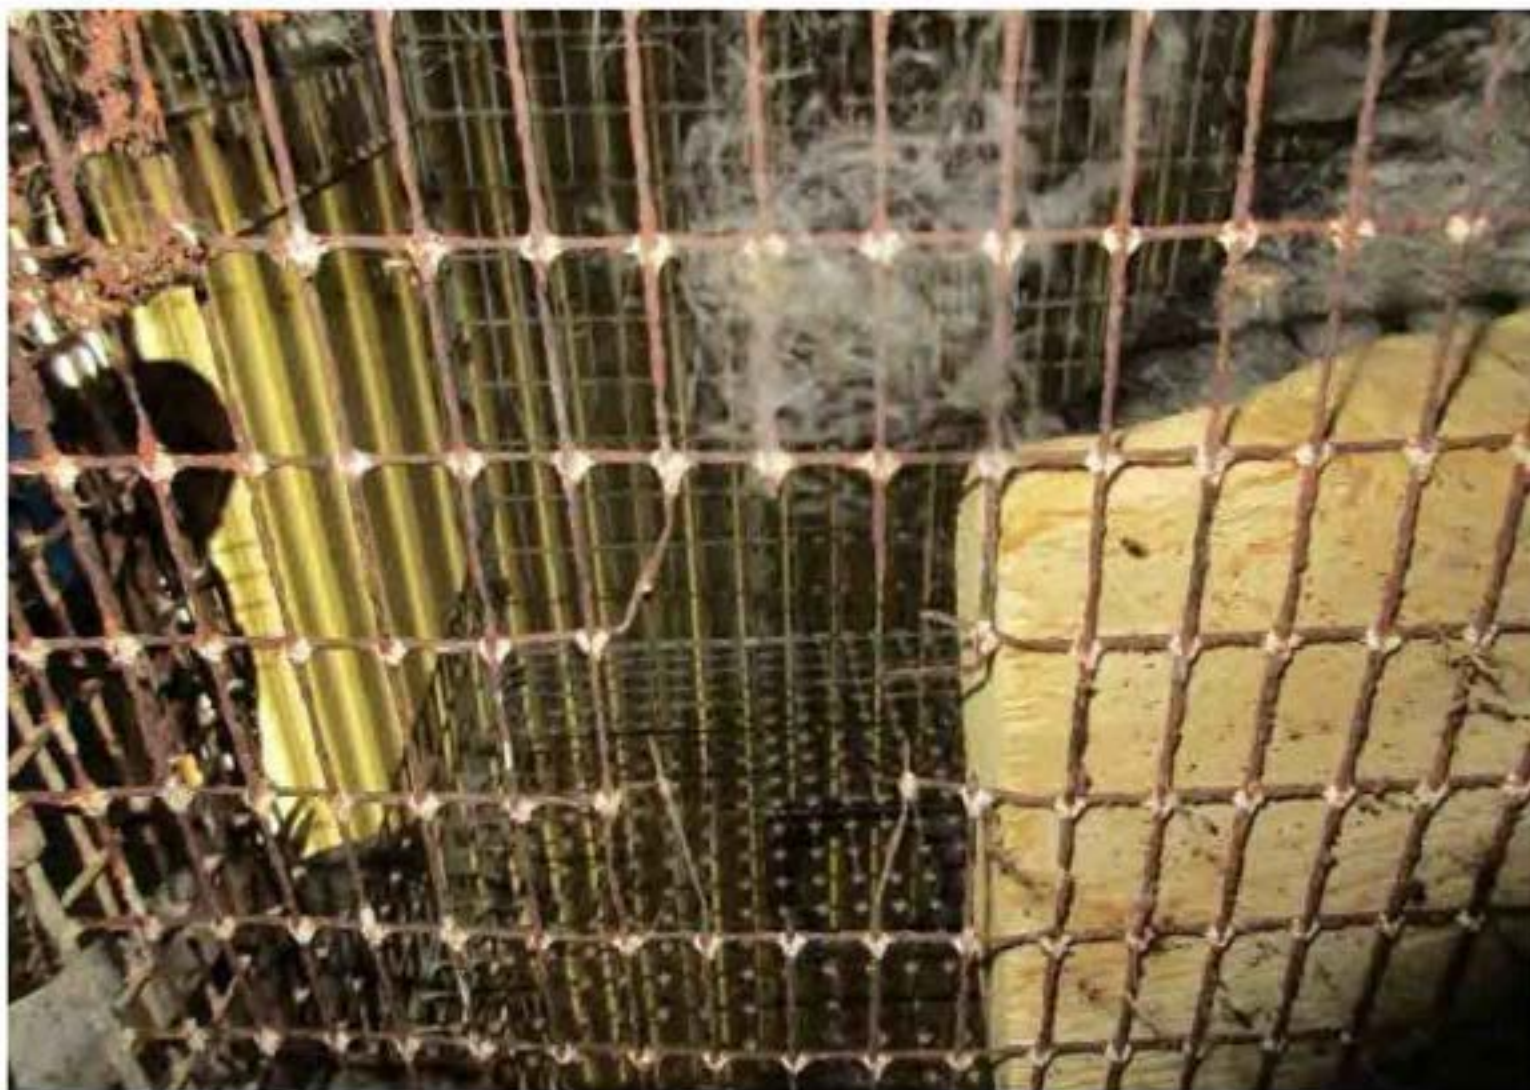
CFR: 3.125 (a)

Photographer:	Kevin Wilken	Legal Name:	41-B-0239
Photo Taken:	Wed, Feb 3, '16	DAN MOULTON	
Inspection:	40161623280694		
Description:	View of hole in flooring with wire points from underneath enclosure that was housing chinchilla with cage card "BD-Z-46".

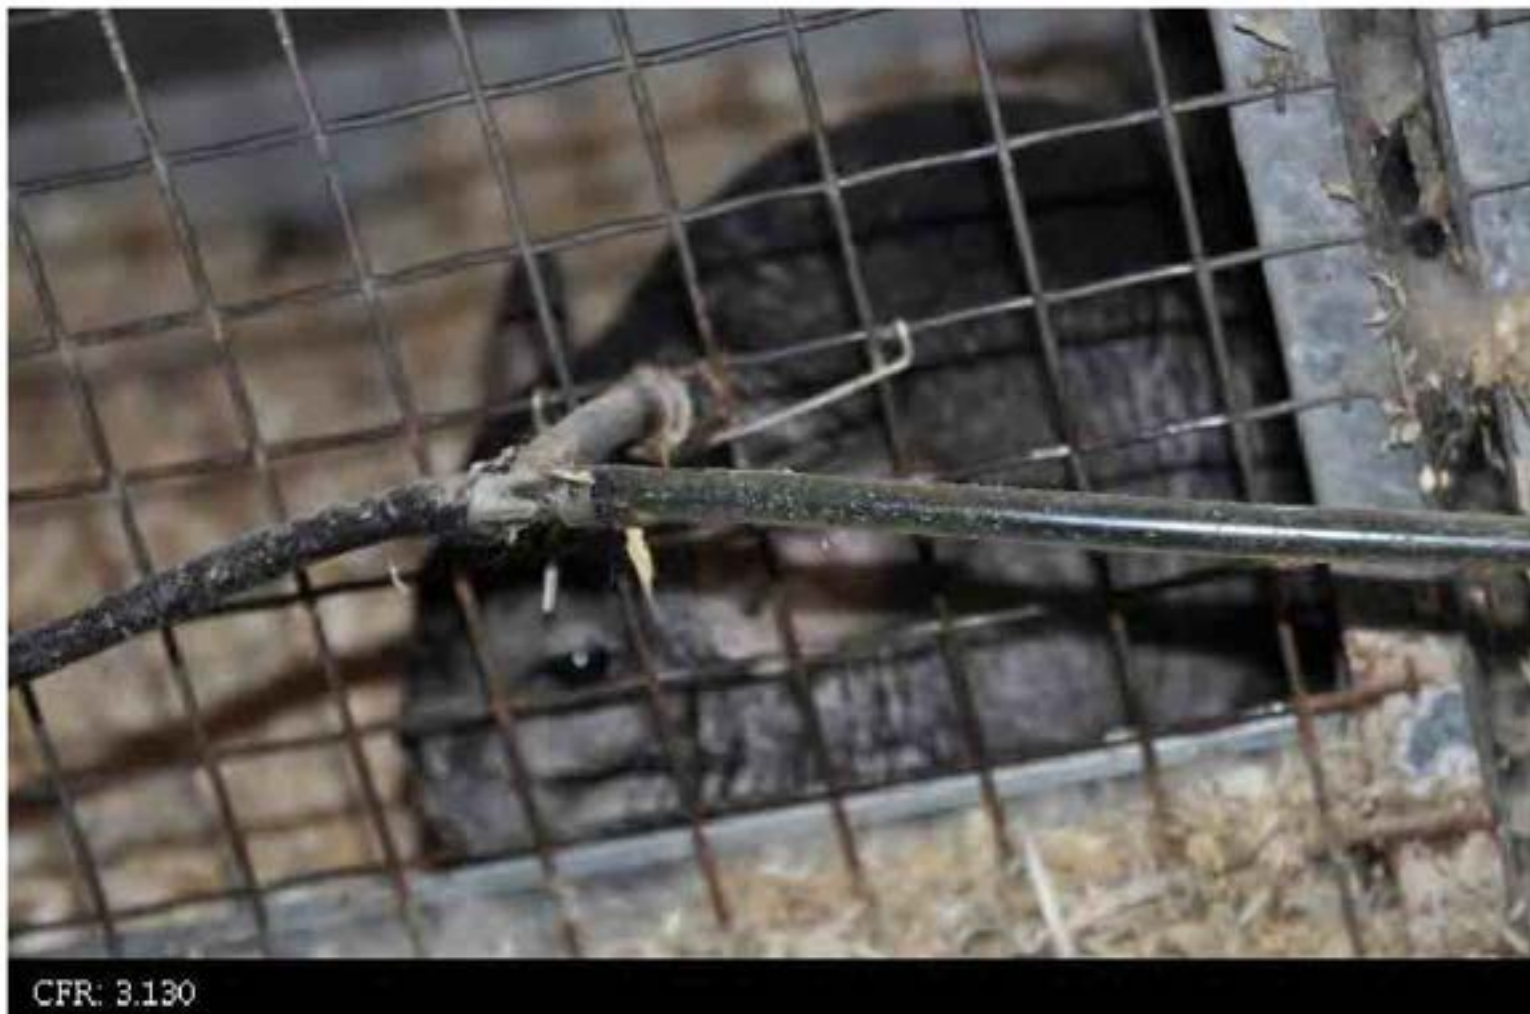
Photographer:	Scott Welch	Legal Name:	41-B-0239
Photo Taken:	Wed, Feb 3, '16	DAN MOULTON	
Inspection:	40161623280694		
Description:	Watering line on right of drinking nozzle is clear and has a greenish appearance on the inside. Line on left of nozzle is a different black material.

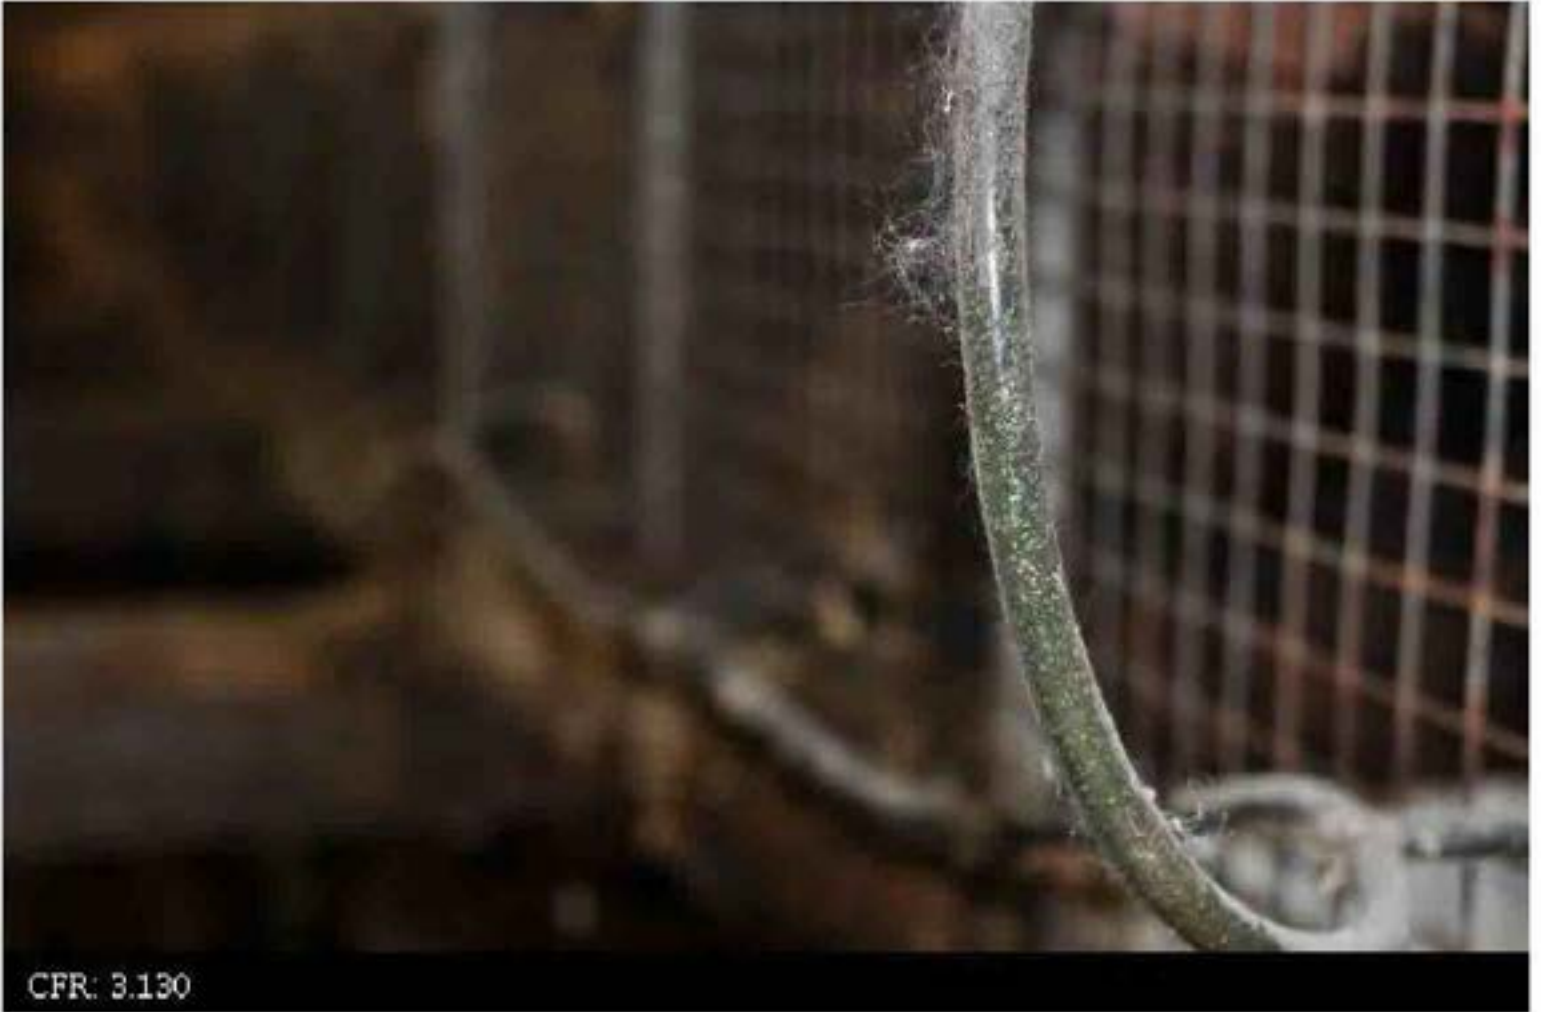
Photographer:	Scott Welch	Legal Name:	41-B-0239
Photo Taken:	Wed, Feb 3, '16	DAN MOULTON	
Inspection:	40161623280694		
Description:	Clear water line with greenish appearance.

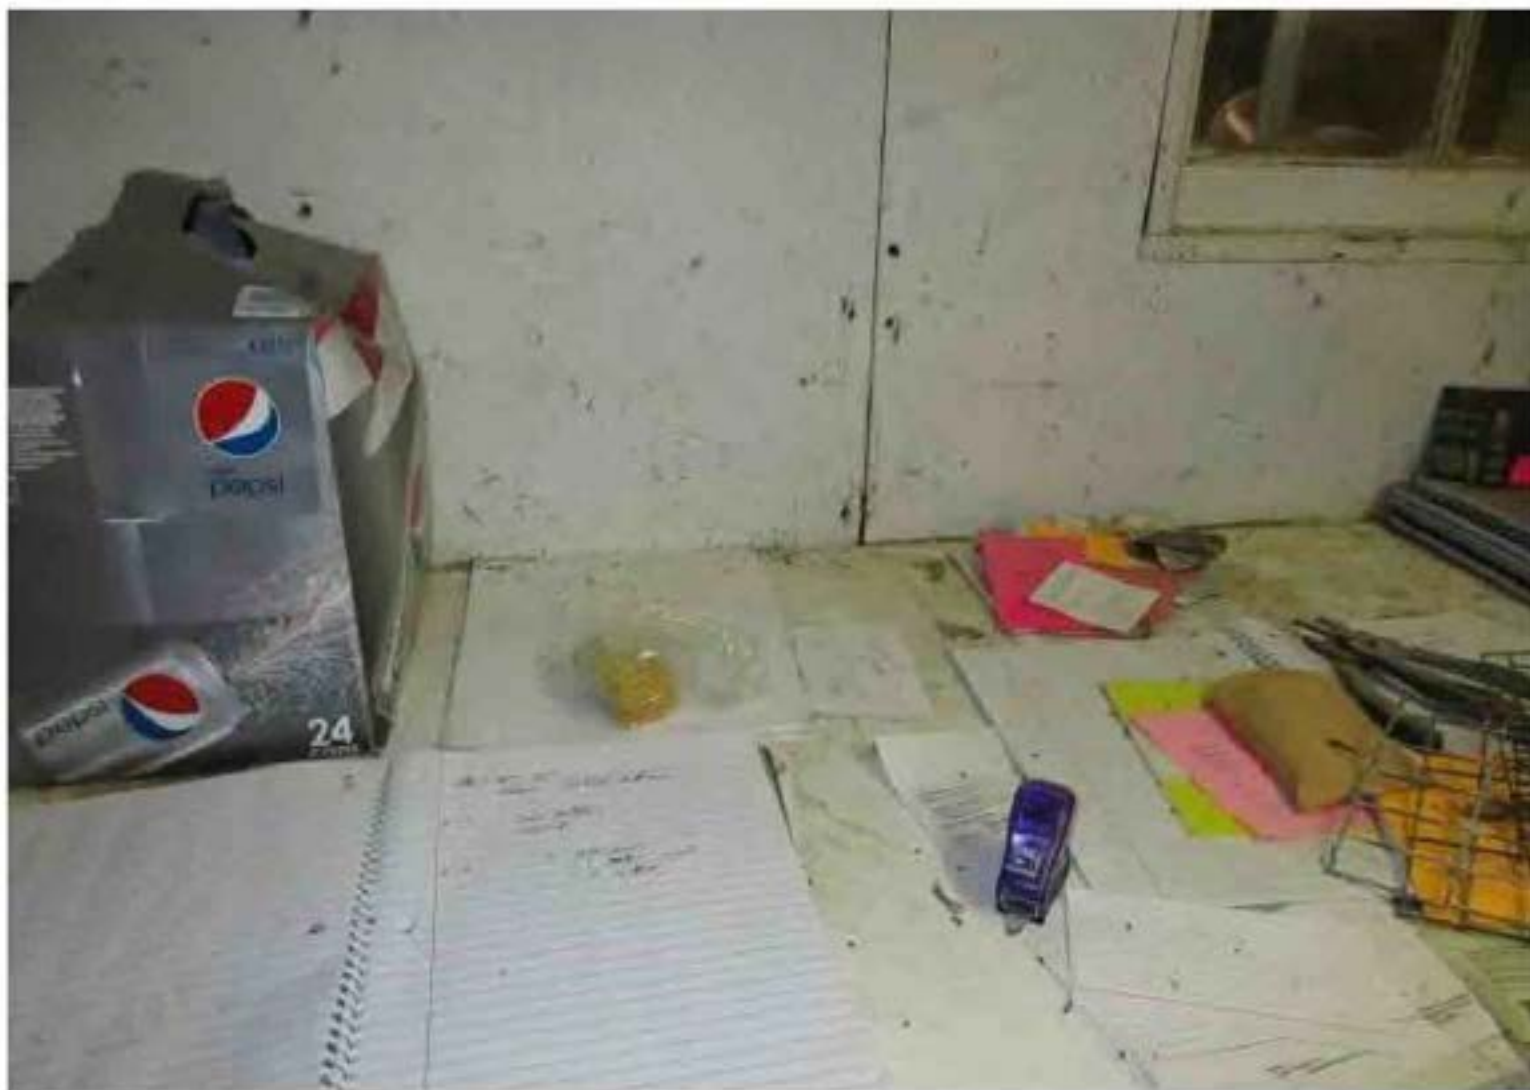
CFR: 3.125 (d)

Photographer:	Kevin Wilken	Legal Name:	41-B-0239
Photo Taken:	Wed, Feb 3, '16	DAN MOULTON	
Inspection:	40161623280694		
Description:	Bench with dead bugs covering the top.
