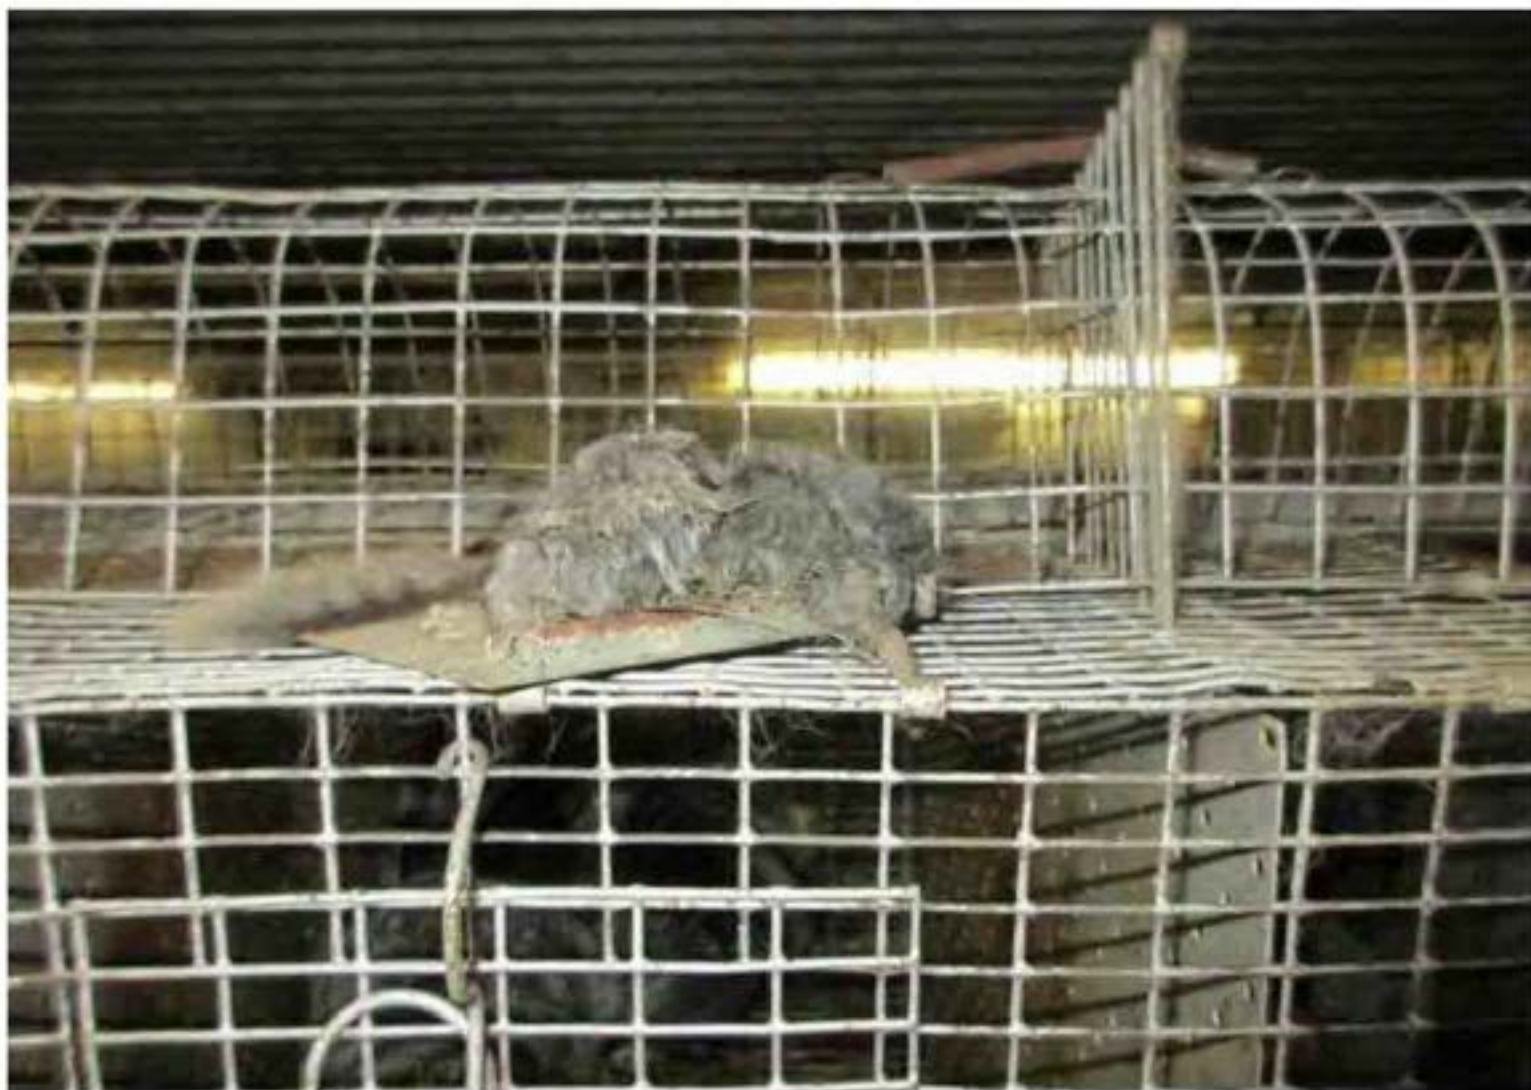
CFR: 3.125 (d)

Photographer:	Kevin Wilken	Legal Name:	41-B-0239
Photo Taken:	Wed, Feb 3, '16	DAN MOULTON	
Inspection:	40161623280694		
Description:	Chinchilla carcass on top of enclosure housing 2 chincillas.

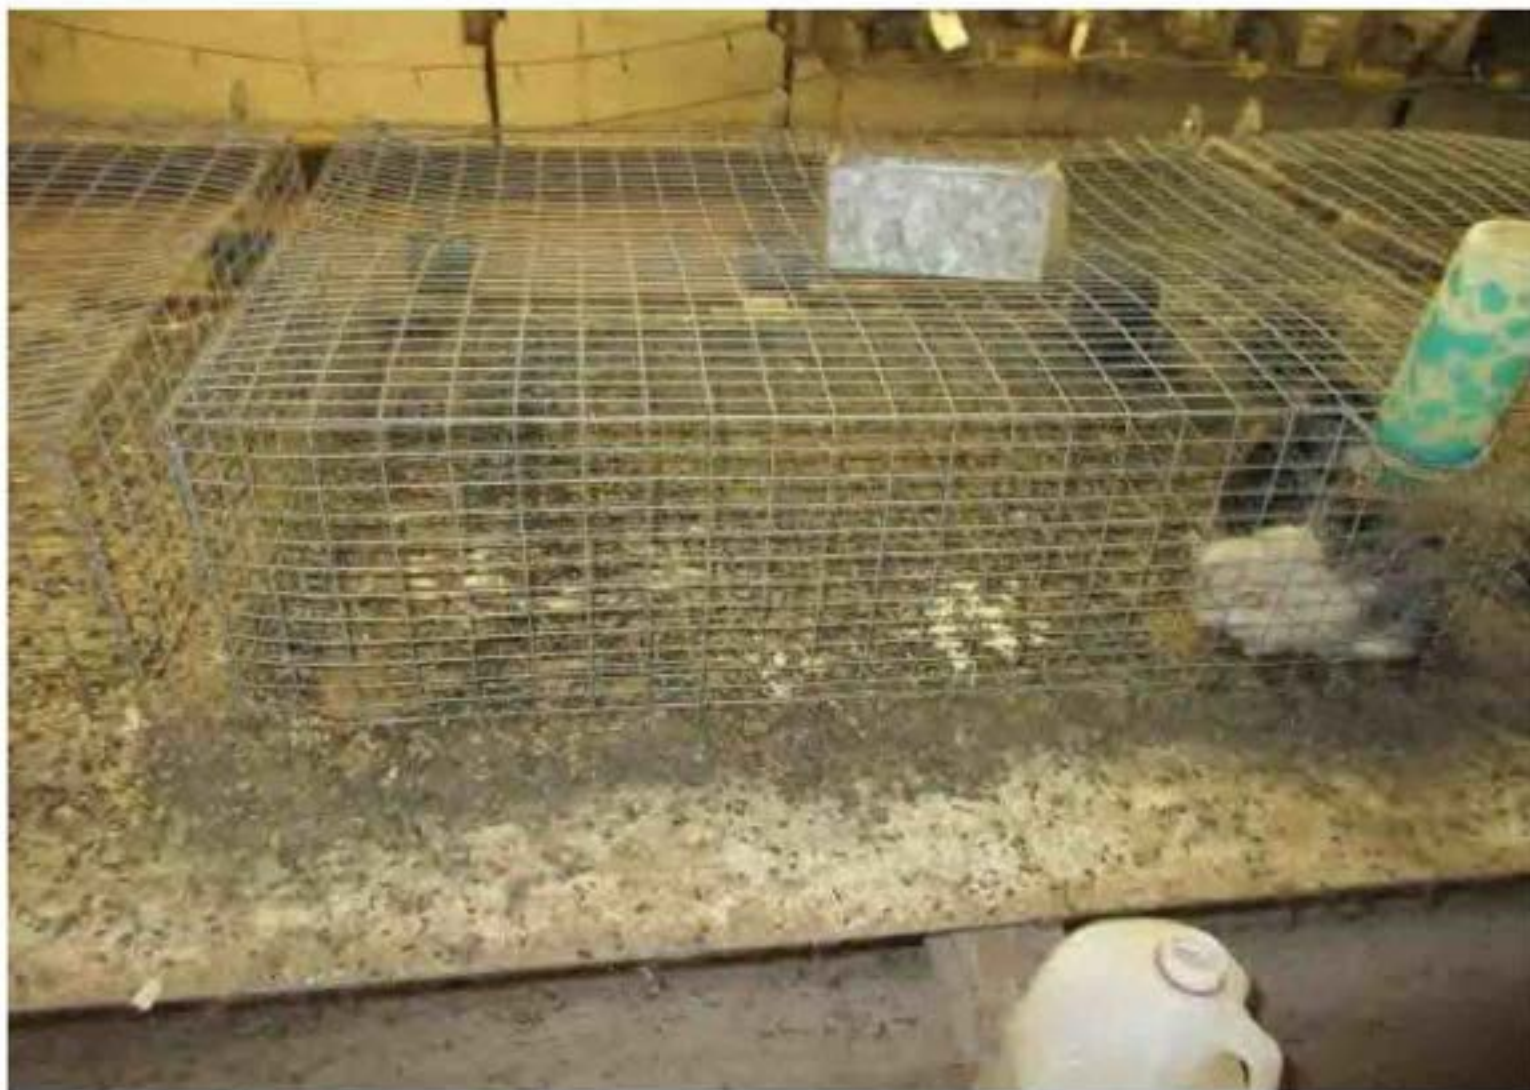
CFR: 3.131 (a)

Photographer:	Kevin Wilken	Legal Name:	41-B-0239
Photo Taken:	Wed, Feb 3, '16	DAN MOULTON	
Inspection:	40161623280694		
Description:	Enclosure in back part of first room with excessive feces. Licensee stated it hadn't been cleaned in four weeks. Representative of enclosures housing about 38 animals in front room.

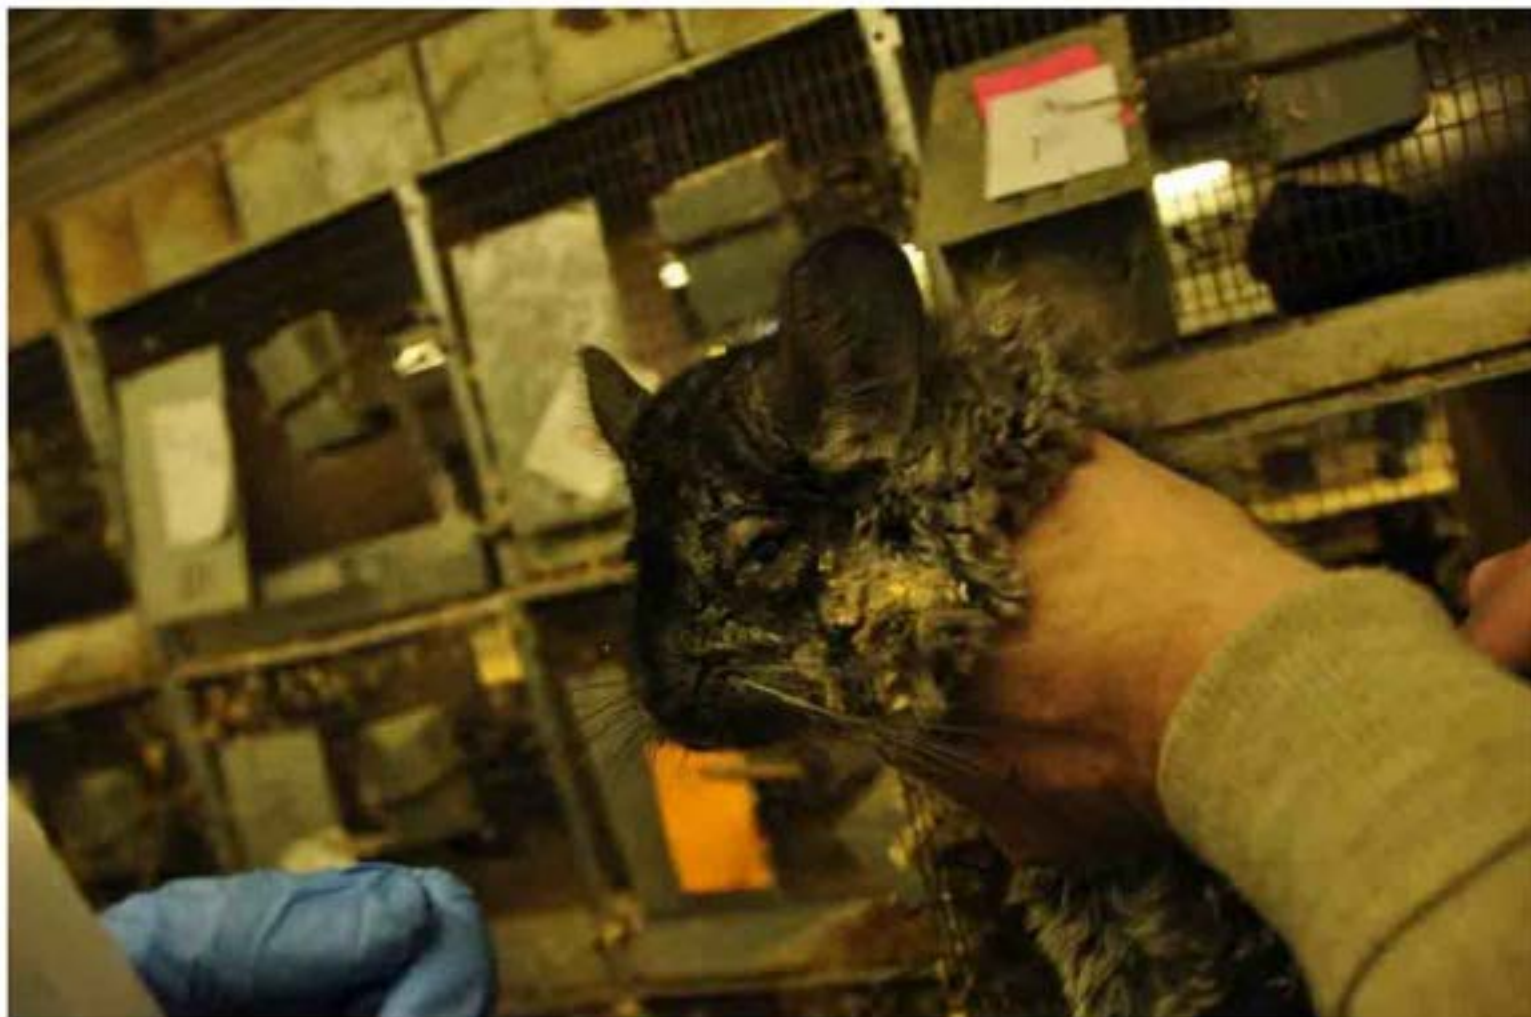
Photographer:	Scott Welch	Legal Name:	41-B-0239
Photo Taken:	Mon, Mar 14, '16	DAN MOULTON	
Inspection:	74161711400131		
Description:	Left eye black and silver female Chinchilla (eartag DJM 145). Per records, cage marker; and licensee, animal is receiving veterinary-prescribed treatment.

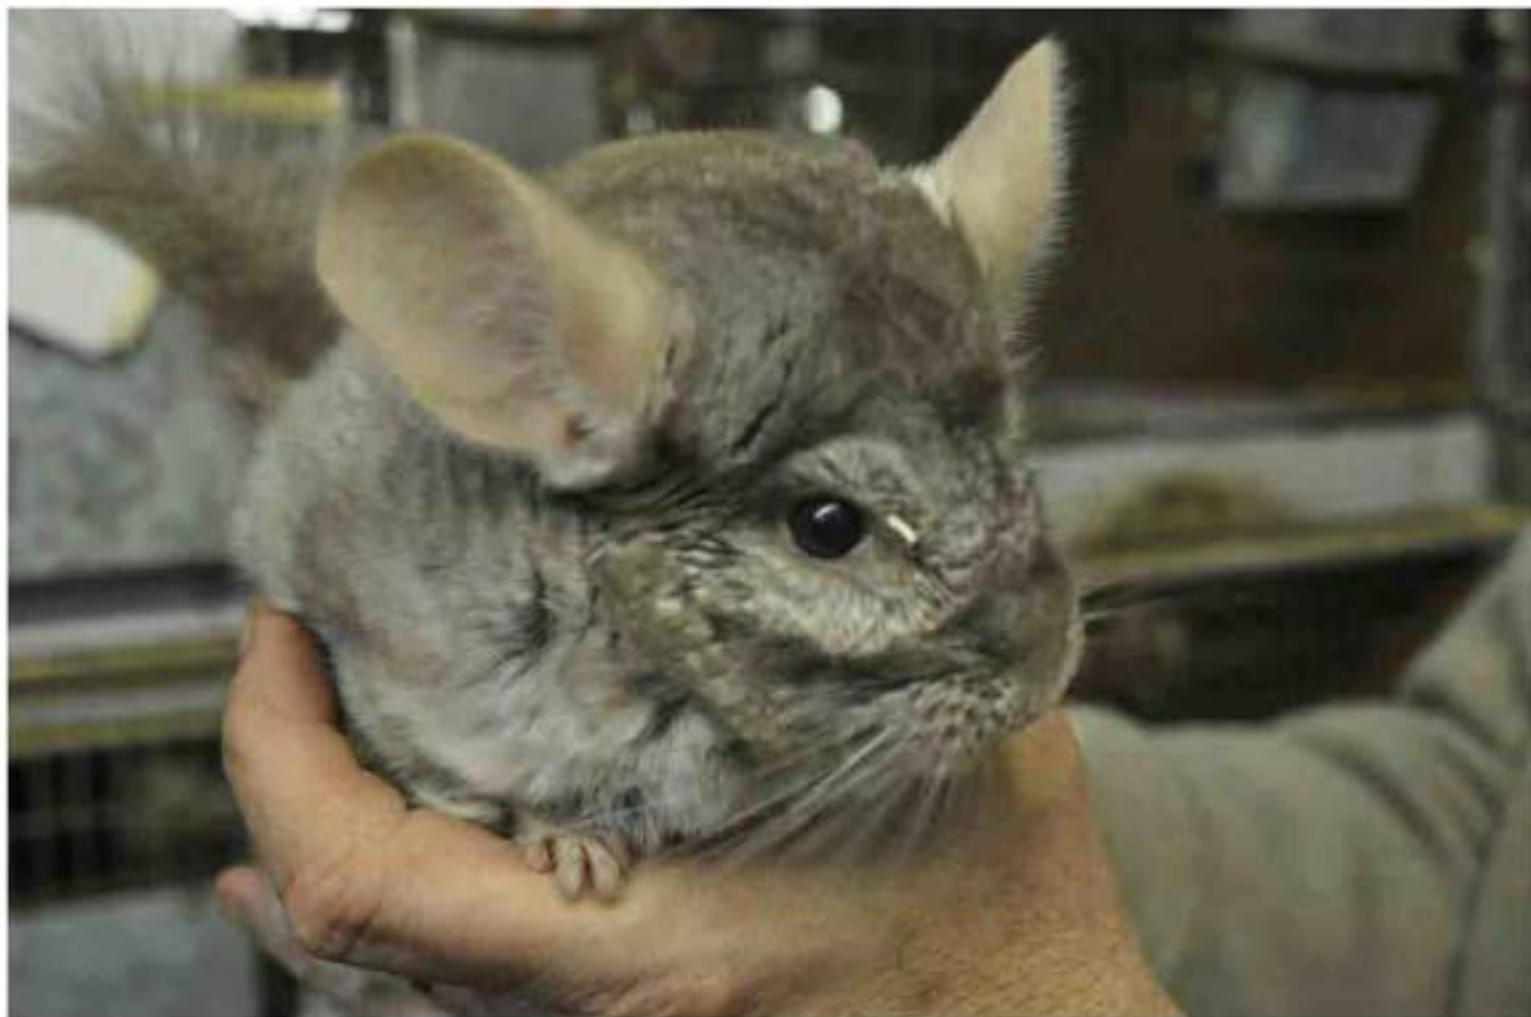
Photographer:	Scott Welch	Legal Name:	41-B-0239
Photo Taken:	Mon, Mar 14, '16	DAN MOULTON	
Inspection:	74161711400131		
Description:	Chinchilla (no id, pen 166); Per records, cage marker; and licensee, animal is receiving veterinary-prescribed treatment.

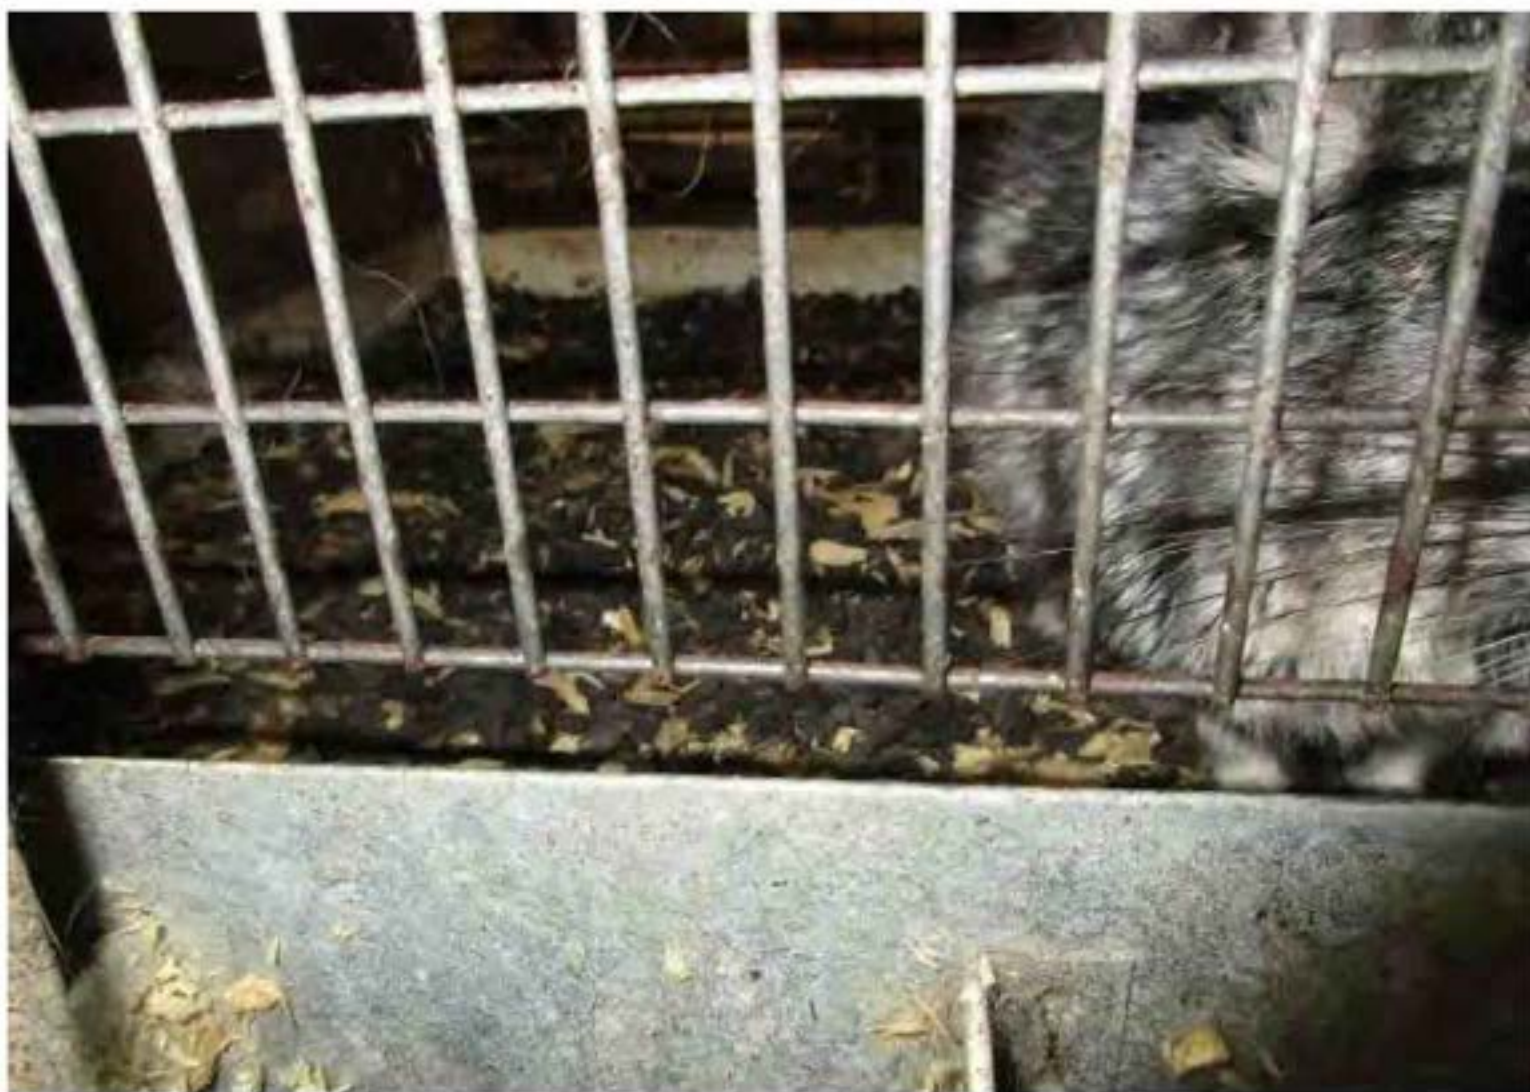
CFR: 3.131 (a)

Photographer:	Kevin Wilken	Legal Name:	41-B-0239
Photo Taken:	Wed, Jun 22, '16	DAN MOULTON	
Inspection:	181161057380243		
Description:	Enclosure in front room, south side; representative of enclosures with excessive feces and soiled material.

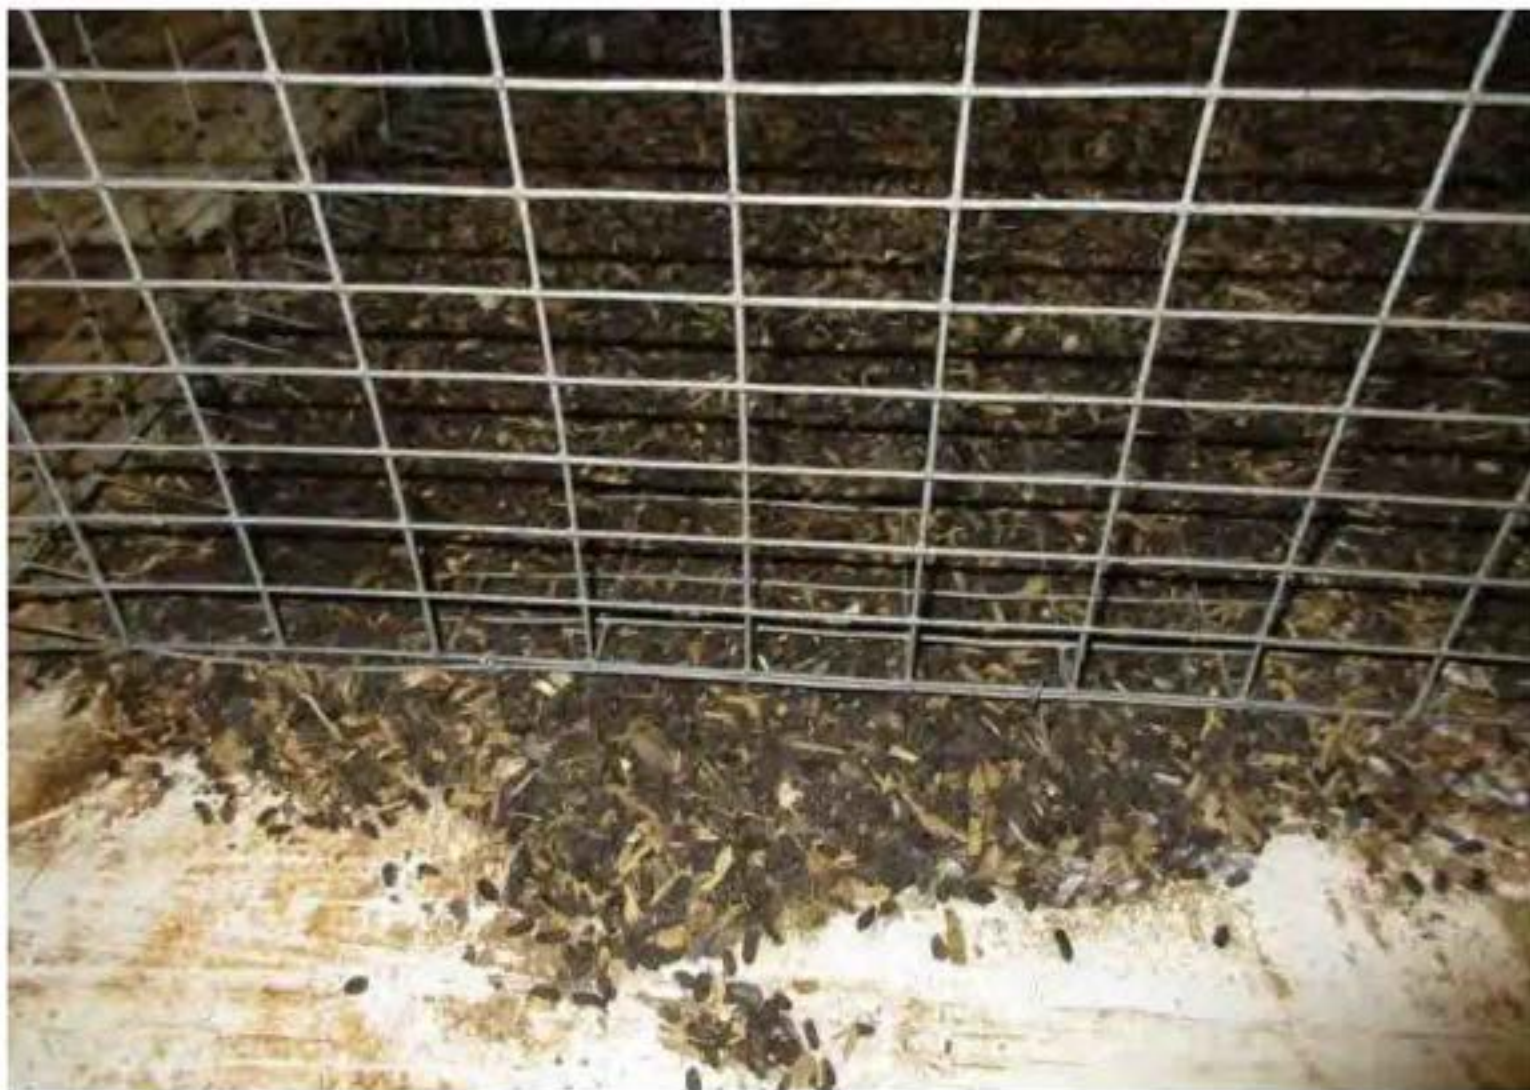
CFR: 3.131 (a)

Photographer:	Kevin Wilken	Legal Name:	41-B-0239
Photo Taken:	Wed, Jun 22, '16	DAN MOULTON	
Inspection:	181161057380243		
Description:	Front room middle pen, excessive feces.

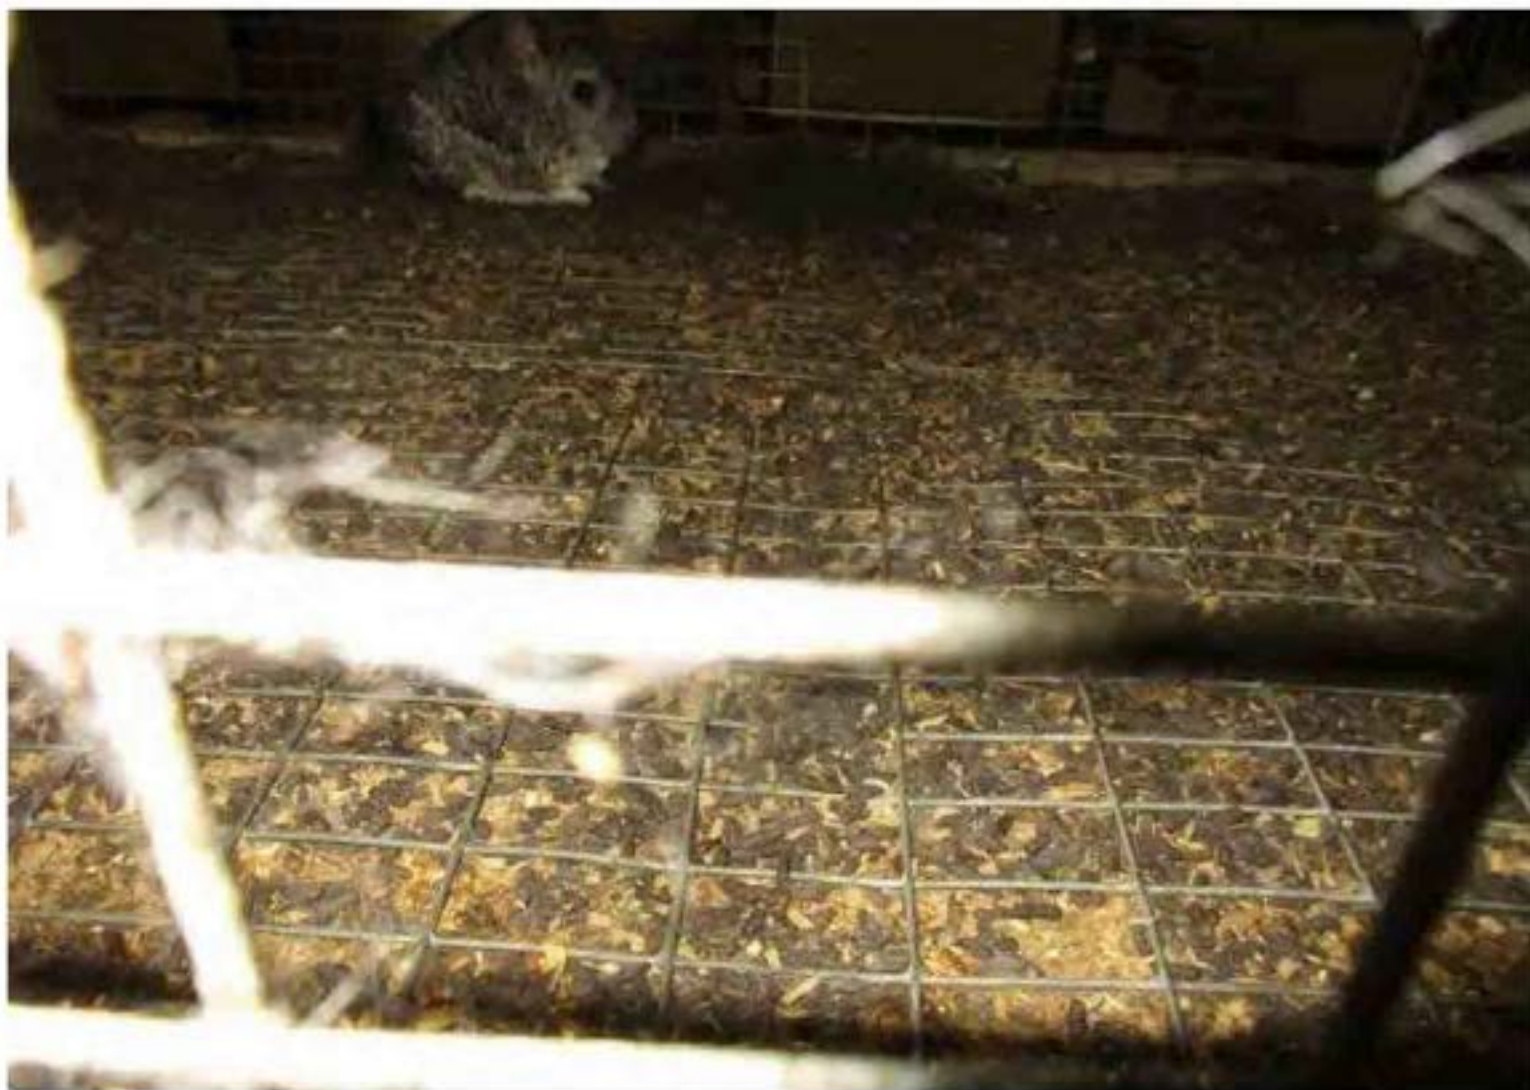
CFR: 3.131 (a)

Photographer:	Kevin Wilken	Legal Name:	41-B-0239
Photo Taken:	Wed, Jun 22, '16	DAN MOULTON	
Inspection:	181161057380243		
Description:	Front room middle row pen, excessive feces.

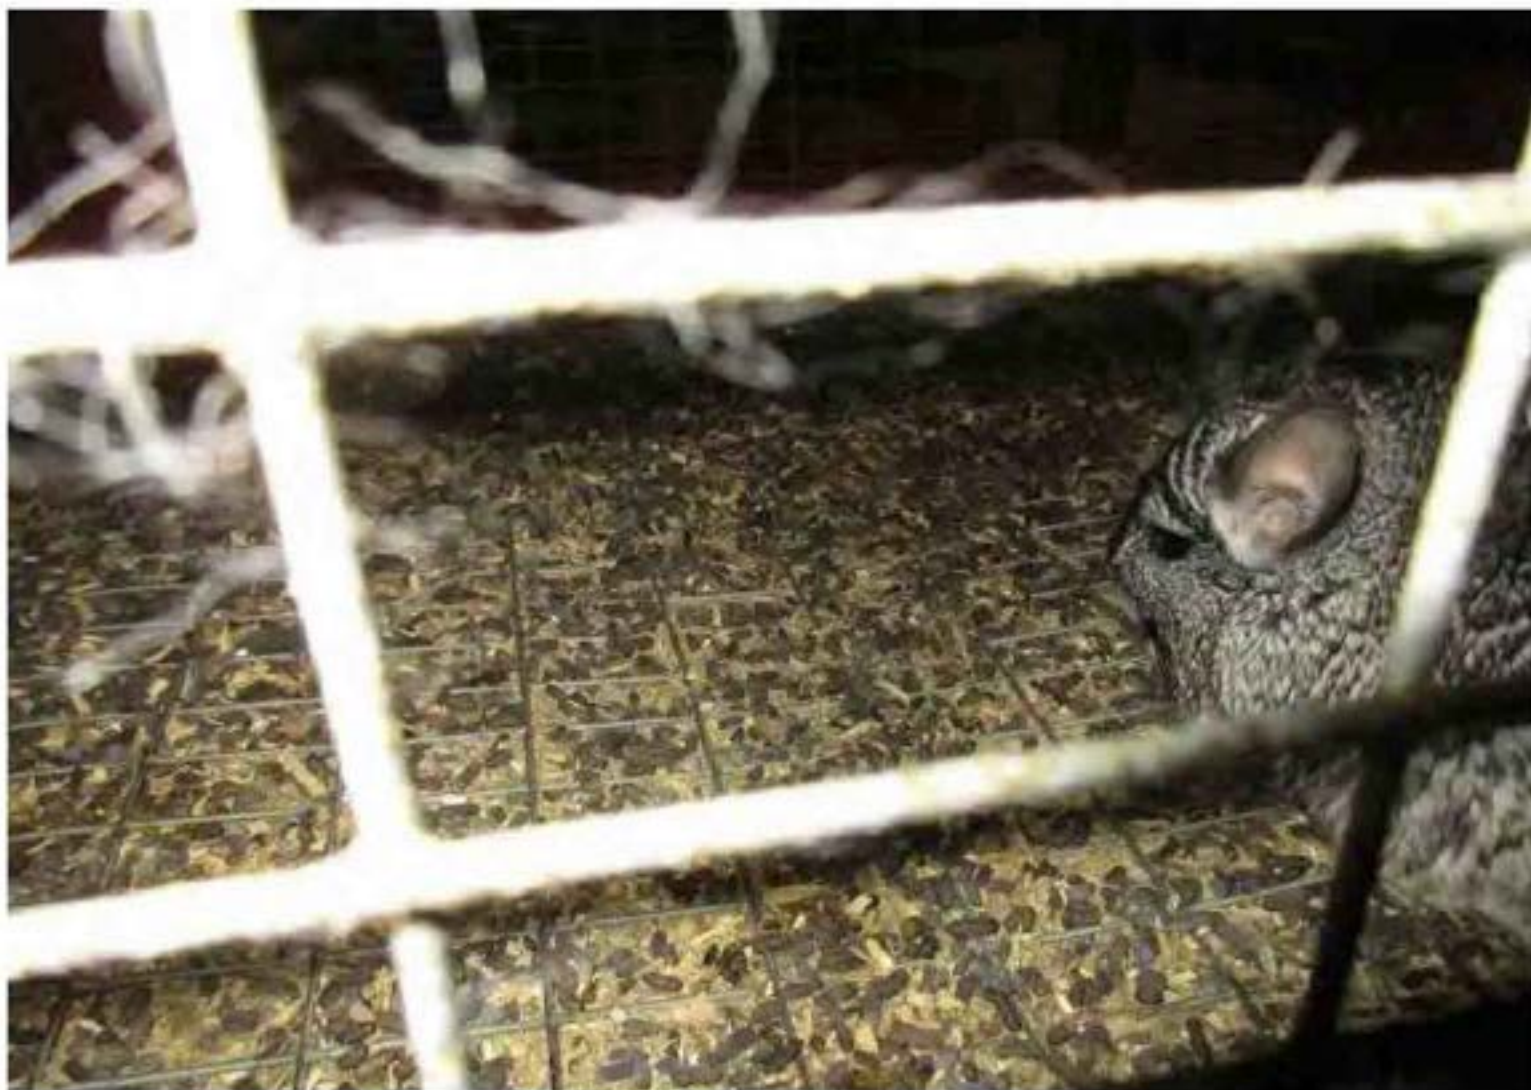
CFR: 3.131 (a)

Photographer:	Kevin Wilken	Legal Name:	41-B-0239
Photo Taken:	Wed, Jun 22, '16	DAN MOULTON	
Inspection:	181161057380243		
Description:	Front room middle row pen, excessive feces.

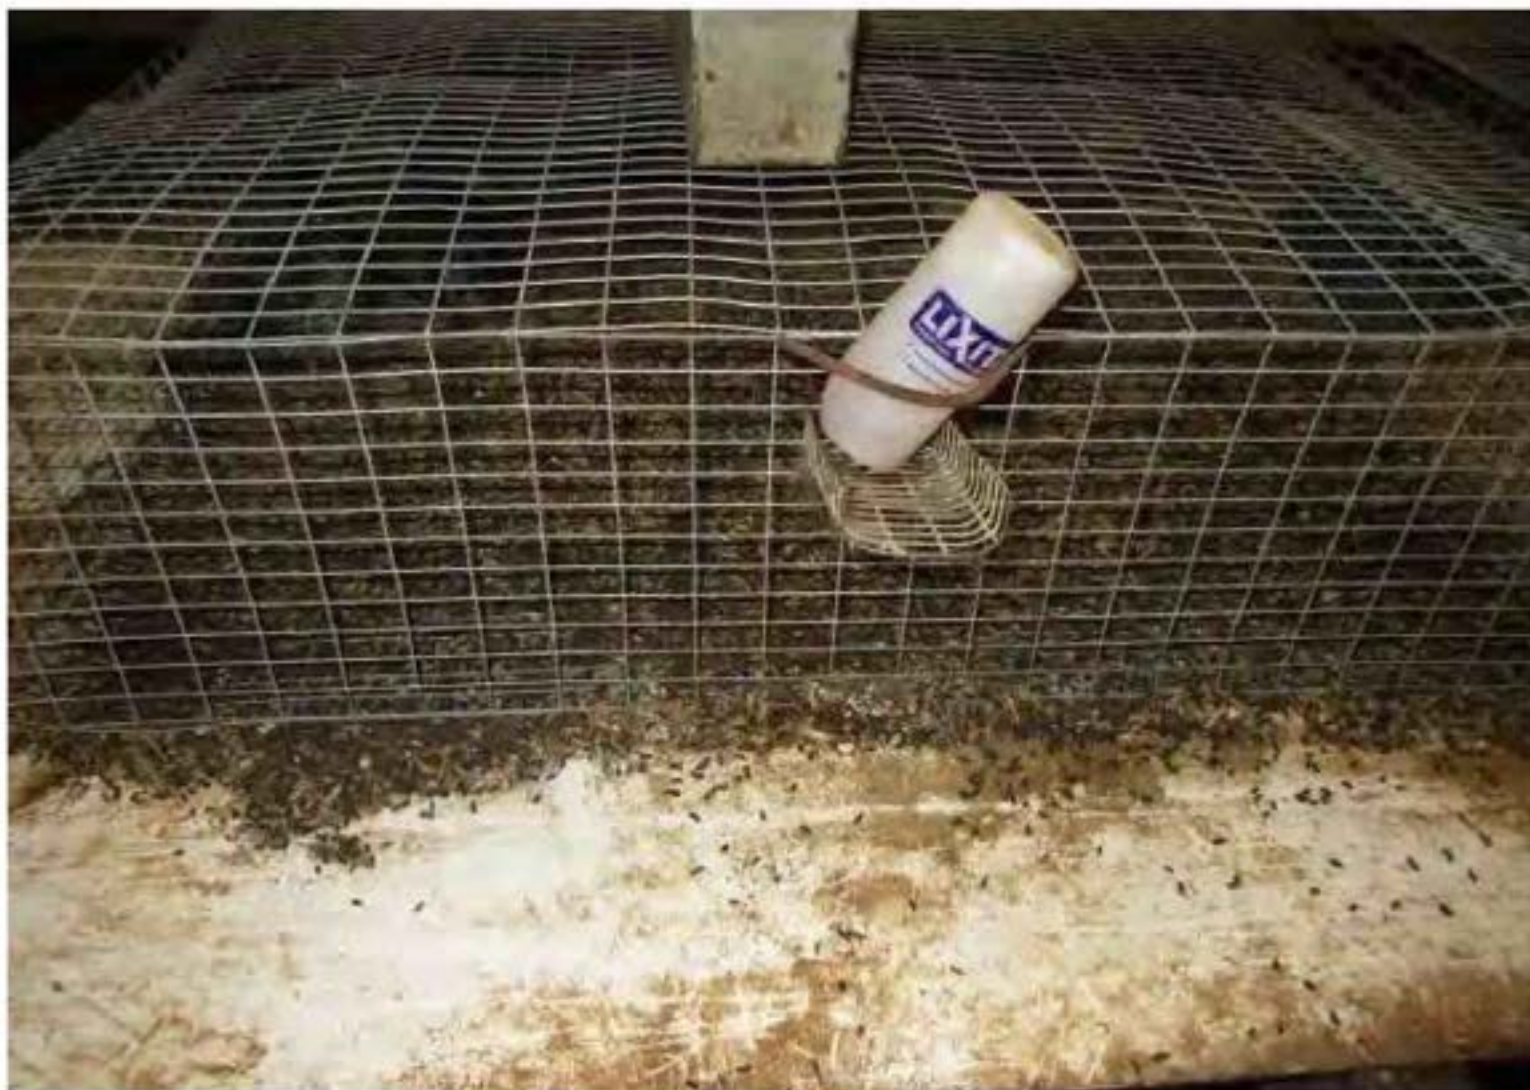
CFR: 3.131 (a)

Photographer:	Kevin Wilken	Legal Name:	41-B-0239
Photo Taken:	Wed, Jun 22, '16	DAN MOULTON	
Inspection:	181161057380243		
Description:	Front room middle row pen, excessive feces.

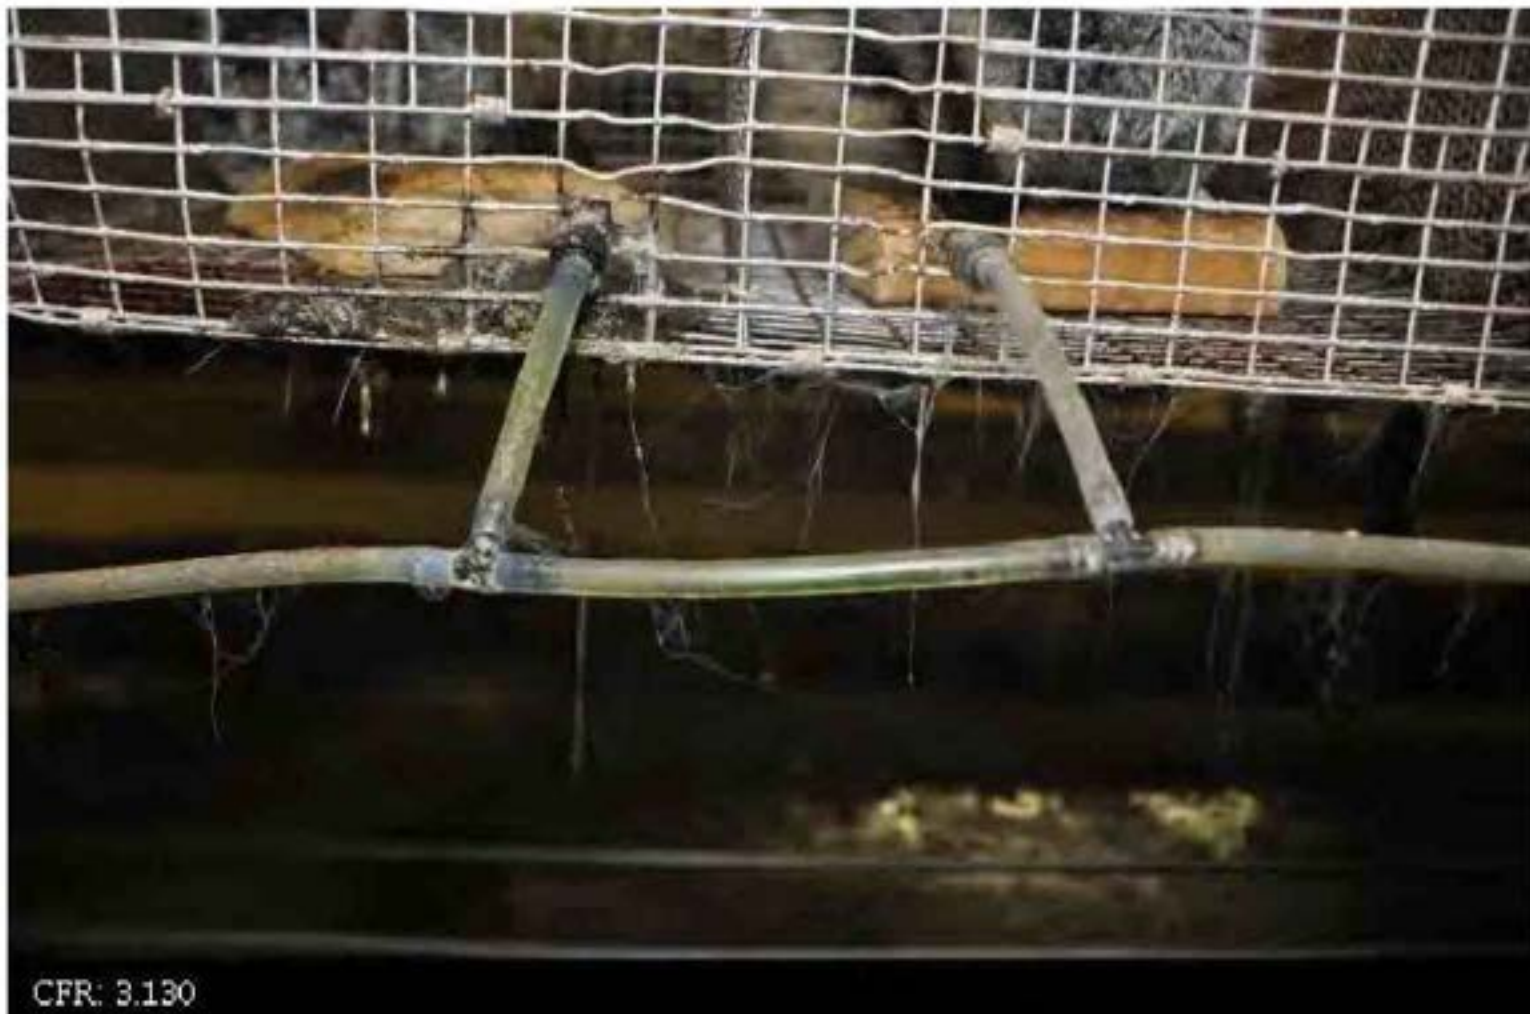
Photographer:	Scott Welch	Legal Name:	41-B-0239
Photo Taken:	Wed, Jun 22, '16	DAN MOULTON	
Inspection:	181161057380243		
Description:	Water line facing north wall with greenish build-up inside.

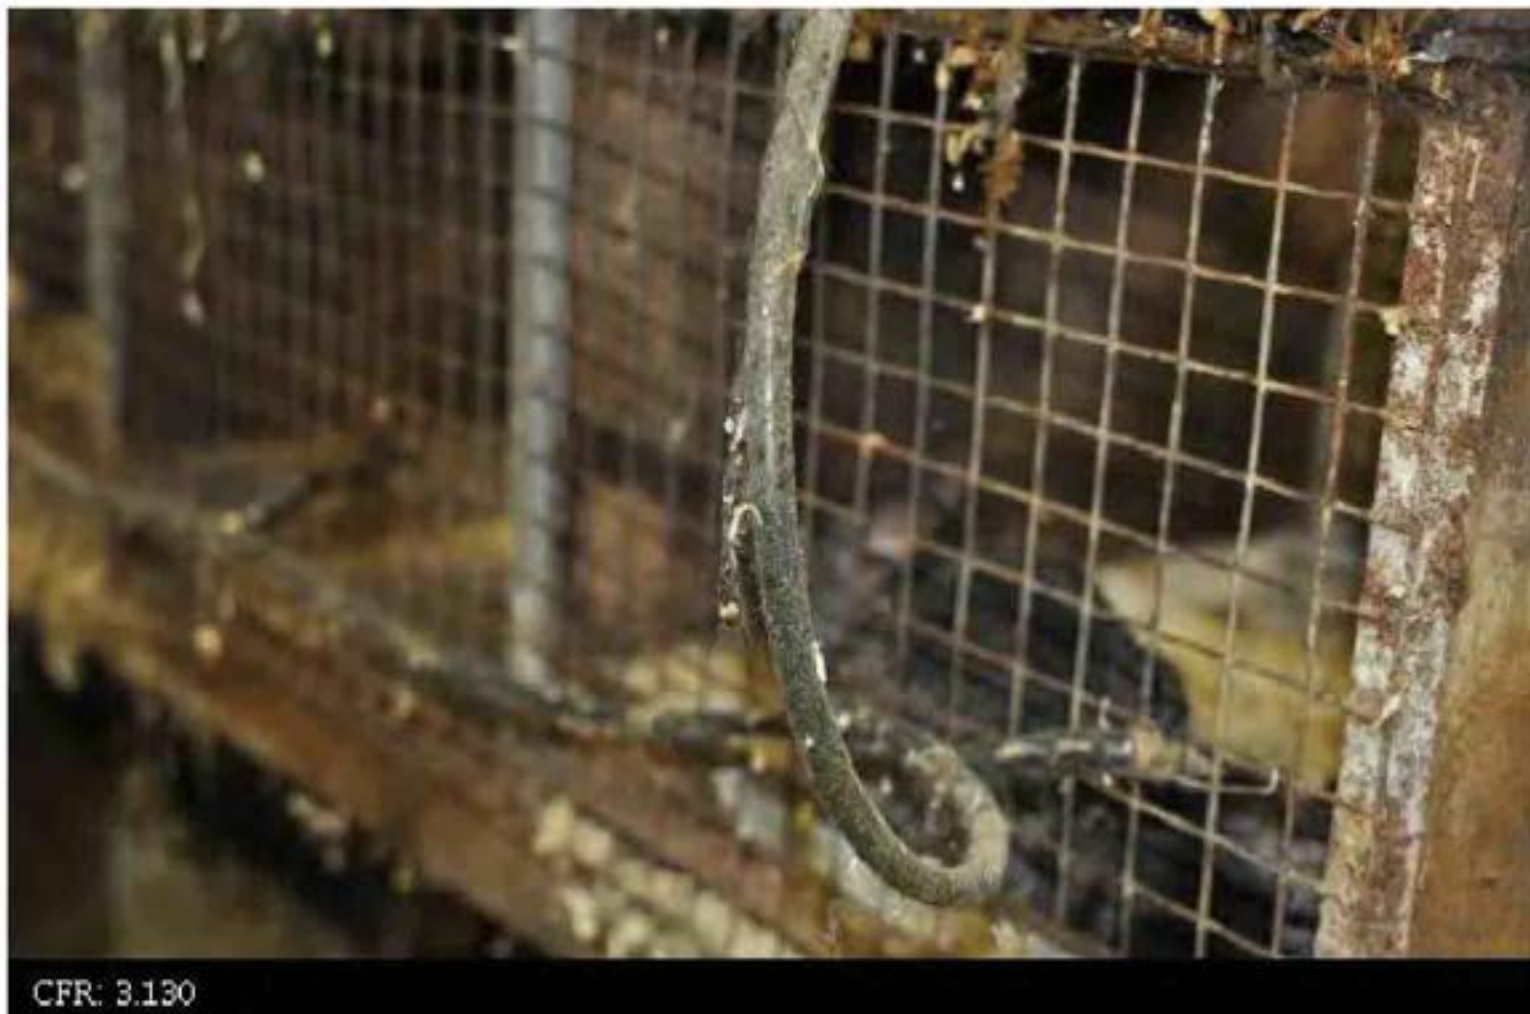
CFR: 3.130

Photographer:	Scott Welch	Legal Name:	41-B-0239
Photo Taken:	Wed, Jun 22, '16	DAN MOULTON	
Inspection:	181161057380243		
Description:	Water line; front room, stacked cages on south wall.

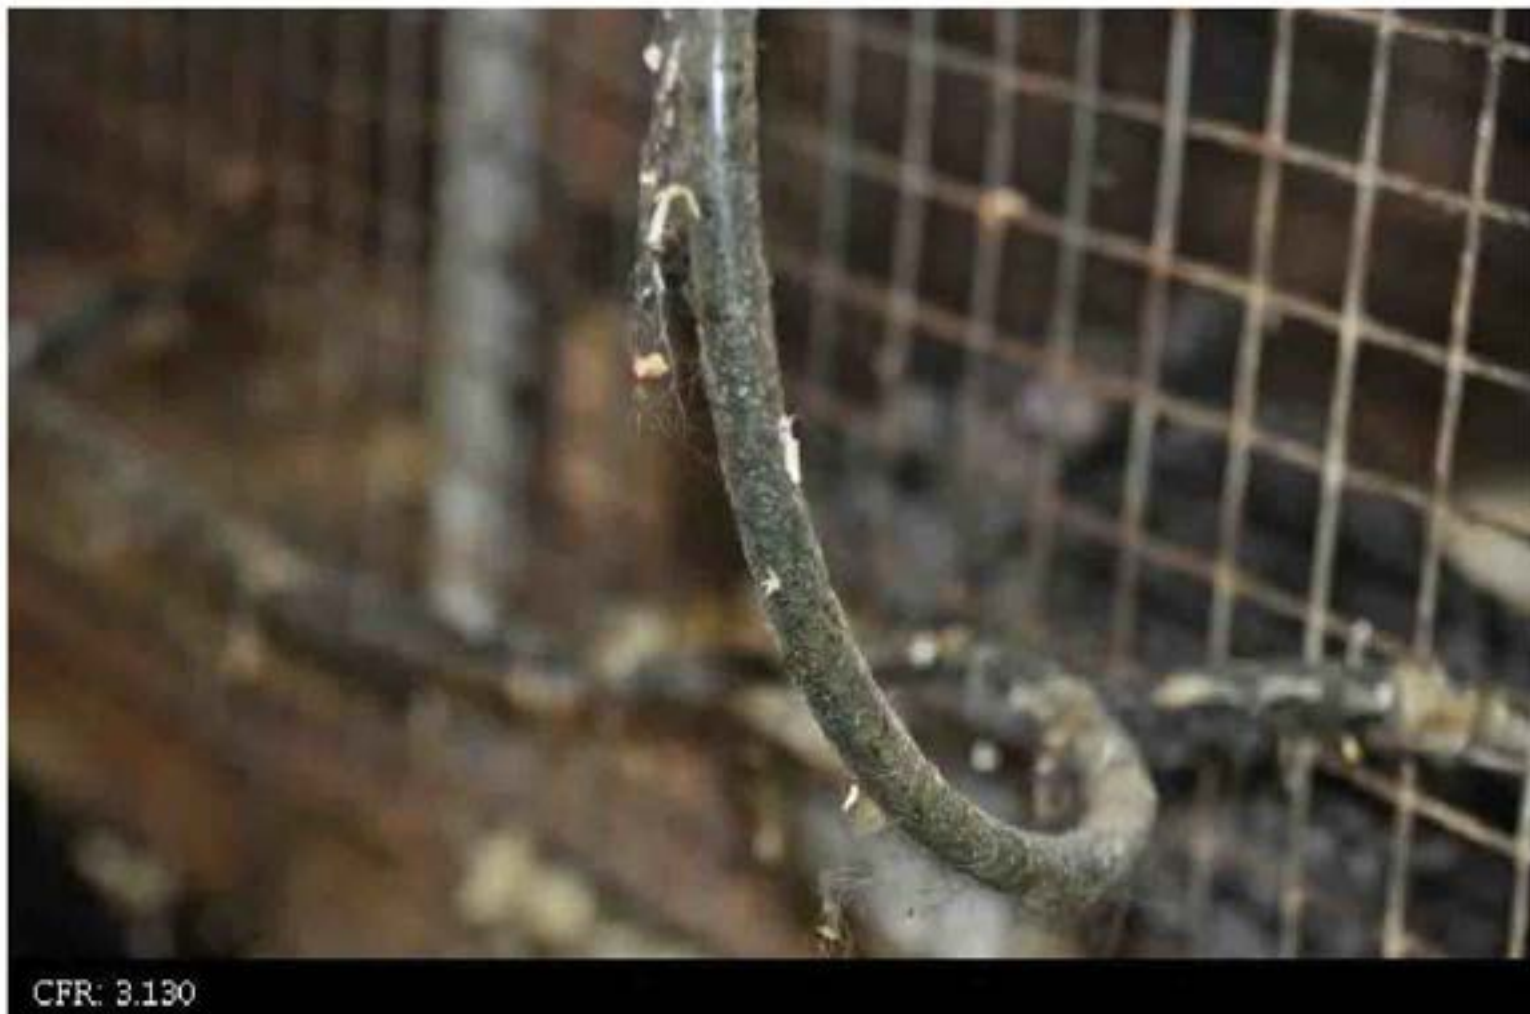
CFR: 3.130

Photographer:	Scott Welch	Legal Name:	41-B-0239
Photo Taken:	Wed, Jun 22, '16	DAN MOULTON	
Inspection:	181161057380243		
Description:	Water line; front room, stacked cages on south wall.

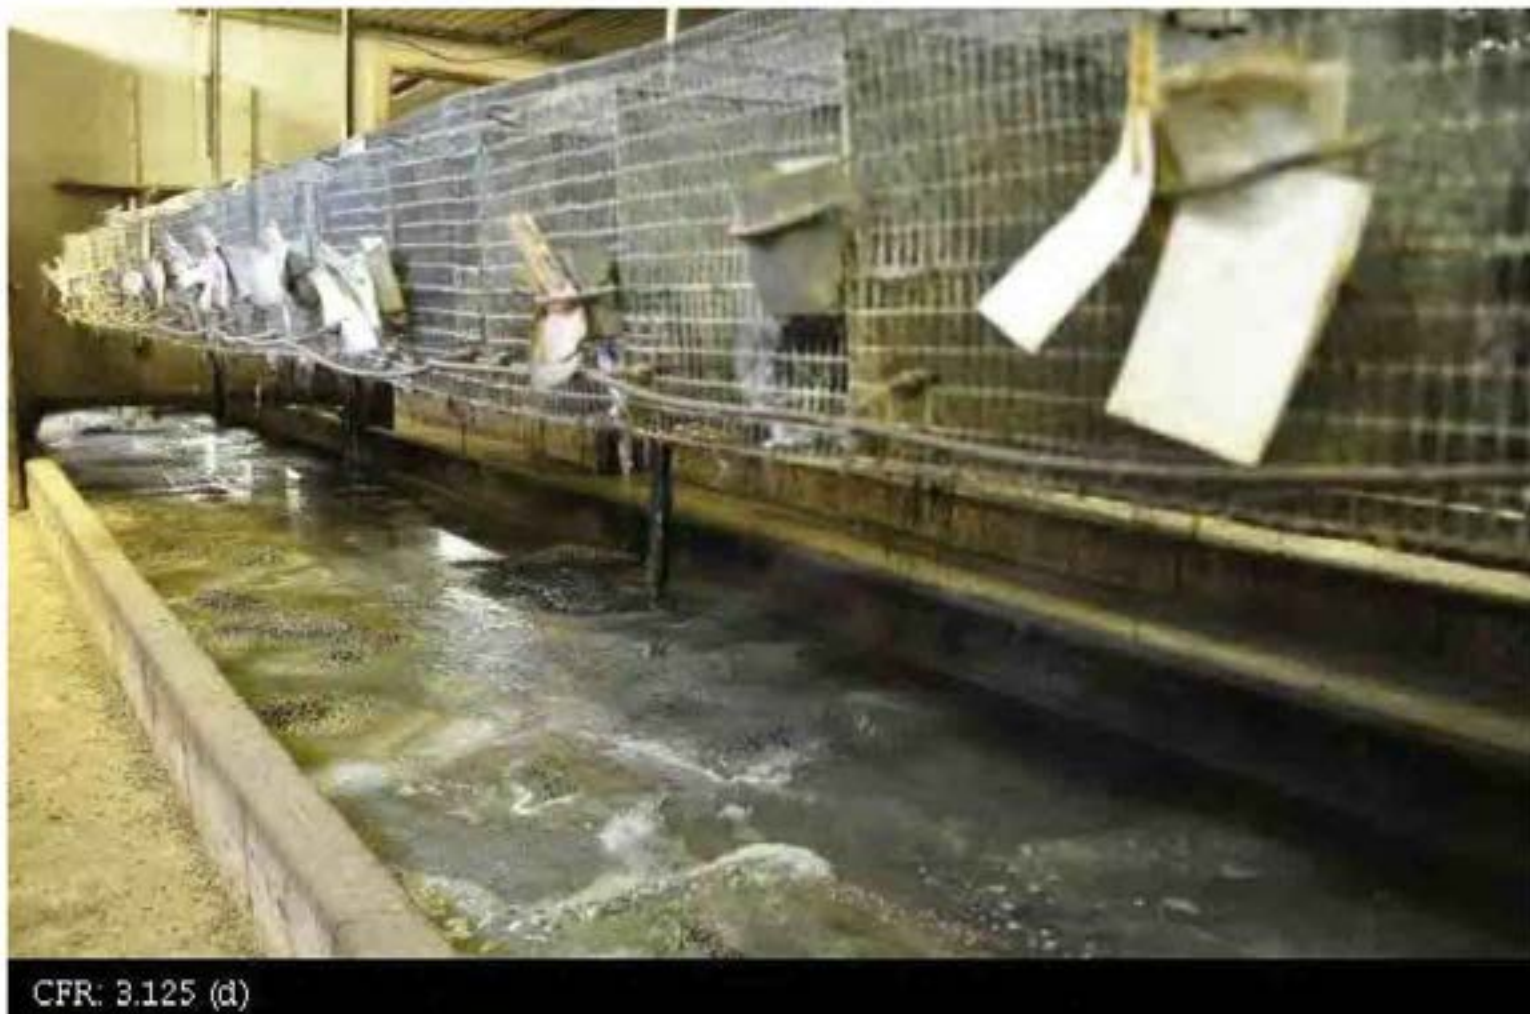
CFR: 3.125 (d)

Photographer:	Scott Welch	Legal Name:	41-B-0239
Photo Taken:	Wed, Jun 22, '16	DAN MOULTON	
Inspection:	181161057380243		
Description:	Build up of soiled material in south gutter of facility; picture taken in middle room looking northwest.

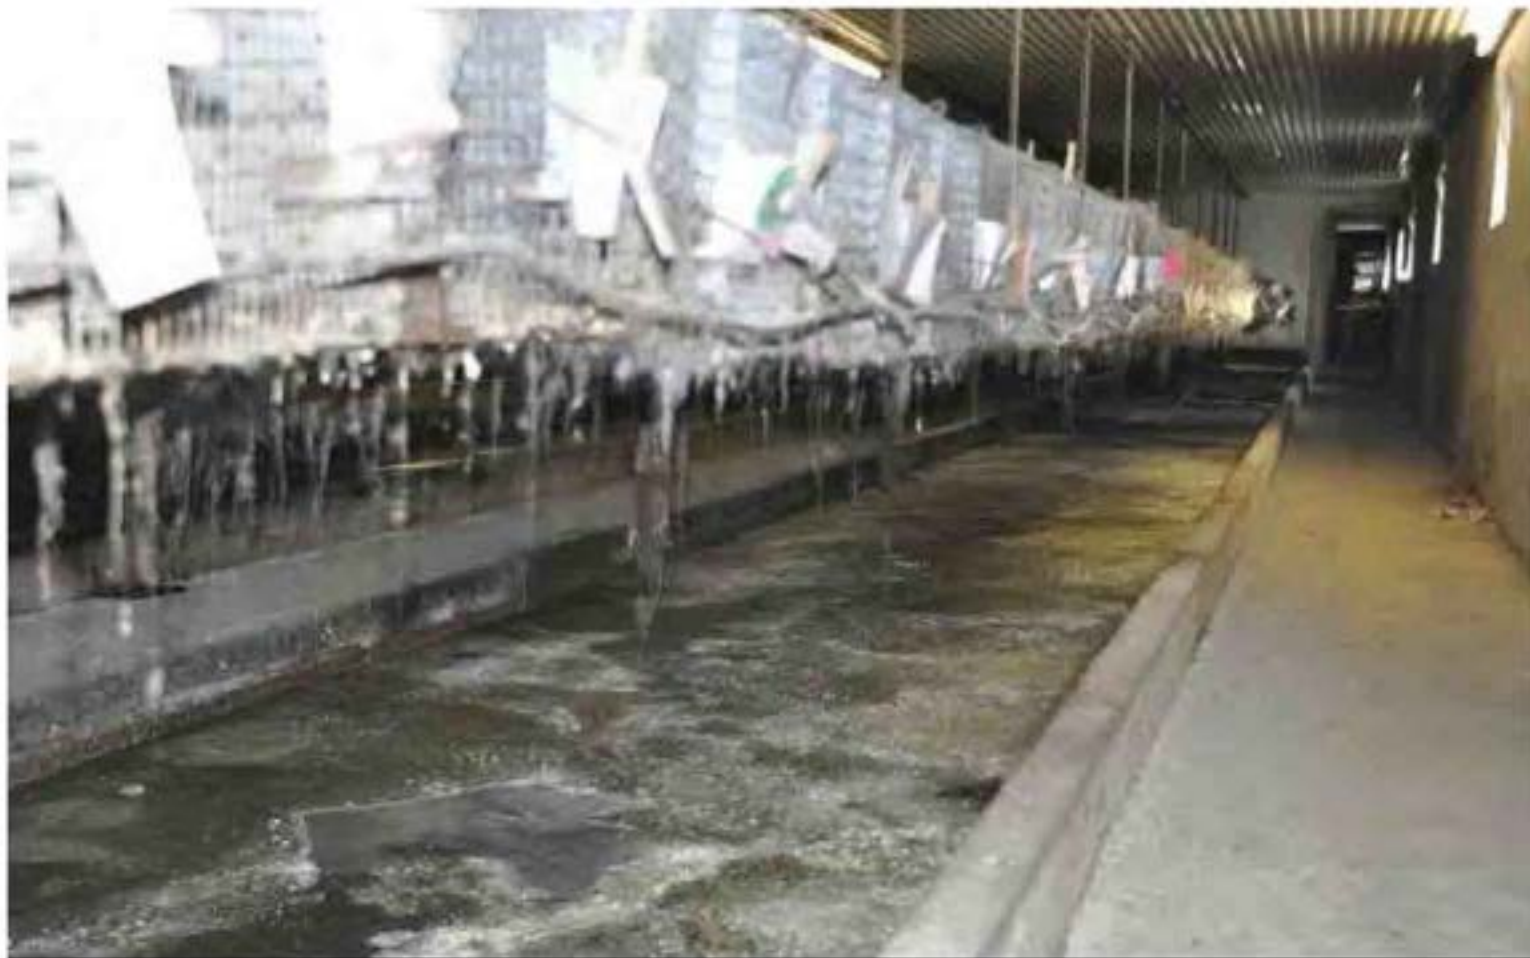
CFR: 3.125 (d)

Photographer:	Scott Welch	Legal Name:	41-B-0239
Photo Taken:	Wed, Jun 22, '16	DAN MOULTON	
Inspection:	181161057380243		
Description:	Build up of soiled material in south gutter of facility; picture taken in middle room looking east.
