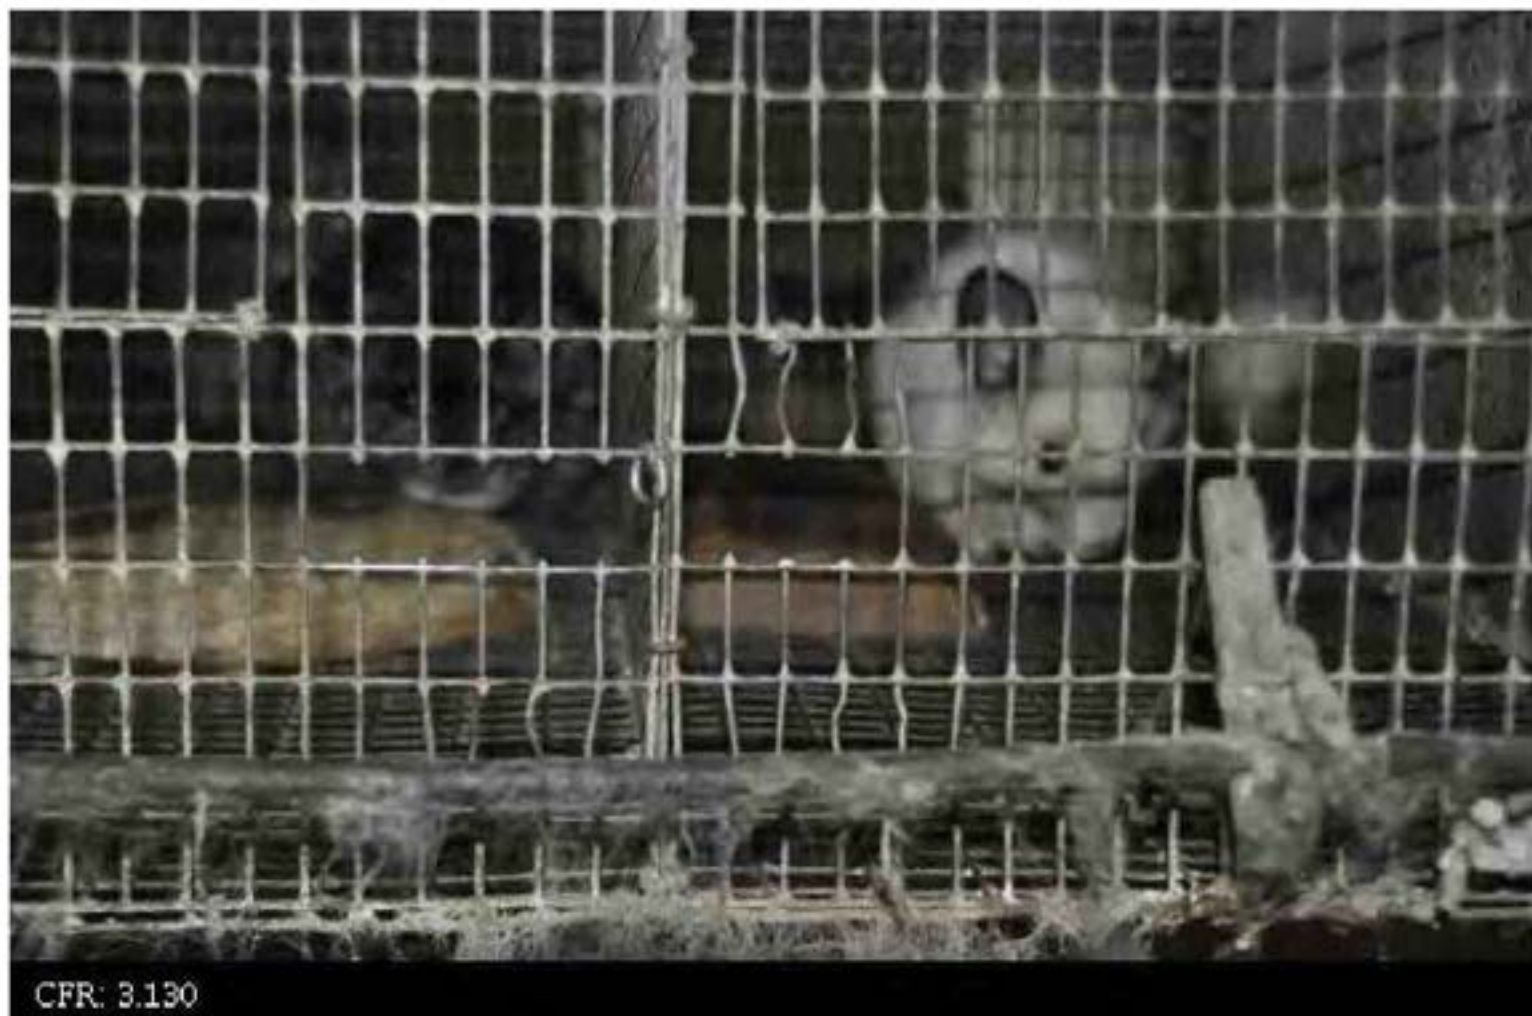
Photographer:	Scott Welch	Legal Name:	41-B-0239
Photo Taken:	Wed, Jun 22, '16	DAN MOULTON	
Inspection:	181161057380243		
Description:	Wire points removed from two affected cages; however, note soiled water-line with hair and soiled material on it (towards bottom of photo).
