Water Hazard Assessment in Active Shafts in Upper Silesian Coal Basin Mines

Przemysław Bukowski

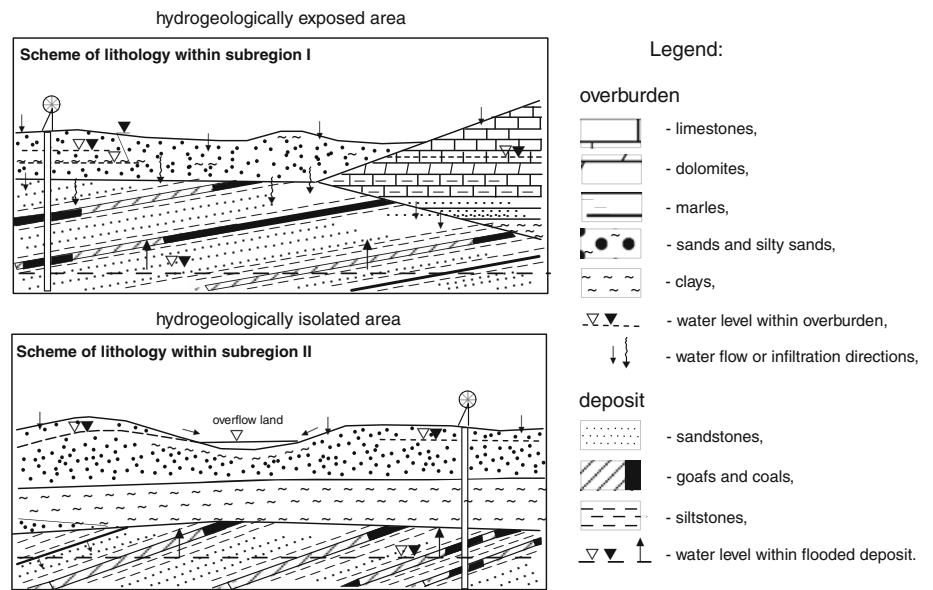
Fig. 1 Generalized lithology within the Upper Silesian Coal Basin, according to Bukowski et al. (2006)

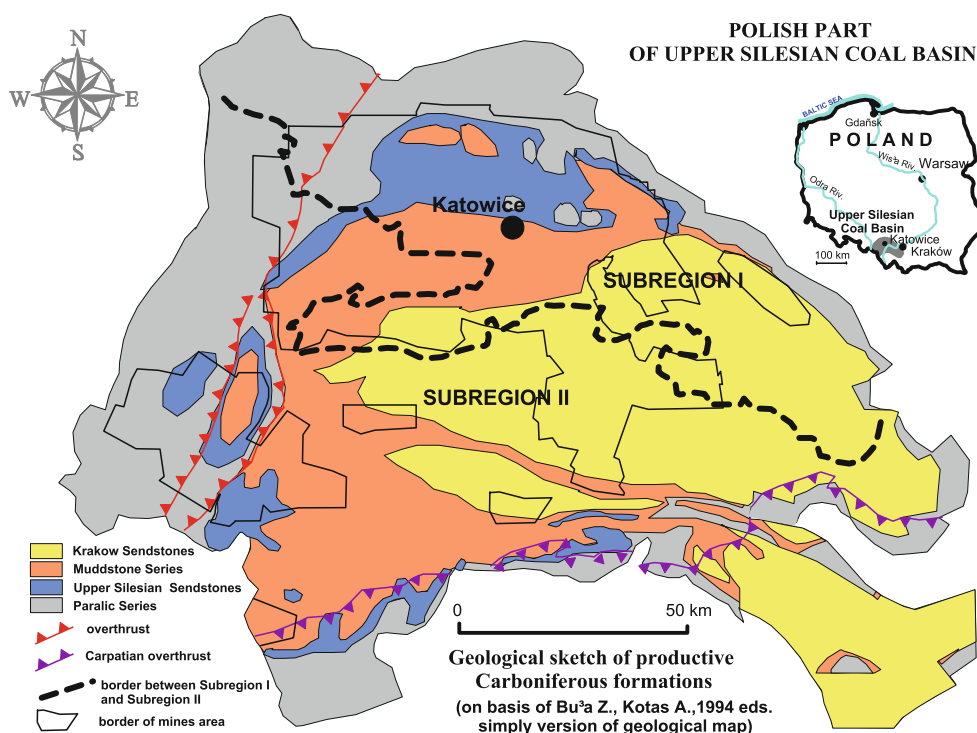
Fig. 2 Sketch of geological situation of productive Carboniferous formations in the Upper Silesian Coal Basin (based on a geological map published by Buła and Kotas (1994), showing the approximate

boundaries of the hydrogeologically exposed (subregion I) and isolated (subregion II) areas, according to Rózkowski (2003)

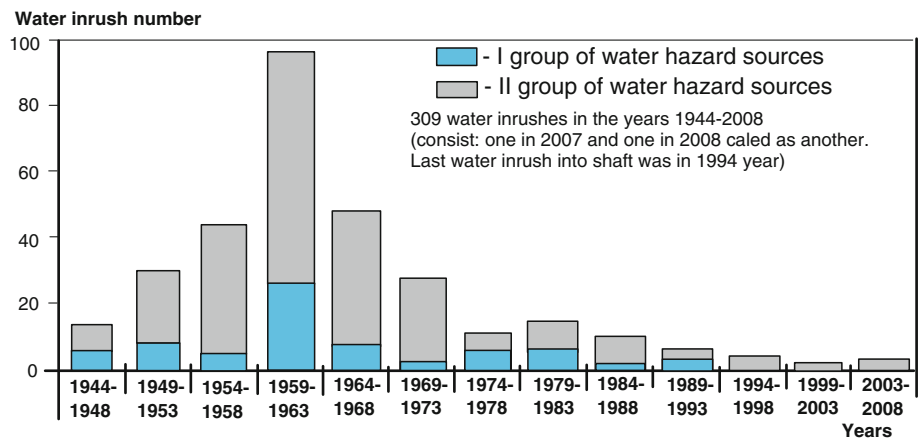
inrushes in USCB mines. Also contributing to that reduction has been the development of techniques to recognize and prevent water inrushes and the development of dewatering technology. Figure 3 illustrates the decrease in the number of water inrushes into active mine workings.

Fig. 3 The chronological distribution of the 309 intrushes that have disrupted mining in the USCB in Poland since World War II; group I, in blue, represent intrushes that had surface reservoirs and streams, water-filled karstic caverns, and flooded mines as their source, and; group II, in grey, where the source of the intrushes were saturated strata, fractures zones, and boreholes
