[54] **INTEGRAL LIGHTNING PROTECTION REPAIR SYSTEM AND METHOD FOR ITS USE**

[73] Assignee: **The Boeing Company**, Seattle, Wash.

[57] ABSTRACT

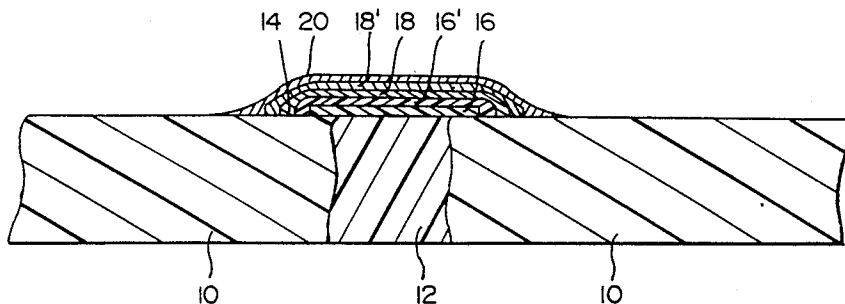
FIG. 1 is a cross-sectional view of a repaired composite structure showing the dielectric layer and ply of the present nickel-plated graphite fiber repair; and

Referring to FIG. 1, an aircraft graphite epoxy structure 10 having a hole 12 has been repaired from the direction of outside surface 14. As can be seen, hole 12 has been faired into the aircraft composite structure, thereby providing a large bonding area for the adhesive used to fill hole 12. The outer surface of the adhesive material is rendered flush with the extensions of skin 10. Outer surface 14 is then covered by dielectric layer 16,

The repair shown in FIG. 1 can be effected by first removing any damaged portion of the aircraft graphite epoxy structure, then refilling the portion of the structure with an adhesive to form a bonded patch, forming a dielectric layer over the outwardly directed surface of the bonded patch, and using at least one outer metal-plated graphite fiber fabric ply over the dielectric layer.
