United States Patent [19]

[54] FASTENED LIGHTNING PROTECTION REPAIR SYSTEM AND METHOD FOR ITS USE

[73] Assignee: The Boeing Company, Seattle, Wash.

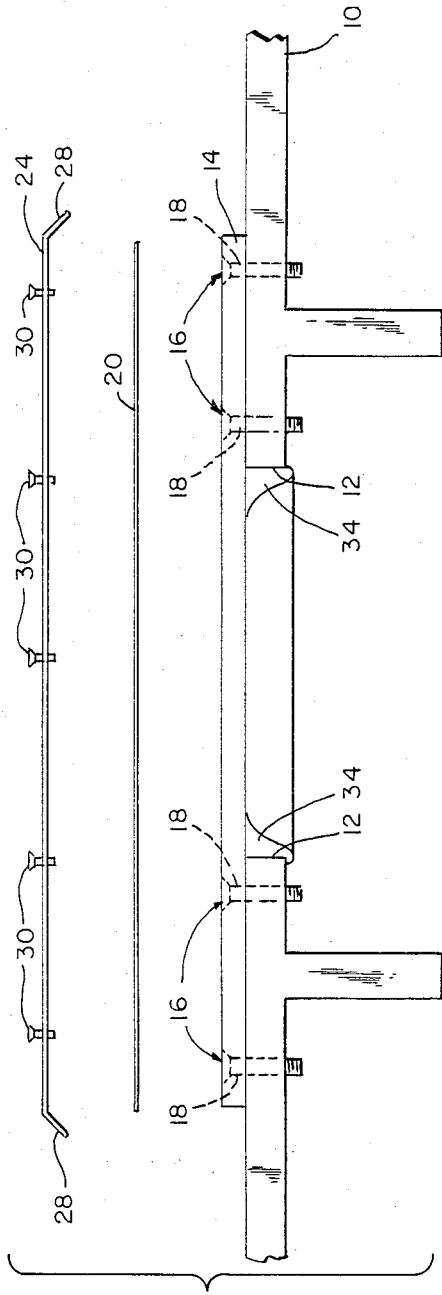
FIG. 1 is a cross-sectional view of a fastened lightning protection repair system showing the repair plate, the dielectric layer, and the diversion sheet; and

Referring to FIG. 1, an aircraft graphite epoxy structure 10 having a hole 12 has been repaired by the fastened lightning protection system of the present invention. Hole 12 has been covered over by a repair plate 14, which can, for example, be made from aluminum. Repair plate 14 completely covers hole 12 from the outside of aircraft graphite epoxy structure 10. Plate 14 can be attached to graphite epoxy structure 10 by means of fasteners 16, which can, for example, be titanium bolts 18. The fasteners are countersunk into the outer surface of metal repair plate 14. A suitable form of fastener 16 is the Hi-Lok™ fastener.

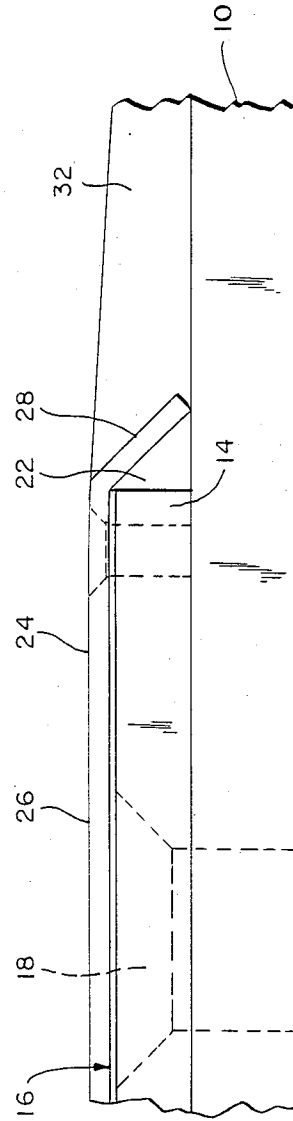
FIG. 2 is a closeup cross-sectional view of the fastened lightning protection repair system showing the relationship of the diversion sheet and the aircraft graphite epoxy structure.

As shown in the closeup view of FIG. 2, the edge of plate 14 can be sealed by means of a polysulfide sealant 22 to prevent moisture intrusion and subsequent freeze-thaw cycle damage. An electrically conducting lightning diversion plate 24 conforms surface of repair plate 14. The edges 28 of the diversion plate 24 are bent downwardly around the whole periphery of lightning diversion plate 24. Lightning diversion plate 24, which may be made from 32 mil aluminum sheet, is then attached to repair plate 14 by means of fasteners, such as countersunk screws 30. Edge 28 is bent downwardly so as to be adjacent the outer surface of aircraft graphite epoxy structure 10 (see FIG. 2). This creates an electrical path between the diversion plate 24 and the aircraft graphite epoxy structure. Finally, diversion plate 24 is faired into the surface of the aircraft graphite epoxy structure 10 by means of a ramp of fairing compound 32.
