(10) **Pub. No.: US 2020/0242853 A1**

(54) **SYSTEM AND METHOD FOR ESTIMATING VEHICLE BODY DAMAGE**

(71) Applicant: **Hunter Engineering Company,**
Bridgeton, MO (US)

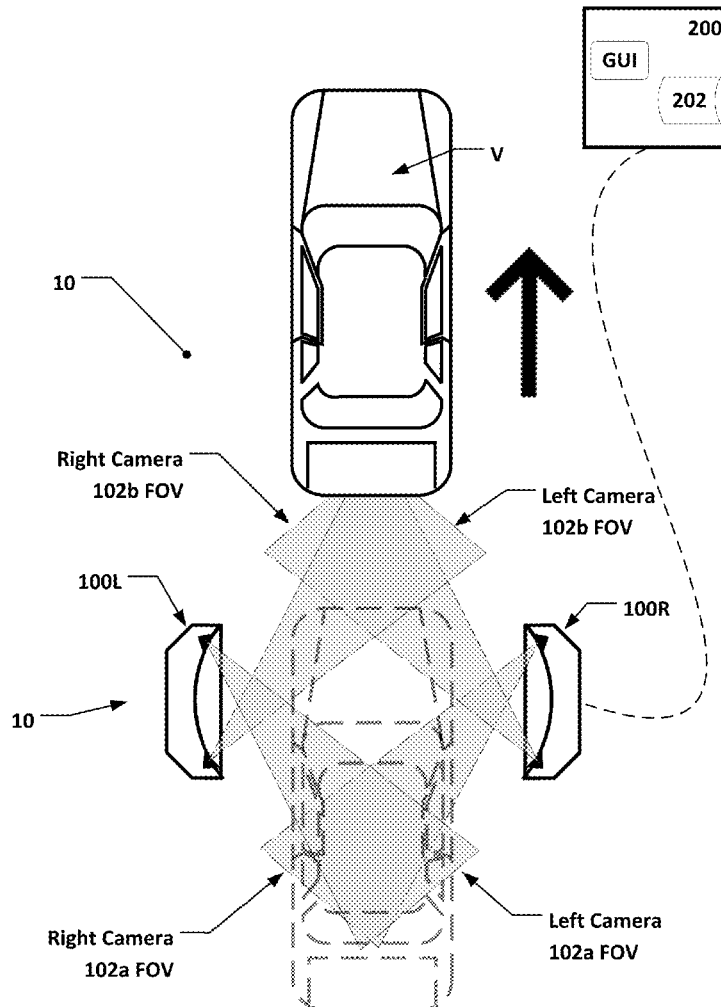
FIGURE 1

[0012] FIG. 1 is a perspective view of a multi-camera exemplary sensor unit for use in a vehicle inspection lane;

[0019] Turning to the figures, and to FIGS. 1 and 2 in particular, a drive-through vehicle inspection system 10 is shown in which a pair of sensor units 100R, 100L (FIG. 1) are disposed on opposite lateral sides of an inspection lane 12 (FIG. 2) through which a vehicle V is driven. Each sensor unit 100 includes at least one imaging sensor 102 configured to acquire a sequence of images encompassing a fixed field of view as a vehicle passes through the inspection lane. The fields of view for each imaging sensor 102 are oriented non-orthogonal to the intended travel direction of vehicles V passing through the inspection lane 12, as best seen in FIG. 2. Utilizing non-orthogonal fields of view enables each imaging sensor 102 to capture a sequence of images either as the vehicle V approaches and passes through the inspection lane 12, or as the vehicle V passes through and departs from the vehicle inspection lane 12. A sequence of images from an individual imaging sensor 102 includes images of body surfaces along one lateral side of the vehicle V as well as images of either the front or rear body surfaces. Utilizing two imaging sensors 102a, 102b within each sensor unit 100, one with a field of view oriented towards a vehicle approach to the inspection lane (102a) and one with a field of view oriented toward a vehicle V exit from the inspection lane (102b) as shown in FIG. 2 enables the acquired
