Site Accessibility Evaluation

Americans with Disabilities Act Title II (Public Services: State and Local Government)

Bear Creek Nature Center

Accessibility Evaluation

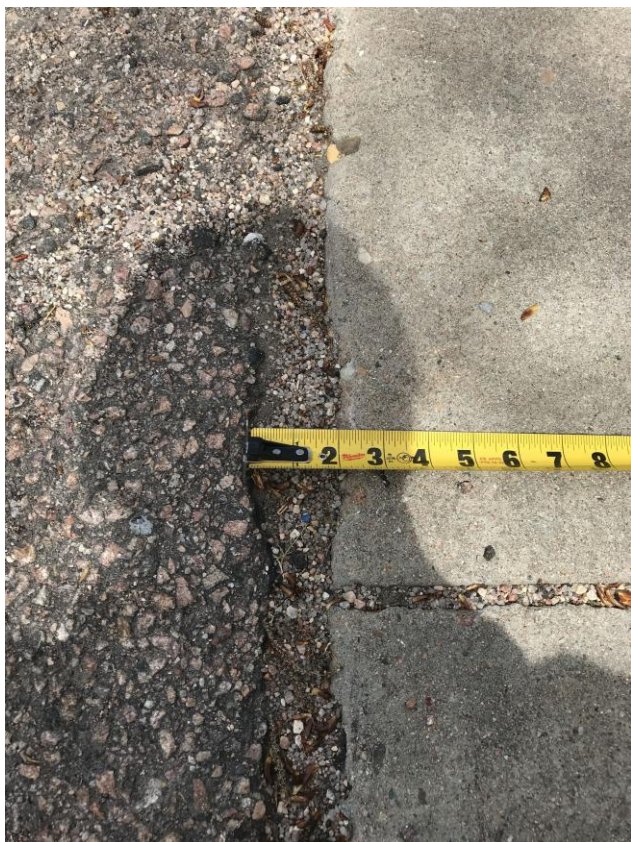
Finding 299242 Main Photo

The concrete expansion joint is spaced greater than 1/2 inch.

Expansion joint 2
inches in width

Crack fill expansion joints to ensure an opening no more than 1/2 inch in diameter.

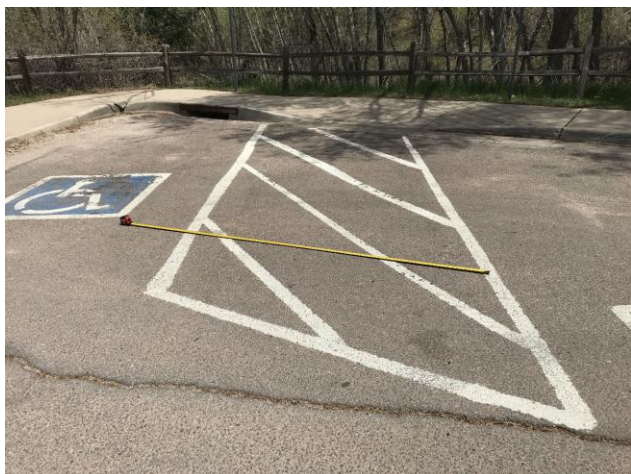
Finding 299243 Main Photo

The access aisle is not a minimum 8 feet to the centerline of the stripe.

7ft 2 inches in width

Re-stripe access aisle and ensure a minimum width of 8 feet measured to the center of the paint stripe.

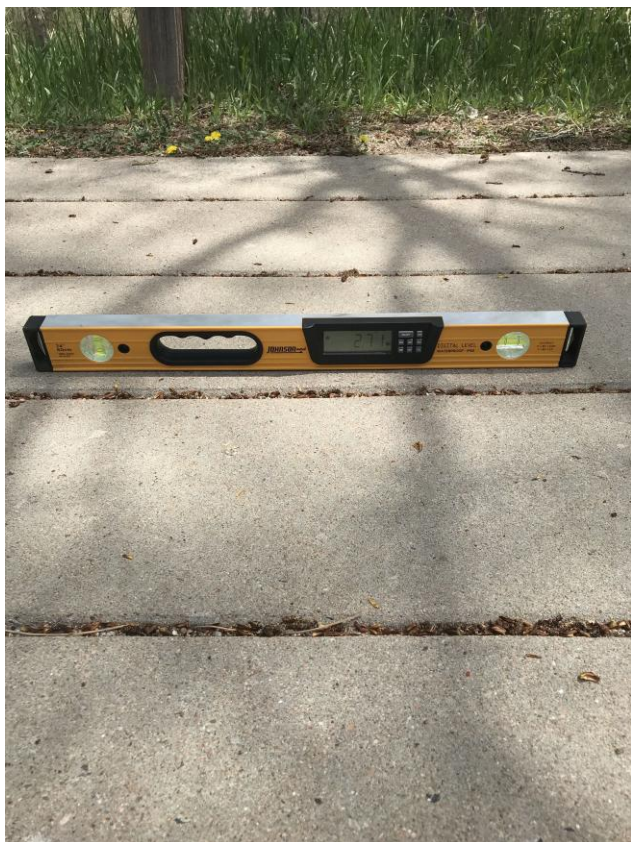
Finding 299244 Main Photo

The curb ramp on the accessible route contains cross slopes greater than 2%.

Curb ramp has 2.71%
cross slope

During re-construction/remodel, replace existing pedestrian ramp and construct a parallel curb ramp to meet current ADA standards.

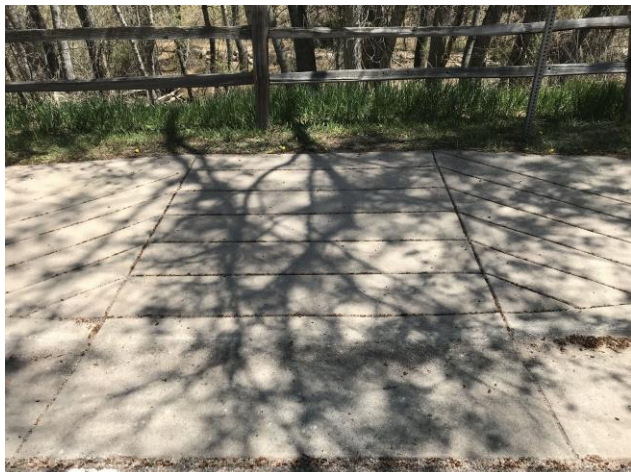
Finding 299245 Main Photo

The top of the curb ramp does not have a level landing.

No level landing exists
on top of curb ramp

During re-construction/remodel, replace existing pedestrian ramp and construct a parallel curb ramp to meet current ADA standards.

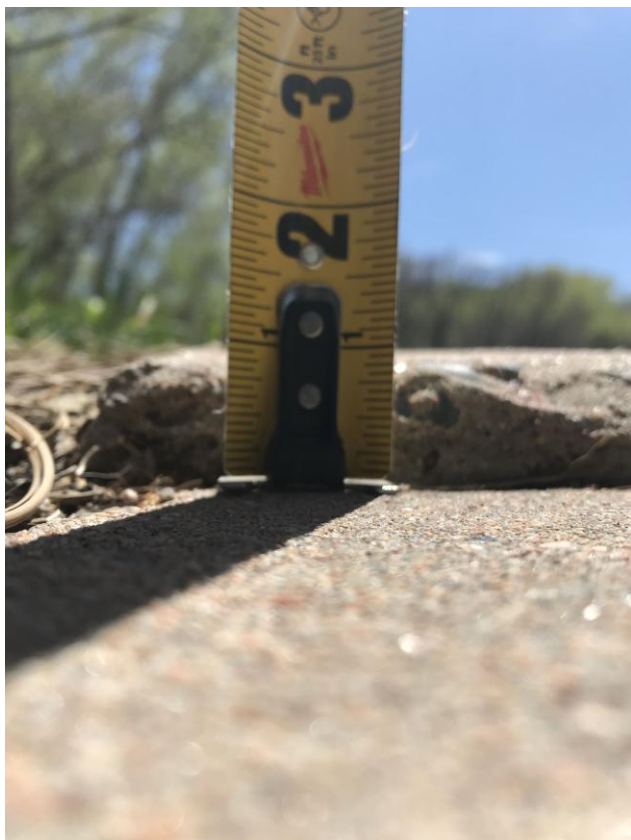
Finding 299246 Main Photo

The walkway contains abrupt vertical edges and/or variations over a 1/4 inch.

Path of travel contains
a couple of abrupt
vertical changes
greater than 1/4 inch

Shave abrupt vertical changes along the walkway/path of travel.

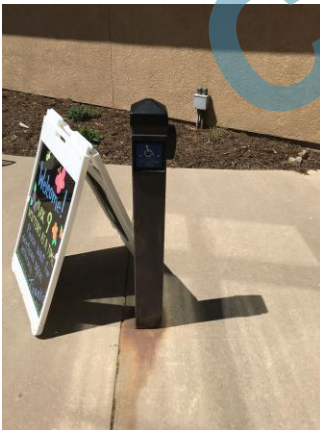
Finding 299247 Main Photo

Push button to main entrance automatic door not operational.

Push button non operational

Replace batteries or replace push button.

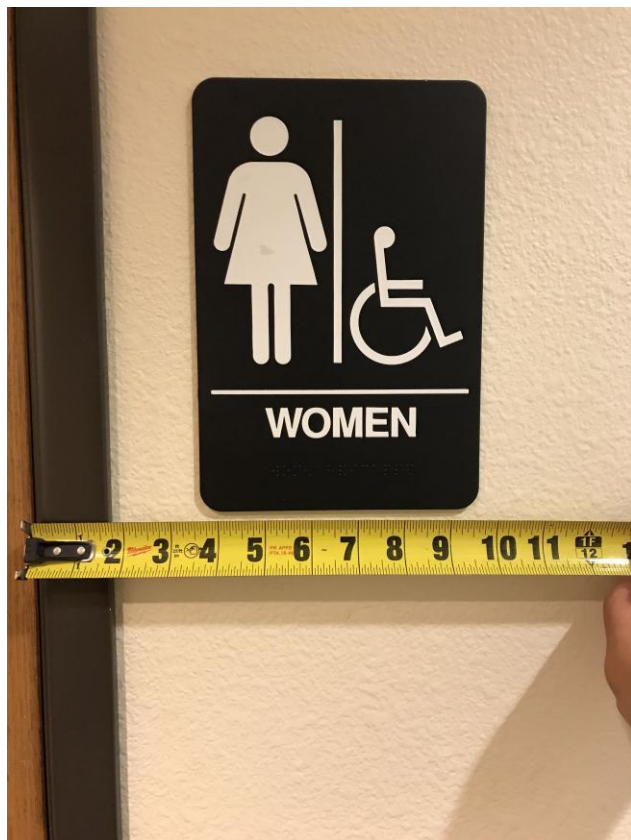
Finding 299248 Main Photo

Clear floor space is not provide at the tactile door sign.

6.5 inches to centerline of sign

Reposition restroom sign to 9 inches minimum centerline of tactile sign measured from the edge of door frame opening.

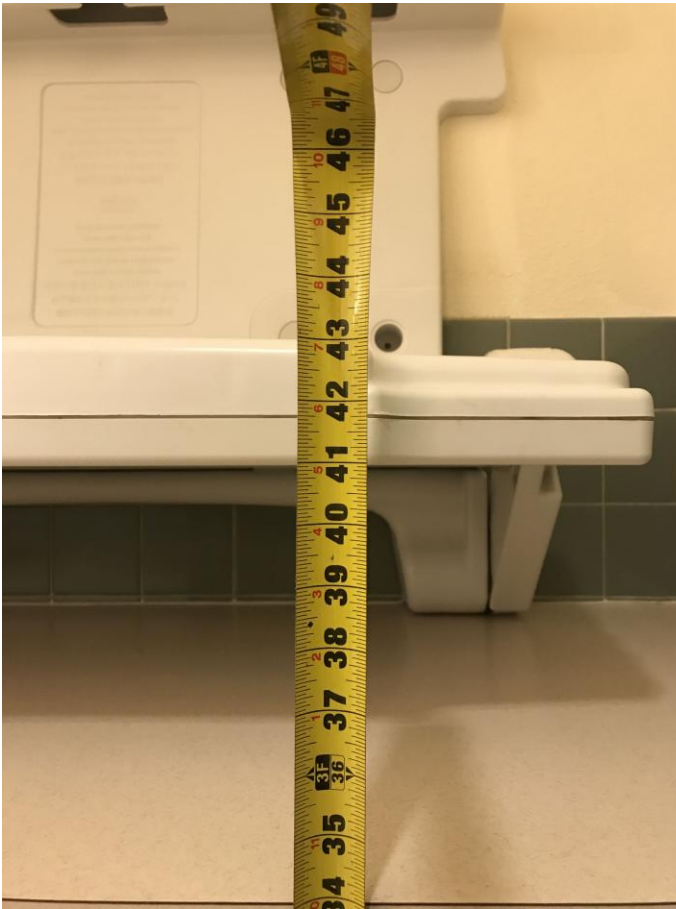
Finding 299250 Main Photo

The baby changing table is too high when folded down.

43 inches above
finished floor

If possible, relocate baby changing station to another section/wall and ensure it meets ADA standards. If baby changing station cannot be relocated, remove and use existing table/counter as baby changing station. Existing table/counter meets ADA compliance for knee, toe, height and forward approach clearance.

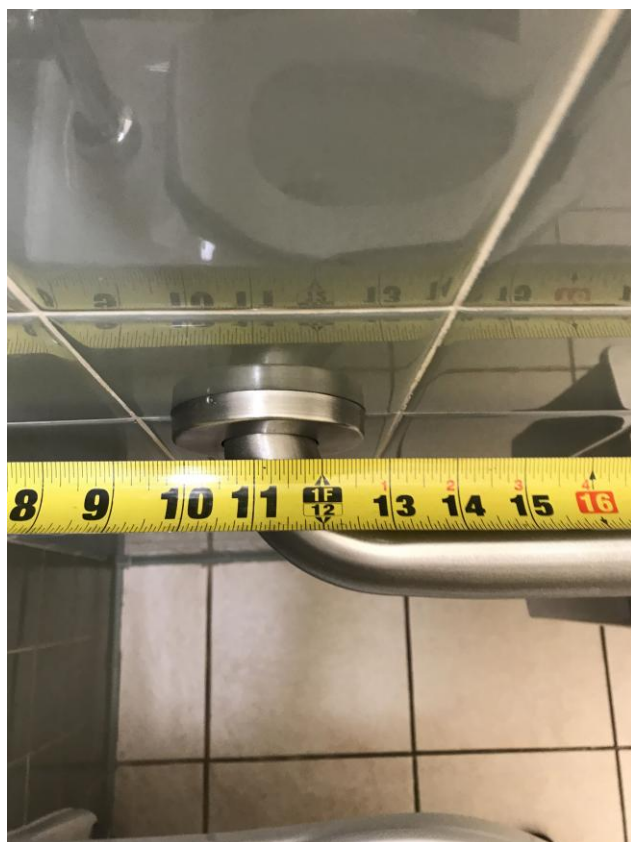
Finding 299251 Main Photo

The side grab bar is located greater than 12 inches from the rear wall.

11.25 inches from rear wall

Adjust side grab bar not to exceed 12 inches from rear wall measured to the centerline of the grab bar. Side grab bar must be 42 inches minimum in length and extend at least 54 inches minimum beyond the rear wall measured to the centerline of the grab bar.

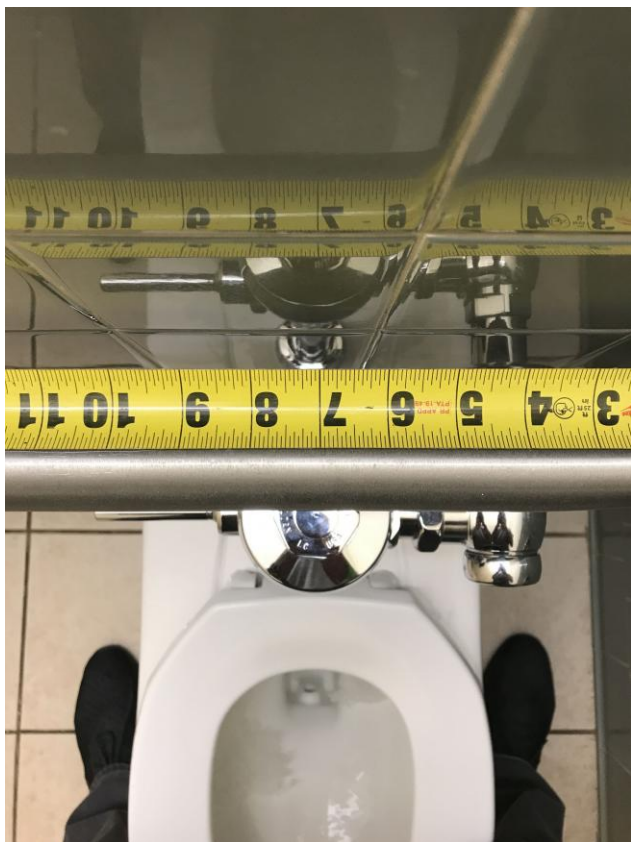
Finding 299252 Main Photo

The rear grab bar does not extend adequately past the centerline of the toilet on the wall side.

7 inches past
centerline of toilet to
wall side

Re-position rear grab bar to extend from the centerline of the toilet 12 inches minimum to the wall side and 24 inches minimum to the transfer/open side.

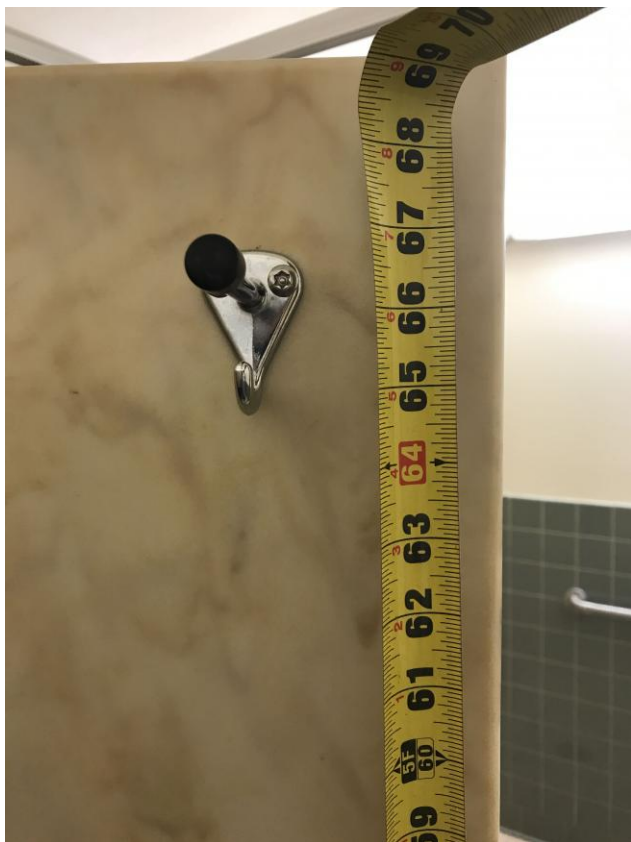
Finding 299253 Main Photo

The coat hook is installed greater than 48 inches above the finished floor.

Coat hook 66.25
inches above finished
floor

Lower coat hook 19 inches minimum or install another coat hook not to exceed a maximum height of 48 inches above finished floor.

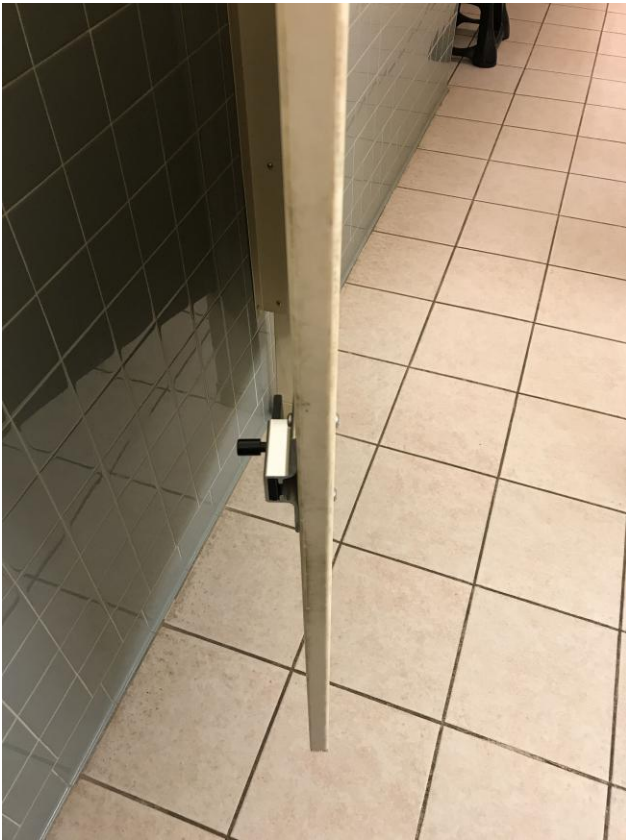
Finding 299254 Main Photo

The water closet compartment door is missing a loop handle.

**Compartment door
missing loop handles**

Install loop or U-shape handles on the inside and outside of the compartment door. Between 36 - 40 inches preferred.

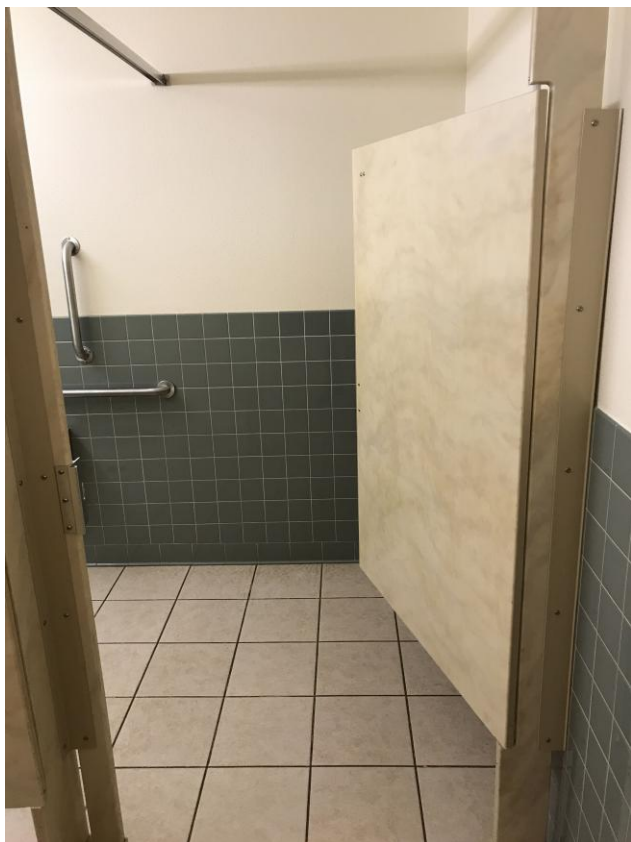
Finding 299255 Main Photo

The compartment door is not self closing.

Compartment door not self-closing

Adjust or install automatic closing hinges.

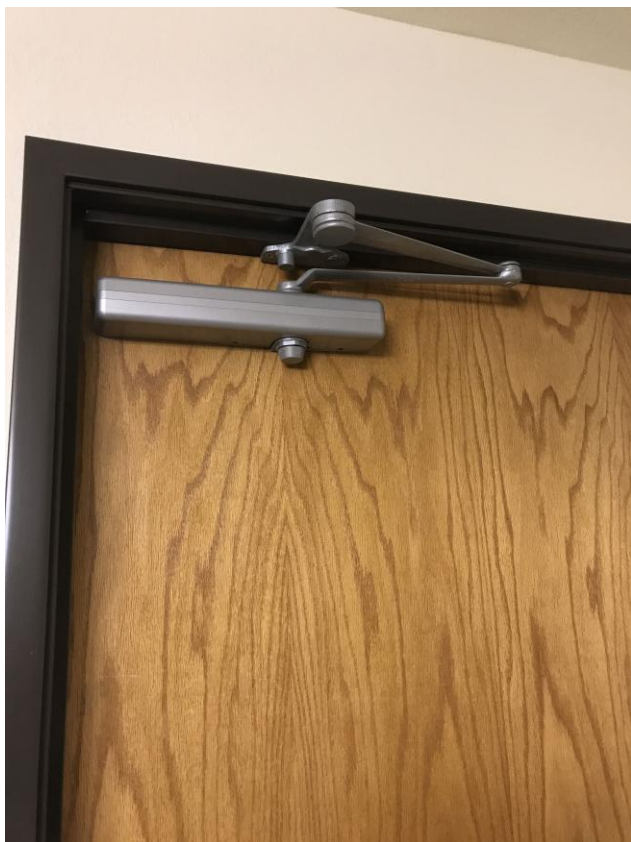
Finding 299256 Main Photo

The door is equipped with a door closer and returns to a closed position too quickly.

4.96 seconds to closed position

Adjust door closer to allow a minimum of 5 seconds to move from the open position at 90 degrees to 12 degrees from the latch/locking mechanism.
