Site Accessibility Evaluation

Americans with Disabilities Act Title II (Public Services: State and Local Government)

Santa Fe Regional Trail Restroom

*Inspection Date: 07/09/2019
Inspector: David Mejia*

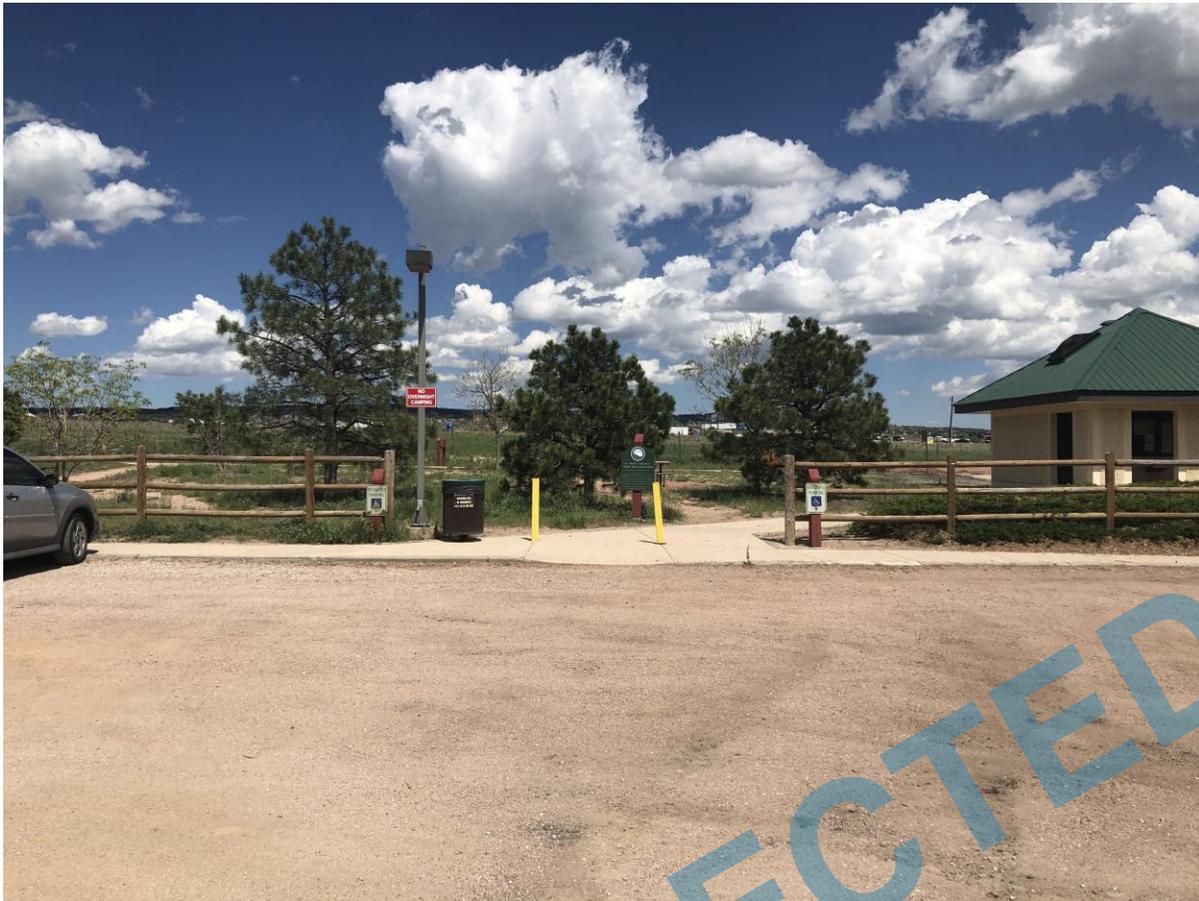
Finding #1 Continued

The surfaces of the accessible parking spaces and access aisles are not firm, stable, and slip resistant.

Compact road top
which is not stable nor
slip resistant

Add 1 van accessible stall with an access aisle . Also add 3 accessible parking stalls ensuring access to an access aisle. Ensure all access aisles connect to the main path of travel. Material used for the new parking stalls shall be stable, firm and slip resistant.

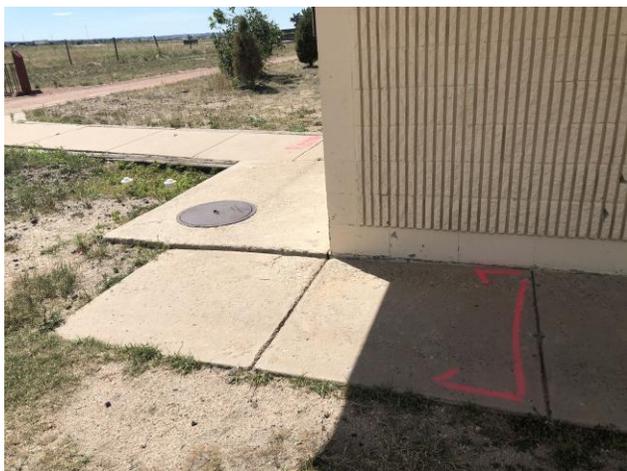
Finding 299376 Main Photo

The walkway contains abrupt vertical edges and/or variations over a 1/4 inch.

Exterior walkway around restrooms contains abrupt vertical changes greater than 1/4/ inch

Replace sections of concrete to ensure a leveled path of travel.

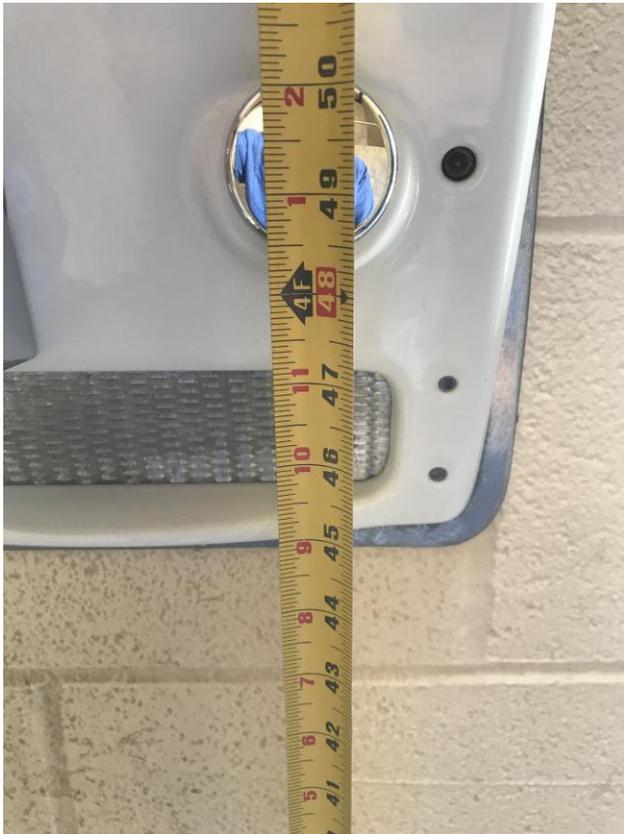
Finding 297231 Main Photo

The hand dryer dispenser's operation mechanism is too high off the floor.

49.25 inches above
finished floor

Lower hand dryer 2 inches minimum. Operable part must not exceed 48 inches above finished floor.

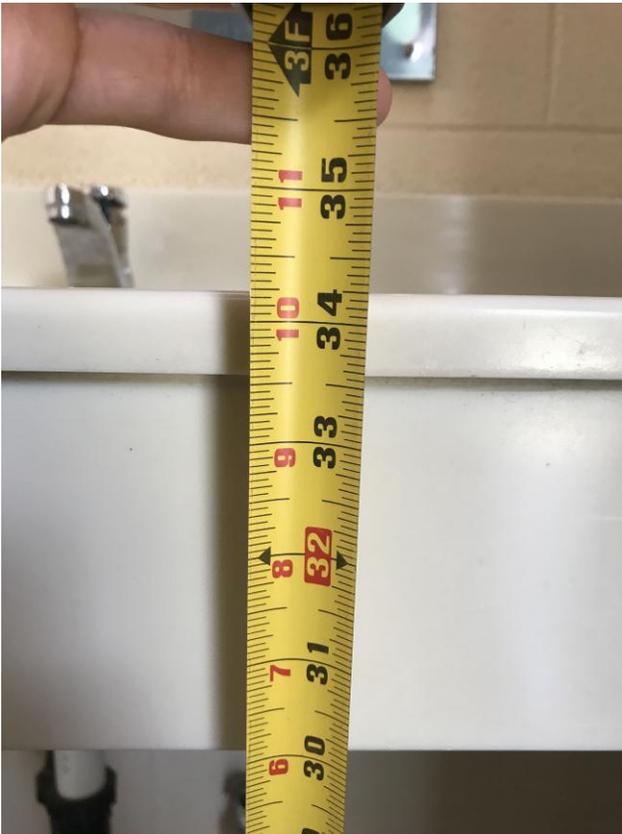
Finding 297232 Main Photo

The top rim of the lavatory is too high.

34.25 inches above finished floor

Lower lavatory .5 to 1.0 inch so that top surface of lavatory does not exceed the 34 inch maximum.

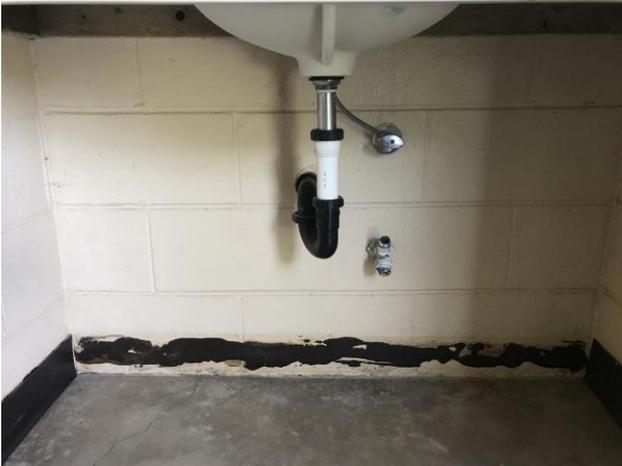
Finding 297233 Main Photo

The water and drain pipes under the lavatory are not adequately insulated.

Missing pipe insulation

Insulate drain pipes under lavatory.

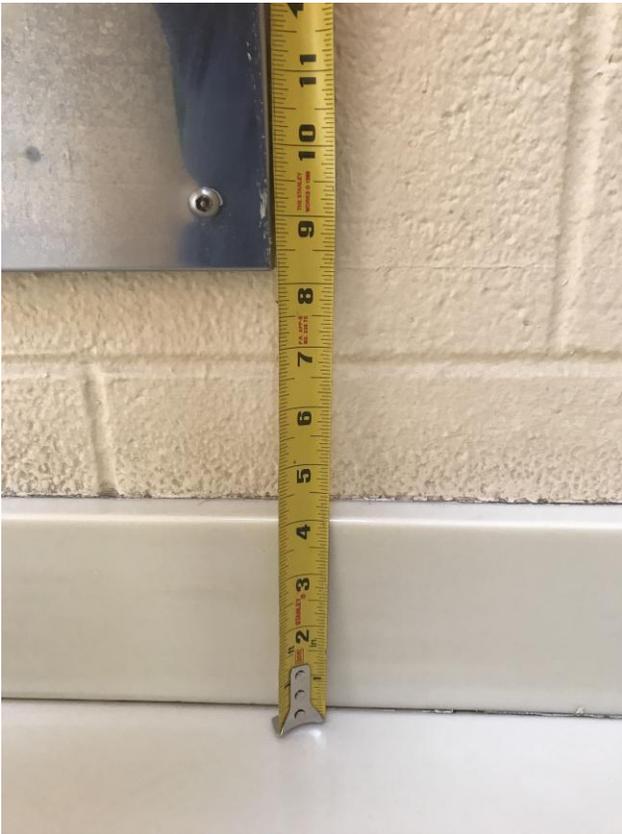
Finding 297234 Main Photo

The mirror is mounted too high.

42.25 inches above finished

Lower mirror so that bottom edge of reflective surface measures no more than 40 inches above the floor.

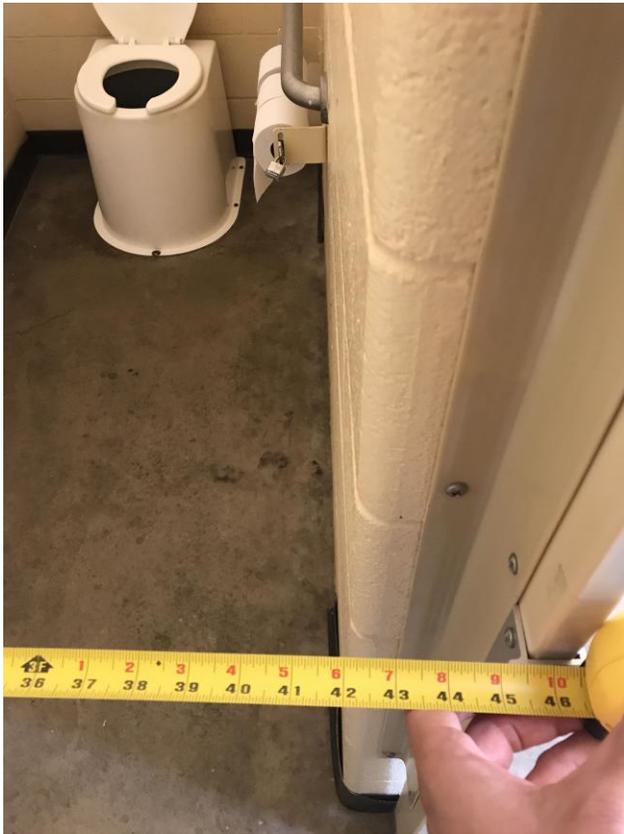
Finding 297235 Main Photo

The toilet compartment is not wide enough.

42.5 inches wide

Toilet compartments should be a minimum of 60 inches. Due to space restrictions, meeting compliance may not be possible. A full project remodel is in the planning stages.

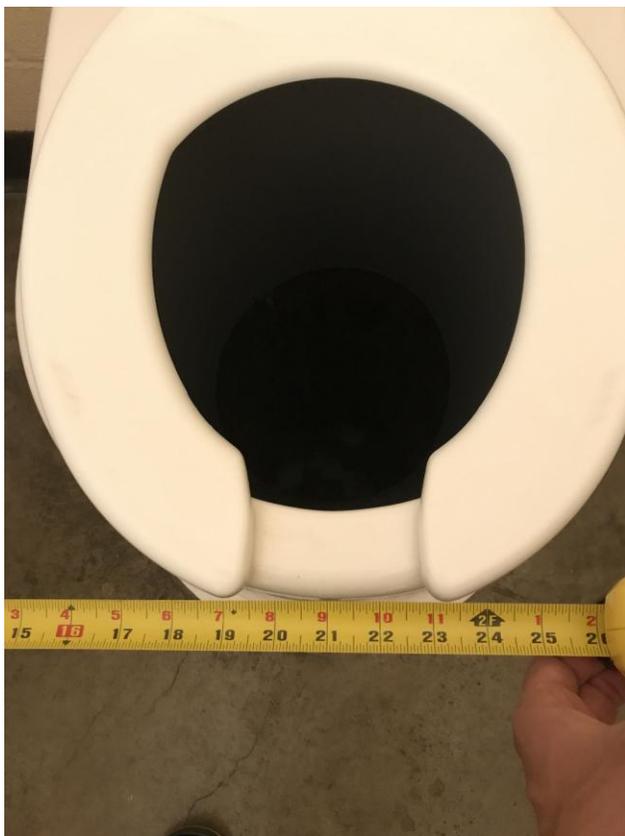
Finding 297236 Main Photo

The toilet is not located within the range allowed from the side wall or partition.

21.5 inches from side wall to centerline of toilet

Re-position toilet between 16 inches minimum and 18 maximum from centerline of toilet to side wall. A full project remodel is in the planning stages.

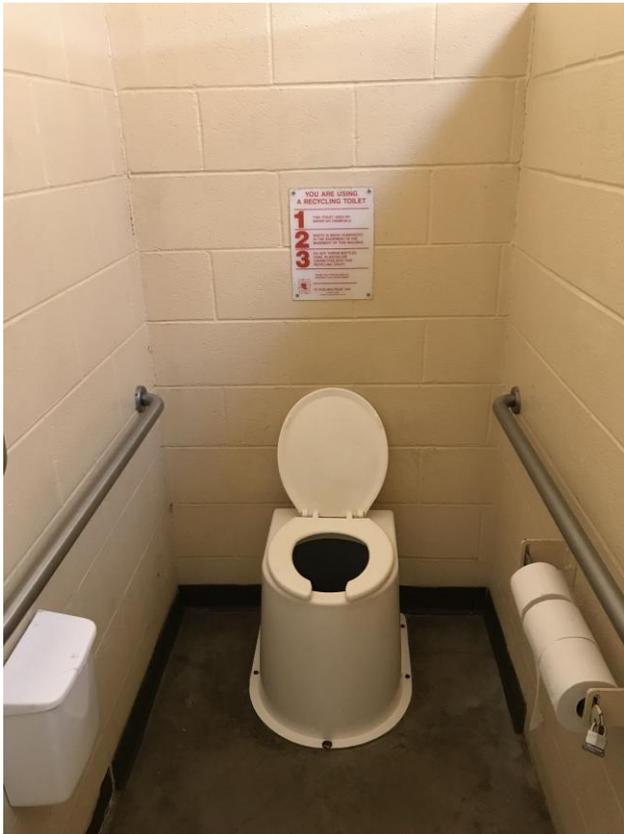
Finding 297237 Main Photo

The rear grab bar is missing.

Missing rear grab bar

Install rear grab 12 inches from centerline of water closet to wall side and 24 inches from centerline of water closet to transfer side.

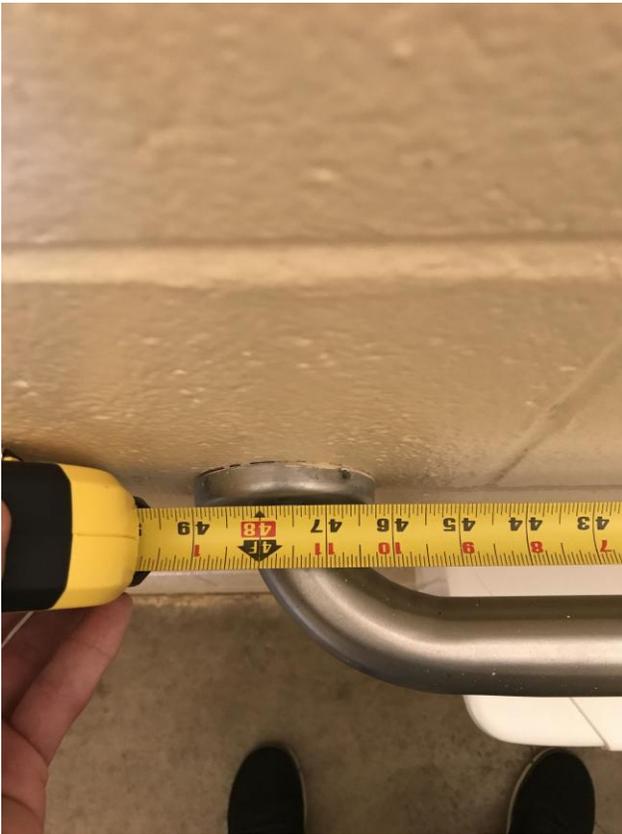
Finding 297238 Main Photo

The side grab bar does not extend far enough from the rear wall.

47.5 inches from rear wall

Adjust side grab bar to extend at least 54 inches minimum beyond the rear wall and start a maximum of 12 inches from the rear wall.

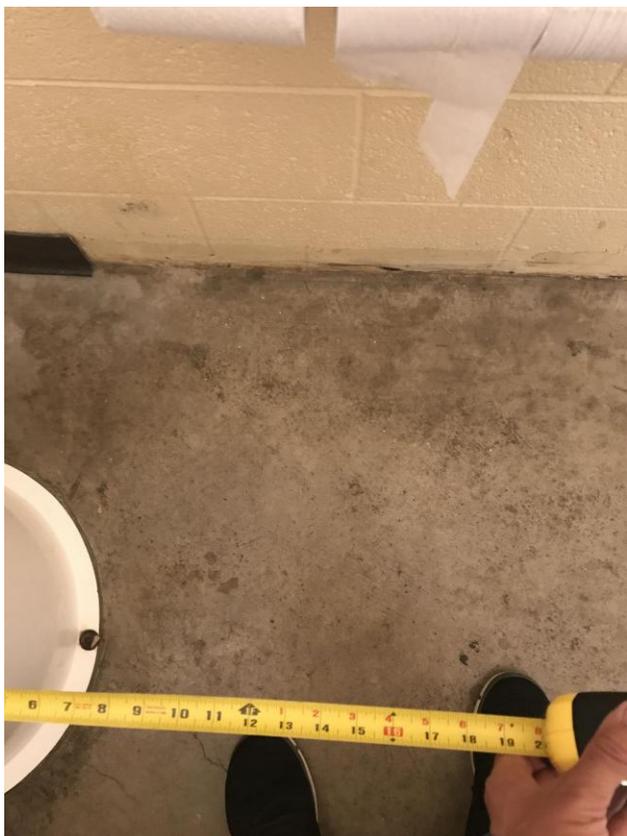
Finding 297239 Main Photo

The toilet paper is not installed within the compliant range in front of the toilet.

13 inches in front of toilet

Re-position toilet paper dispenser between 7 to 9 inches in front of toilet measured to the centerline of the toilet paper dispenser.

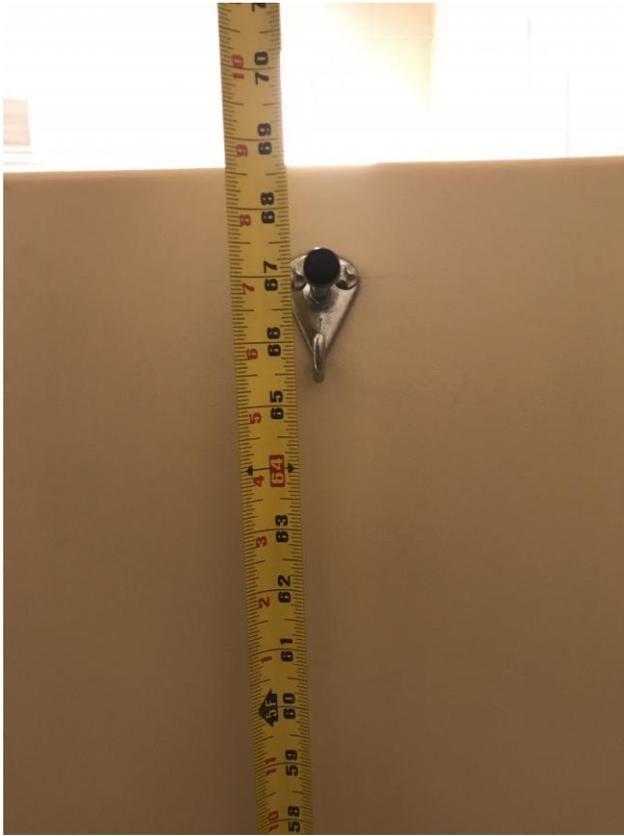
Finding 297240 Main Photo

The coat hook is installed greater than 48 inches above the finished floor.

67 inches above
finished floor

Considered
Unobstructed

Lower coat hook a minimum of 20 inches or install another coat hook. A maximum height of 48 inches is allowed above the finished floor.

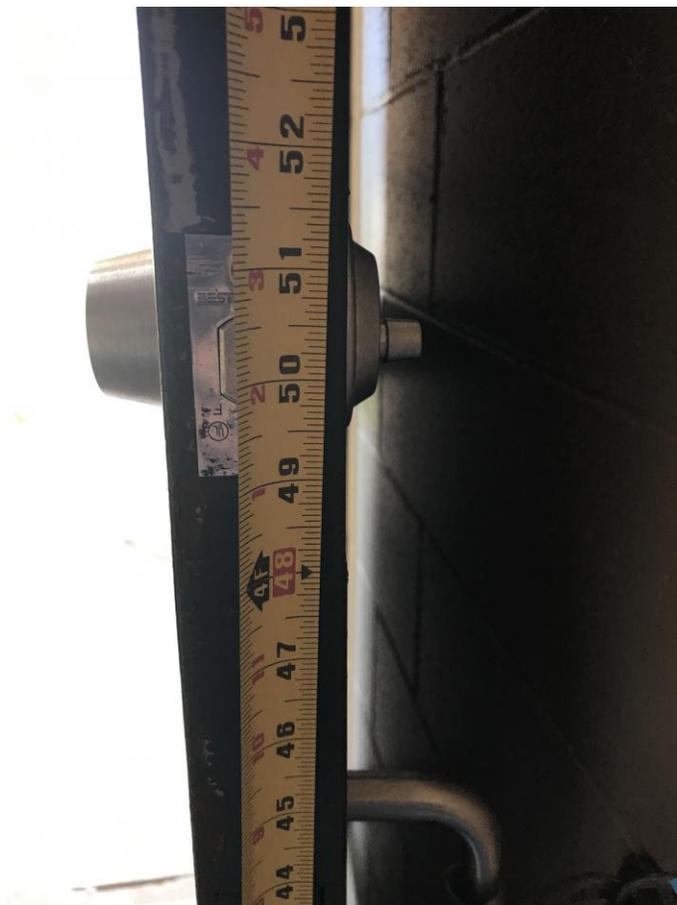
Finding 297241 Main Photo

The door operating hardware is too high.

50 inches above
finished floor

Replace door with opening hardware located between 34 inches minimum and 48 inches maximum above finished floor.

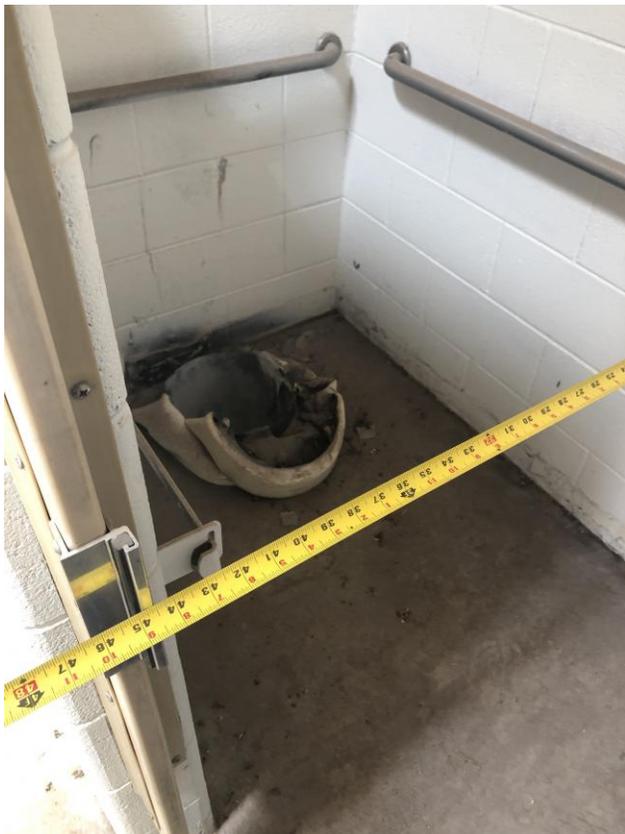
Finding 297246 Main Photo

The toilet compartment is not wide enough.

44 inches in width

Toilet compartments should be a minimum of 60 inches. Due to space restriction, meeting compliance may not be possible. A full project remodel is in the planning stages due to recent fire damage. The women's restroom adjacent is being utilized temporarily as a unisex restroom.

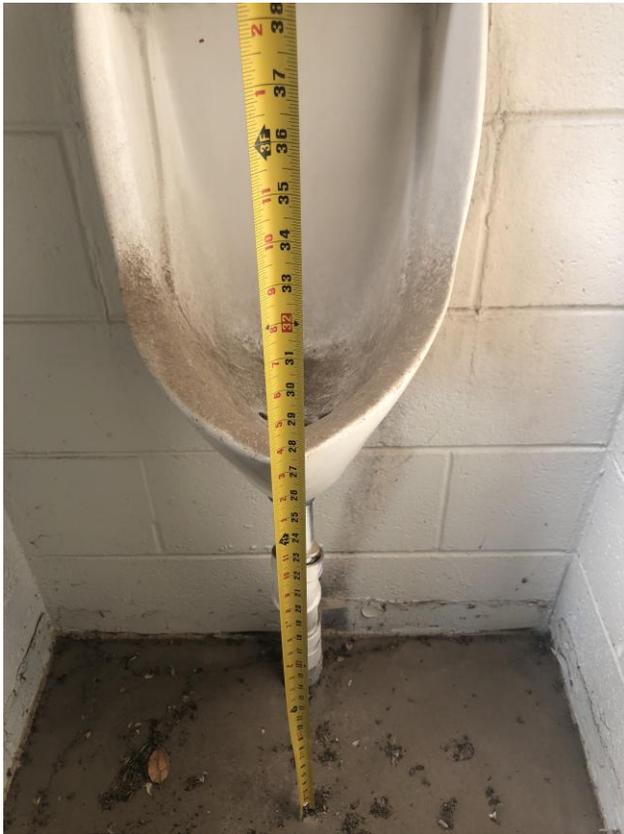
Finding #15 Continued

The rim of the urinal is too high.

Rim height at 27.5 inches above finished floor

Lower or replace urinal to meet compliance. A rim height of 17 inches maximum above the finished floor and rim projecting a minimum of 13.5 inches from wall.

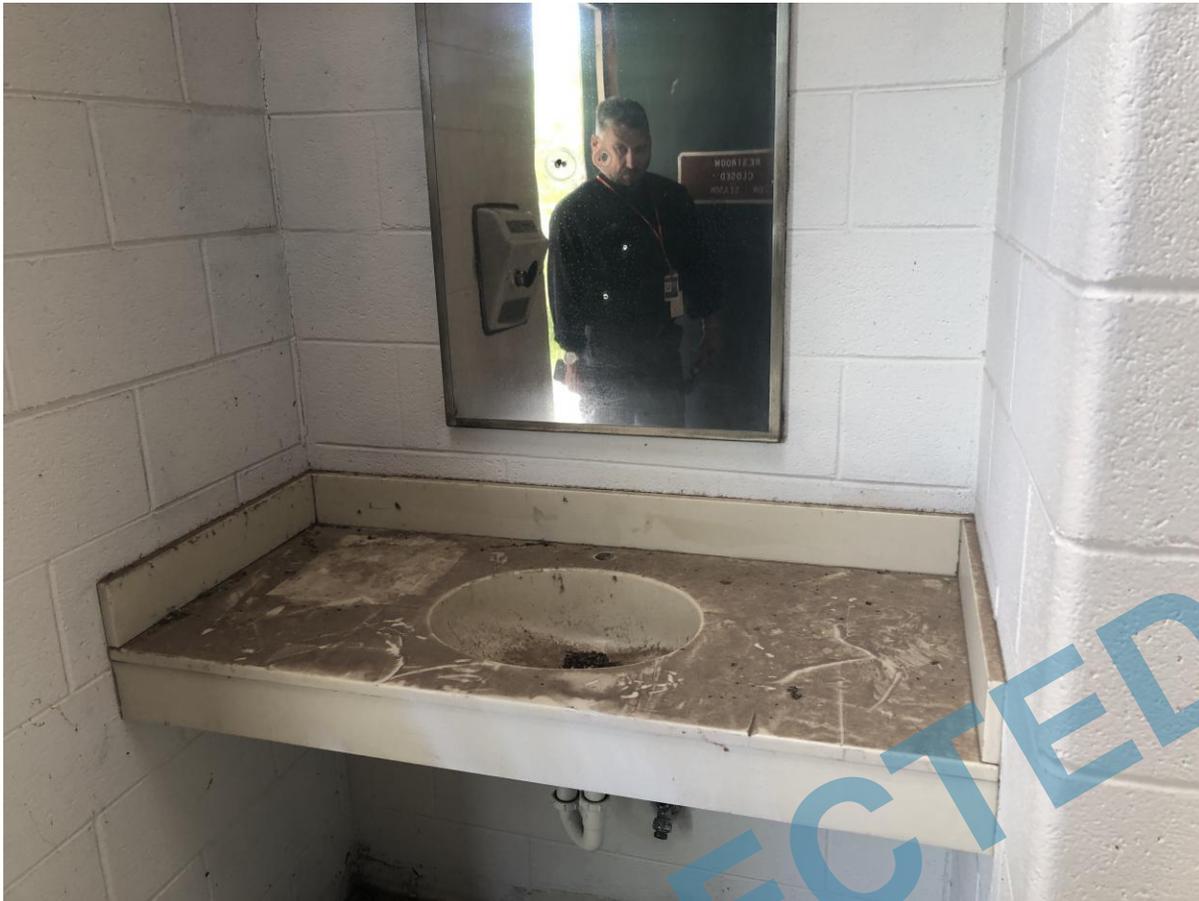
Finding #16 Continued

Inoperable lavatory due to recent fire damage.

Inoperable lavatory

A full project remodel is in the planning stages due to recent fire damage.
The women's restroom adjacent is being utilized temporarily as a unisex restroom.

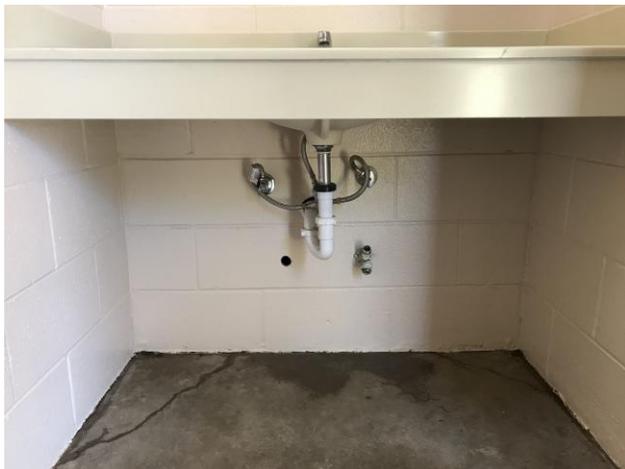
Finding 299236 Main Photo

The water and drain pipes under the lavatory are not adequately insulated.

Missing pipe insulation

Insulate drain pipes under lavatory.
