End User Impacts of Automated Electrochromic Windows in a Pilot Retrofit Application

Eleanor S. Lee, Erin S. Claybaugh, Marc LaFrance¹

Published in: *Energy and Buildings* 47 (2012) 267-284.
doi 10.1016/j.enbuild.2011.12.003.

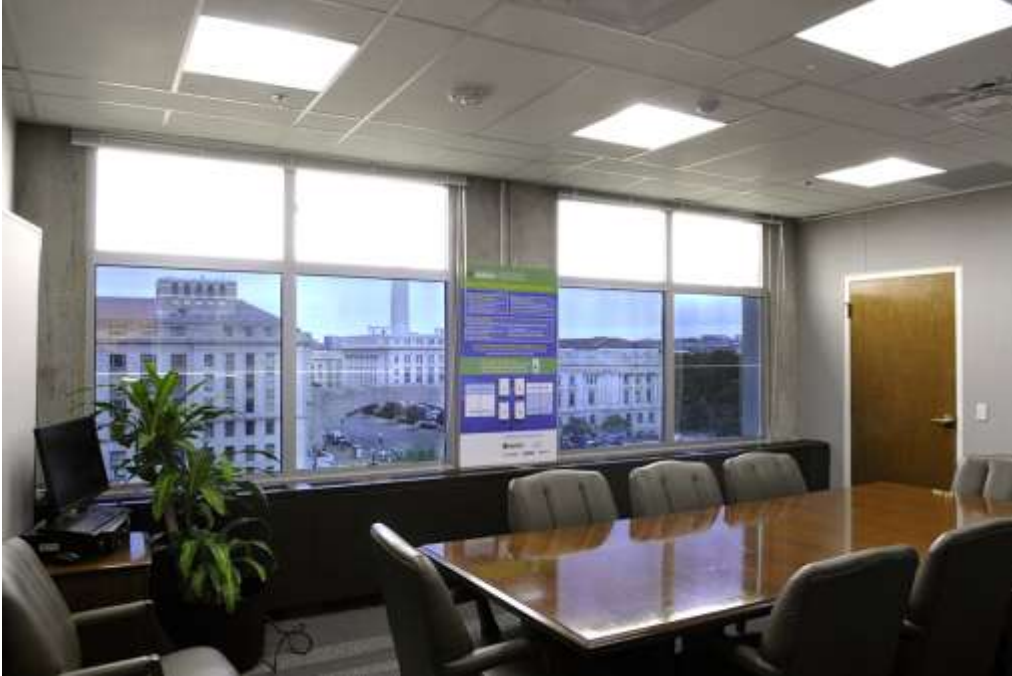
Fig. 1. Interior view of the conference room with upper and lower control zones.

The pilot demonstration occurred in a single, west-facing, 5.94 m wide by 4.57 m deep by 2.74 m high (19.5 x 15 x 9 ft) conference room located on the sixth floor of a seven-story office building in Washington DC (Figure 1). The existing conventional single-pane windows and lighting system were replaced with commercially-available, dual-pane EC windows and a dimmable lighting system. The interior of the conference room had light gray walls, a dark gray carpet, and a white acoustical tile ceiling. Furnishings included a large wooden conference table and chairs. There were two entry doors: one leading to an open plan interior work area, the other leading to an adjacent office. Space conditioning was provided through the overhead diffusers with supplementary space conditioning provided by a convector unit at the perimeter windows (air was blown at a 45° angle away from the window).

Each EC window was subdivided into an upper and lower zone, consisting of two panes per zone (Figure 1). Each upper pane was 1.06 m wide by 0.61 m tall (3.46 x 1.99 ft). Each lower pane was 1.06 m wide by 1.26 m tall (3.46 x 4.12 ft) subdivided by a thin horizontal bus bar in the middle of the glazing (0.63 m, 2.07 ft from the edge). The upper panes of the two windows were grouped into one automated control zone. The lower panes were grouped in a similar way.

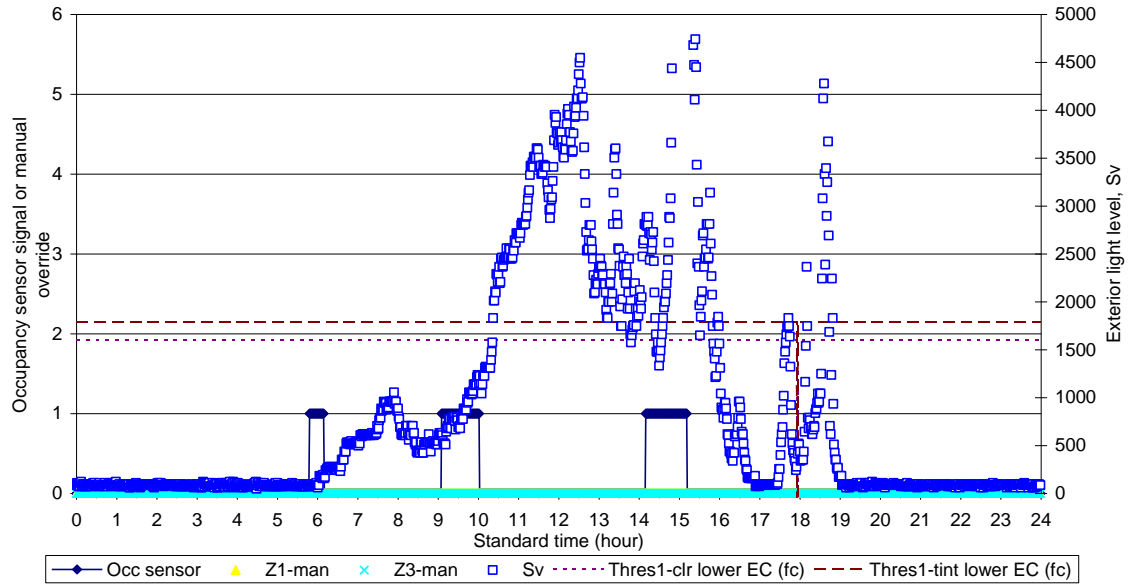
- 1) occupancy (1=occupied, 0=not) (left y-axis)
- 2) manual override of Z1 and Z3 where 1=override, 0=auto, -1=error (left y-axis) (no override for this day)
- 3) Sv = vertical exterior light level with clear and tint thresholds for lower window zones indicated as dotted lines (right y-axis)

- 1) Desired control state -- see Table 2 (left y-axis)
- 2) Desired EC color (0=bleach, 1=tint) (left y-axis)
- 3) Is control of Z1 and Z3 correct? (1=yes, -1=no, -10=sim or switch error) (right y-axis)

Fig. 2. Example graphs of control diagnostics for July 29, 2009.

For each monitored day, sensor inputs were used to independently determine the automatic state of the EC windows (Figure 2). These computed values were compared to the actual state of controls and queries were made when the two values disagreed. Periods when the automated system was manually overridden were excluded from this analysis. There were a few errors in the data stream that complicated the analysis: a) bad lines of data, and b) erroneous pane status data. The first error was due to noise on the

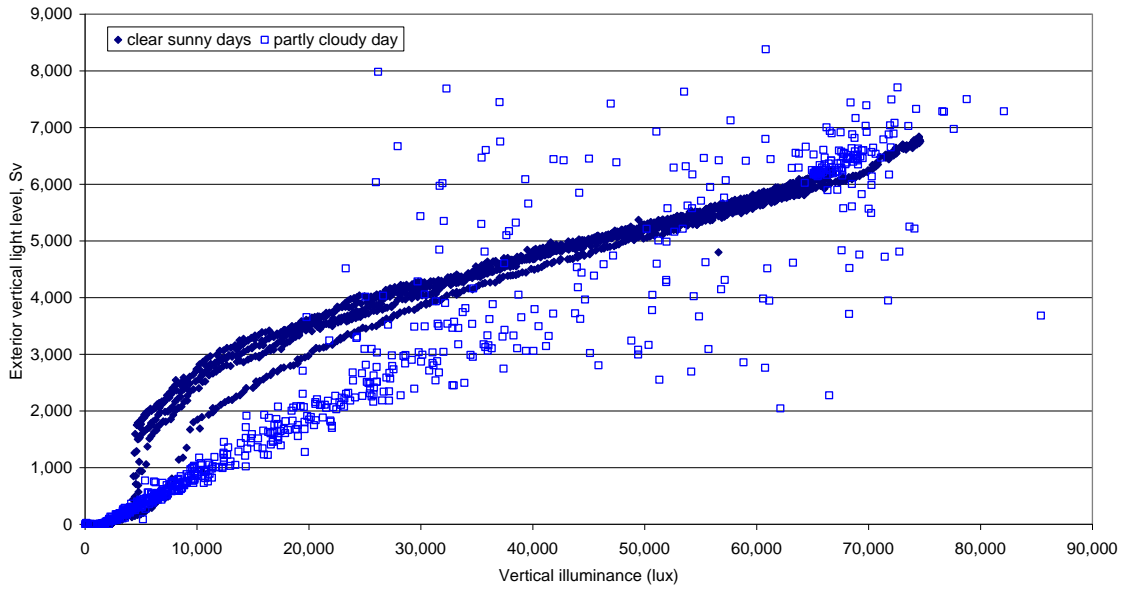
Fig. 3. Relationship of exterior vertical illuminance to exterior vertical light level, Sv, measured by the commercial light sensor. Data are given for clear sunny days (September 4, 6, 7, 8, and 20, 2009) and one partly cloudy day (September 5, 2009). Note the variation in output as solar angles change on clear sunny days over the course of the month.

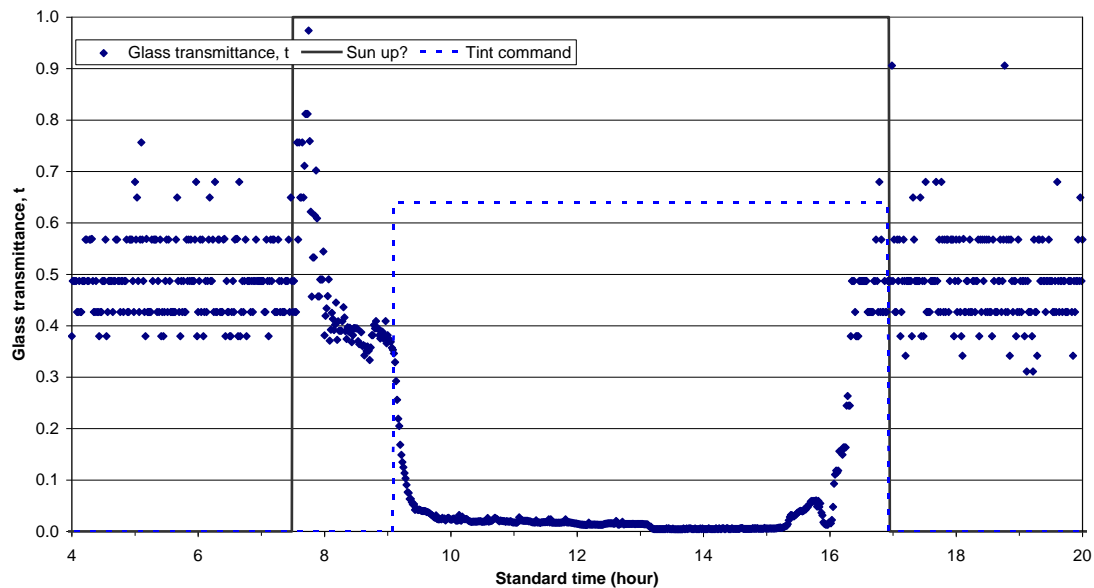
Fig. 5. Measured “t” ratio of interior vertical illuminance to exterior vertical light level, S_v , on a cold, partly sunny day (December 21, 2009). A positive “sun up” value indicates the time when the sun is above the horizon.

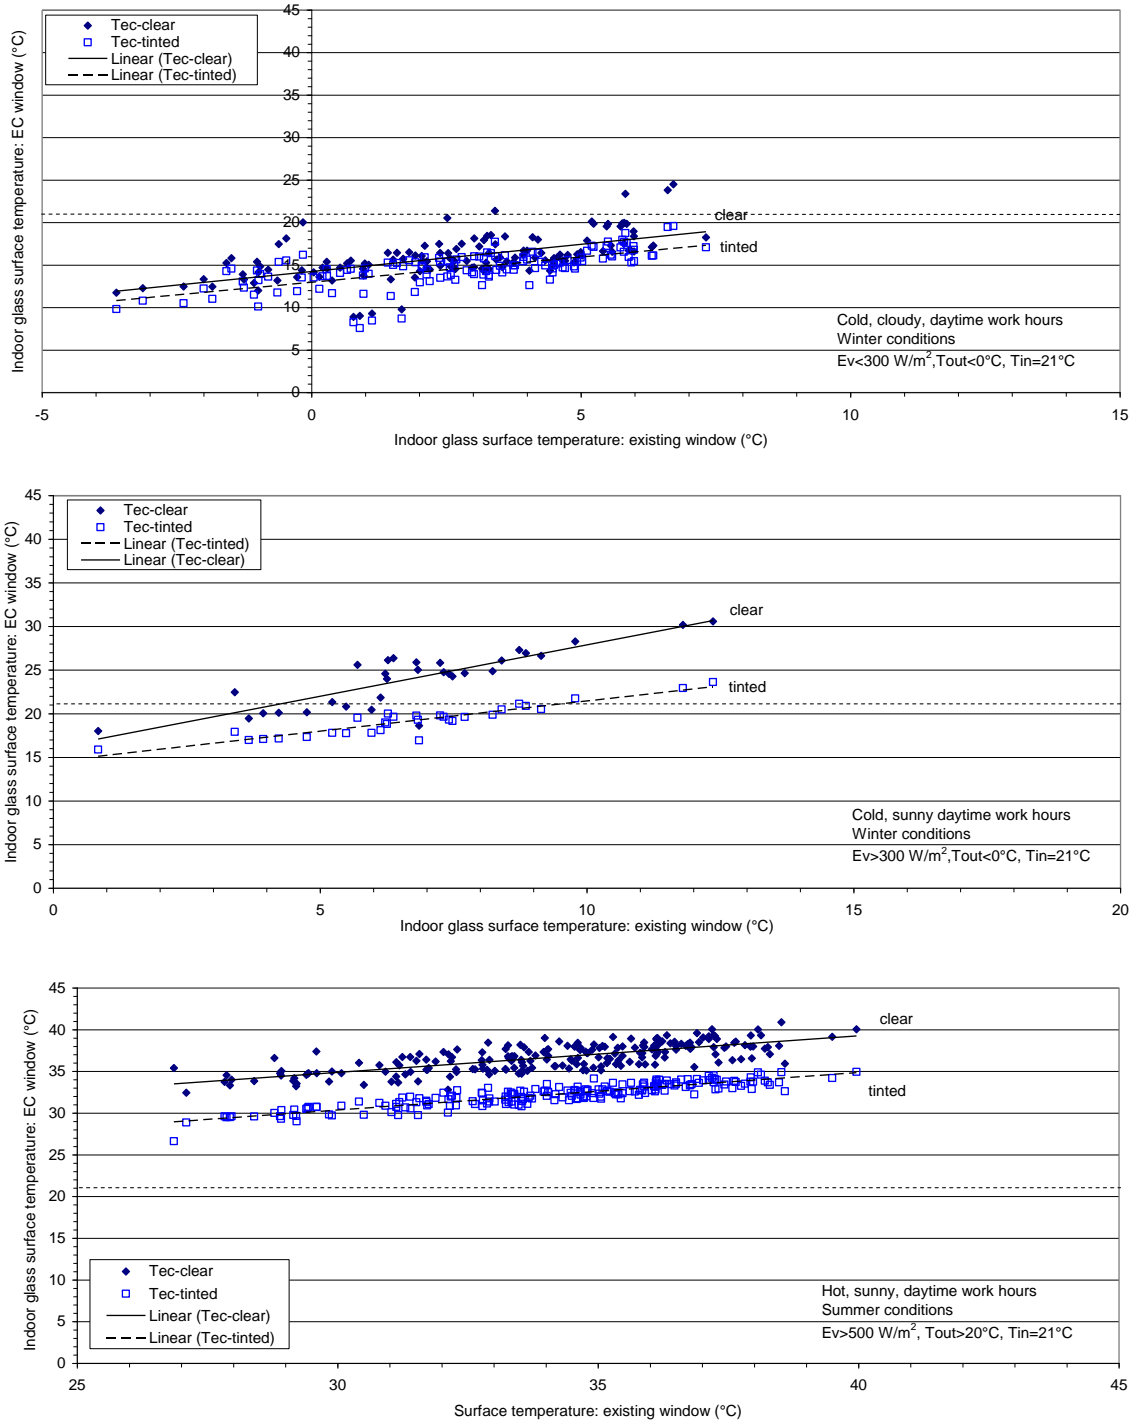
Fig. 7. Indoor glass surface temperature of the existing and EC window during daytime work hours when outdoor environmental conditions were a) cold and cloudy (top), b) cold and sunny (middle), and c) hot and sunny (bottom) as determined by EnergyPlus simulations. The horizontal line at 21°C indicates when EC surface temperature is near the ambient air temperature level.

During daytime work hours when outdoor conditions were cold and cloudy, the indoor EC glass surface temperature (surface #4) in the clear or tinted state was found to be an average of 13-14°C (23-25°F) warmer than the indoor glass surface temperature of the existing window. The average indoor surface temperature of the existing window was 2°C (36°F) under these conditions while the average indoor surface temperature of the EC window was 15-16°C (59-61°F) (Figure 7a). The ambient room air temperature was 21°C (70°F). Cold, cloudy outdoor conditions were defined by all hours in the year when the outdoor dry-bulb temperature was less than 0°C (32°F) and the exterior vertical irradiance level, E_v , was less than 300 W/m². E_v values in this range denoted conditions during early morning and early afternoon hours on clear days or cloudy days for this west-facing orientation. Summary data are given in Table 7.

During daytime work hours when outdoor conditions were cold and sunny, the indoor glass temperature of the EC window was 17°C or 12°C (31° F or 22°F) warmer than the existing window for the clear and tinted states, respectively (Figure 7b). The average indoor surface temperature of the existing window was 7°C (44°F) under these conditions while the average indoor surface temperature of the EC window was 24°C and 19°C (75°F and 66°F). Cold, sunny conditions were defined by outdoor temperatures less than 0°C (32°F) and E_v levels greater than 300 W/m².

During daytime work hours when outdoor conditions were hot and sunny, the indoor glass surface temperature of the EC window in the clear state was $3\pm 2^{\circ}\text{C}$ ($5\pm 4^{\circ}\text{F}$) on average warmer than the existing window but in the tinted state, the EC window was $2\pm 2^{\circ}\text{C}$ ($4\pm 4^{\circ}\text{F}$) cooler than the existing window. The average indoor surface temperature of the existing window was 34°C (93°F) under these conditions while the average indoor surface temperature of the EC window was 37°C and 32°C (98°F and 90°F) for the clear and tinted states, respectively (Figure 7c). Hot, sunny conditions were defined in this case by outdoor dry-bulb temperatures greater than 20°C (68°F) and incident vertical irradiance levels greater than 500 W/m^2 . The ambient room air temperature was 24°C (75°F).
