## Toilets dominate environmental detection of SARS-CoV-2 virus in a hospital

*Background:* Respiratory and faecal aerosols play a suspected role in transmitting the SARS-CoV-2 virus. We performed extensive environmental sampling in a dedicated hospital building for Covid-19 patients in both toilet and non-toilet environments, and analysed the associated environmental factors.

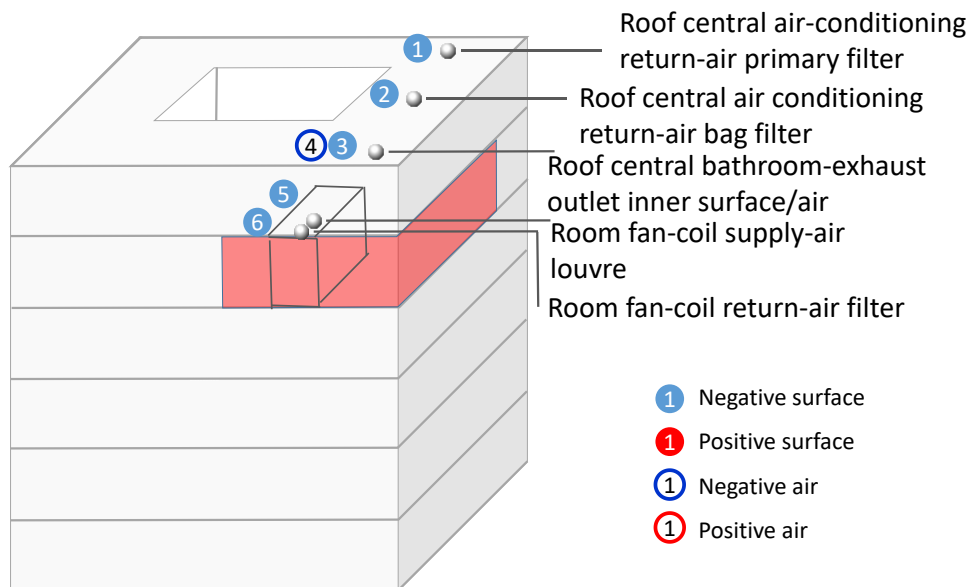
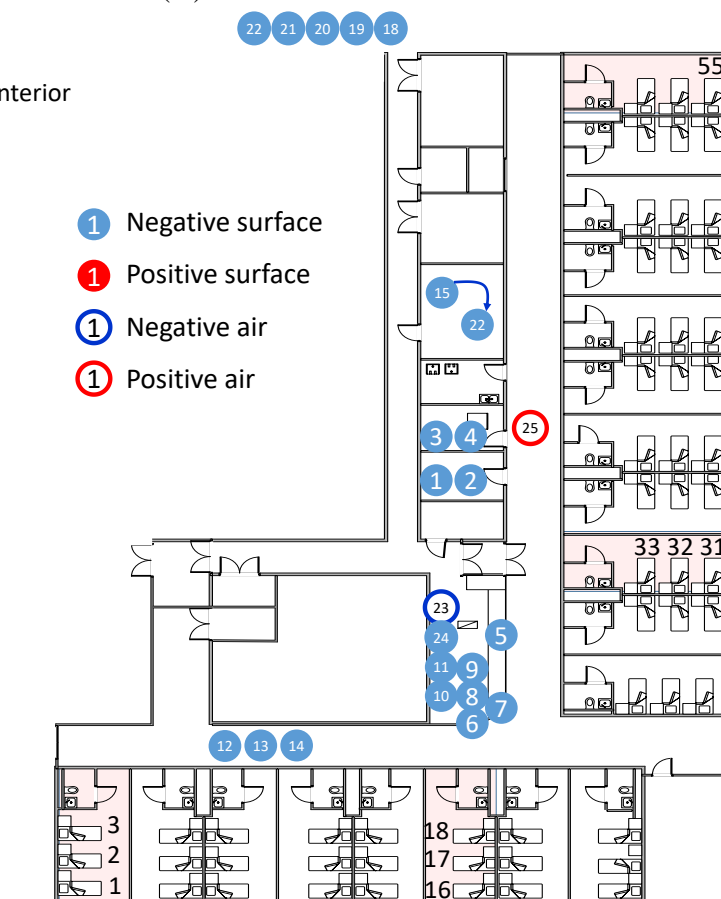
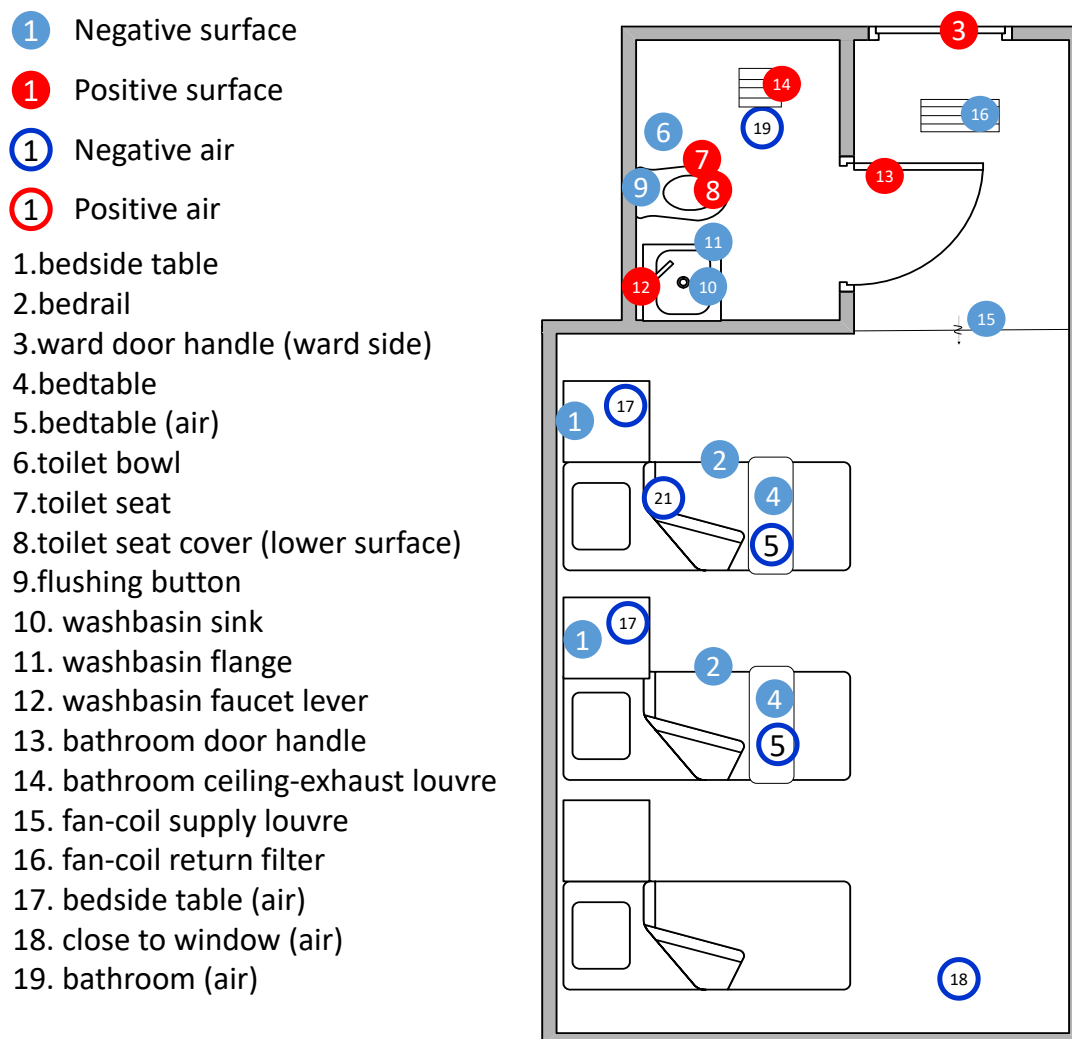
1. cleaner's: mop
2. squeeze mop
3. Storage room: medical waste-bin (interior surface)
4. medical waste-bin pedal
5. nursing station: front desk
6. door handle
7. disinfectant-station button
8. computer keyboard
9. operating clinical desk
10. phone
11. hand-disinfectant spray button
12. corridor: nurses' trolley handle
13. nurses' tray
14. handrail
15. change room: desk
16. Floor
17. hand-disinfectant spray button
18. waste-bin interior surface
19. waste-bin pedal
20. washbasin sink
21. washbasin flange
22. washbasin surface
23. nursing station: below air-supply inlet (air)
24. nursing station: below air-supply inlet (surface)
25. corridor outside storage room

**Figure 1.** Summary of the sites where the air and surface samples were taken in the hospital. (A) In the air-conditioning systems of the isolation rooms and on the building roof. The highlighted area in red is the airborne infectious disease zone on the 5<sup>th</sup> floor; (B) at the nursing station, storage/cleaner’s rooms, healthcare workers’ PPE changing room, and corridor; and (C) in the isolation rooms, but note that in some of the rooms, fewer surface and air samples were taken than are shown here. The positive samples are shown by either empty circle in red or filled circle in red. The negative samples are shown by either empty circle in blue or filled circle in blue. In Figure 1B, the four sampled rooms are highlighted in light red, i.e. isolation rooms containing beds 2 and 3, beds 16-18, beds 31 and 32, and bed 55.

The sites for the air and surface samples are shown in [Figure 1](#). All samples were collected by a trained CDC officer who had a medical background, assisted by two trained nurses from the hospital. The CDC officer wore full personal protective equipment (PPE), namely an N95 respirator, goggles, face shield, gloves, shoe covers, cap, and gown. He was quarantined for 12 days after the collection on 8 February, disinfected, and resumed sampling on 20 and 22 February. Thereafter he was quarantined again for another 14 days, and again disinfected.

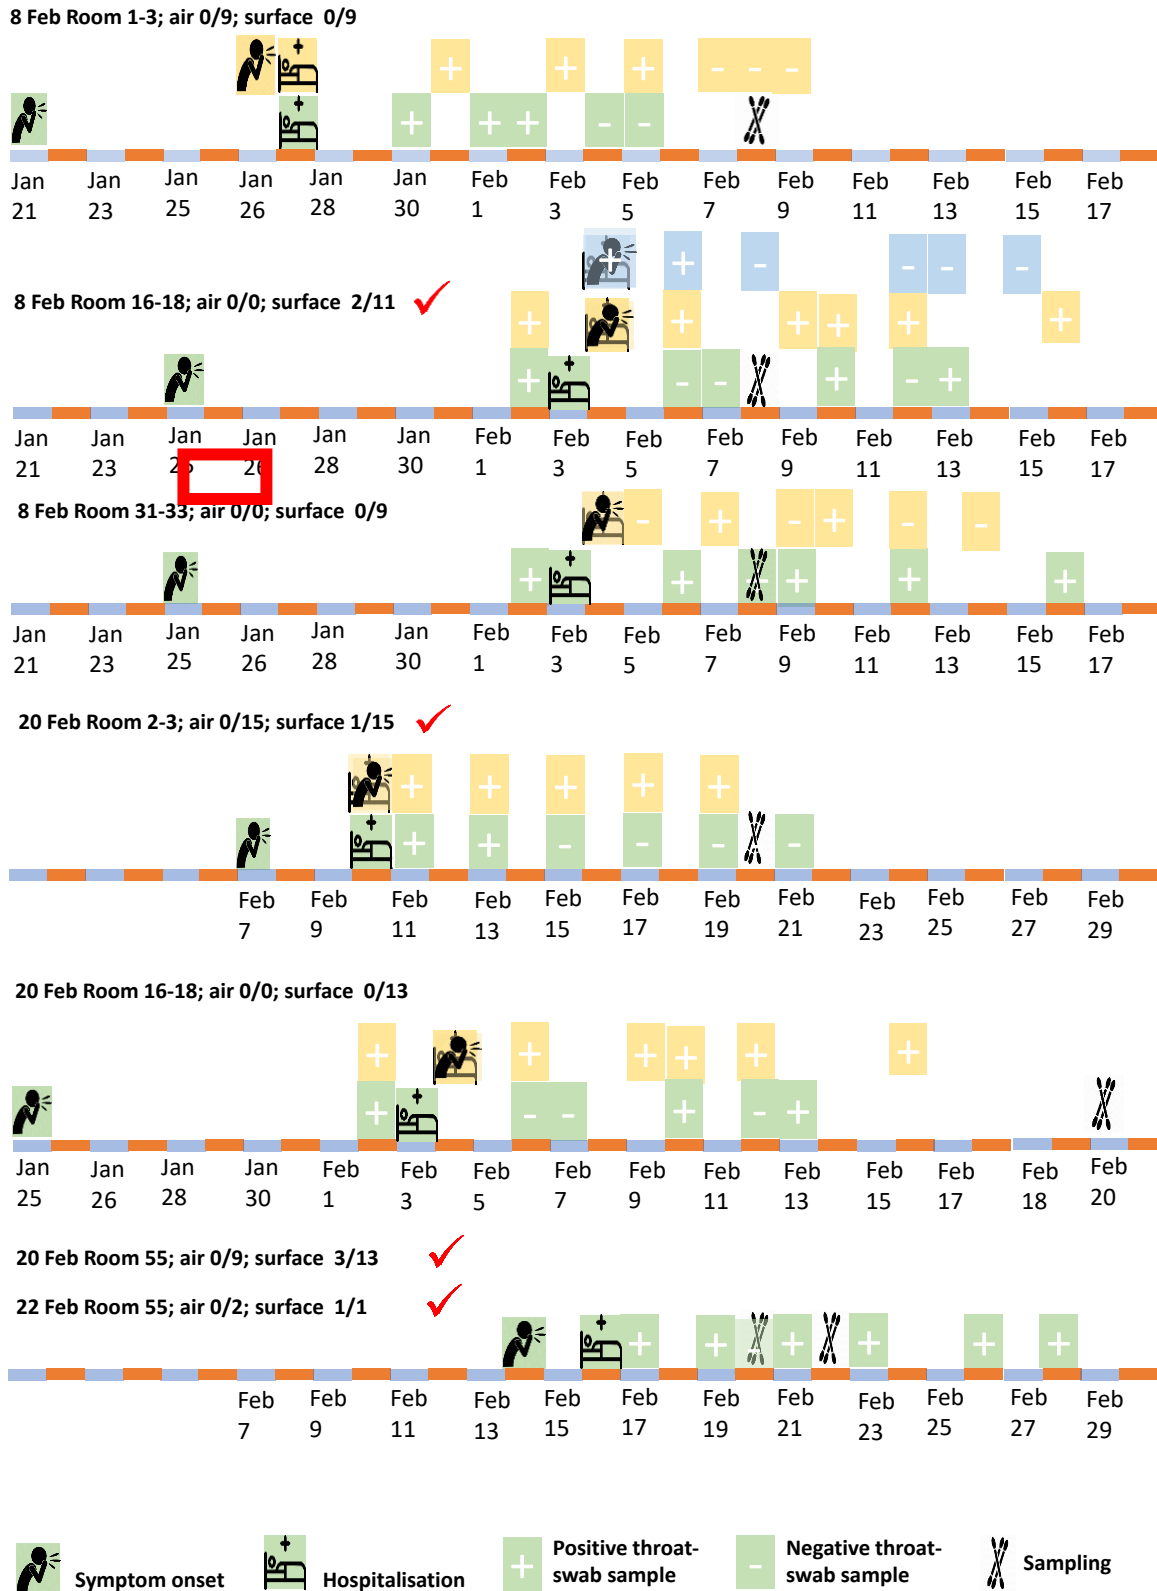
**Figure 2.** Summary of the isolation rooms containing beds 2 and 3, beds 16-18, beds 31 and 32, and bed 55, and their 10 patients (onset and hospitalisation dates), and the sampling dates. The sampling dates on which positive samples were detected are also shown by a red tick. In each room, a patient and his/her bed are shown in the same colour. When events occurred on the same day, such as symptom onset and hospitalisation, the symbols overlap and are shown in transparent style.

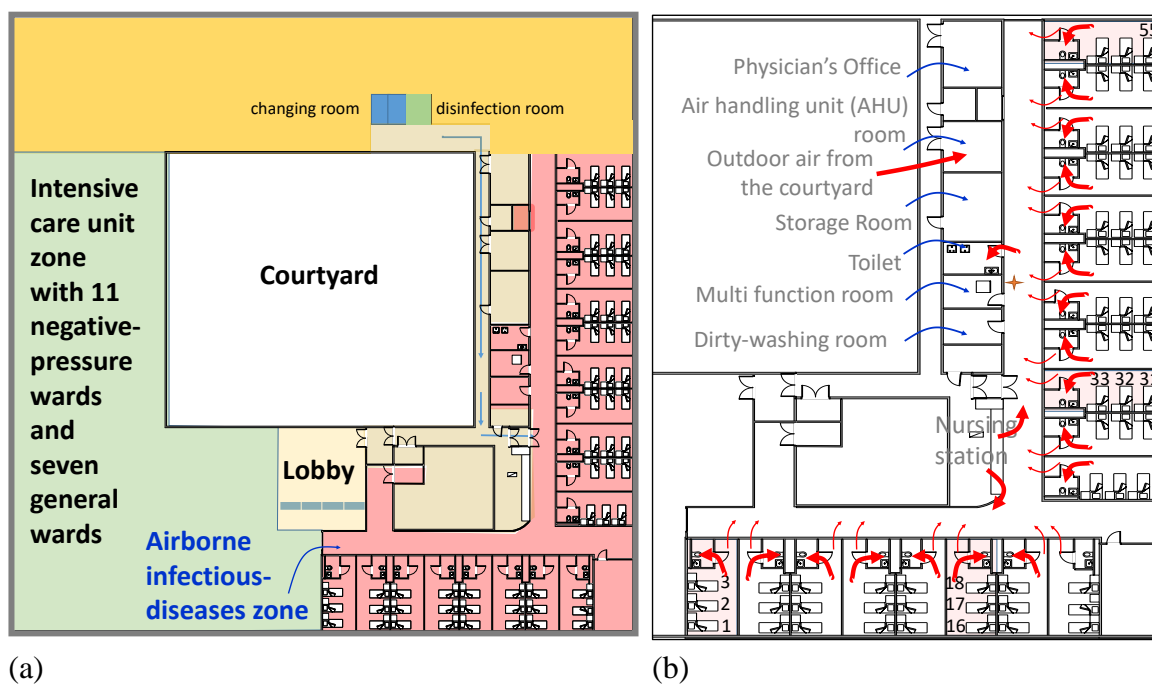
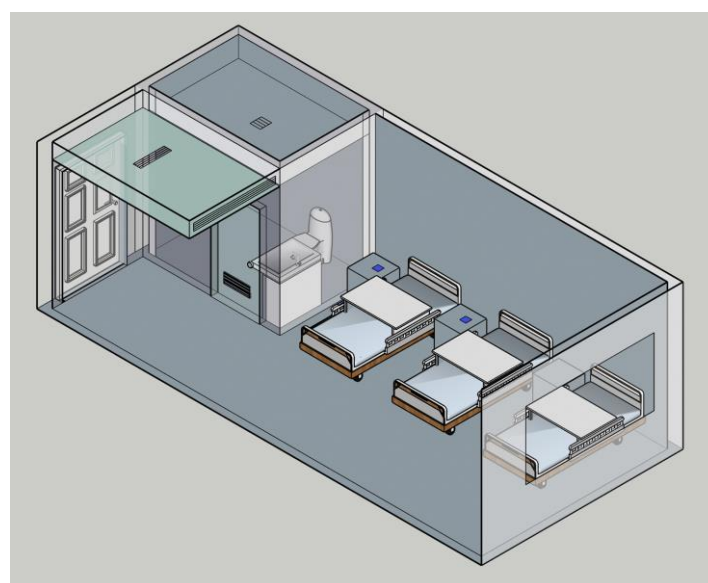
**Figure S1.** (a) Floor plan of the fifth floor of the hospital, with the airborne infectious-disease zone shown in transparent pink. (b) Floor plan of the airborne infectious-disease zone showing the location of the sampled isolation rooms (with beds 1-3; beds 16-18; beds 31-33; bed 55 shown), nursing station, and other rooms. The general airflow pattern is shown by red arrows. (c) Three-dimensional perspective view of the isolation room, showing the location of various objects.
