Site Accessibility Evaluation

Americans with Disabilities Act Title II (Public Services: State and Local Government)

DOT Operations Center

**3275 Akers Dr
Colorado Springs, CO
80922**

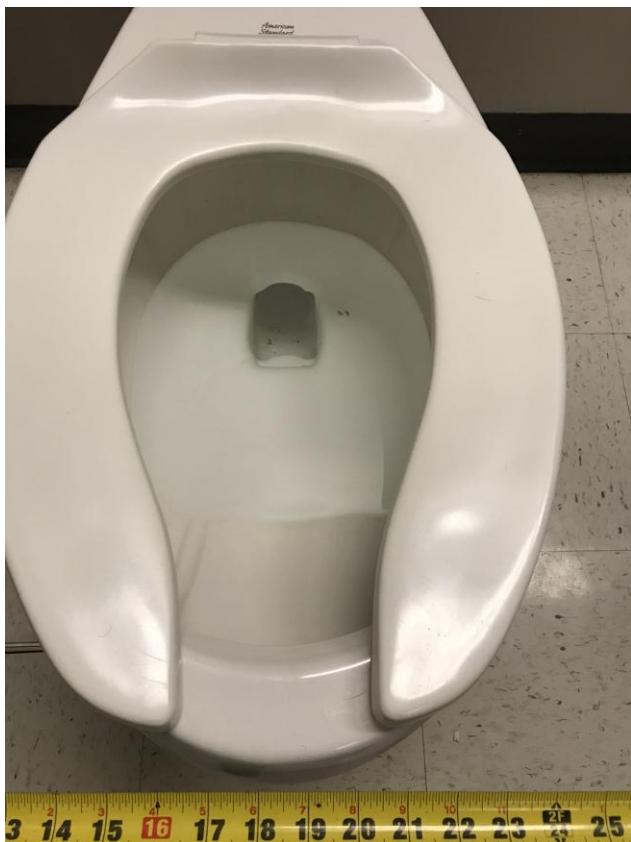
Finding 299213 Main Photo

Administrative Area Men's Restroom

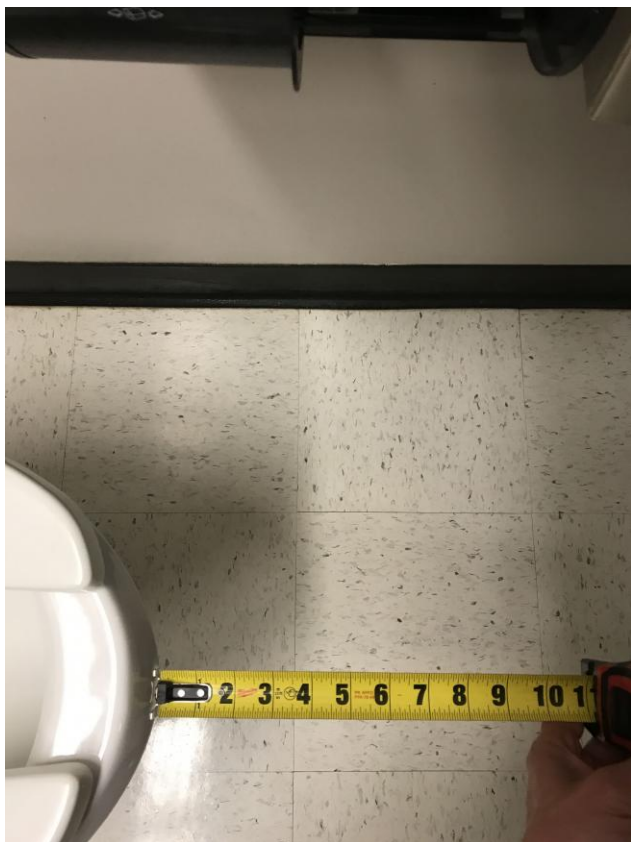
Finding 299215 Main Photo

Mens Public Restroom

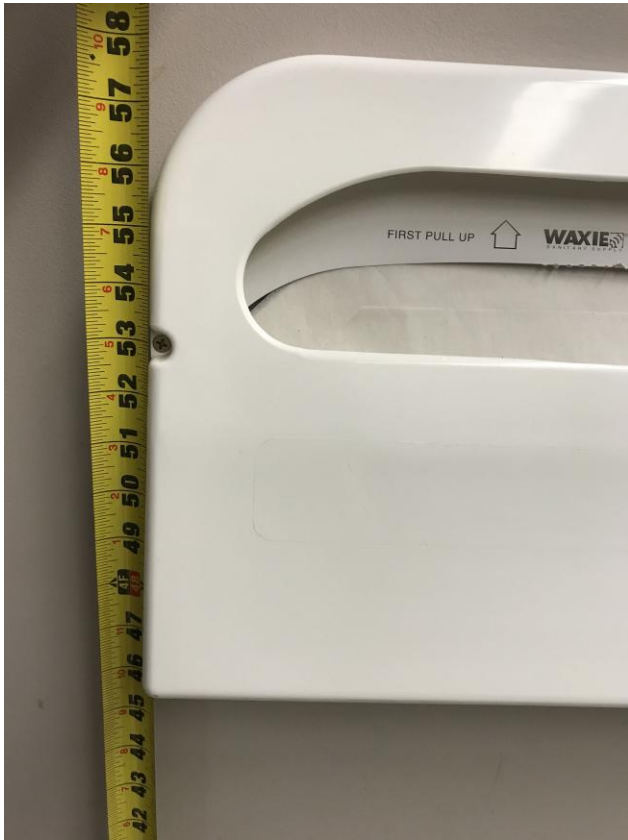
Finding 299202 Main Photo

Mens Public Restroom

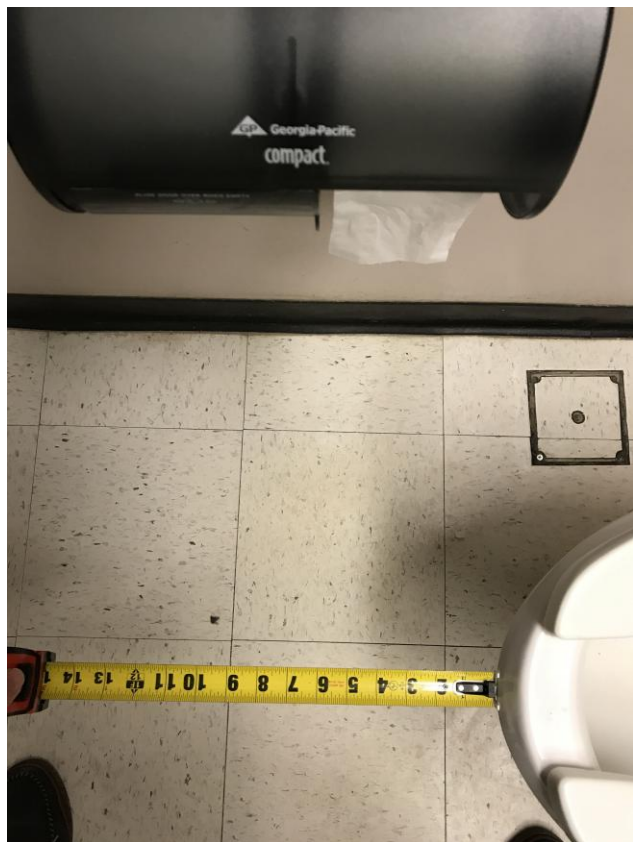
Finding 299203 Main Photo

Womens Public Restroom

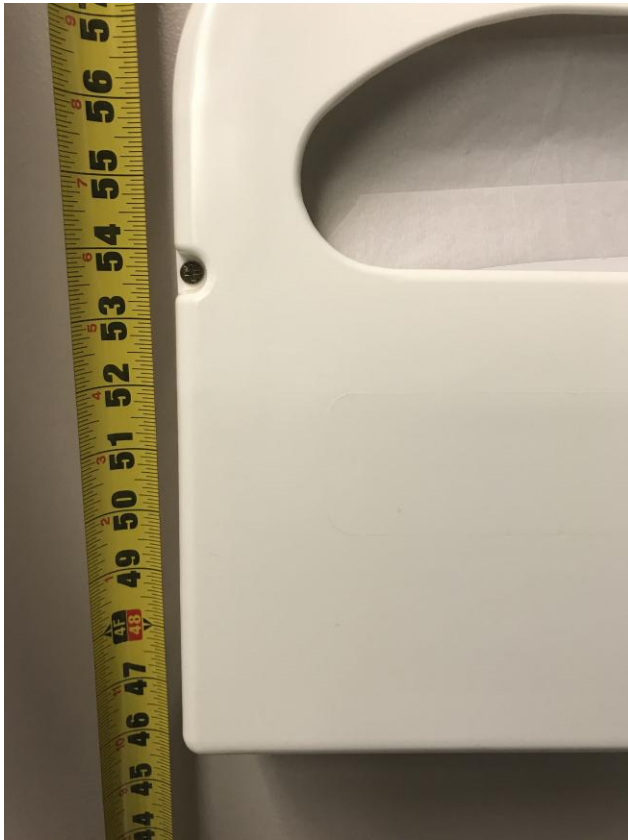
Finding 299205 Main Photo

Womens Public Restroom

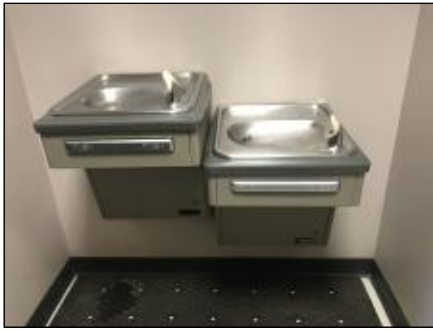
Finding 299208 Additional Photo

East Hallway Drinking Fountain
