# Site Accessibility Evaluation

**Human Services 17 N.  
Spruce**

**Accessibility Evaluation**

***Inspection Date: 04/08/2019***

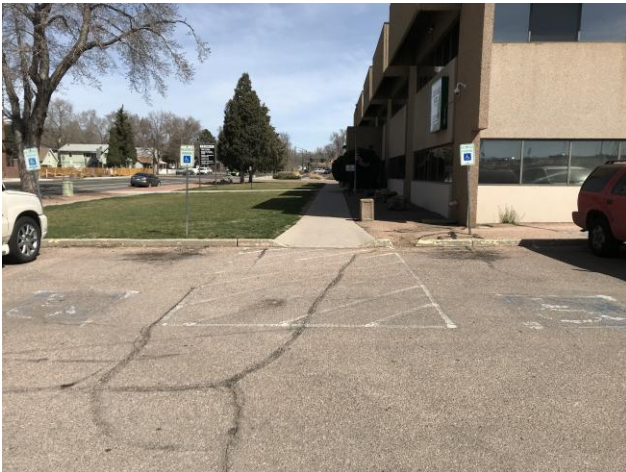
Finding #1 Continued

The striping and markings for the accessible parking stall's, loading/unloading access aisle are dilapidated and in need of repair and/or maintenance.

Access aisle and accessible parking stalls striping barely visible

Re-stripe parking lot to include 2 accessible parking stalls, 2 van accessible parking stalls, van access aisle and the international symbol of accessibility on the accessible parking stalls.

Corrective Action: Work order # 461133 submitted on 5/2/19

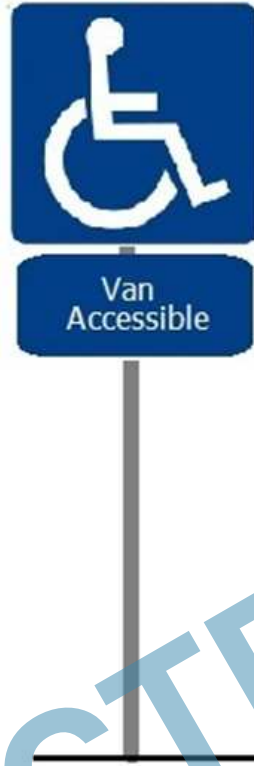
Finding #2 Continued

The van stall is missing a sign identifying it as a van accessible stall.

Van accessible signage is missing

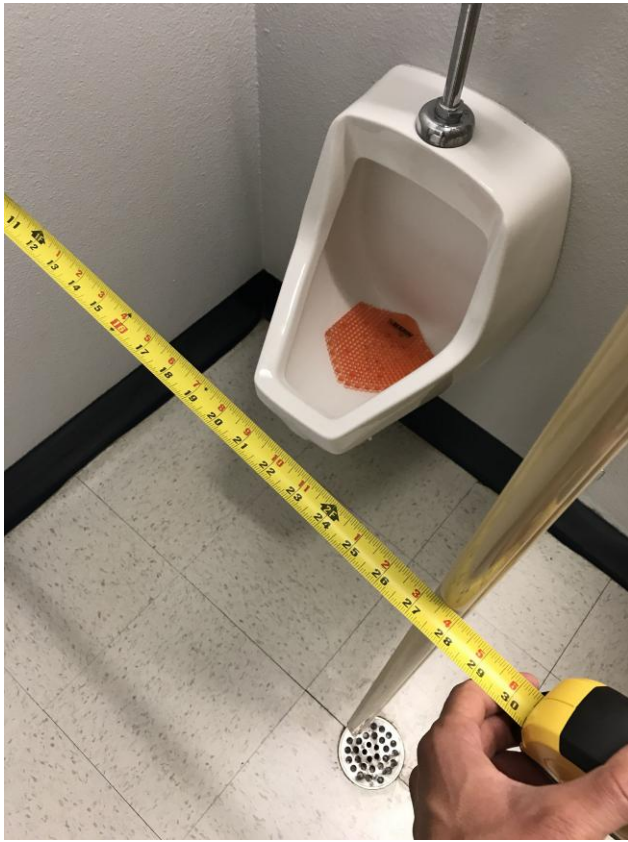
Finding 297202 Main Photo

URINAL CLEAR SPACE  
PARTITION 24" OR LESS

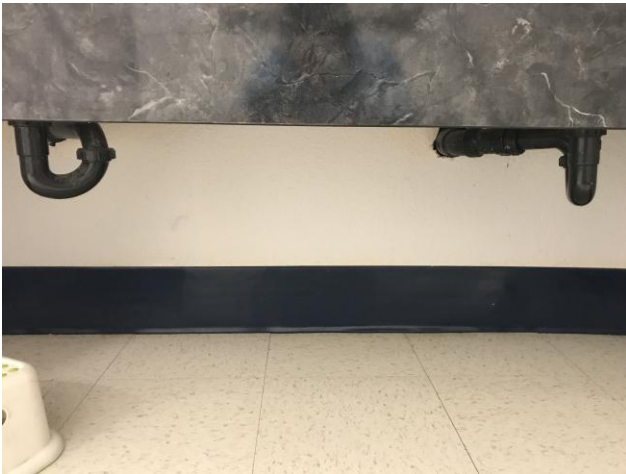
Finding 297204 Main Photo

Missing drain pipe insulation

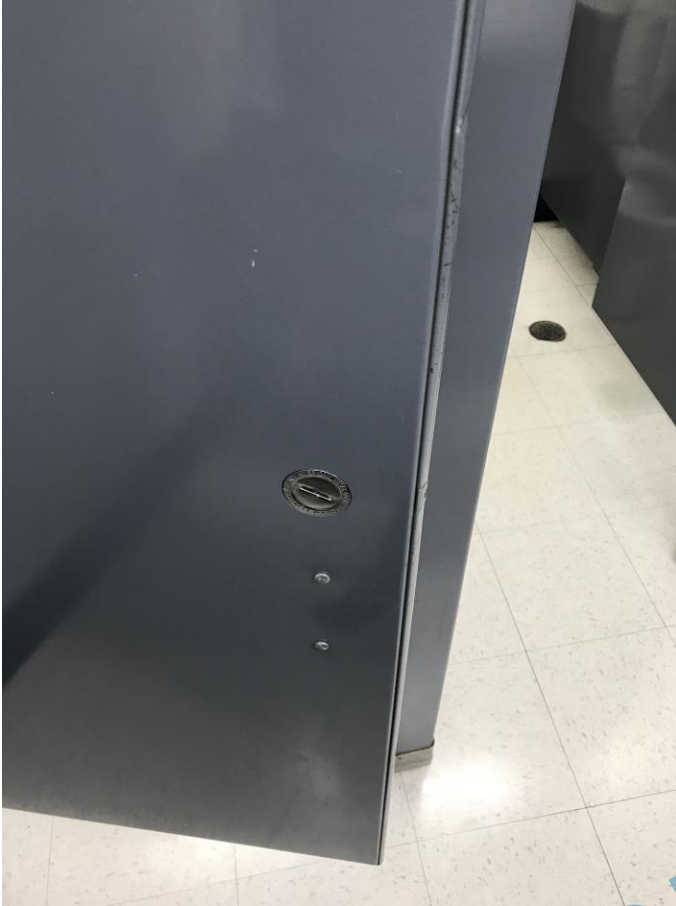
Finding 297207 Main Photo

The water closet compartment door is missing a loop handle on the outside.

Missing loop handle on the outside of compartment door

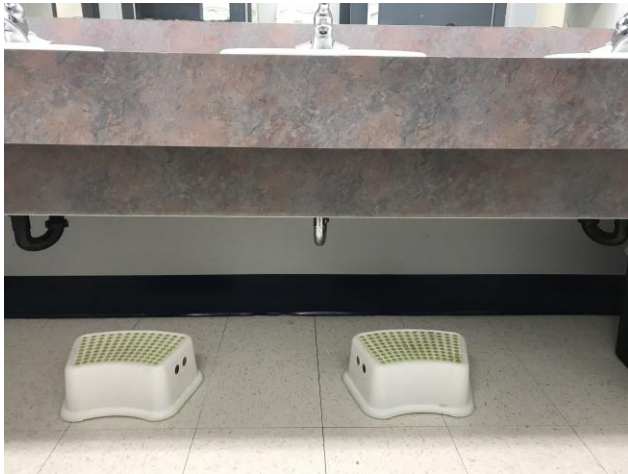
Finding 297213 Main Photo

Drain pipe insulation missing

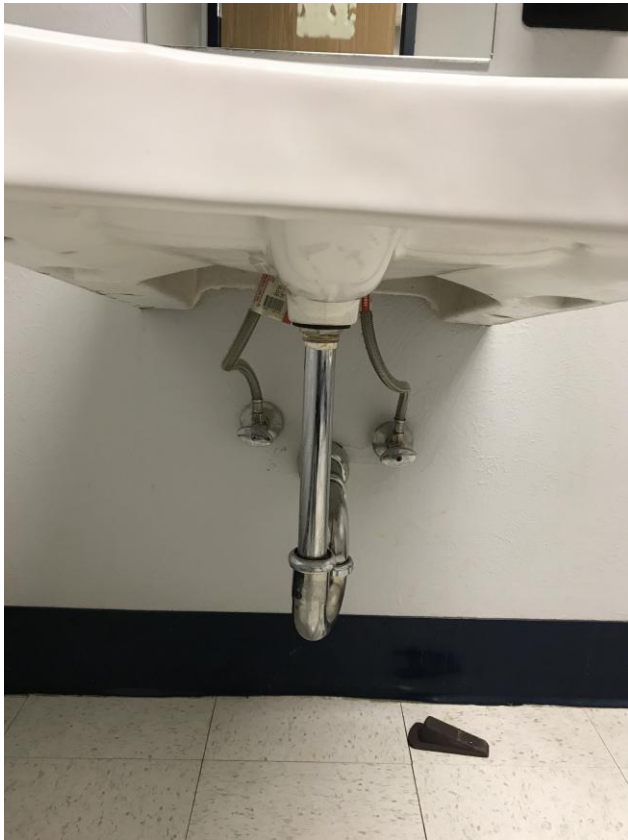
Finding 297182 Main Photo

Missing drain pipe insulation

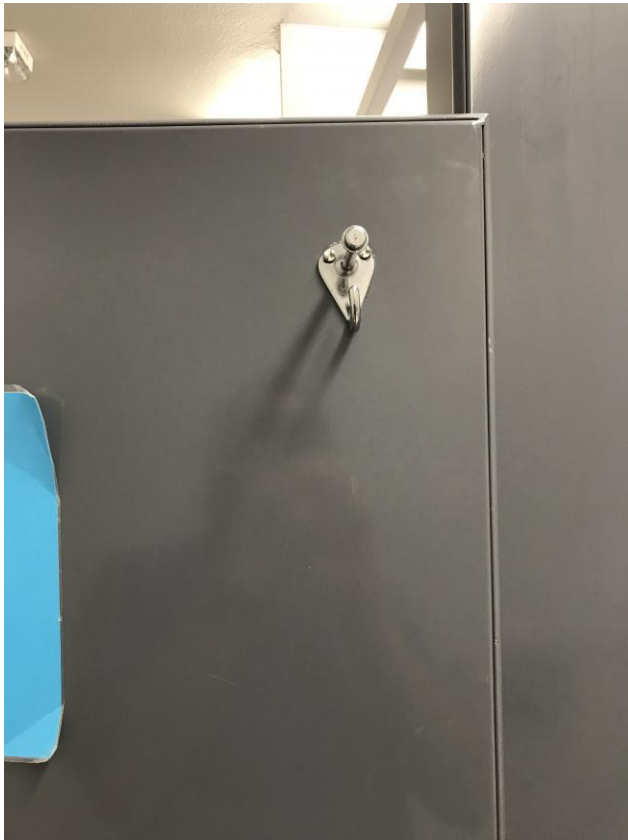
Finding #54 Continued

Considered  
Unobstructed
